PHYSICAL CONDITION REPORT

**OTIC DESIGN PROJECT NO. 71-22-12
PROSPECT ROAD BRIDGE (CR 34) OVER THE OHIO TURNPIKE
MILEPOST 182.1
SUMMIT COUNTY, OHIO**

CIG Project No.: 10043

August 2023

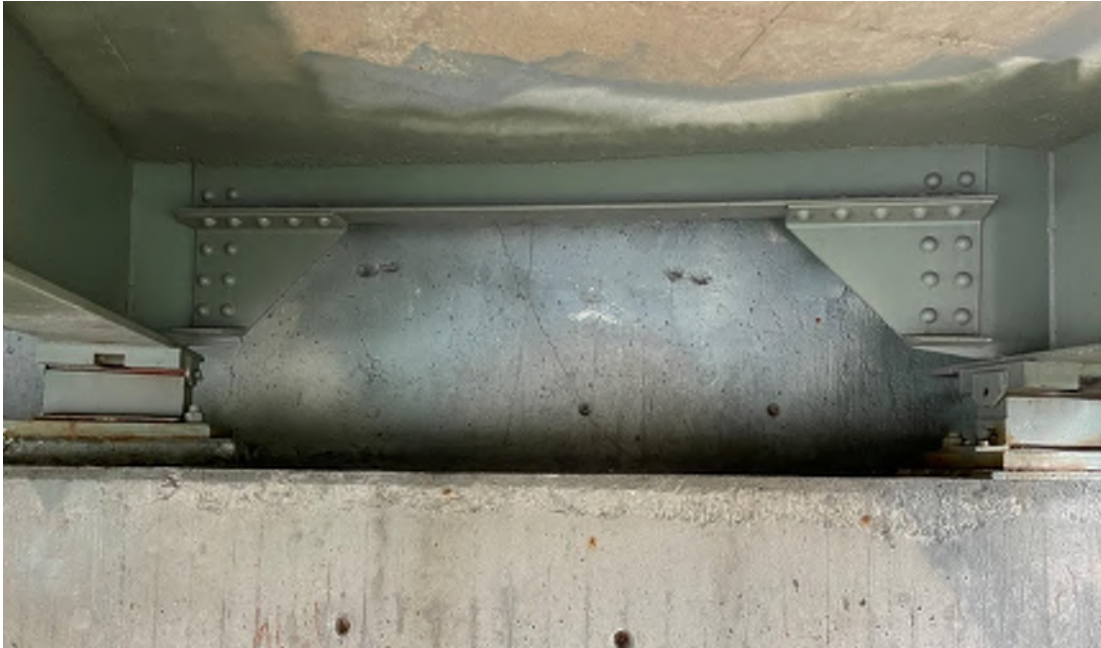
Photograph #4 - Typical End Diaphragm Condition (Main Span) MP 182.1

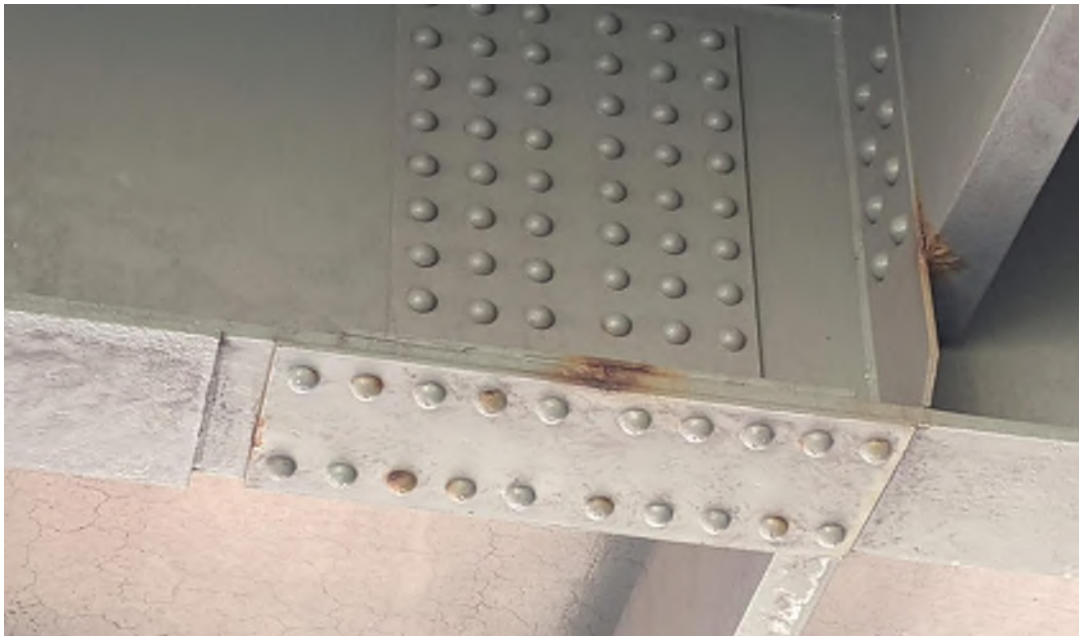
Photograph #5 - Beam 2 Splice with Light Rust, Span 1 MP 182.1

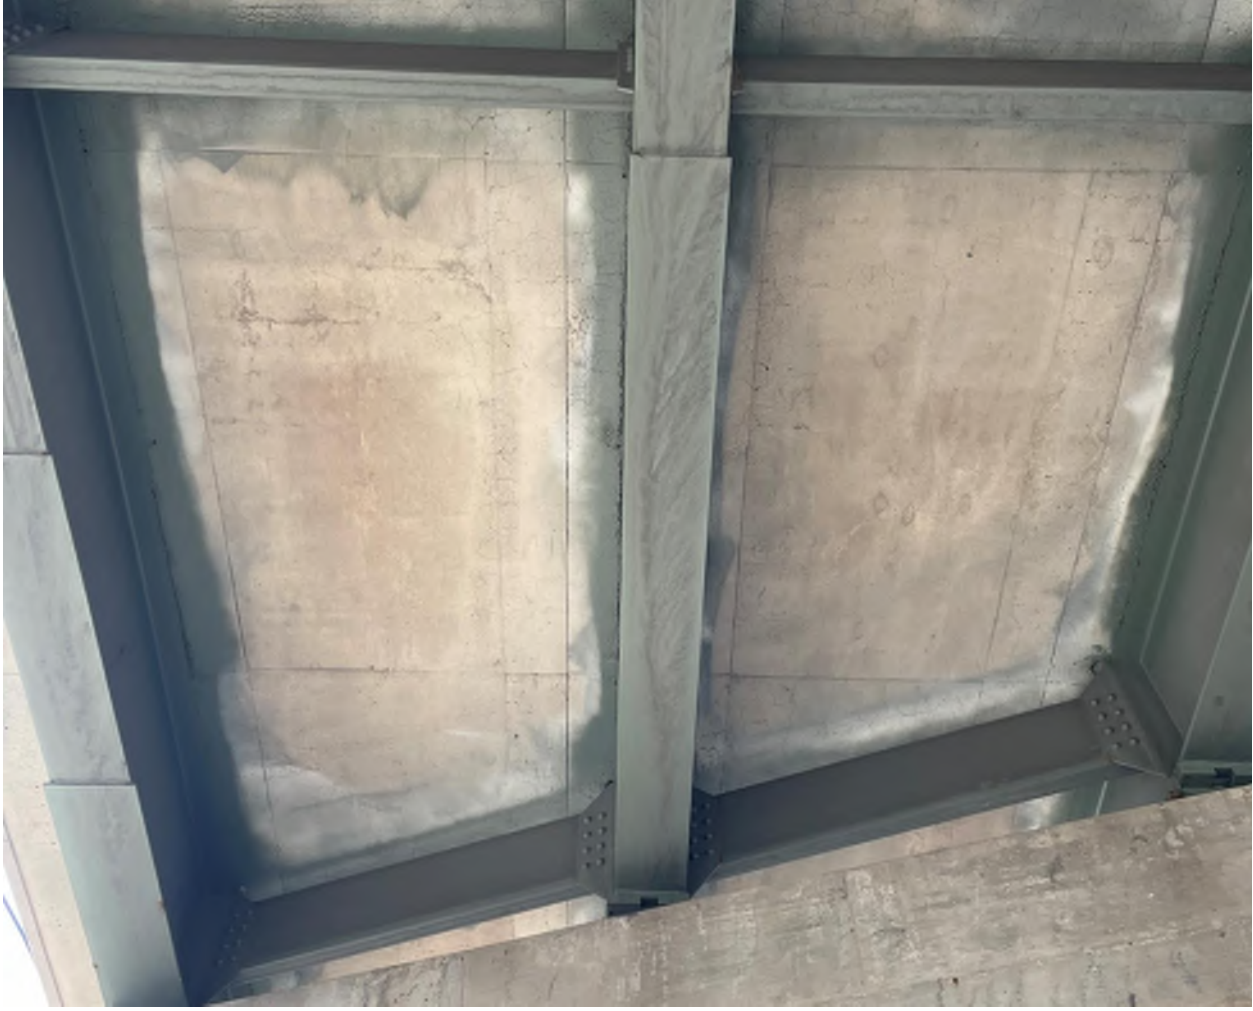
The fatigue prone connections are in good condition. For this structure the fatigue prone connections are the transverse welds at the ends of the welded moment cover plates over Pier 1, Pier 2, and Pier 3. No distress was observed in the bottom flange cover plate welds at the piers. The top flange cover plates could not be inspected because they are encased in the concrete deck and should be inspected after deck removal.

Photograph #6 - Typical Moment Plate Condition MP 182.1

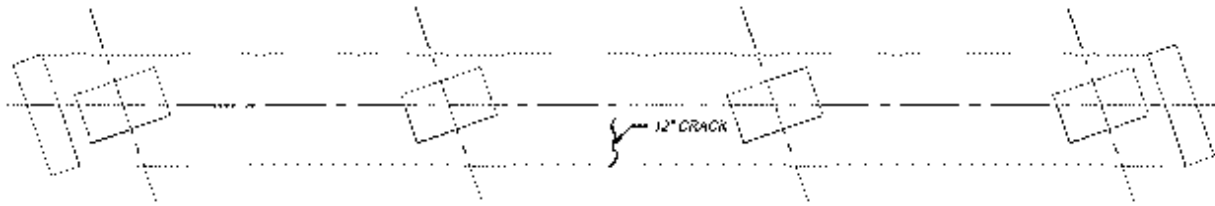
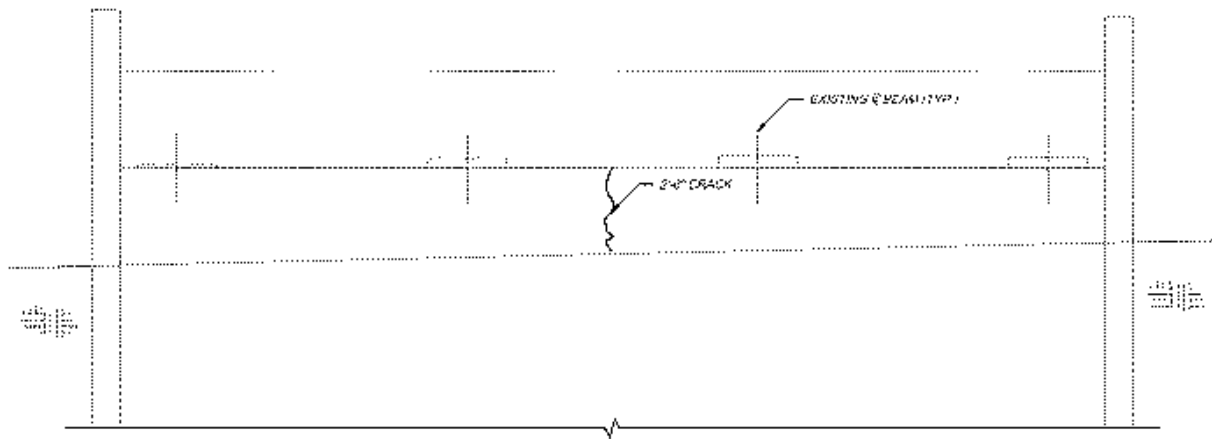
Figure 3 - Location of Proposed Concrete Repairs - Rear (South) Abutment Plan MP 182.1

Figure 4 - Location of Proposed Concrete Repairs - Rear (South) Abutment Elevation MP 182.1

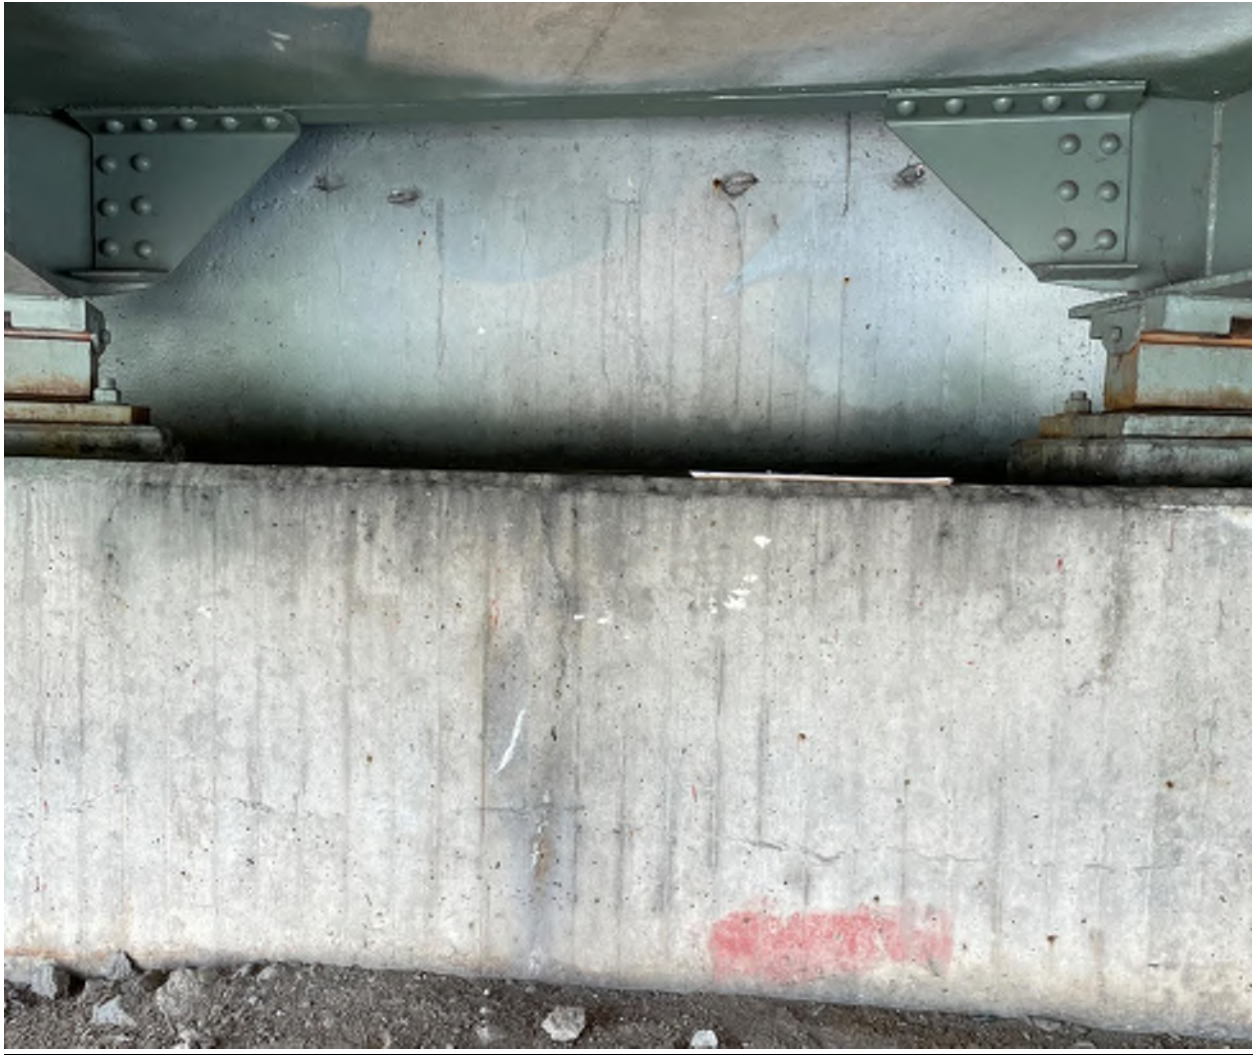
Photograph #8 - Forward (North) Abutment Vertical Crack MP 182.1

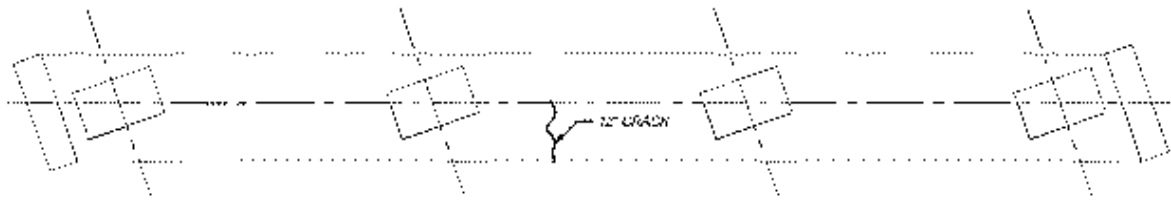
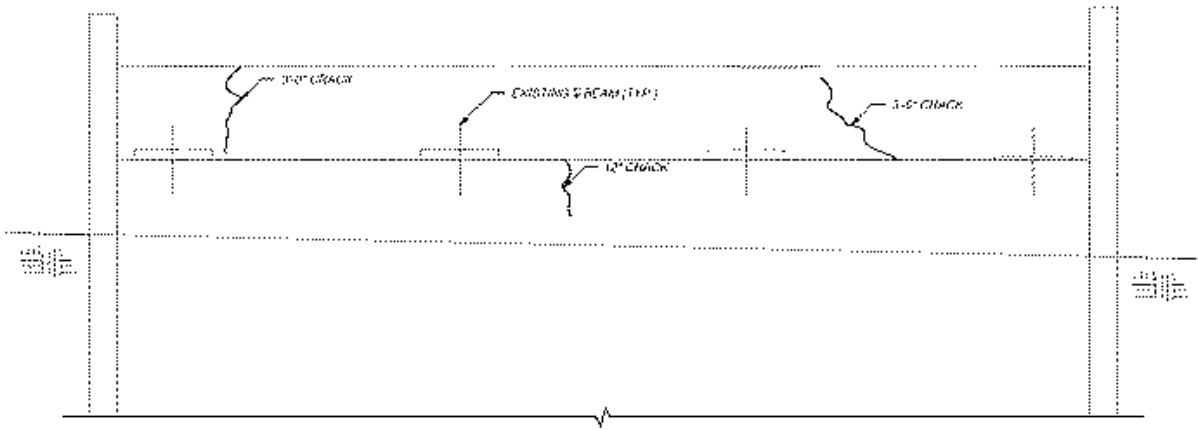
Figure 5 - Location of Proposed Concrete Repairs - Forward (North) Abutment Plan MP 182.1

Figure 6 - Location of Proposed Concrete Repairs - Forward (North) Abutment Elevation MP 182.1

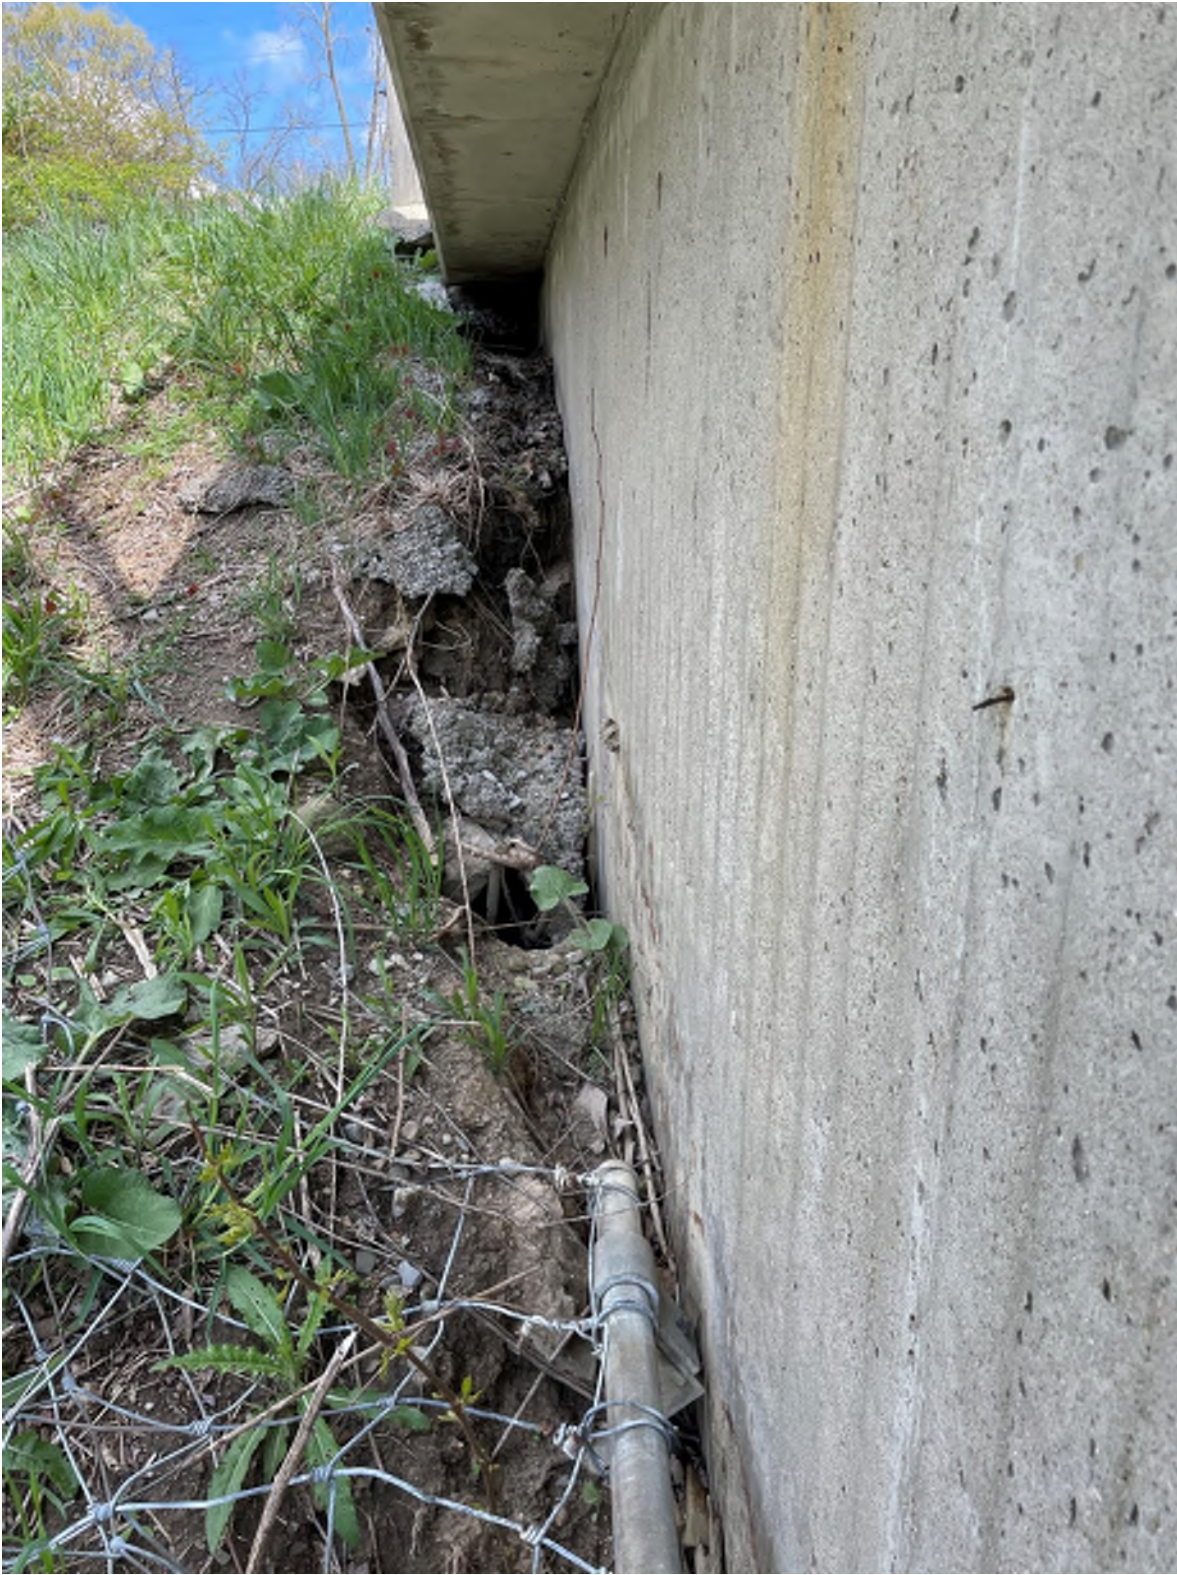
**Photograph #10 - Typical Wingwall Condition and Slope Erosion at Forward Left
(Northwest) MP 182.1**

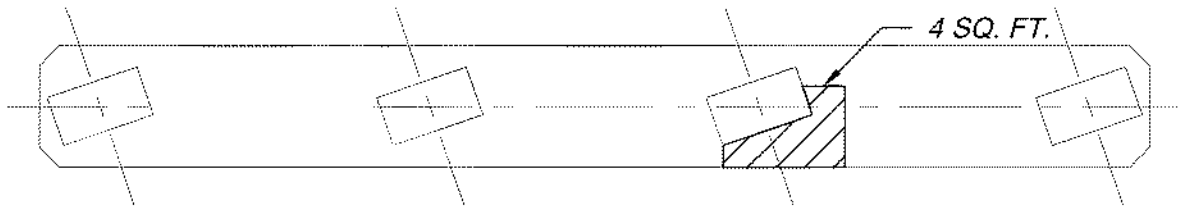
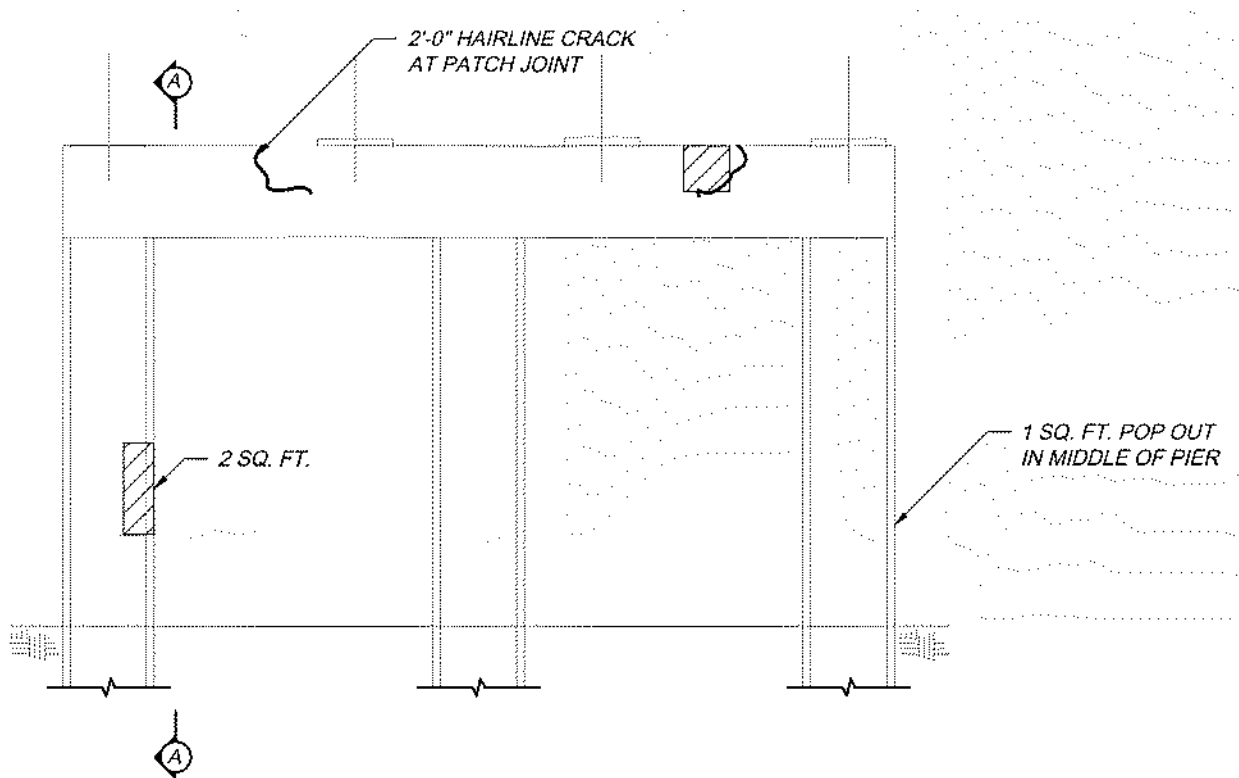
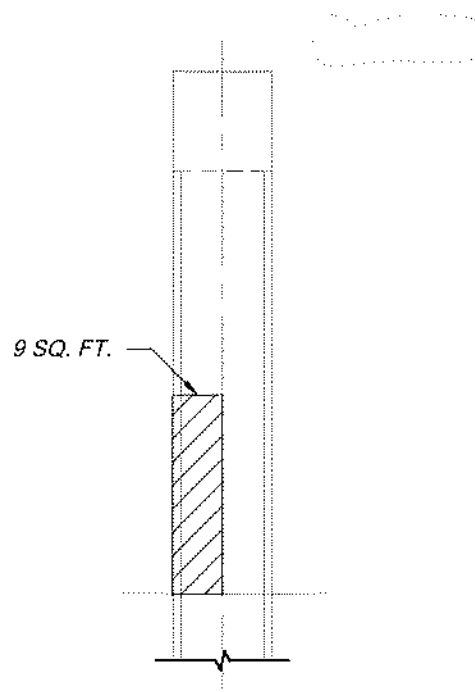
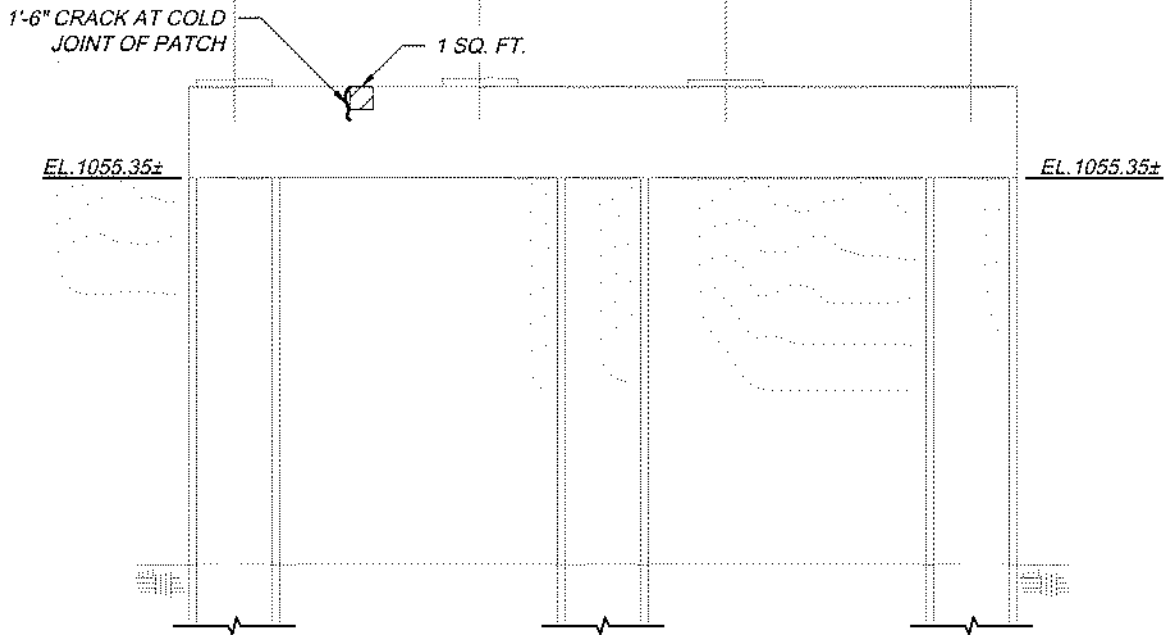
In all three pier caps, a few minor cracks were observed and measured 0.013" to 0.025" wide. Additional minor cracks exist at old patch material cold joints on both faces of Piers 1 and 3. Hammer sounding indicated localized delaminated areas on all three pier caps. The northwest corner on the cap of Pier 3 has a deep spall with reinforcing steel stirrups exposed with moderate section loss and delamination extending to the side face. This spall extends to the bearing seat pedestal, which is missing a corner of concrete extending to the bearing masonry plate with the plate overhanging 1/8".

Pier 1 Column 1 has minor delamination present on the traffic face (north face) that extends onto the west face. No deterioration was observed to Pier 2 columns. Pier 3 Column 2 has minor delamination on the traffic face (south face) that leads to the east face. Pier 3 Column 3 has a spall in the patch on the south east corner, exposing three stirrups with minor section loss. The entire patch on the west, south, and east faces and a halo around the patch are delaminated with wire mesh rust showing through on the face.

Figure 7 - Location of Proposed Concrete Repairs - Pier 1 Plan View MP 182.1

**Figure 8 - Location of Proposed Concrete Repairs - Pier 1 Downstation (North) Face
Elevation MP 182.1**

Figure 8 - Location of Proposed Concrete Repairs - Pier 1 View A-A MP 182.1

**Figure 10 - Location of Proposed Concrete Repairs - Pier 1 Upstation (South) Face
Elevation MP 182.1**

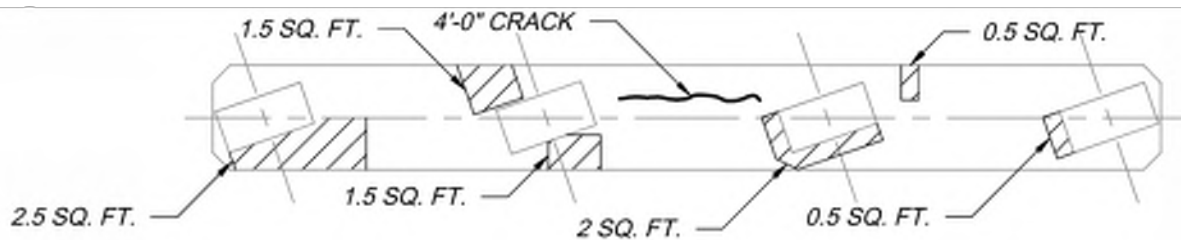
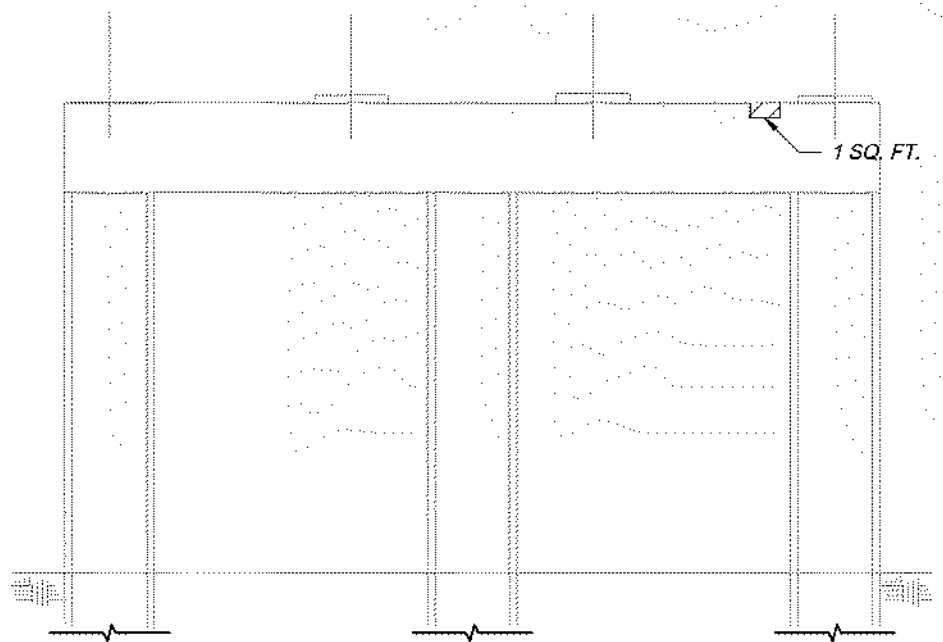
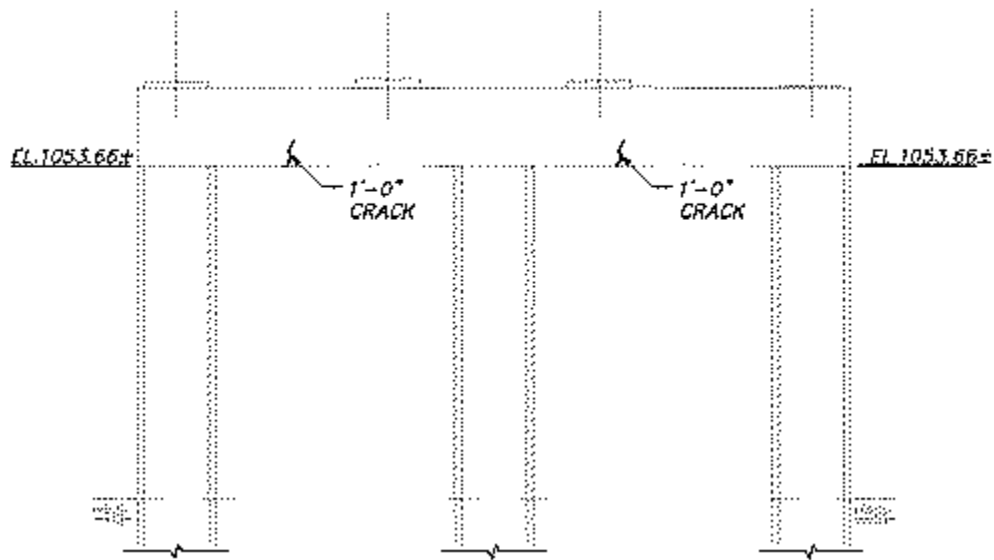
Figure 11 - Location of Proposed Concrete Repairs - Pier 2 Plan View MP 182.1

Figure 12 - Location of Proposed Concrete Repairs - Pier 2 Upstation (South) Face
Elevation MP 182.1

Figure 13 - Location of Proposed Concrete Repairs - Pier 2 Downstation (North) Face
Elevation MP 182.1

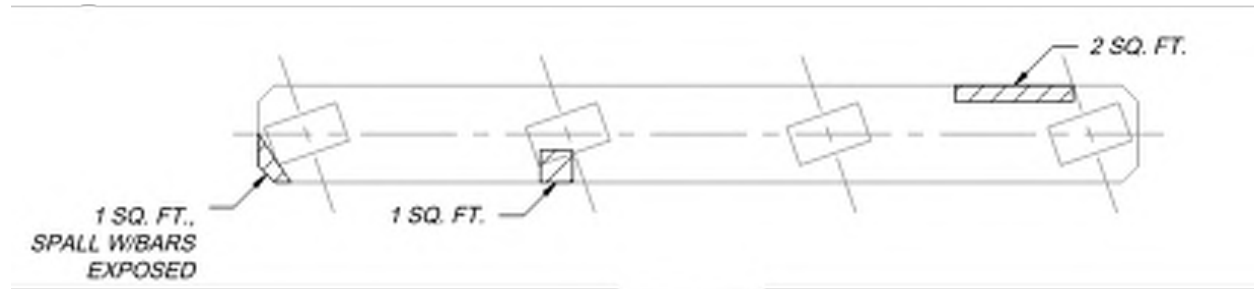
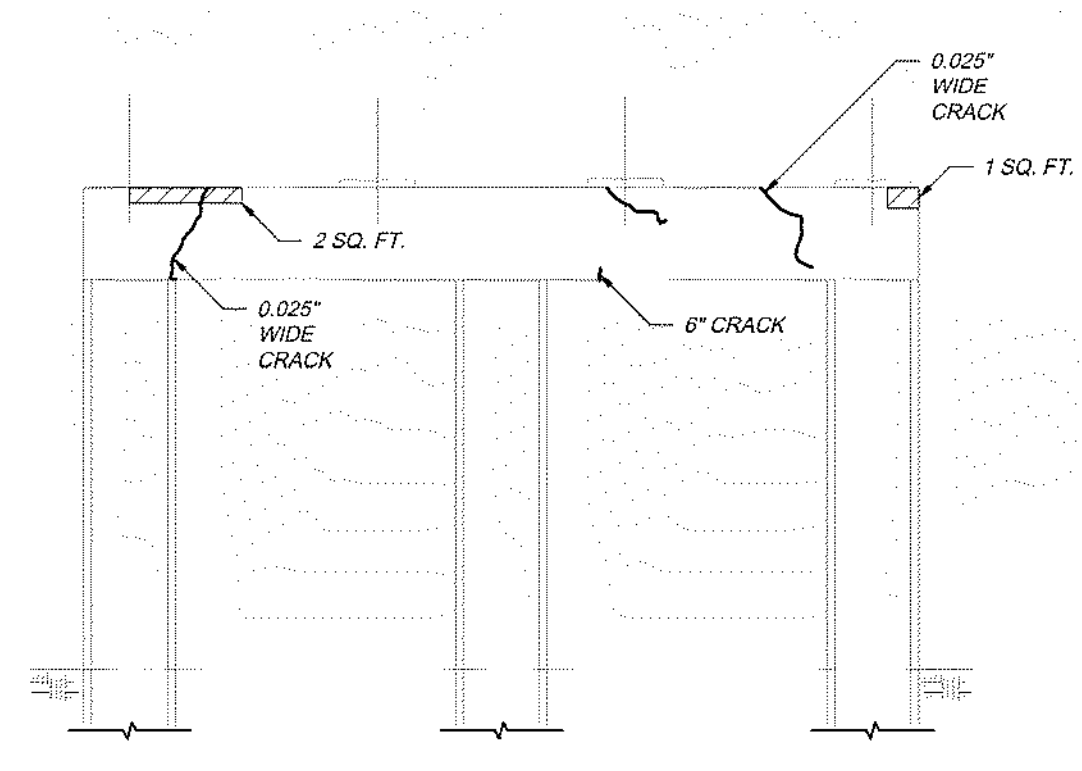
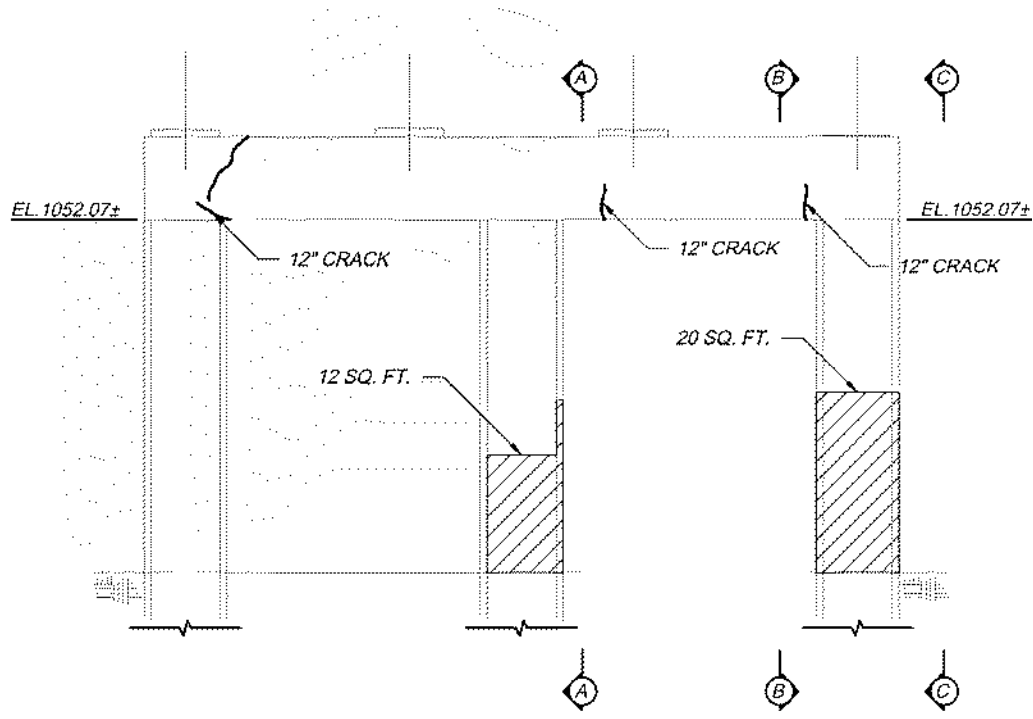
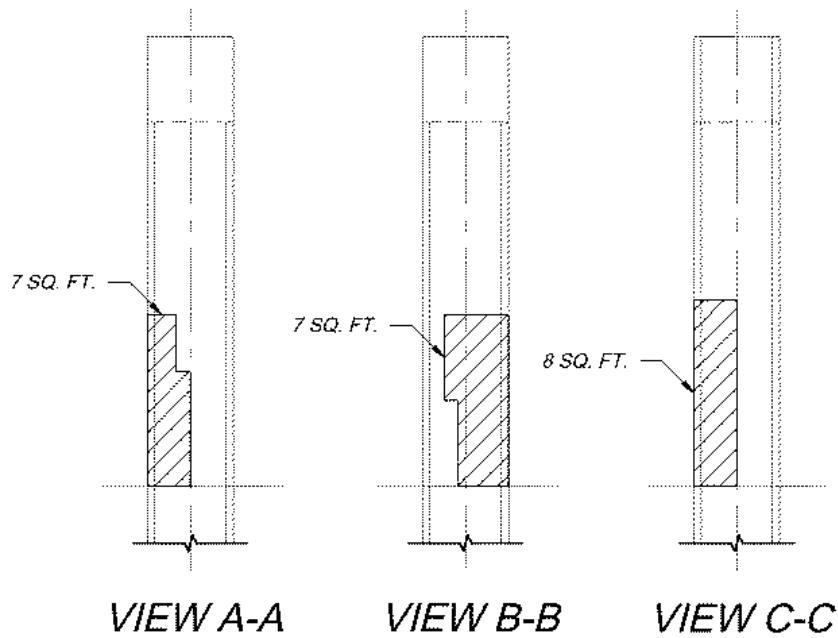
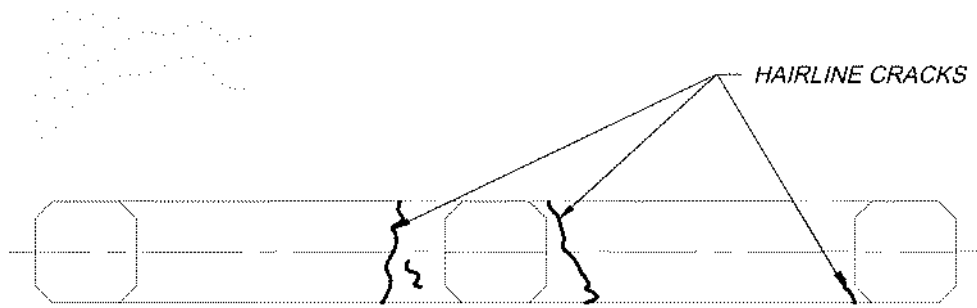
Figure 14 - Location of Proposed Concrete Repairs - Pier 3 Plan View MP 182.1

Figure 15 - Location of Proposed Concrete Repairs - Pier 3 Upstation (South) Face Elevation MP 182.1

**Figure 16 - Location of Proposed Concrete Repairs - Pier 3 Downstation (North) Face
Elevation MP 182.1**

Figure 17 - Location of Proposed Concrete Repairs - Pier 3 View A-A - View C-C MP 182.1

Figure 18 - Location of Proposed Concrete Repairs - Pier 3 Underside of Pier Cap MP 182.1

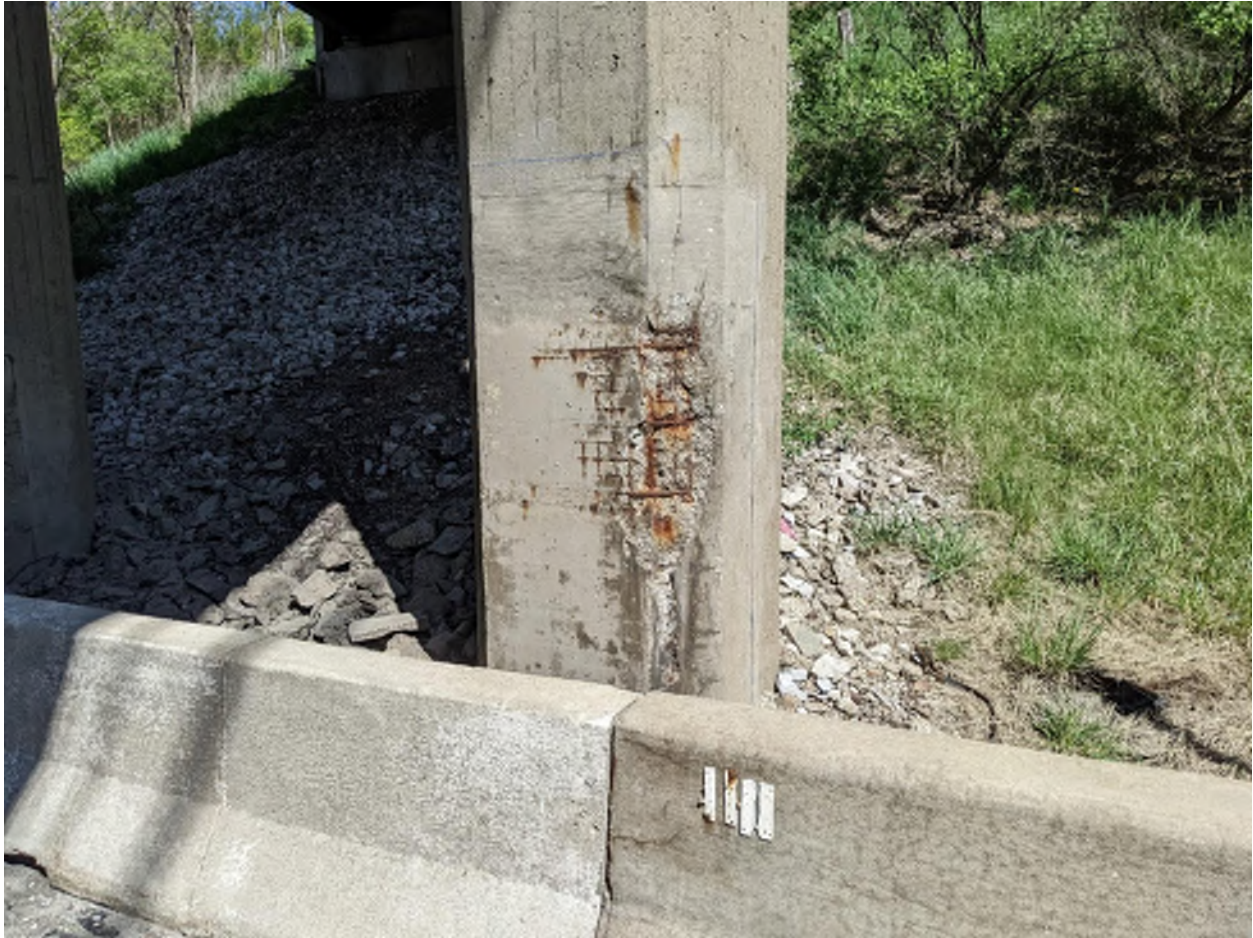
Photograph #12 - Pier 3 Column 3 Spall MP 182.1

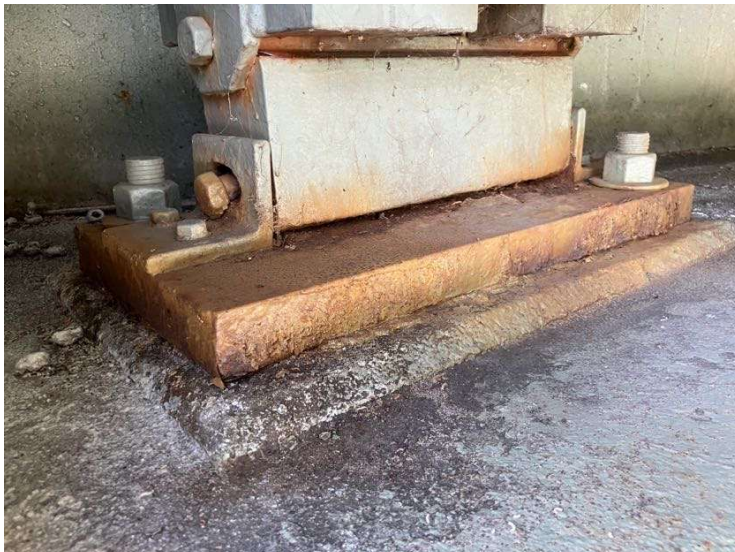
PHOTO 3
View of steel bearing. No
gasketing material observed.

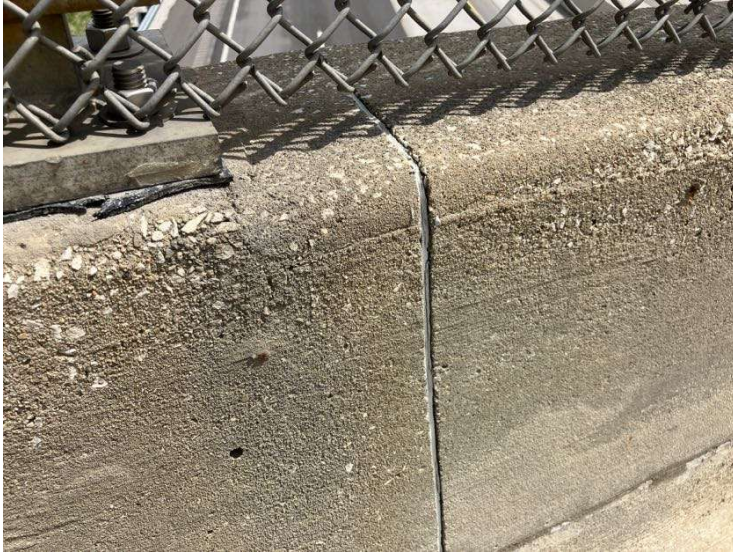
PHOTO 4

View of typical joint on parapet wall. Samples taken of caulk material.

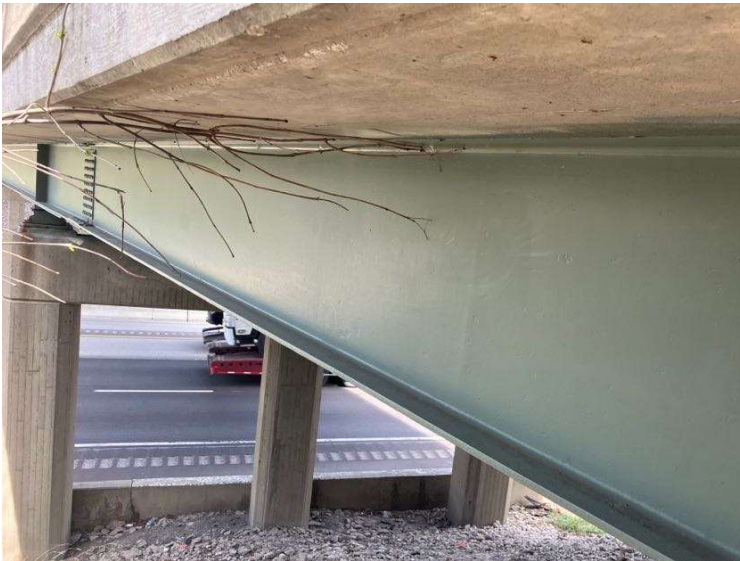
PHOTO 5

View of outer beam. Paint in good condition.

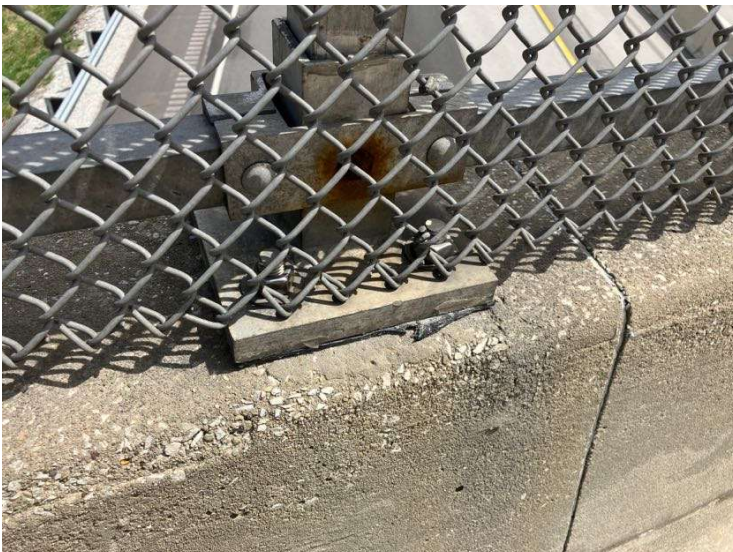
PHOTO 6

View of the vandal fence base plate. Samples taken of caulk material.
