# PHYSICAL CONDITION REPORT

**OTIC DESIGN PROJECT NO. 71-22-12  
PROSPECT ROAD BRIDGE (CR 34) OVER THE OHIO TURNPIKE  
MILEPOST 182.1  
SUMMIT COUNTY, OHIO**

**CIG Project No.: 10043**

*August 2023*

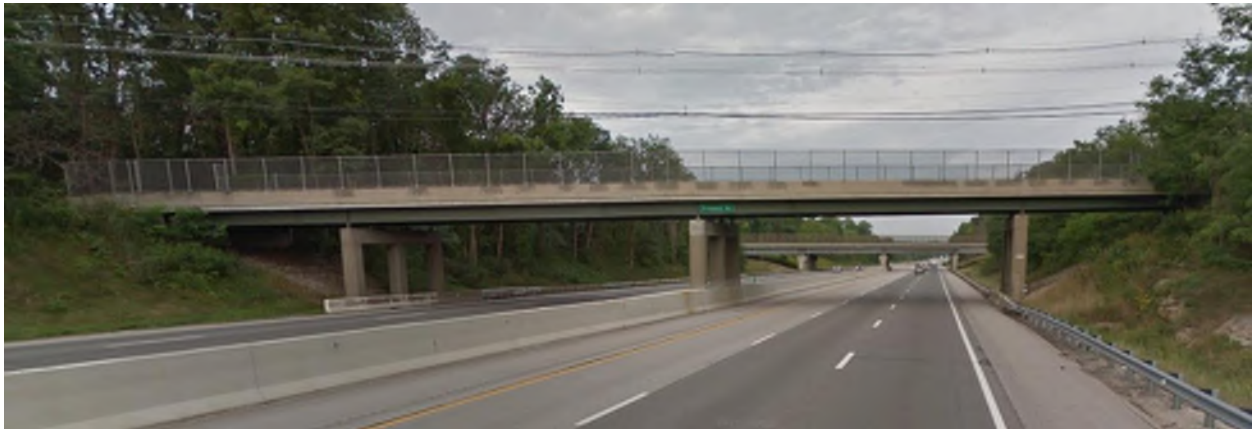
**Photograph #1 - Partial Elevation of Right Fascia (looking West)**

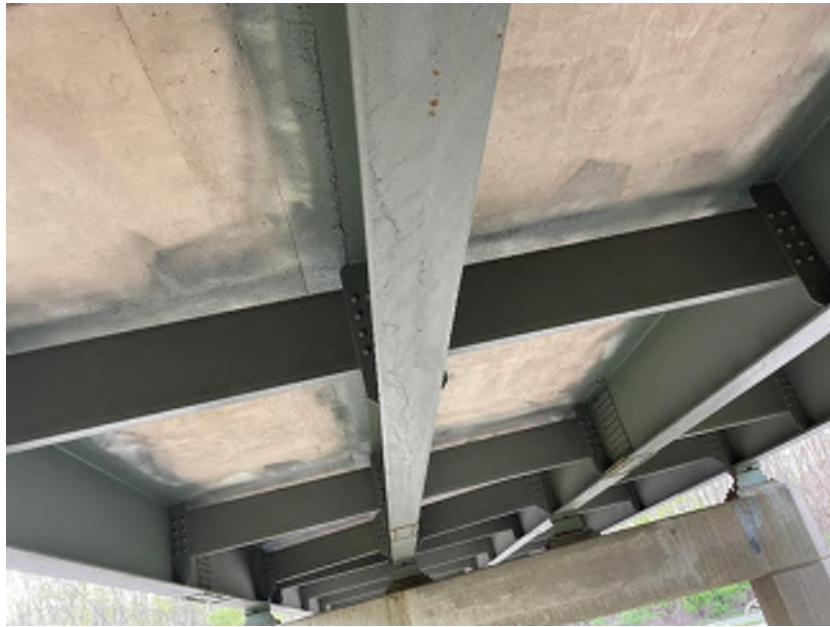
The rolled steel beams are in good condition and received a system OZEU painting in 2008. The beams exhibit localized patches of rust-stained protective coating system, and light surface rust in small patches along the bottom flange where the protective coating system has failed. These minor rust locations are small patches less than 3" wide. The moment plates and splices of the beams are in similar condition. The end diaphragms at the abutments are in good condition. The current condition of the protective coating system does not warrant replacement at this time.

**Photograph #2 - Typical Beam and Intermediate Diaphragm Condition (End Spans) MP 182.1**

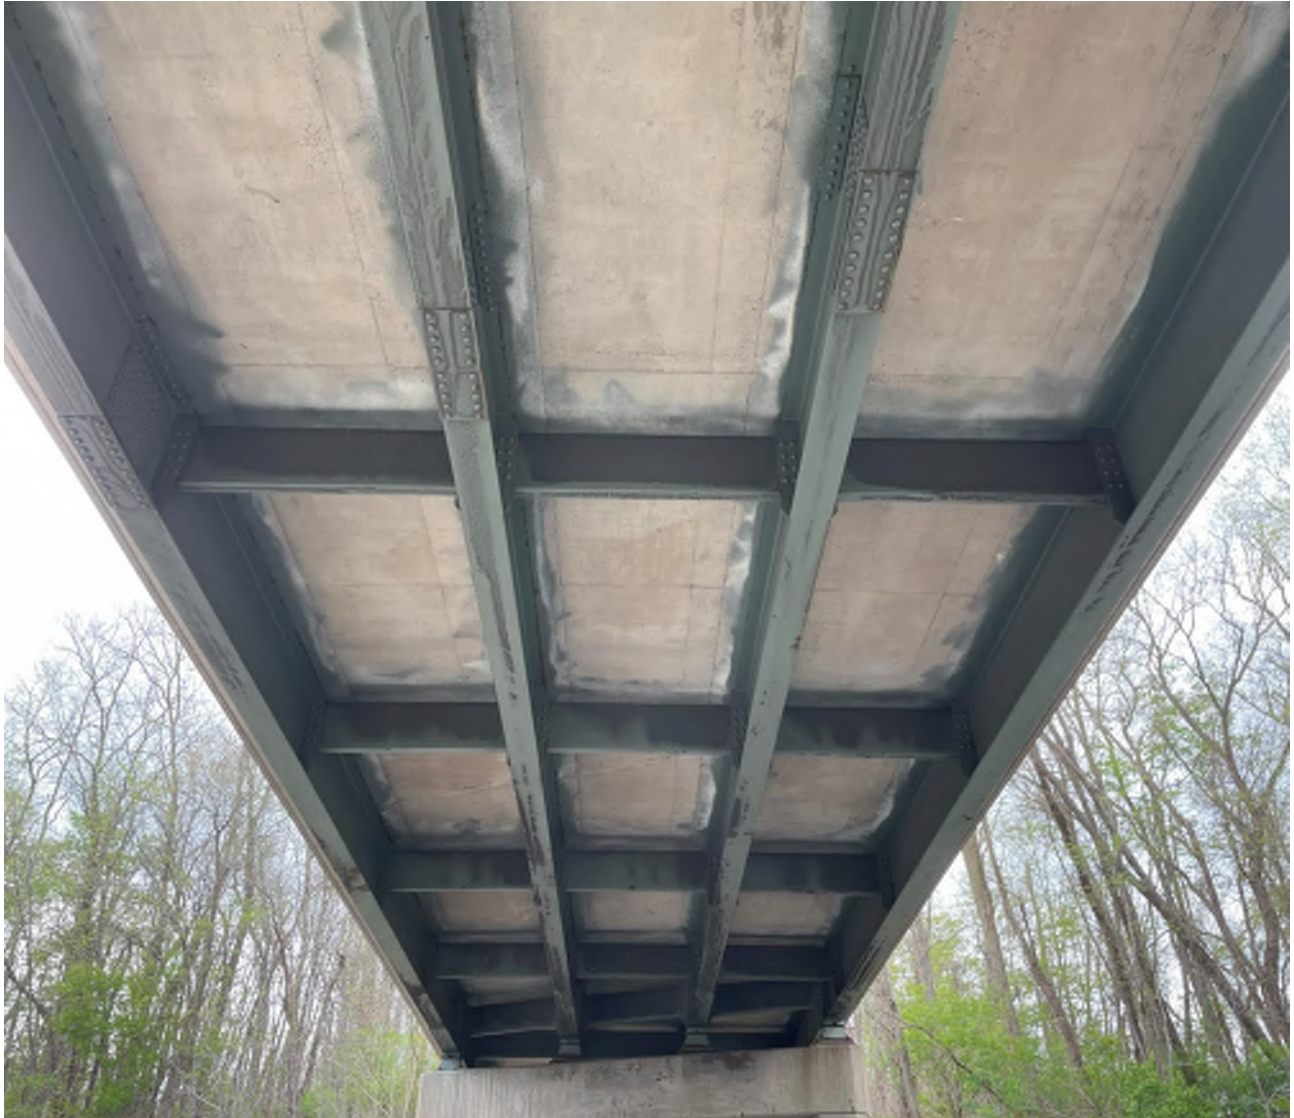
**Photograph #3 - Typical Beam and Intermediate Diaphragm Condition (Main Spans) MP 182.1**

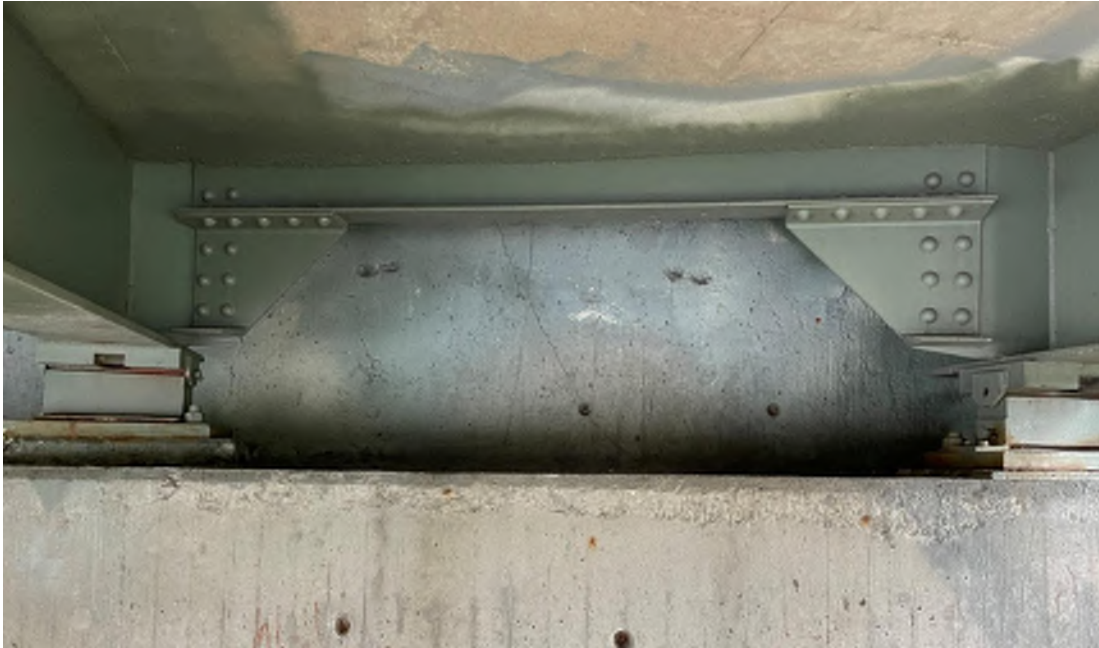
**Photograph #4 - Typical End Diaphragm Condition (Main Span) MP 182.1**

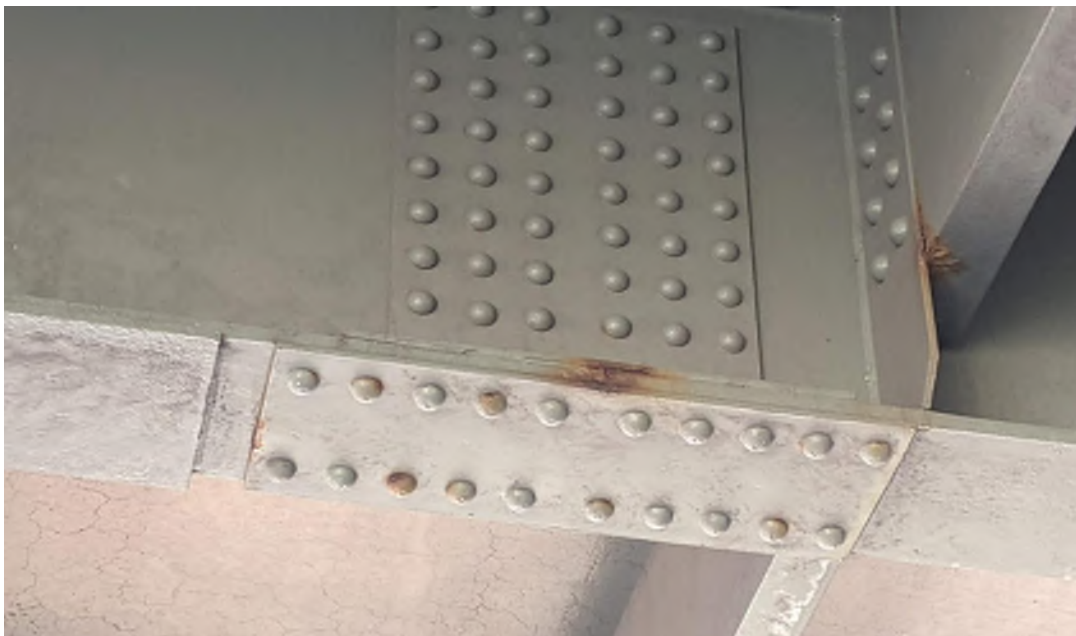
**Photograph #5 - Beam 2 Splice with Light Rust, Span 1 MP 182.1**

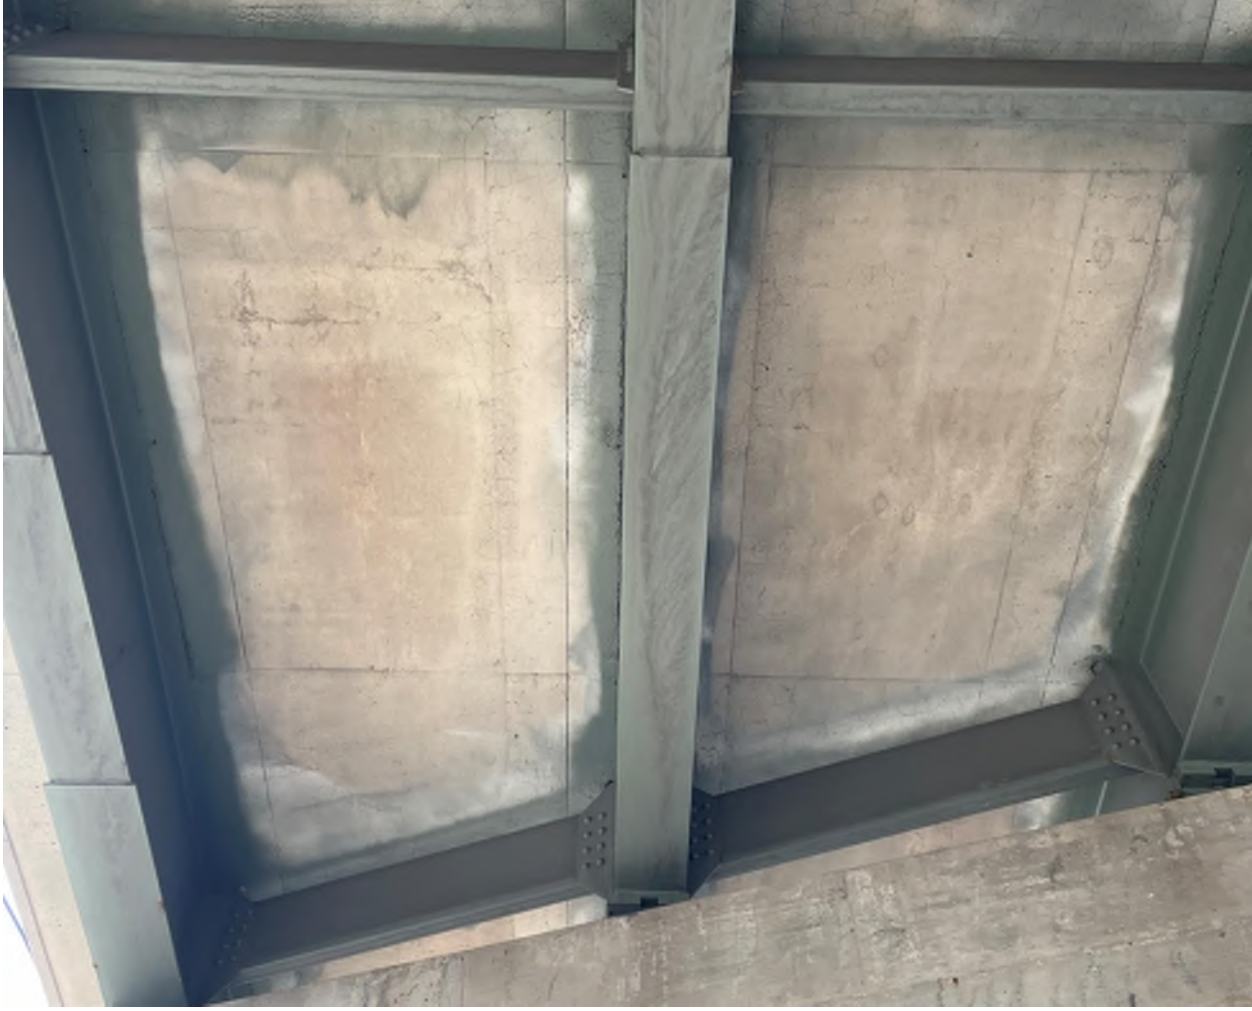
The fatigue prone connections are in good condition. For this structure the fatigue prone connections are the transverse welds at the ends of the welded moment cover plates over Pier 1, Pier 2, and Pier 3. No distress was observed in the bottom flange cover plate welds at the piers. The top flange cover plates could not be inspected because they are encased in the concrete deck and should be inspected after deck removal.

**Photograph #6 - Typical Moment Plate Condition MP 182.1**

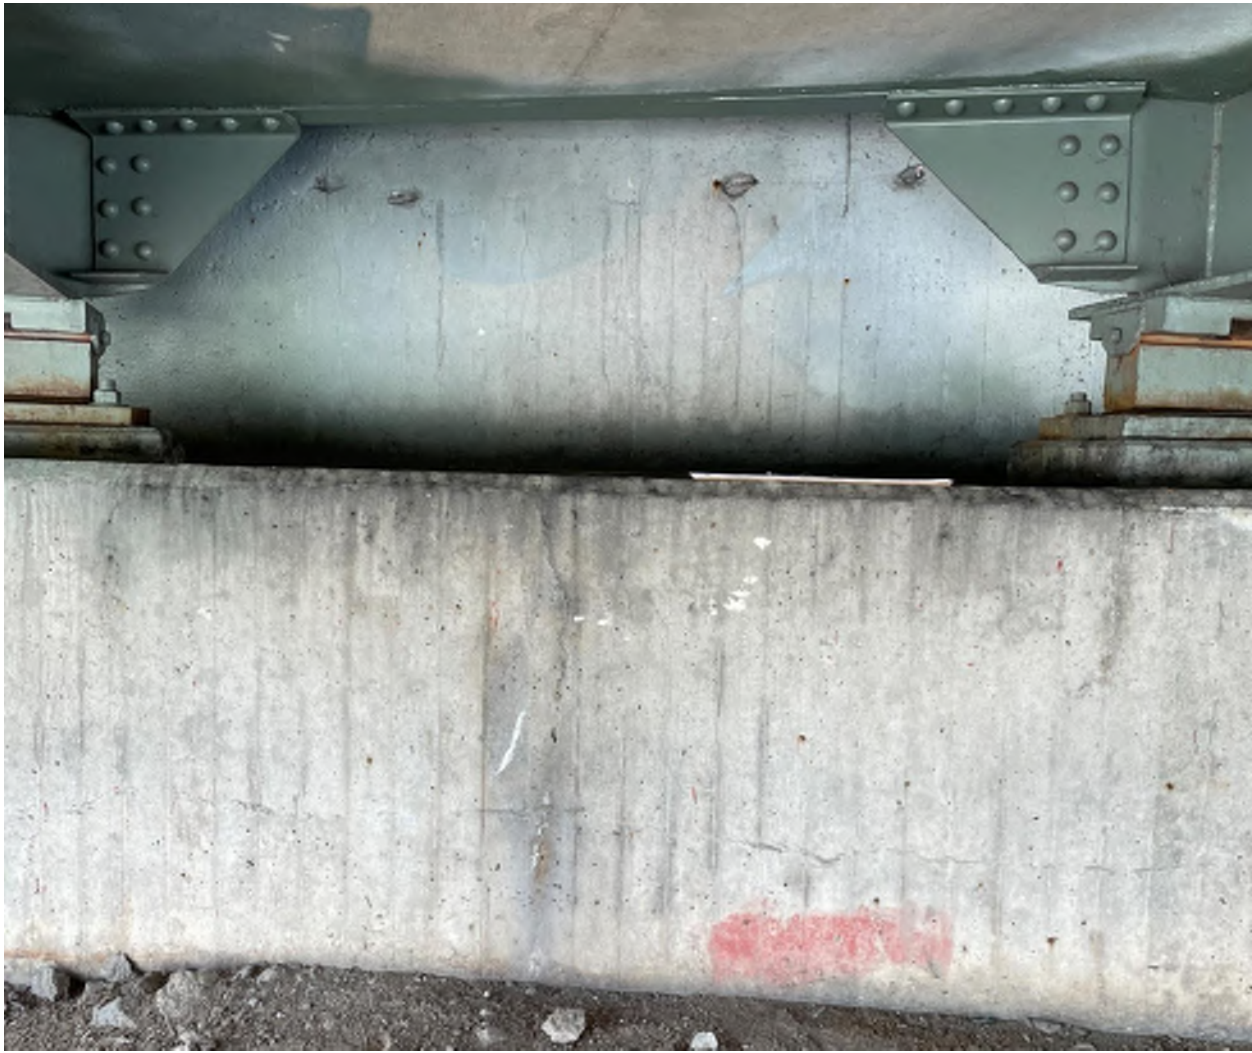
The abutments are in good condition. No spalls were observed on the exposed portions of the backwall. The exposed portions of the abutment stems are also free from spalls but do have some minor vertical cracks. No evidence of deterioration on the exposed faces of the wingwalls was observed. The catch basins at the north approach have failed. The northeast catch basin has collapsed in on itself, and the northwest catch basin has erosion and piping around the drain pipe. These drainage issues are causing the embankment along the wingwalls to erode, pulling away from the side faces of the north abutment wingwalls. The following figures and sketches indicate the limits of cracks recommended to be repaired via epoxy injection to protect against further deterioration in the future. In addition the erosion around the wingwalls should be backfilled with rock channel protection to mitigate further erosion regardless of repairs to the catch basins.

**Photograph #7 - Rear (South) Abutment Vertical Crack MP 182.1**

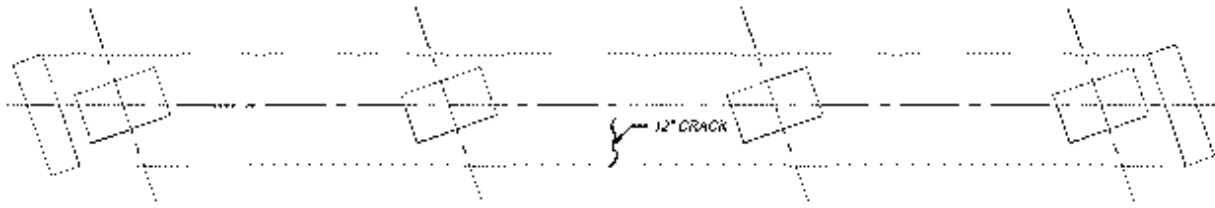
**Figure 3 - Location of Proposed Concrete Repairs - Rear (South) Abutment Plan MP 182.1**

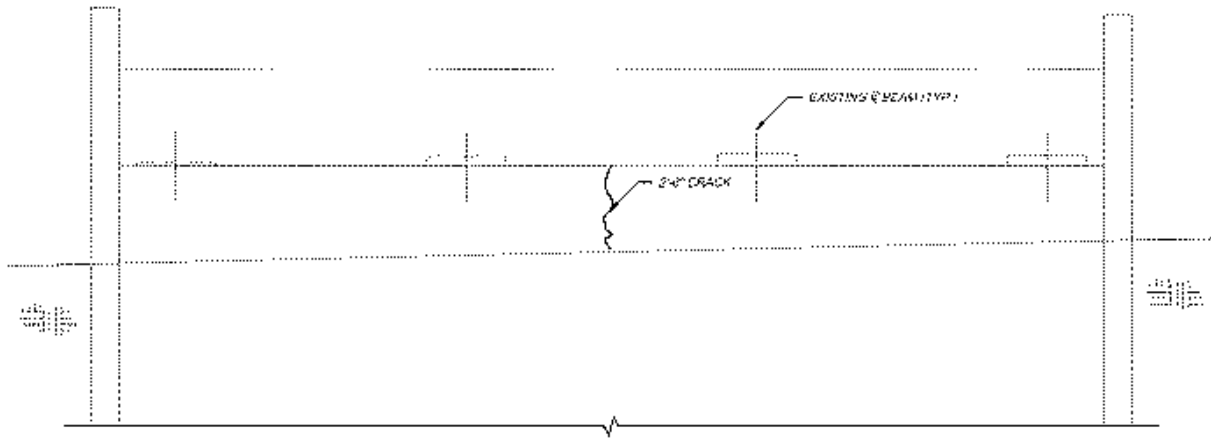
**Figure 4 - Location of Proposed Concrete Repairs - Rear (South) Abutment Elevation MP 182.1**

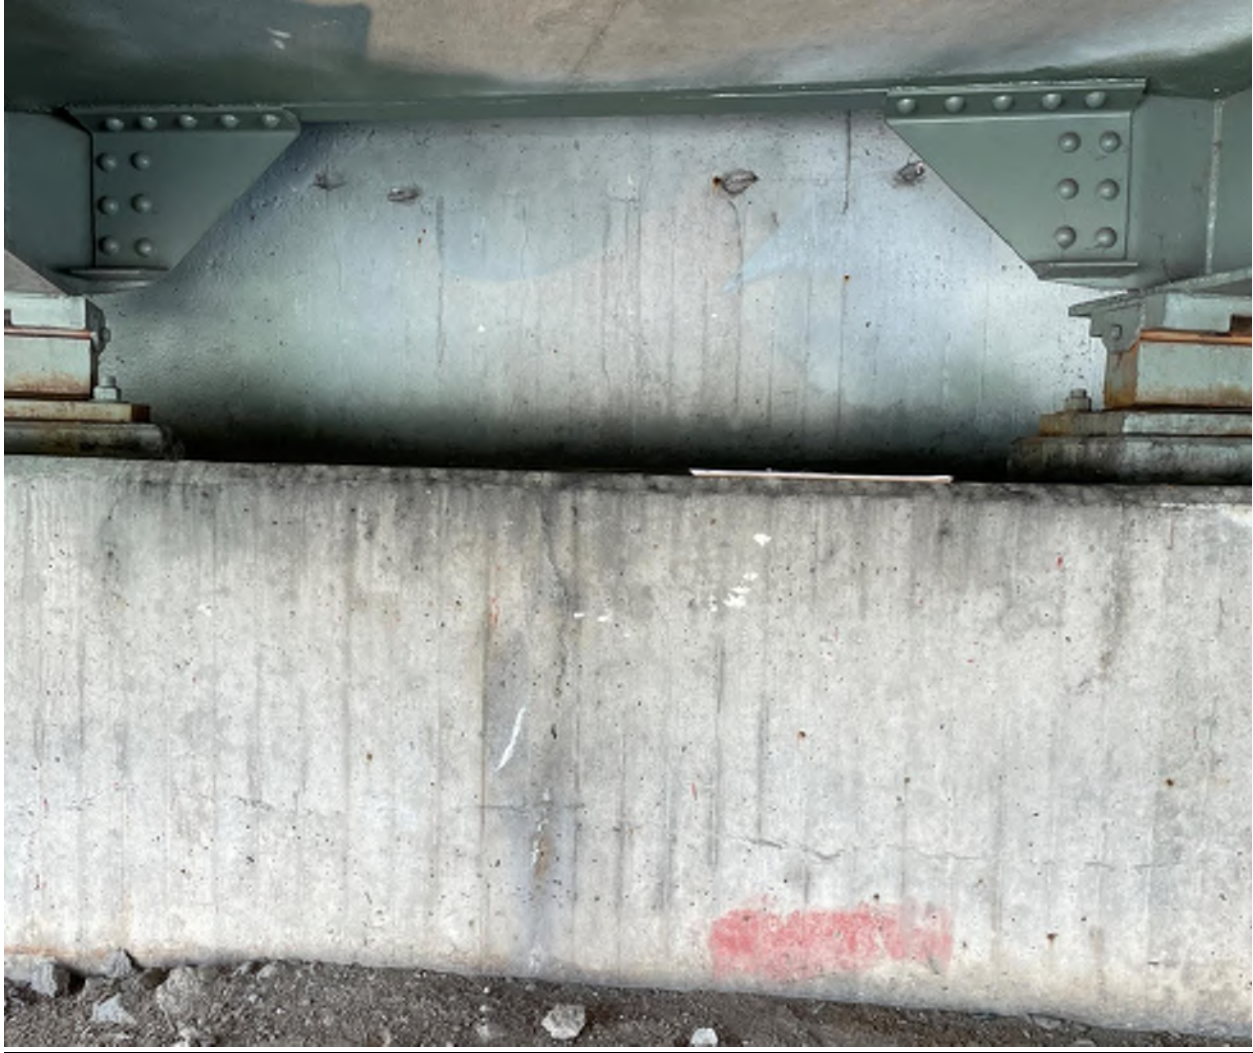
Photograph #8 - Forward (North) Abutment Vertical Crack MP 182.1

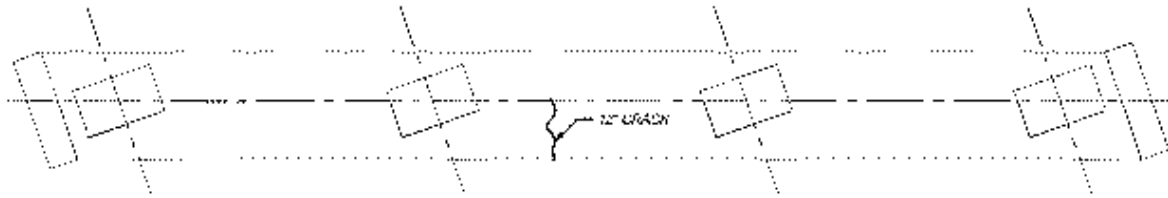
**Figure 5 - Location of Proposed Concrete Repairs - Forward (North) Abutment Plan MP 182.1**

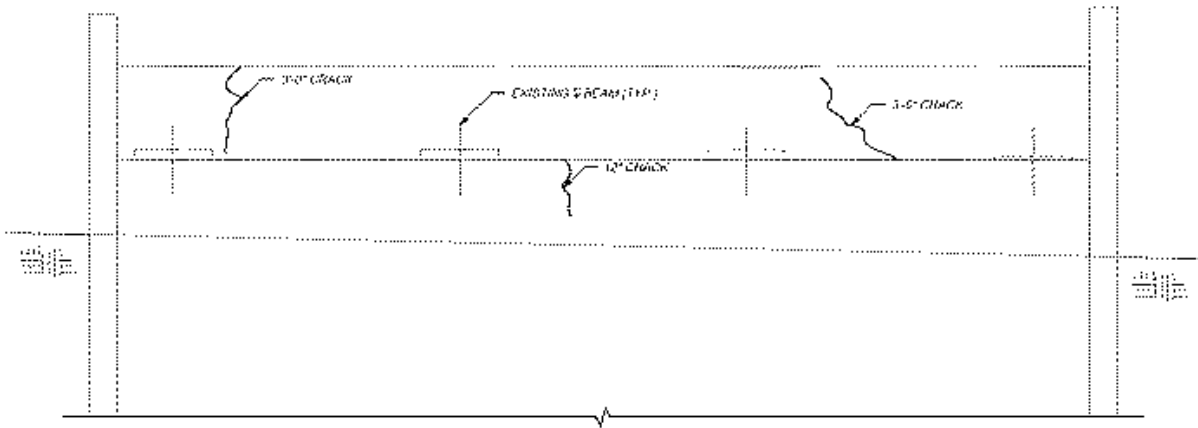
**Figure 6 - Location of Proposed Concrete Repairs - Forward (North) Abutment Elevation MP 182.1**

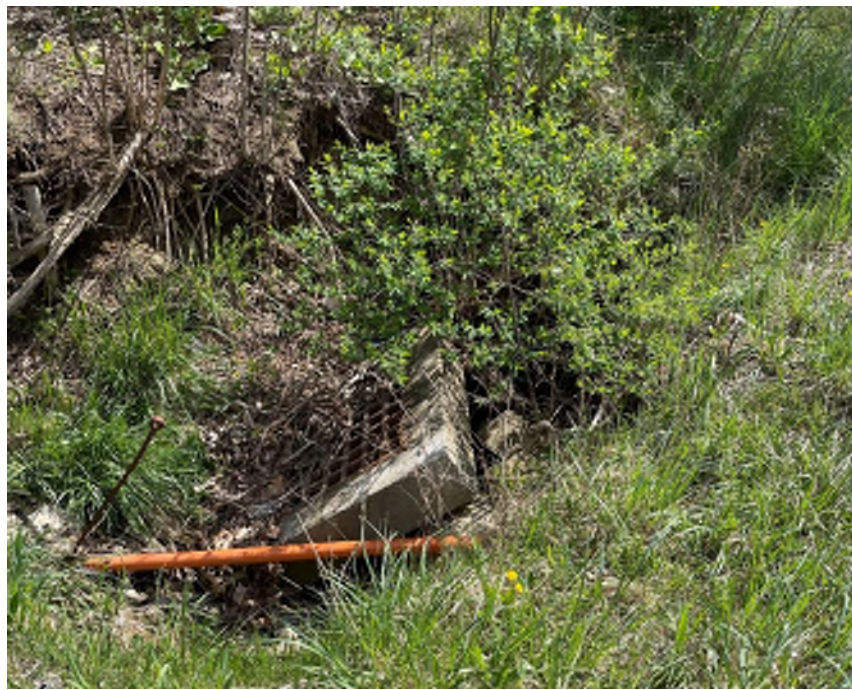
**Photograph #9 - Collapsed Forward Right (Northeast) Catch basin MP 182.1**

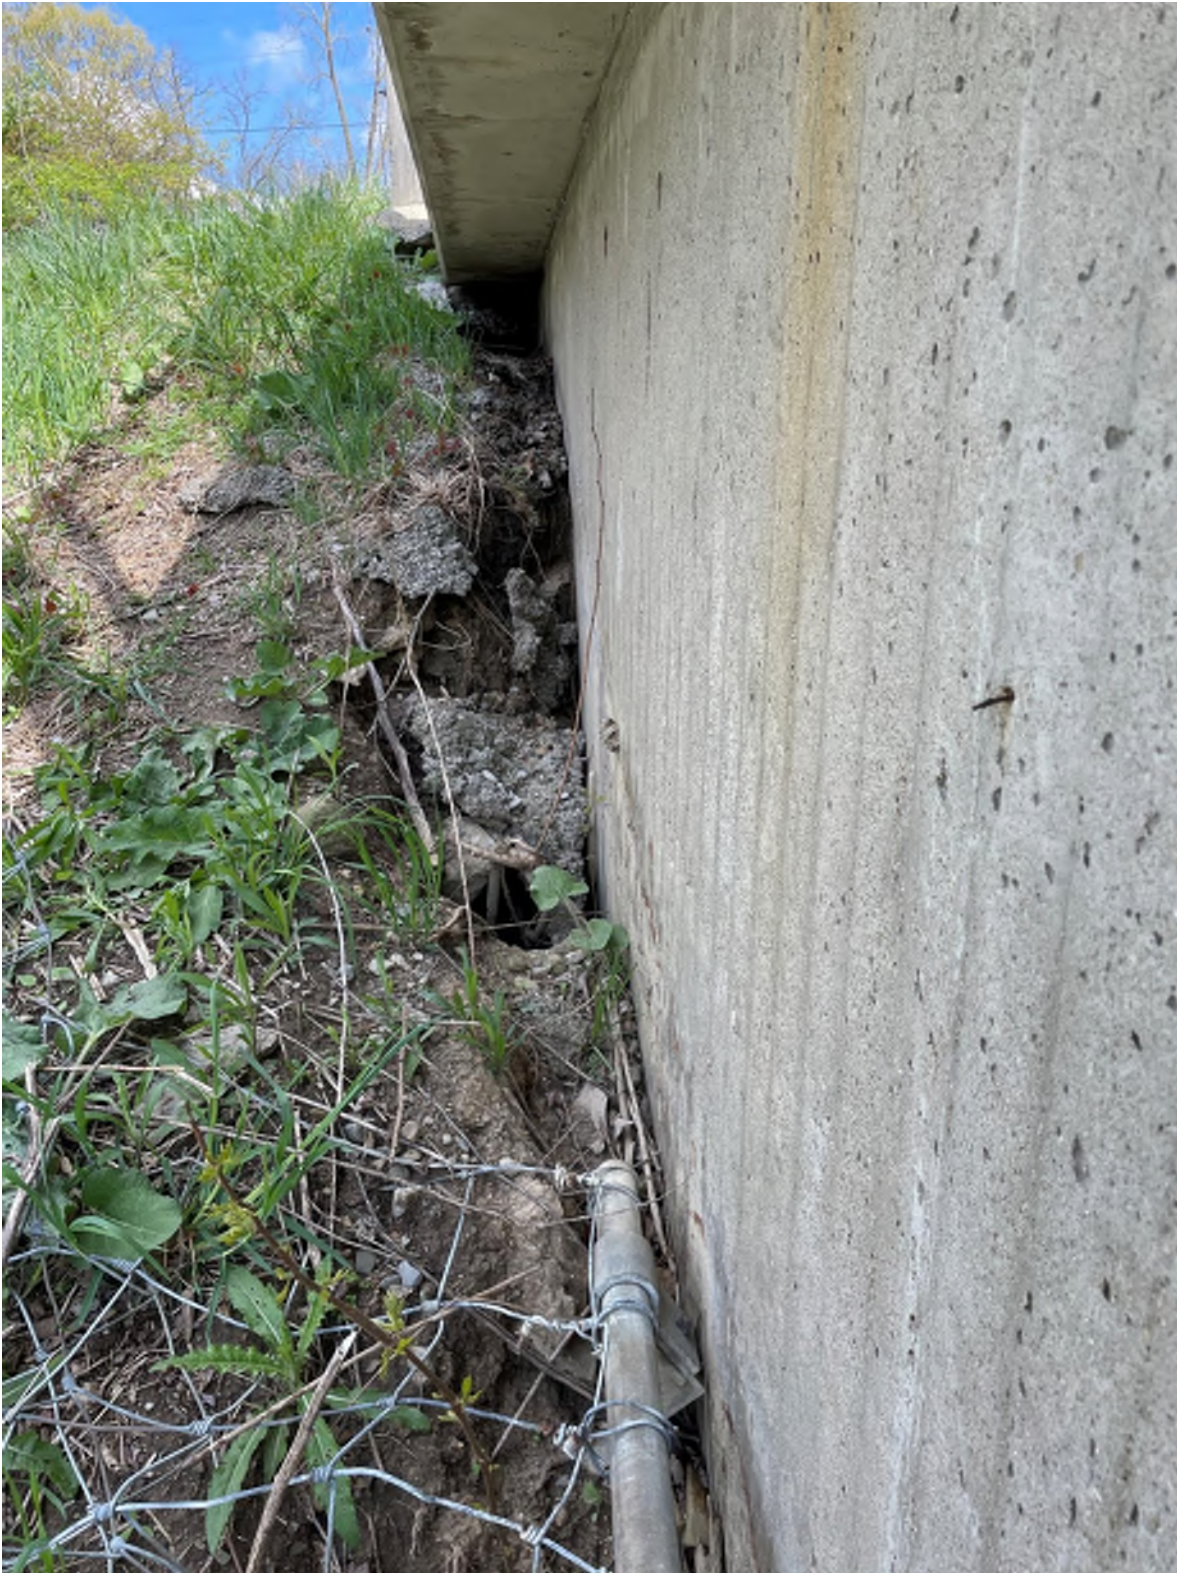
**Photograph #10 - Typical Wingwall Condition and Slope Erosion at Forward Left  
(Northwest) MP 182.1**

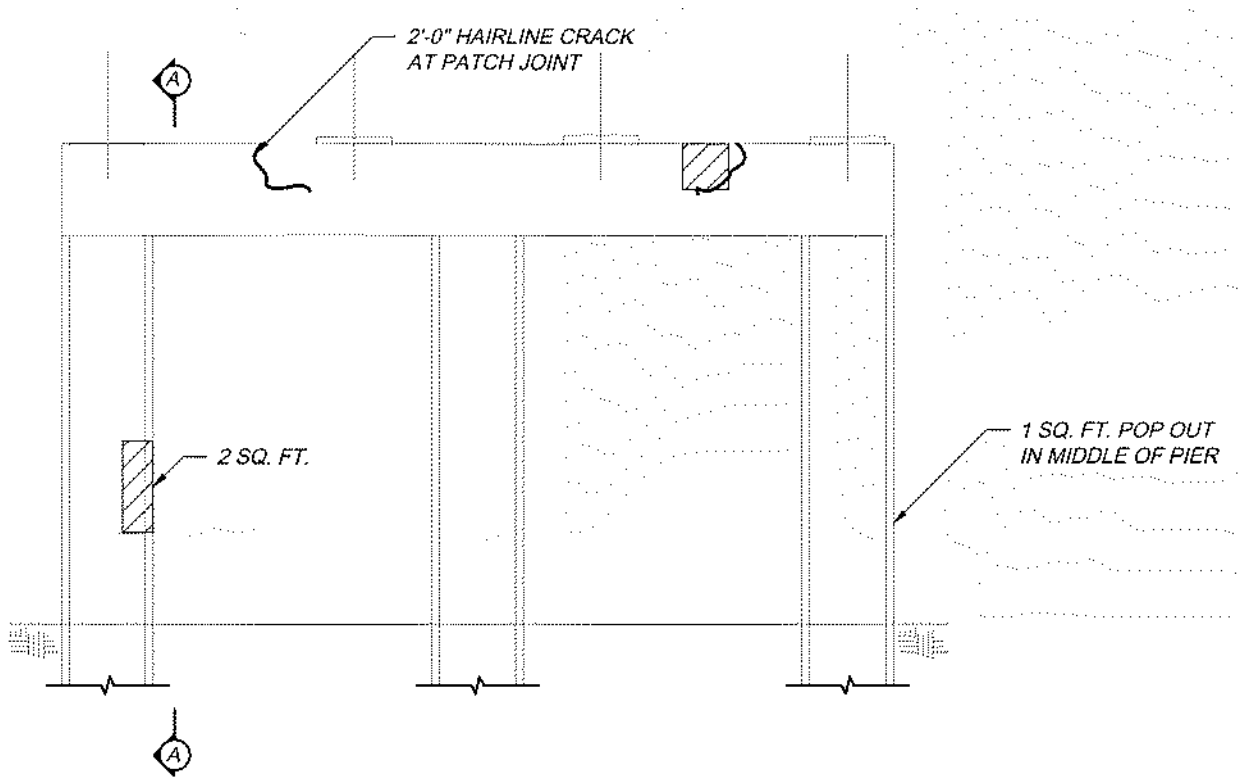
Pier 1 Column 1 has minor delamination present on the traffic face (north face) that extends onto the west face. No deterioration was observed to Pier 2 columns. Pier 3 Column 2 has minor delamination on the traffic face (south face) that leads to the east face. Pier 3 Column 3 has a spall in the patch on the south east corner, exposing three stirrups with minor section loss. The entire patch on the west, south, and east faces and a halo around the patch are delaminated with wire mesh rust showing through on the face.

**Figure 8 - Location of Proposed Concrete Repairs - Pier 1 Downstation (North) Face  
Elevation MP 182.1**

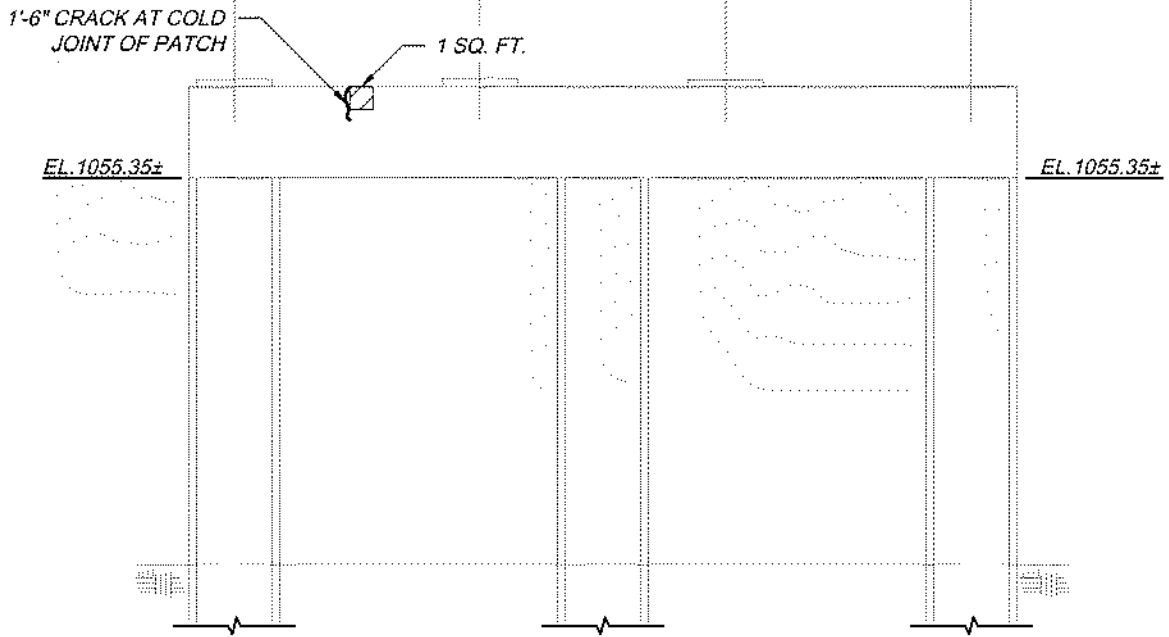
**Figure 10 - Location of Proposed Concrete Repairs - Pier 1 Upstation (South) Face  
Elevation MP 182.1**

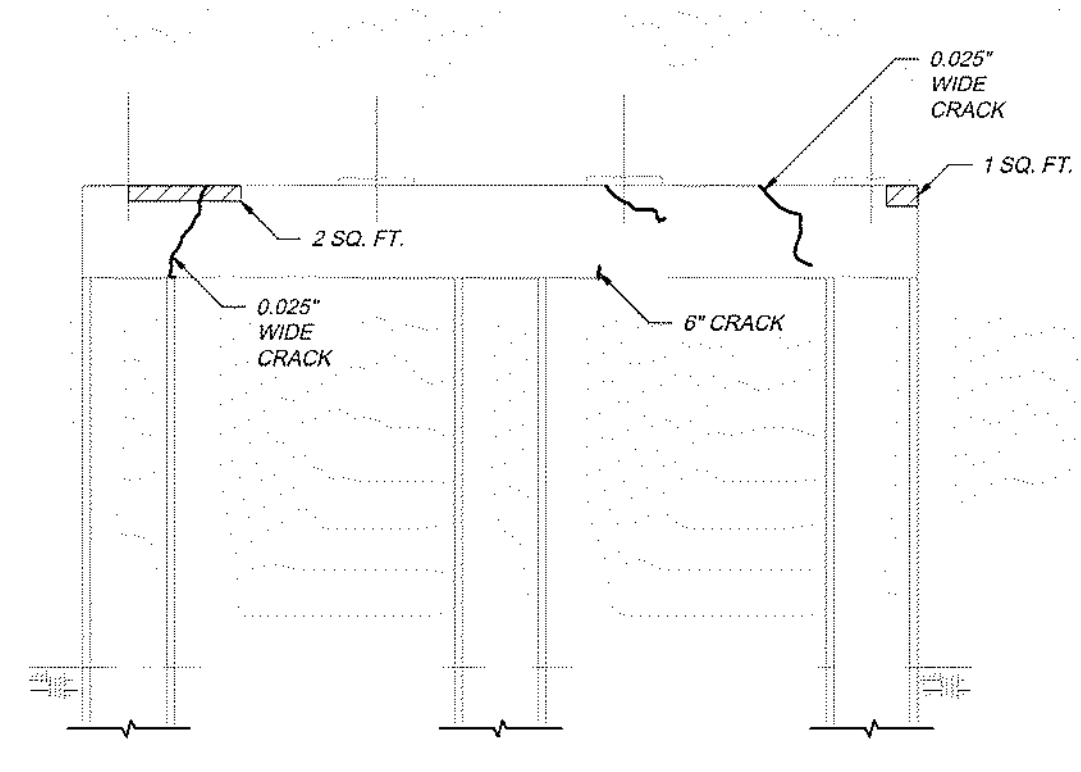
**Figure 15 - Location of Proposed Concrete Repairs - Pier 3 Upstation (South) Face Elevation MP 182.1**

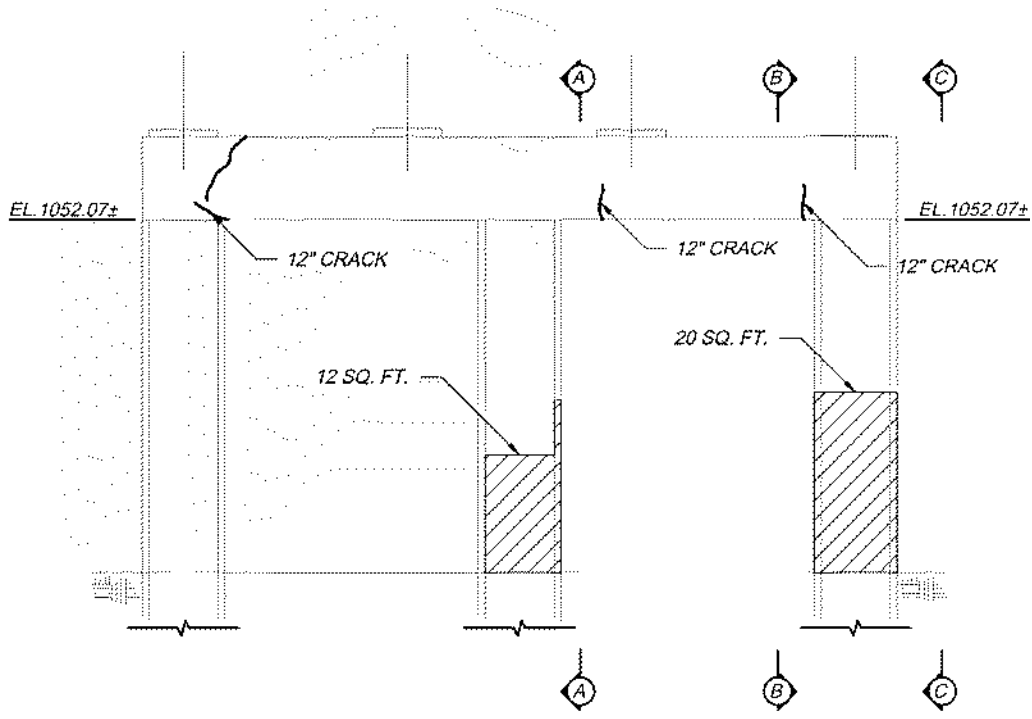
**Figure 16 - Location of Proposed Concrete Repairs - Pier 3 Downstation (North) Face  
Elevation MP 182.1**

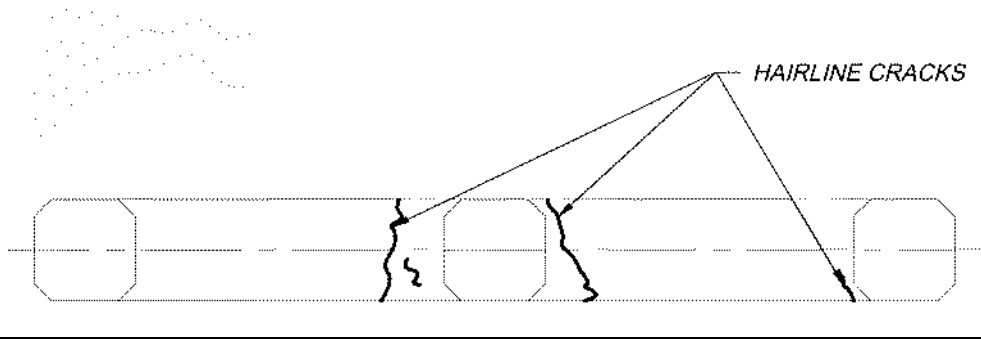
**Figure 18 - Location of Proposed Concrete Repairs - Pier 3 Underside of Pier Cap MP 182.1**

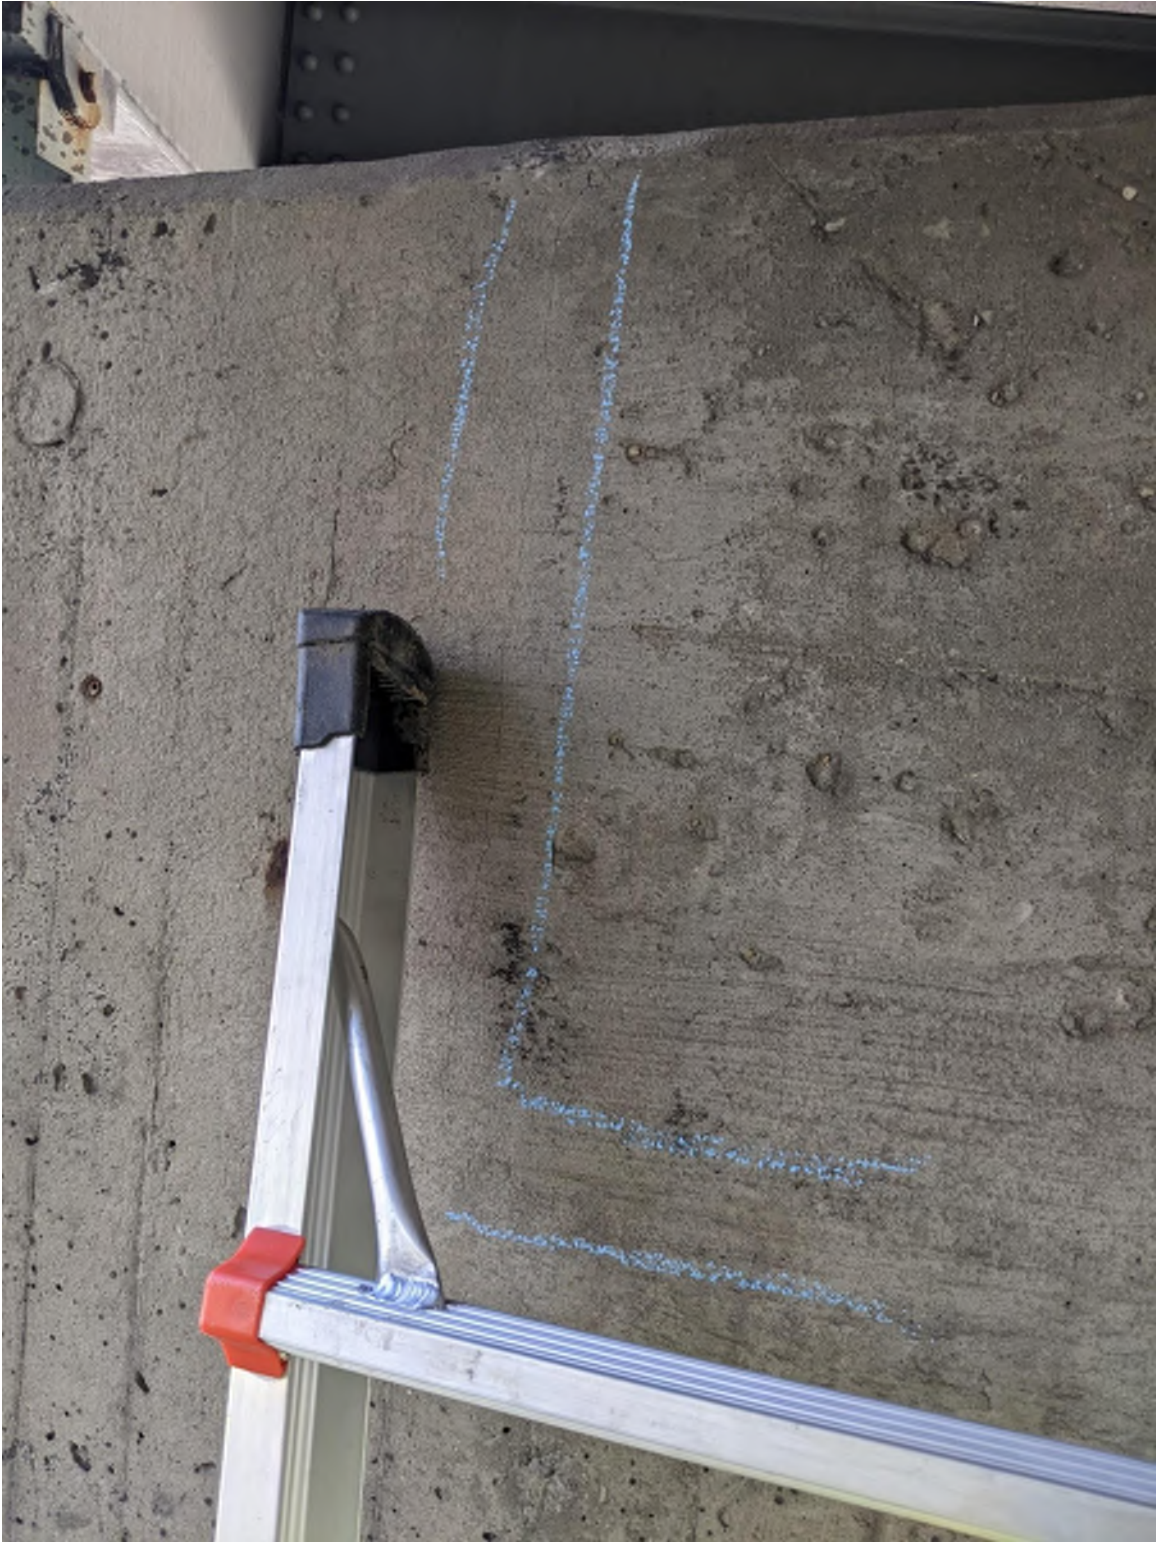
In all three pier caps, a few minor cracks were observed and measured 0.013" to 0.025" wide. Additional minor cracks exist at old patch material cold joints on both faces of Piers 1 and 3. Hammer sounding indicated localized delaminated areas on all three pier caps. The northwest corner on the cap of Pier 3 has a deep spall with reinforcing steel stirrups exposed with moderate section loss and delamination extending to the side face. This spall extends to the bearing seat pedestal, which is missing a corner of concrete extending to the bearing masonry plate with the plate overhanging 1/8".

Photograph #11 - Pier 1 Cap Cracks at Patch MP 182.1

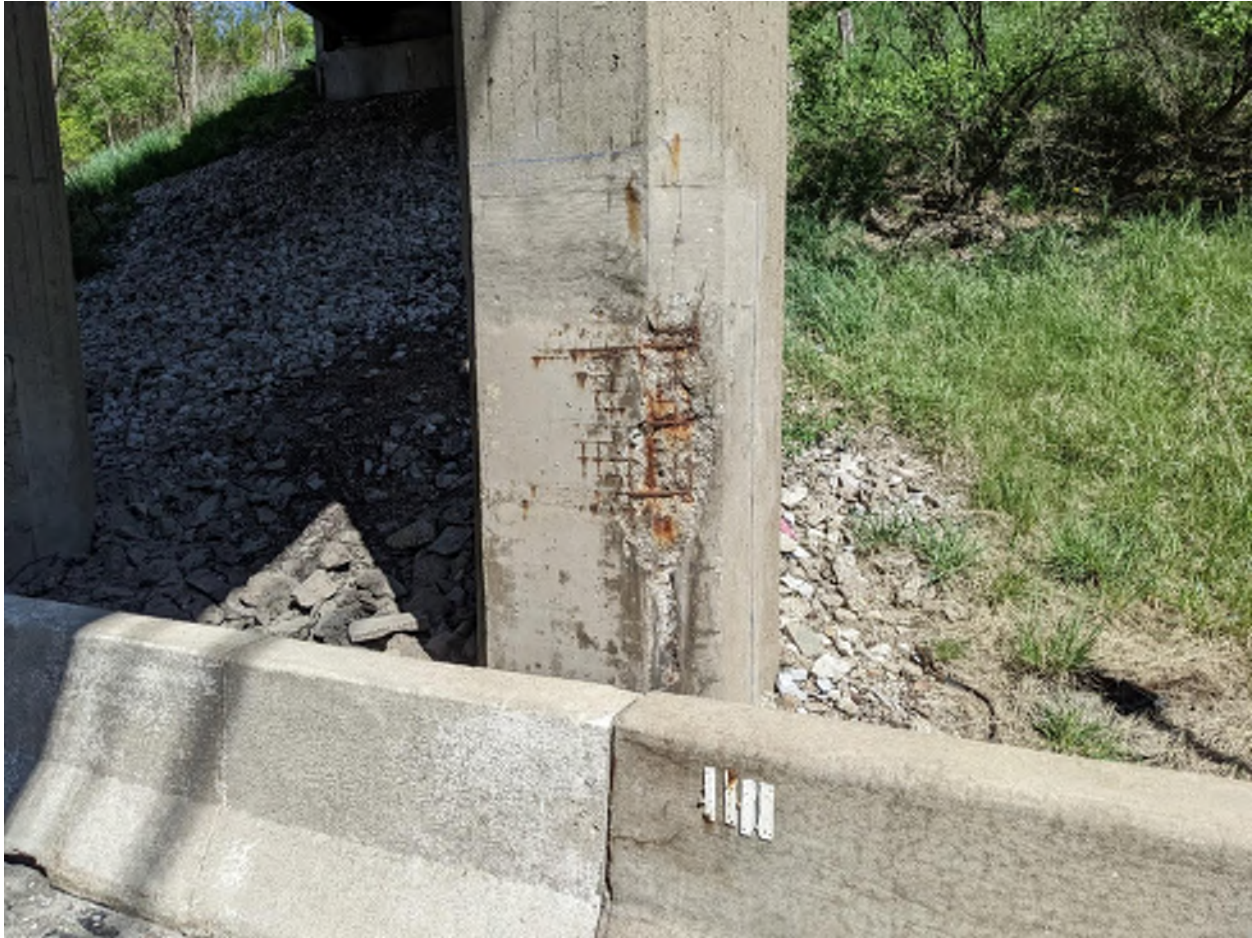
**Photograph #12 - Pier 3 Column 3 Spall MP 182.1**

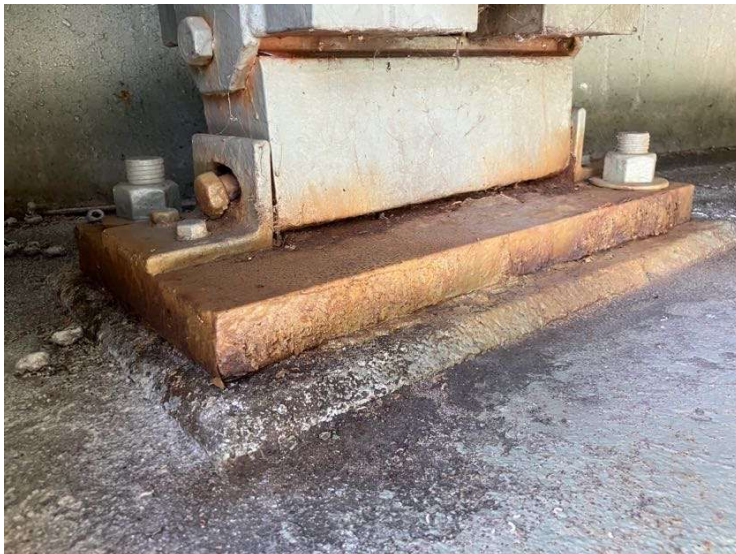
PHOTO 3  
View of steel bearing. No  
gasketing material observed.
