## Existing Chimney Conditions

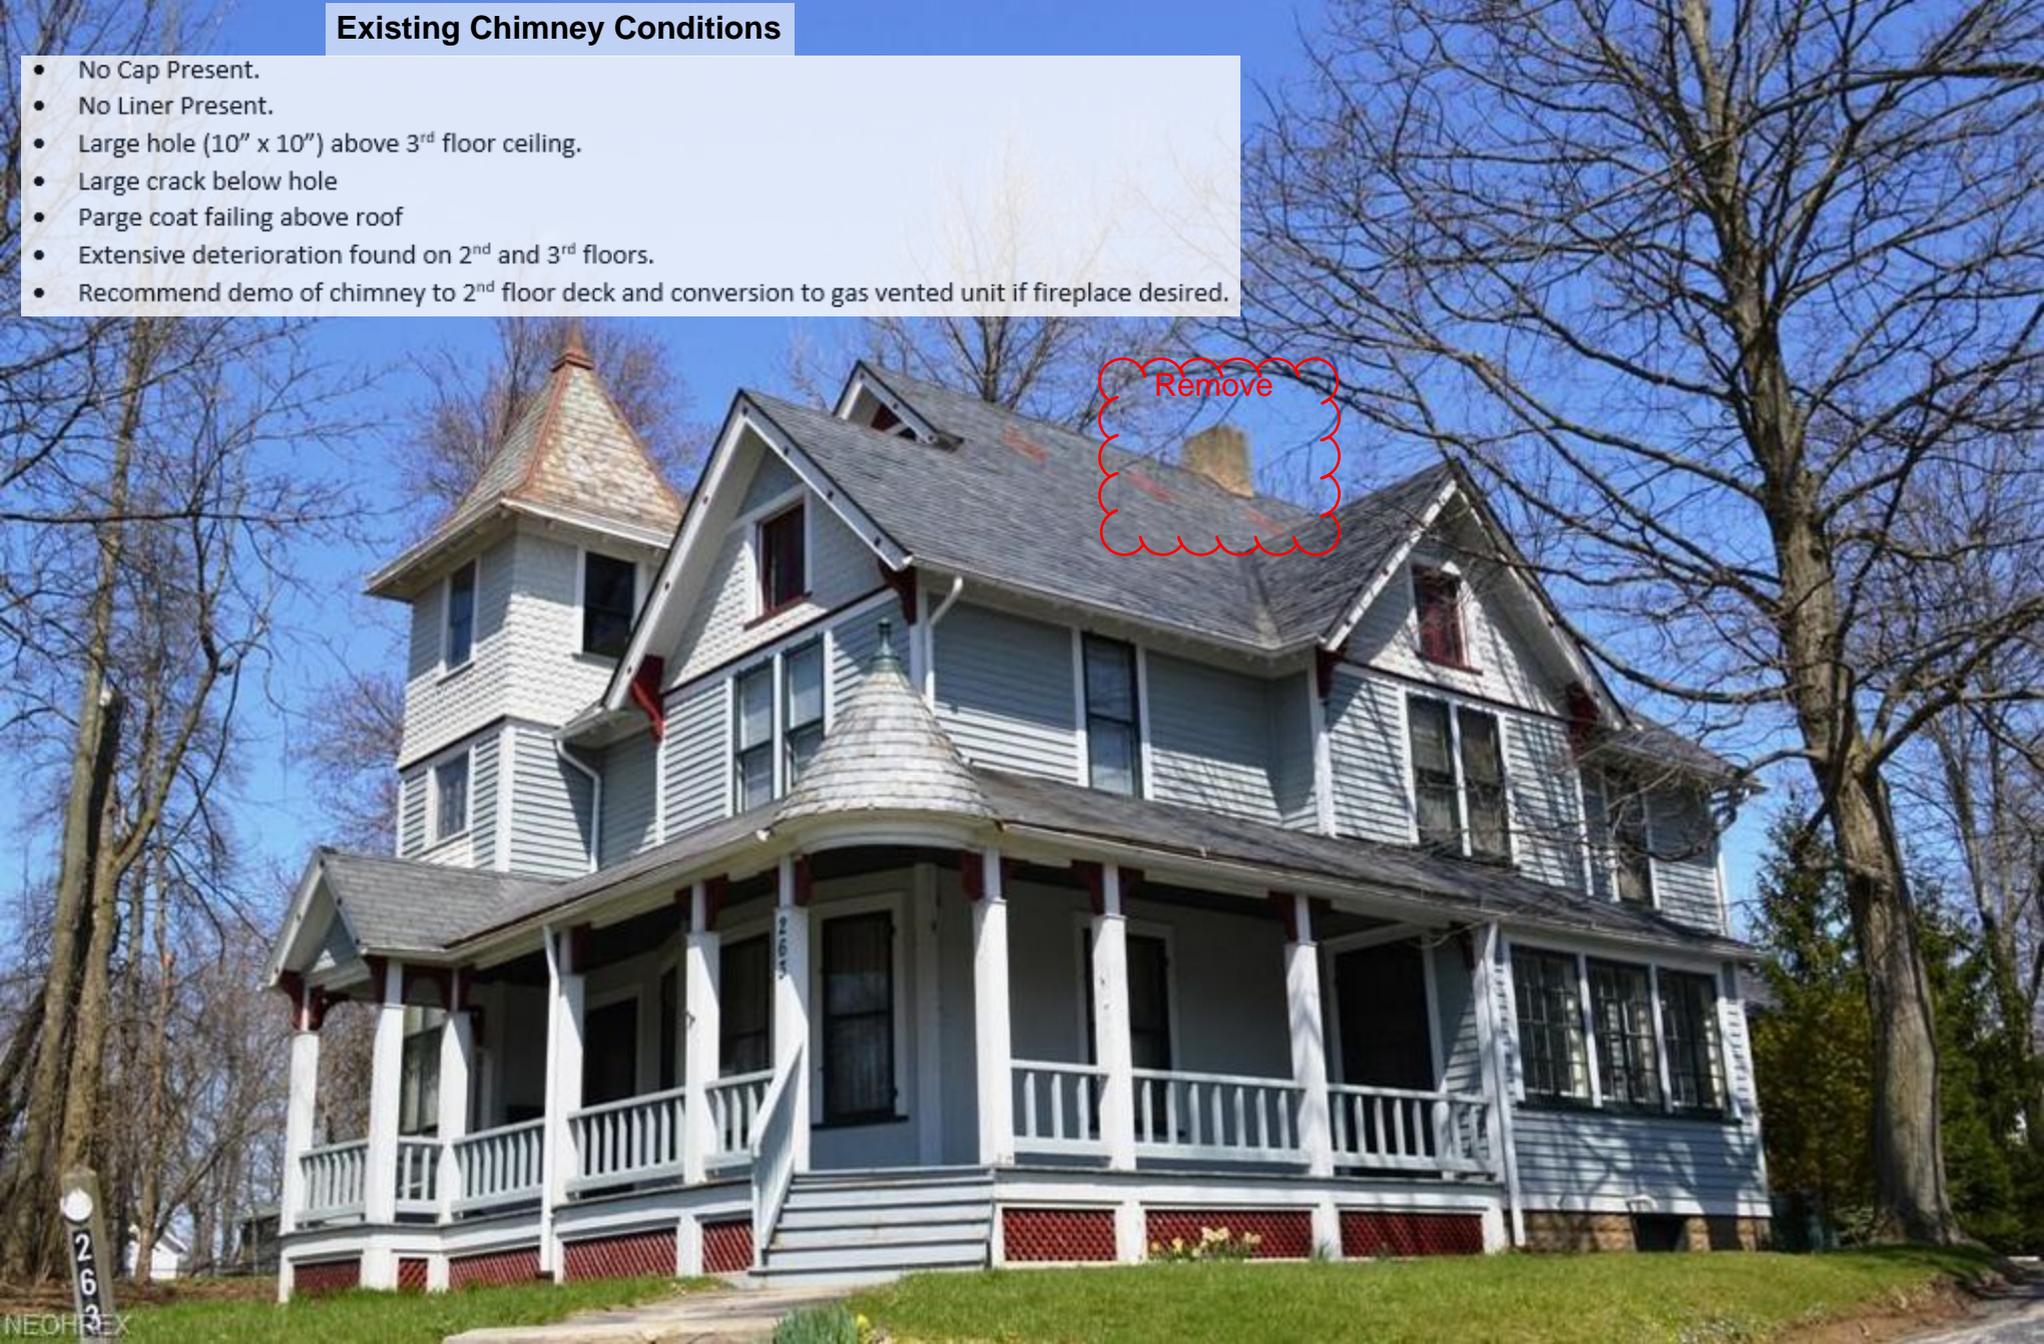
- No Cap Present.
- No Liner Present.
- Large hole (10" x 10") above 3<sup>rd</sup> floor ceiling.
- Large crack below hole
- Parge coat failing above roof
- Extensive deterioration found on 2<sup>nd</sup> and 3<sup>rd</sup> floors.
- Recommend demo of chimney to 2<sup>nd</sup> floor deck and conversion to gas vented unit if fireplace desired.
