52 Aurora Street

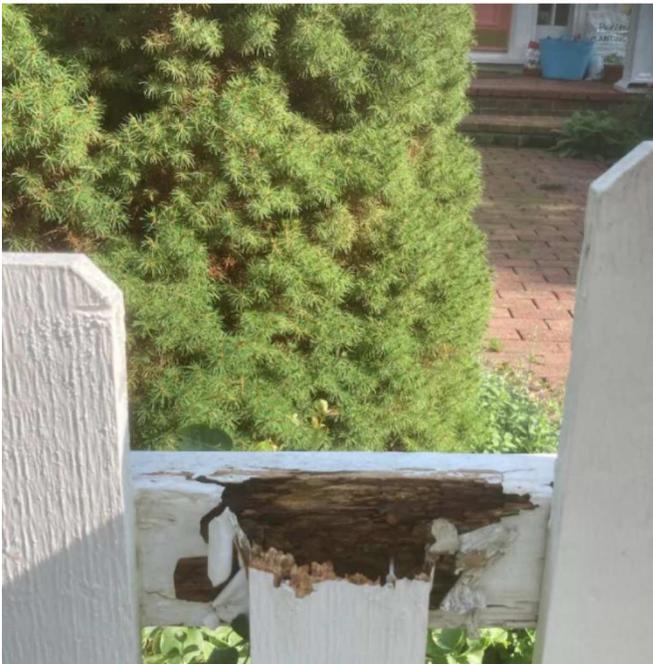
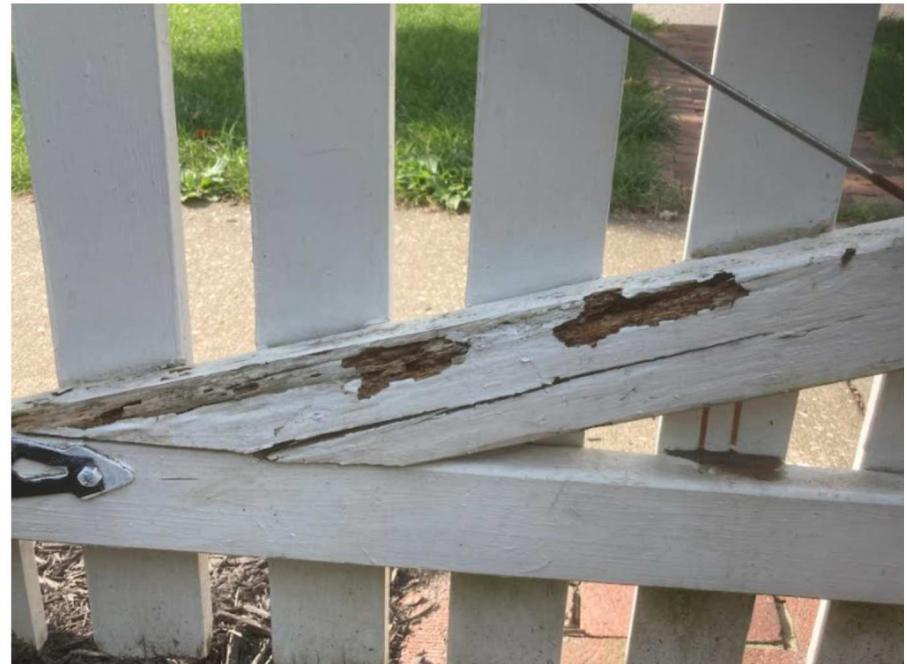
- North-Facing
- Cedar Cellulose & Rotting
- Weathering & Water Damage
- Poor Density & Integrity

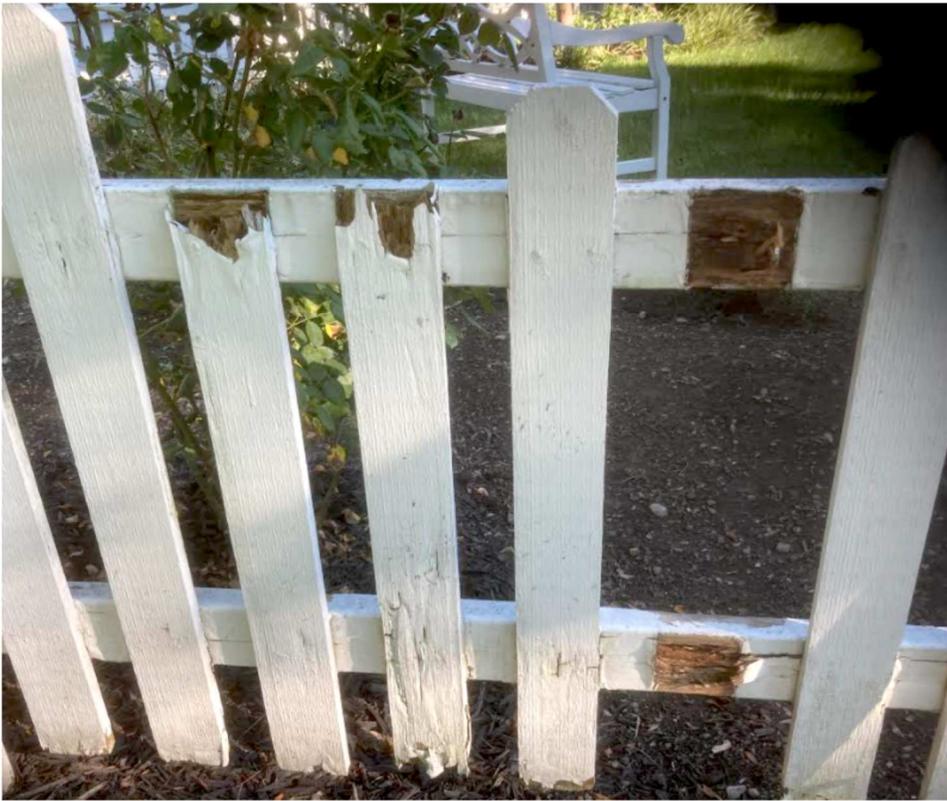
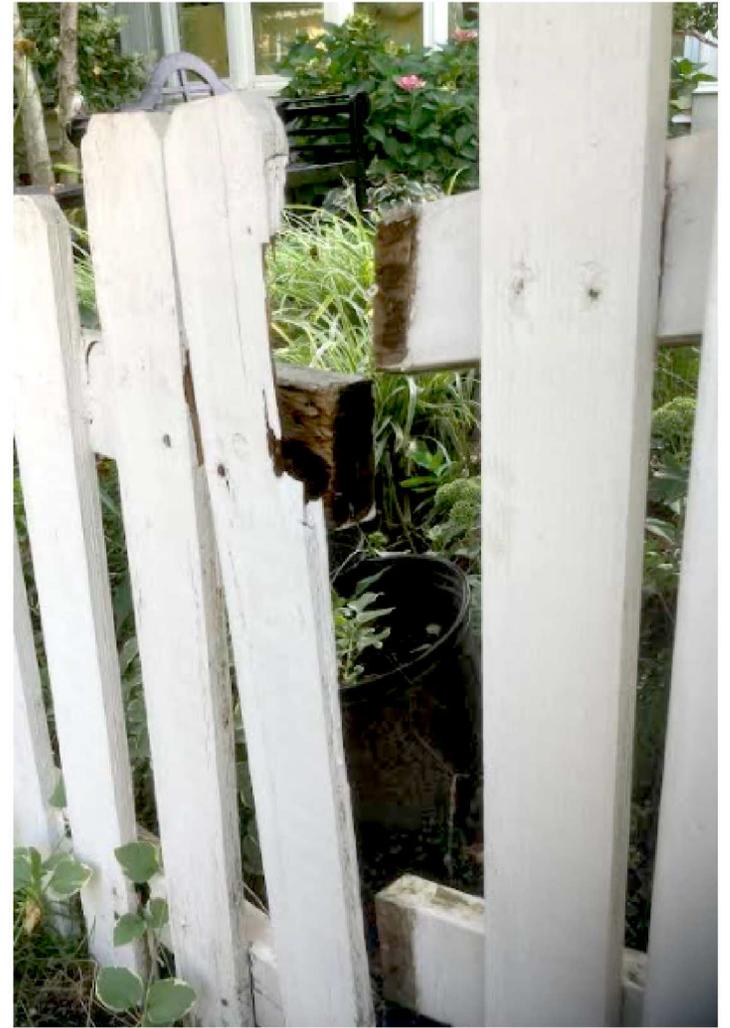
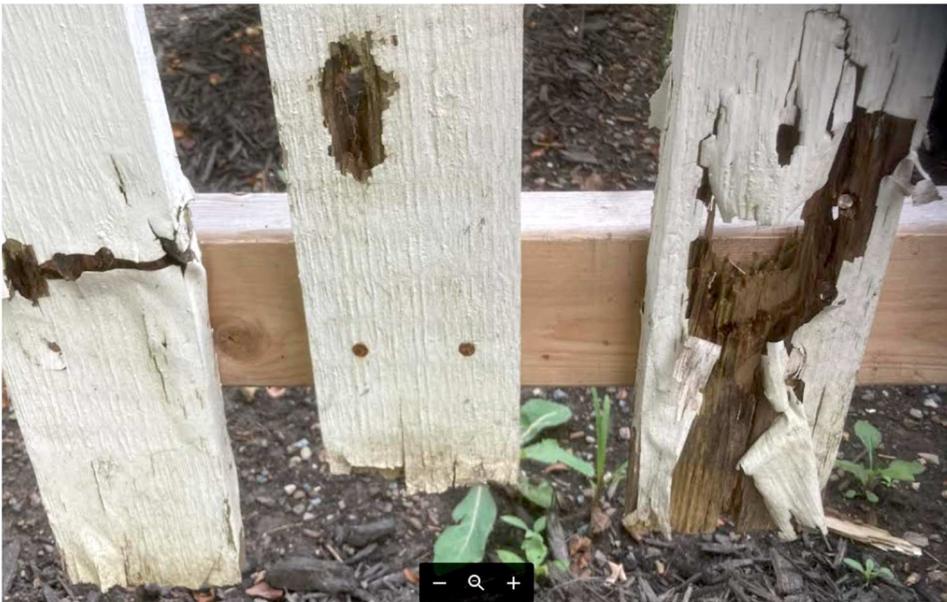
- Rotting

- Lack of Density, Integrity

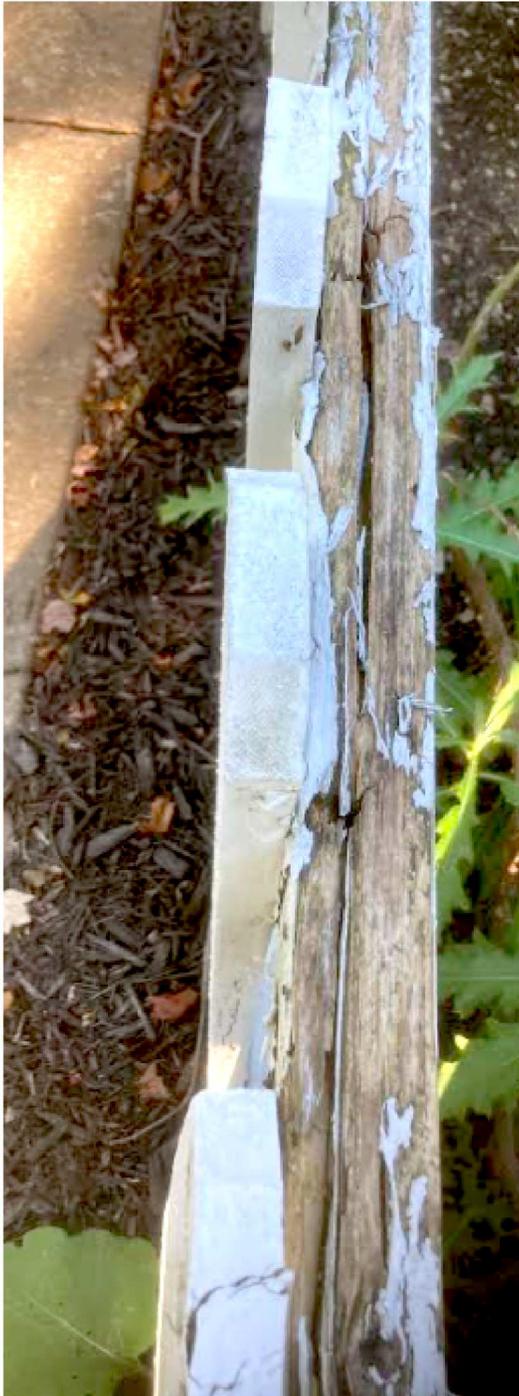
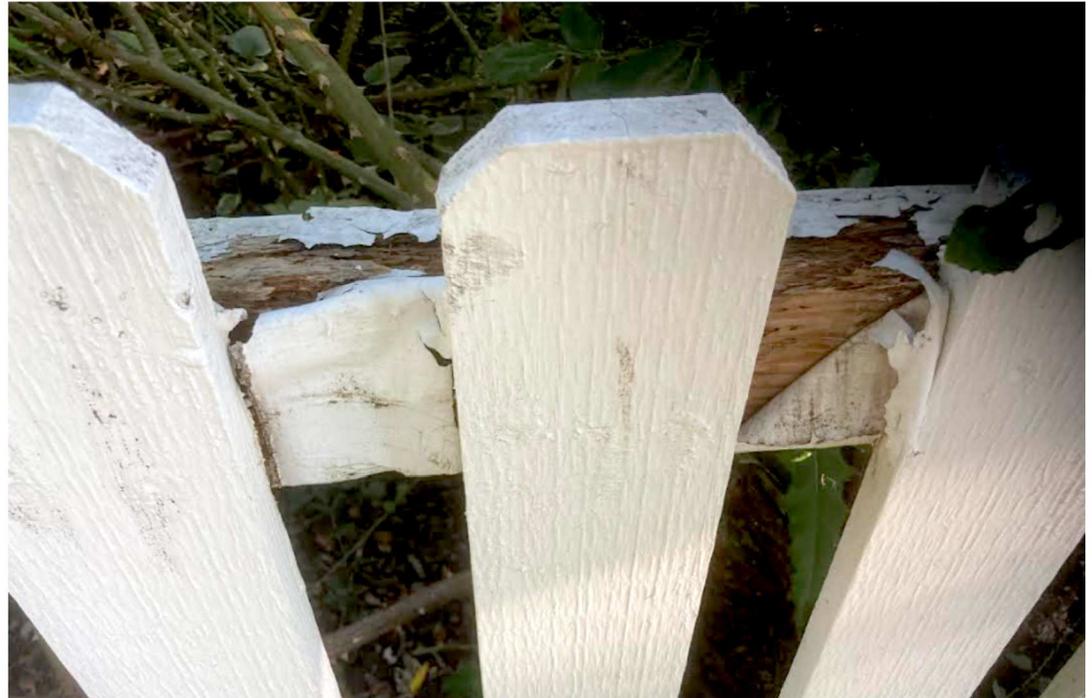
- **Poor Paint Adherence**
- **Not White Underneath**

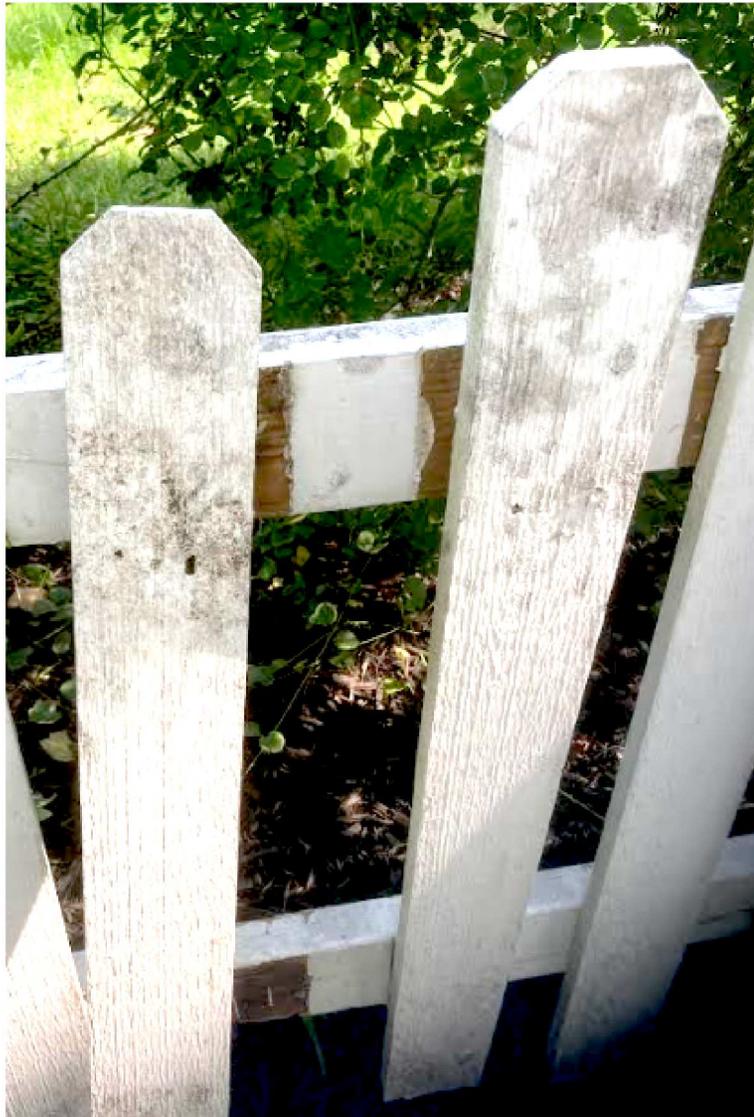
- **Black Mold**

- **Green Mold**

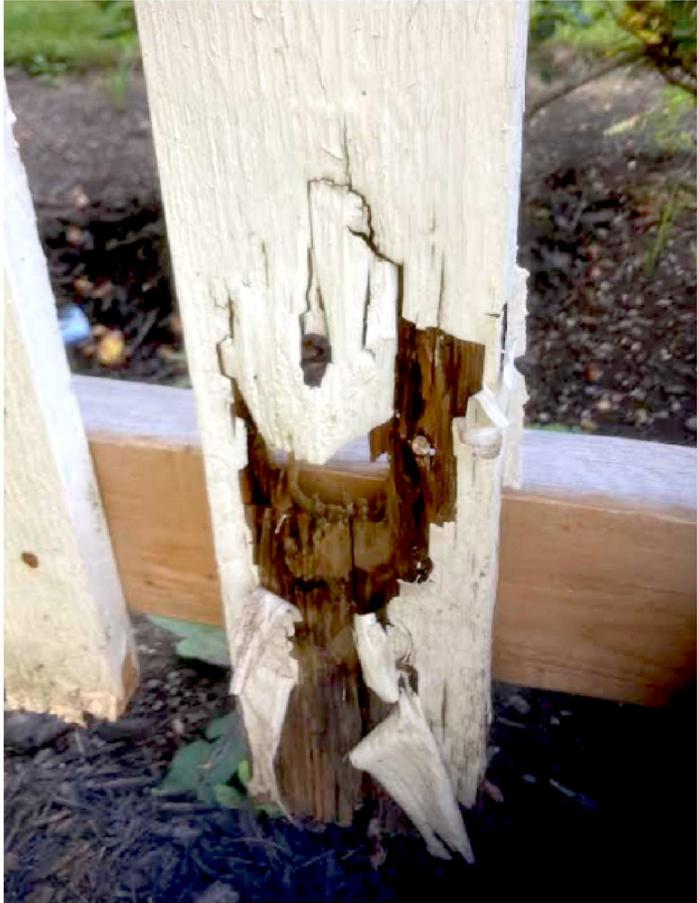
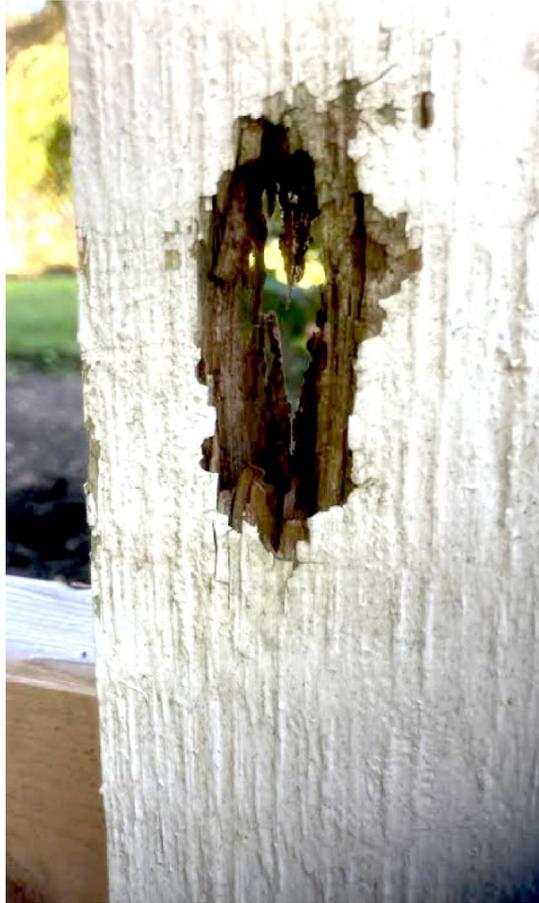
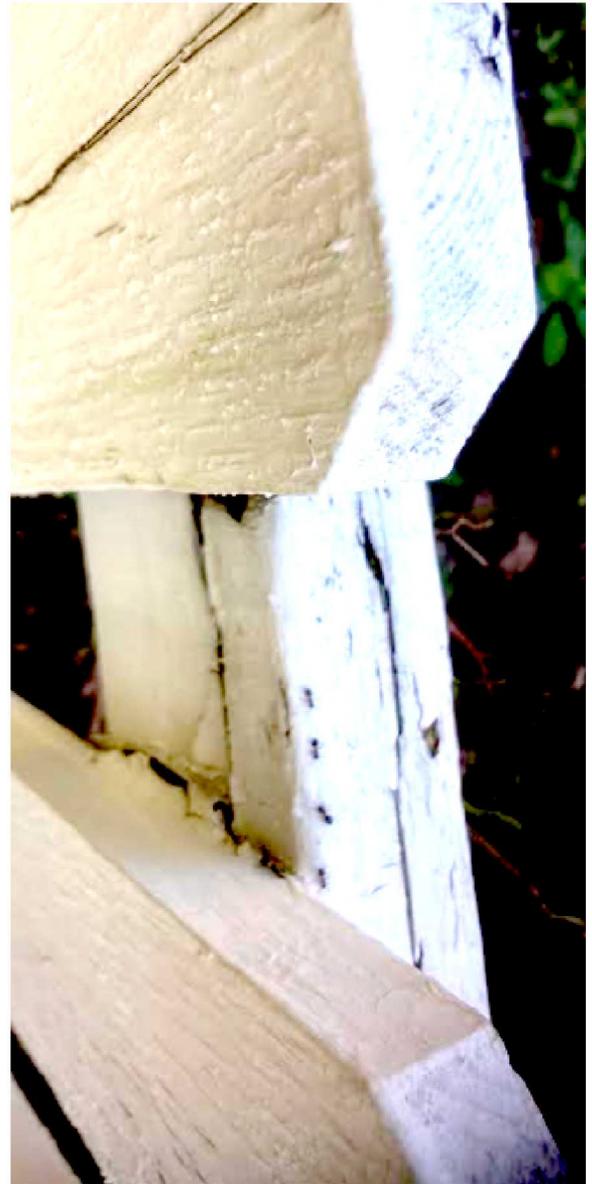
- Termite- & Ant-Consumable & Infestations
