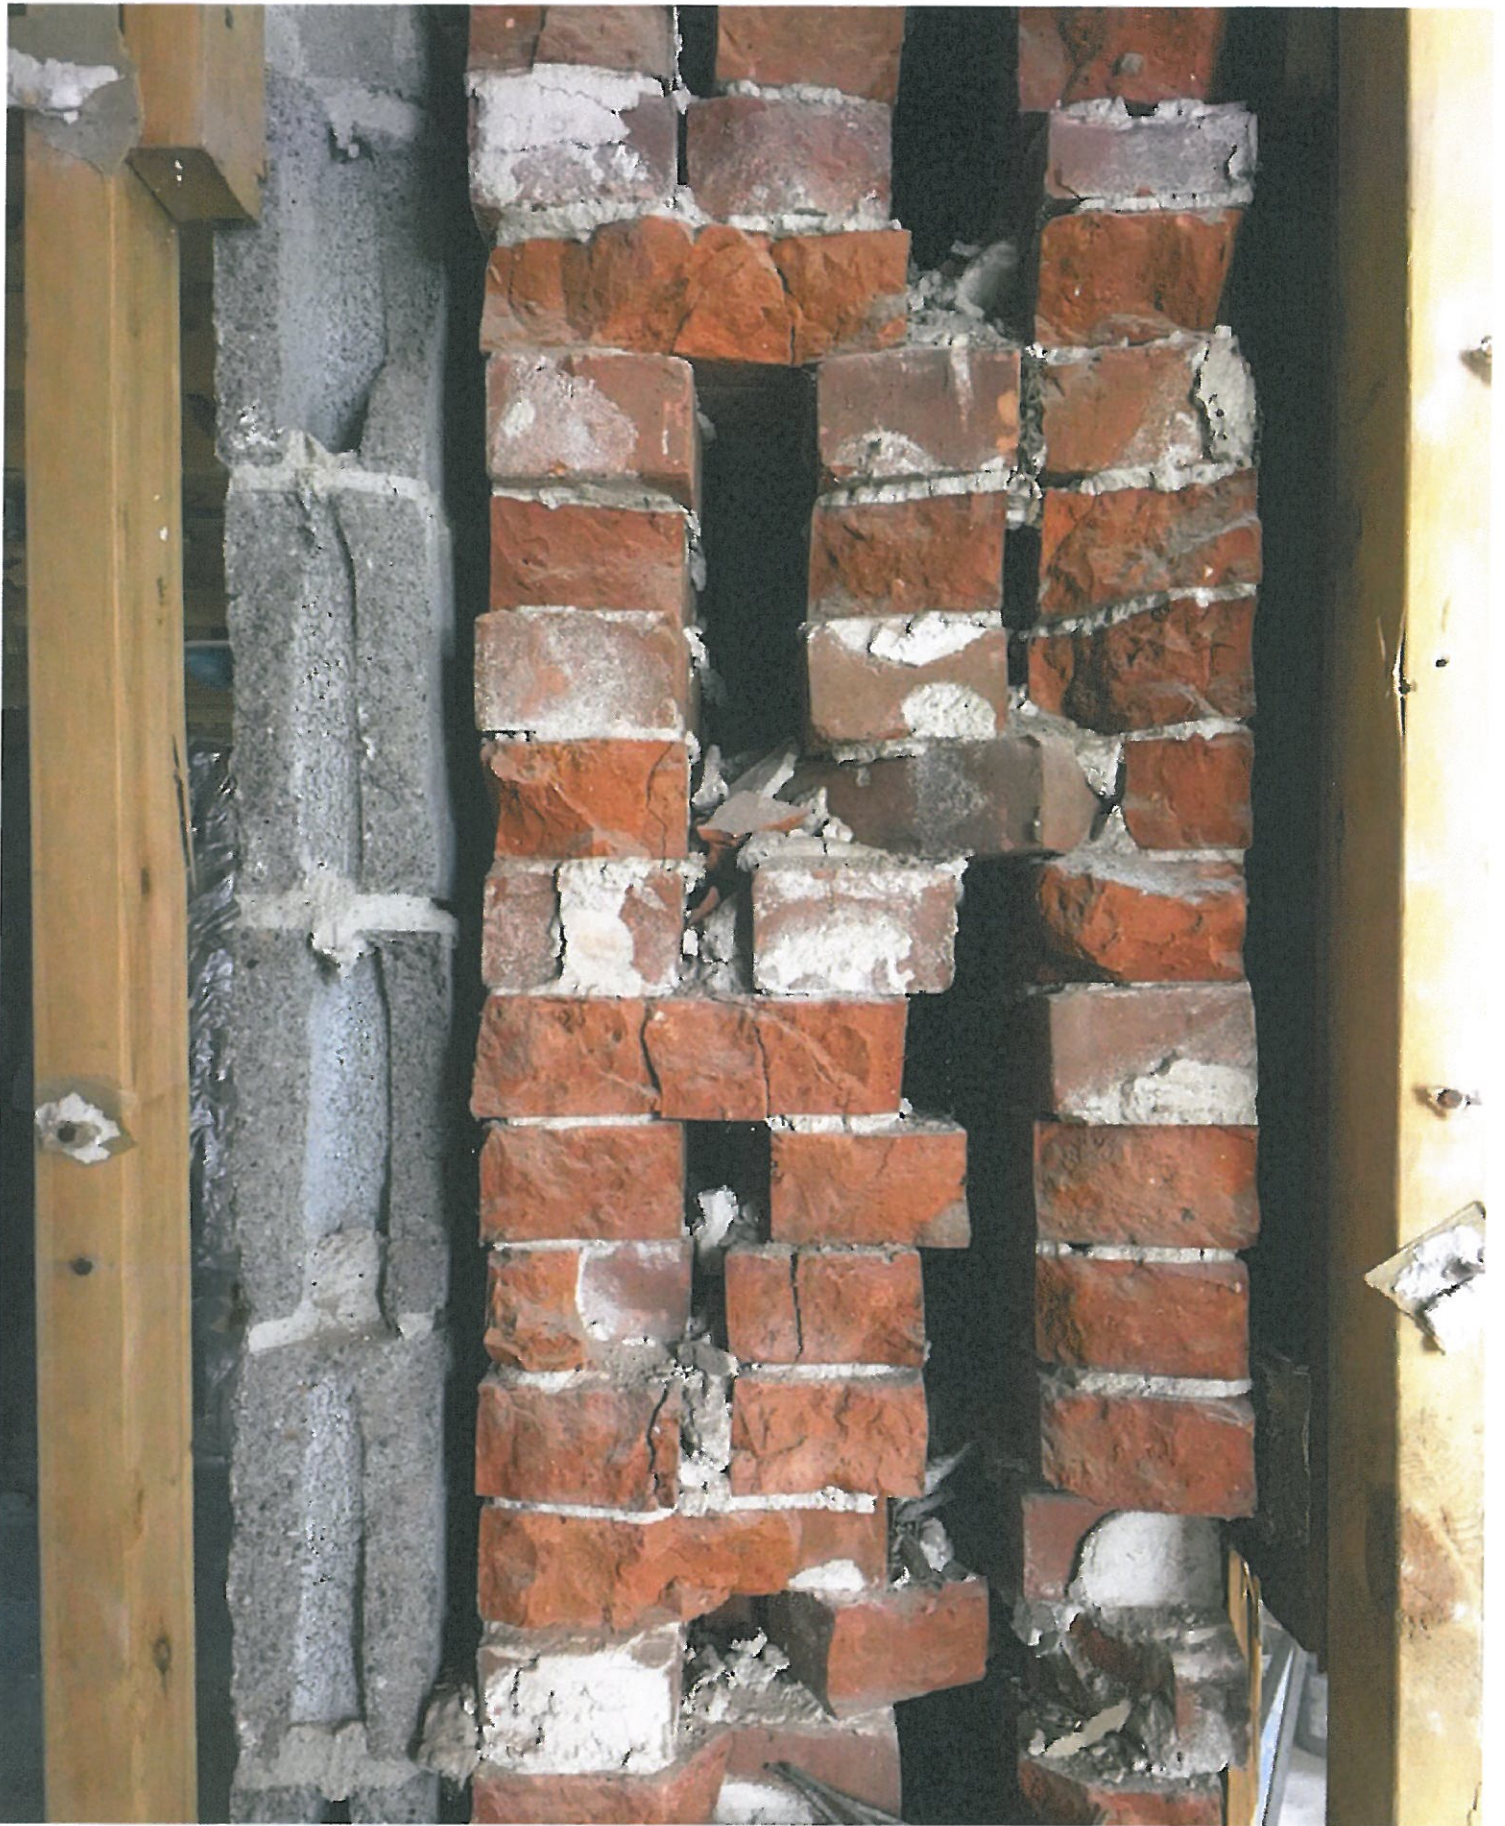
2. Exposed Brick Wall of Original Town Hall East Wall

Three (3) wythes of brick with brick infill and "voids"

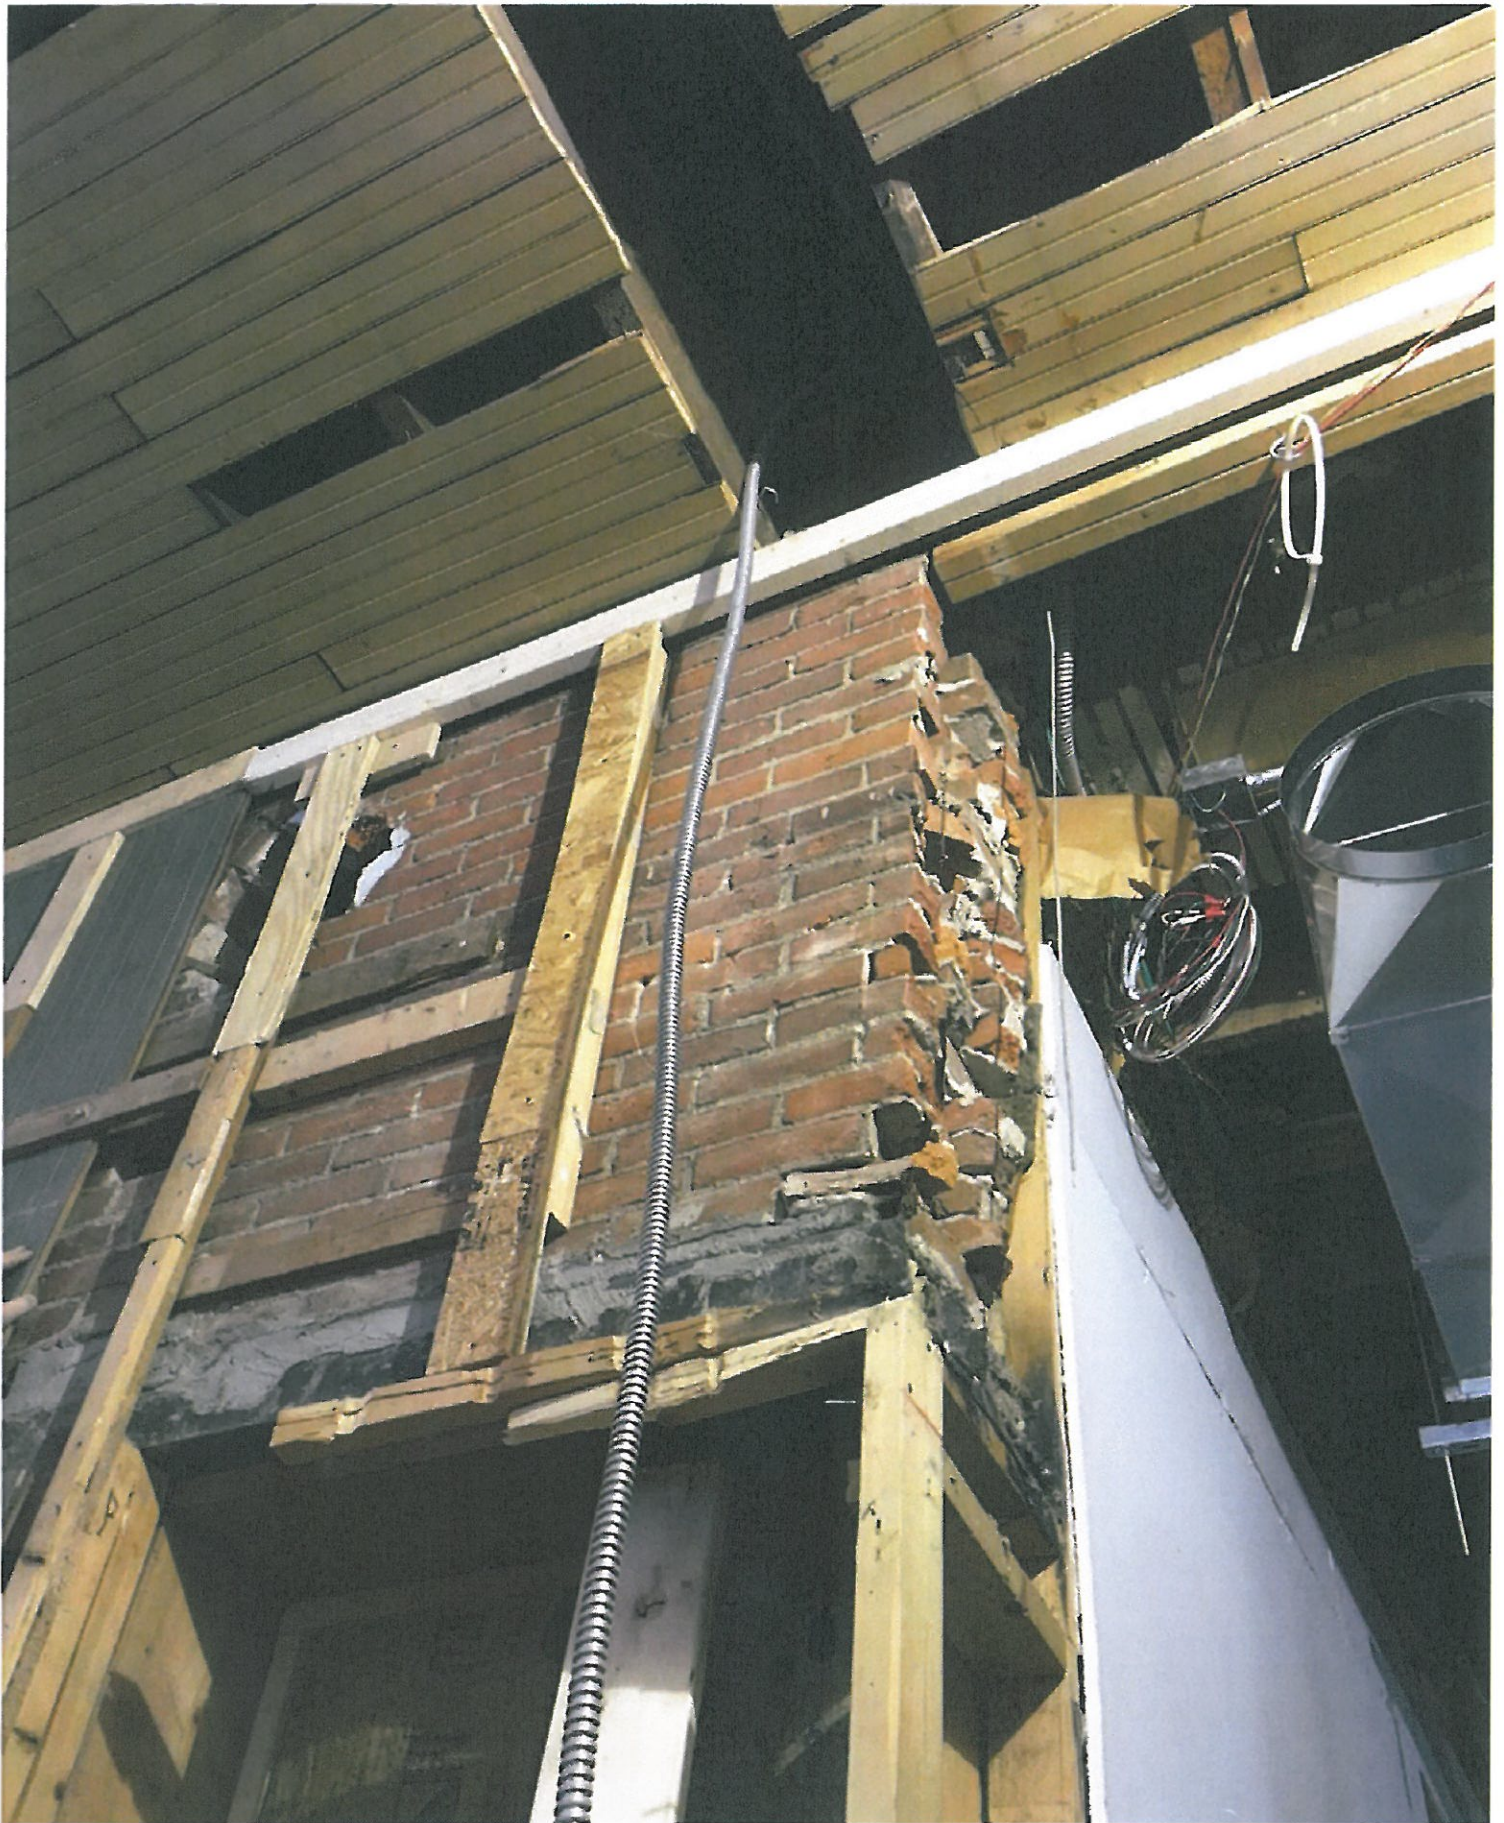
8. Existing East Brick Wall at Fire Museum Entrance (South)

View looking west. Brick wall and wood floor joists above are supported by thin 2"x4" wood framing

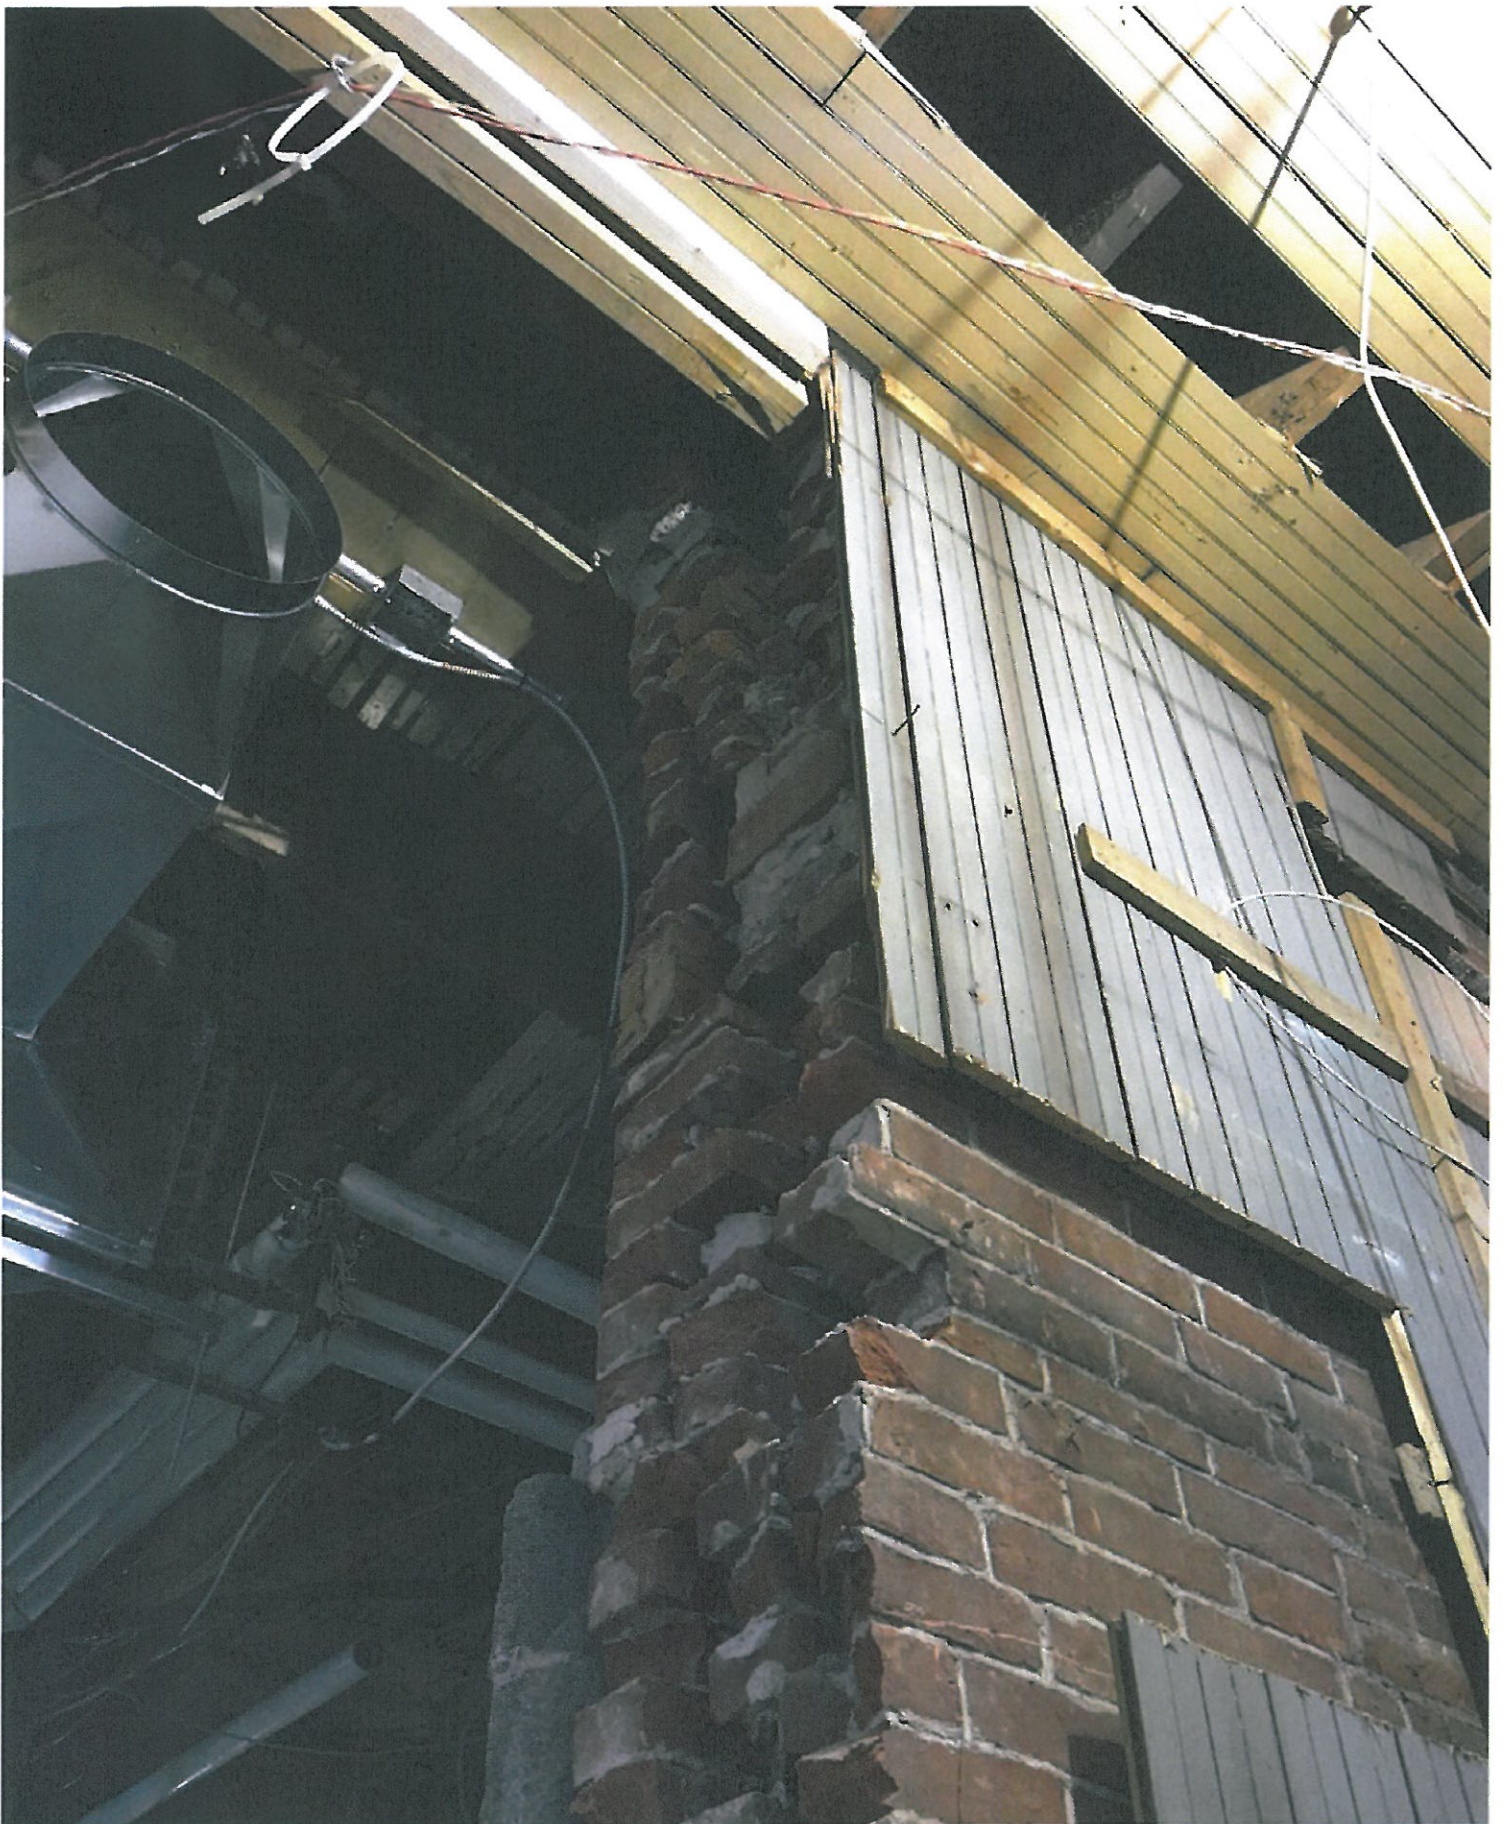
9. Existing East Brick Wall at Fire Museum Entrance (North)

View looking west. Brick wall and wood floor joists above are supported by thin 2"x4" wood framing

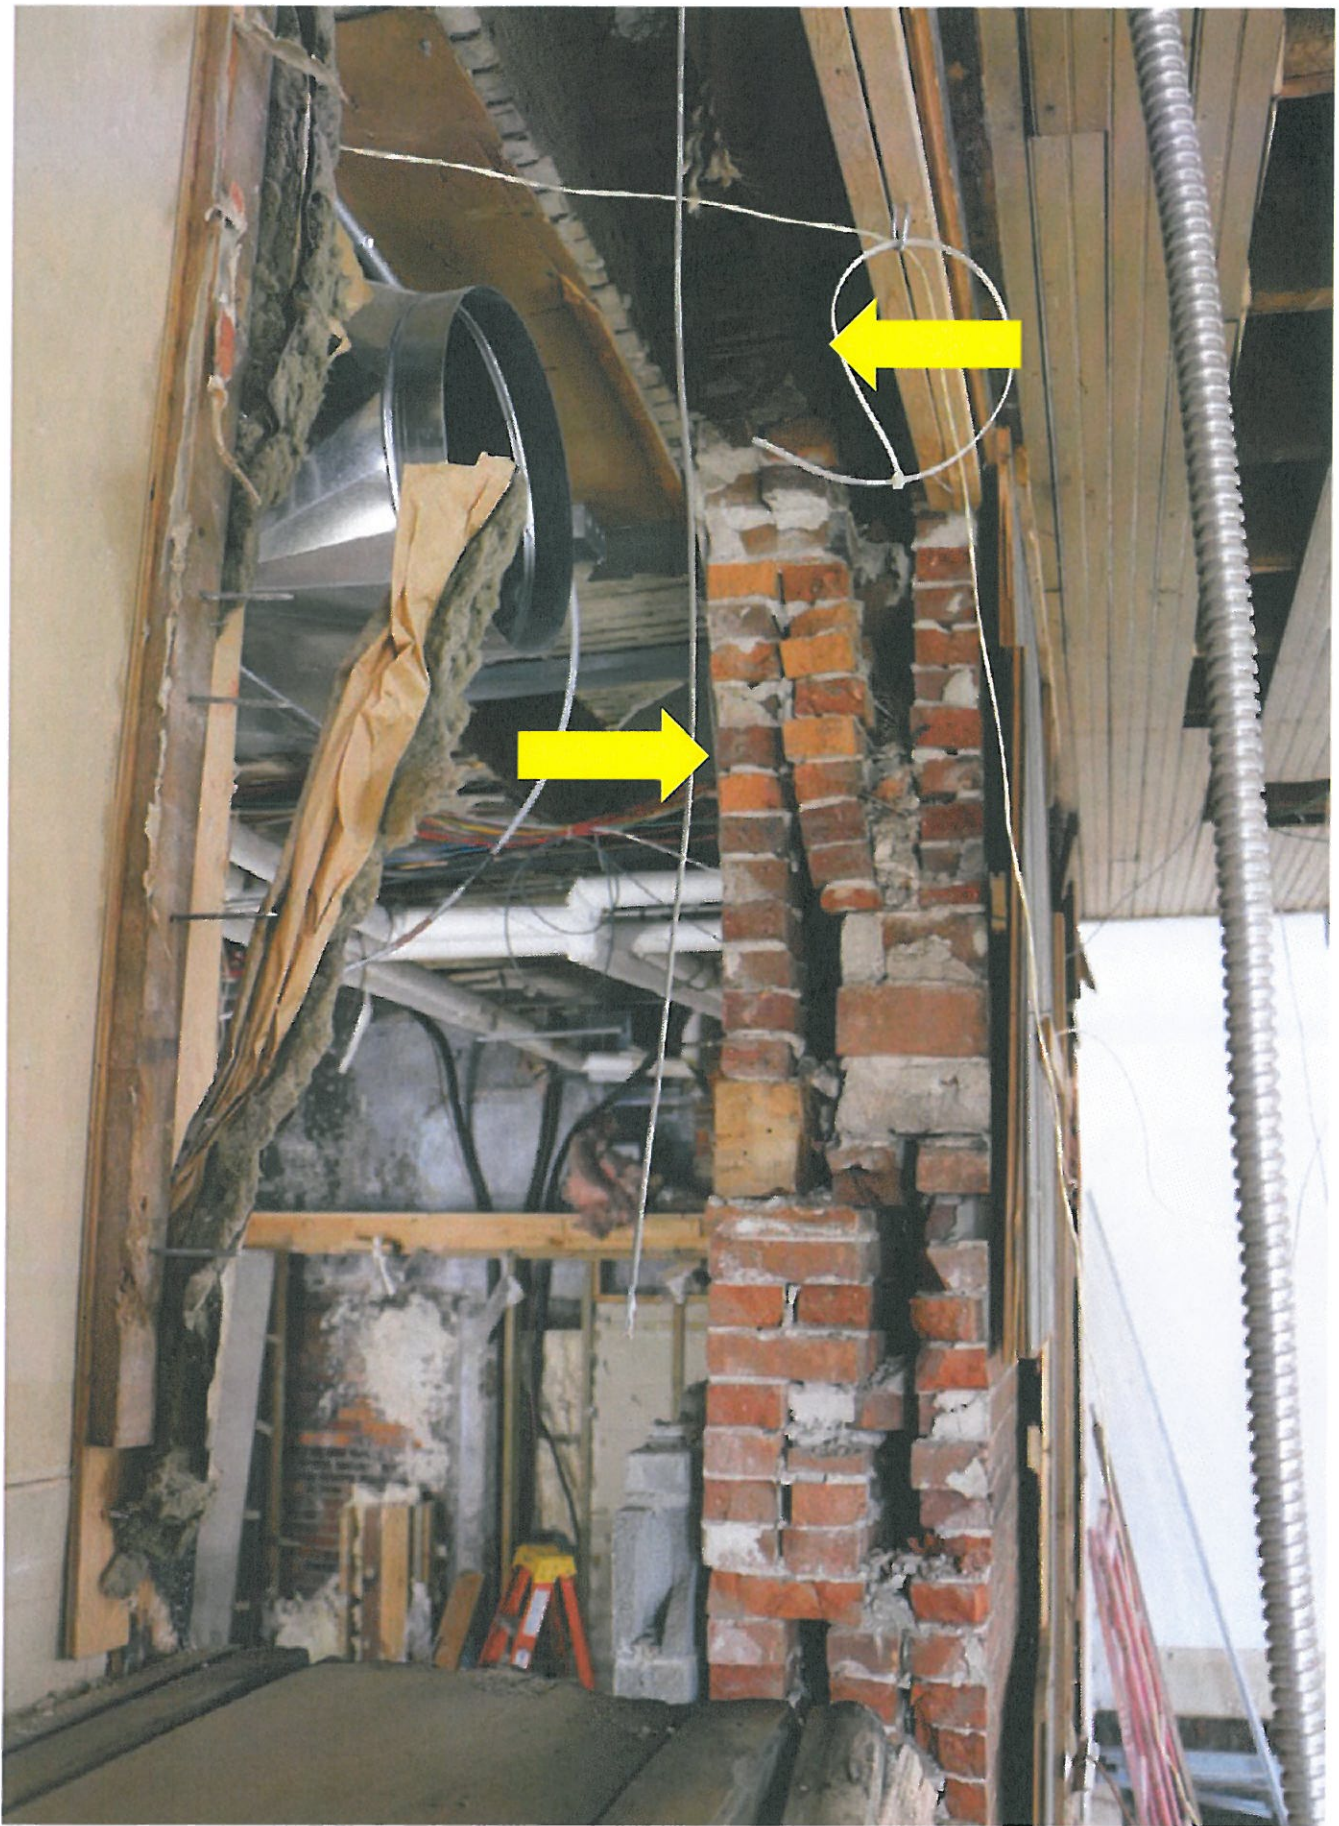
12. Exposed Brick Wall & Wood Timber Beam Above

Existing 12"x12" wood timber beam rests on two wythes of brick, wall is visibly leading toward west

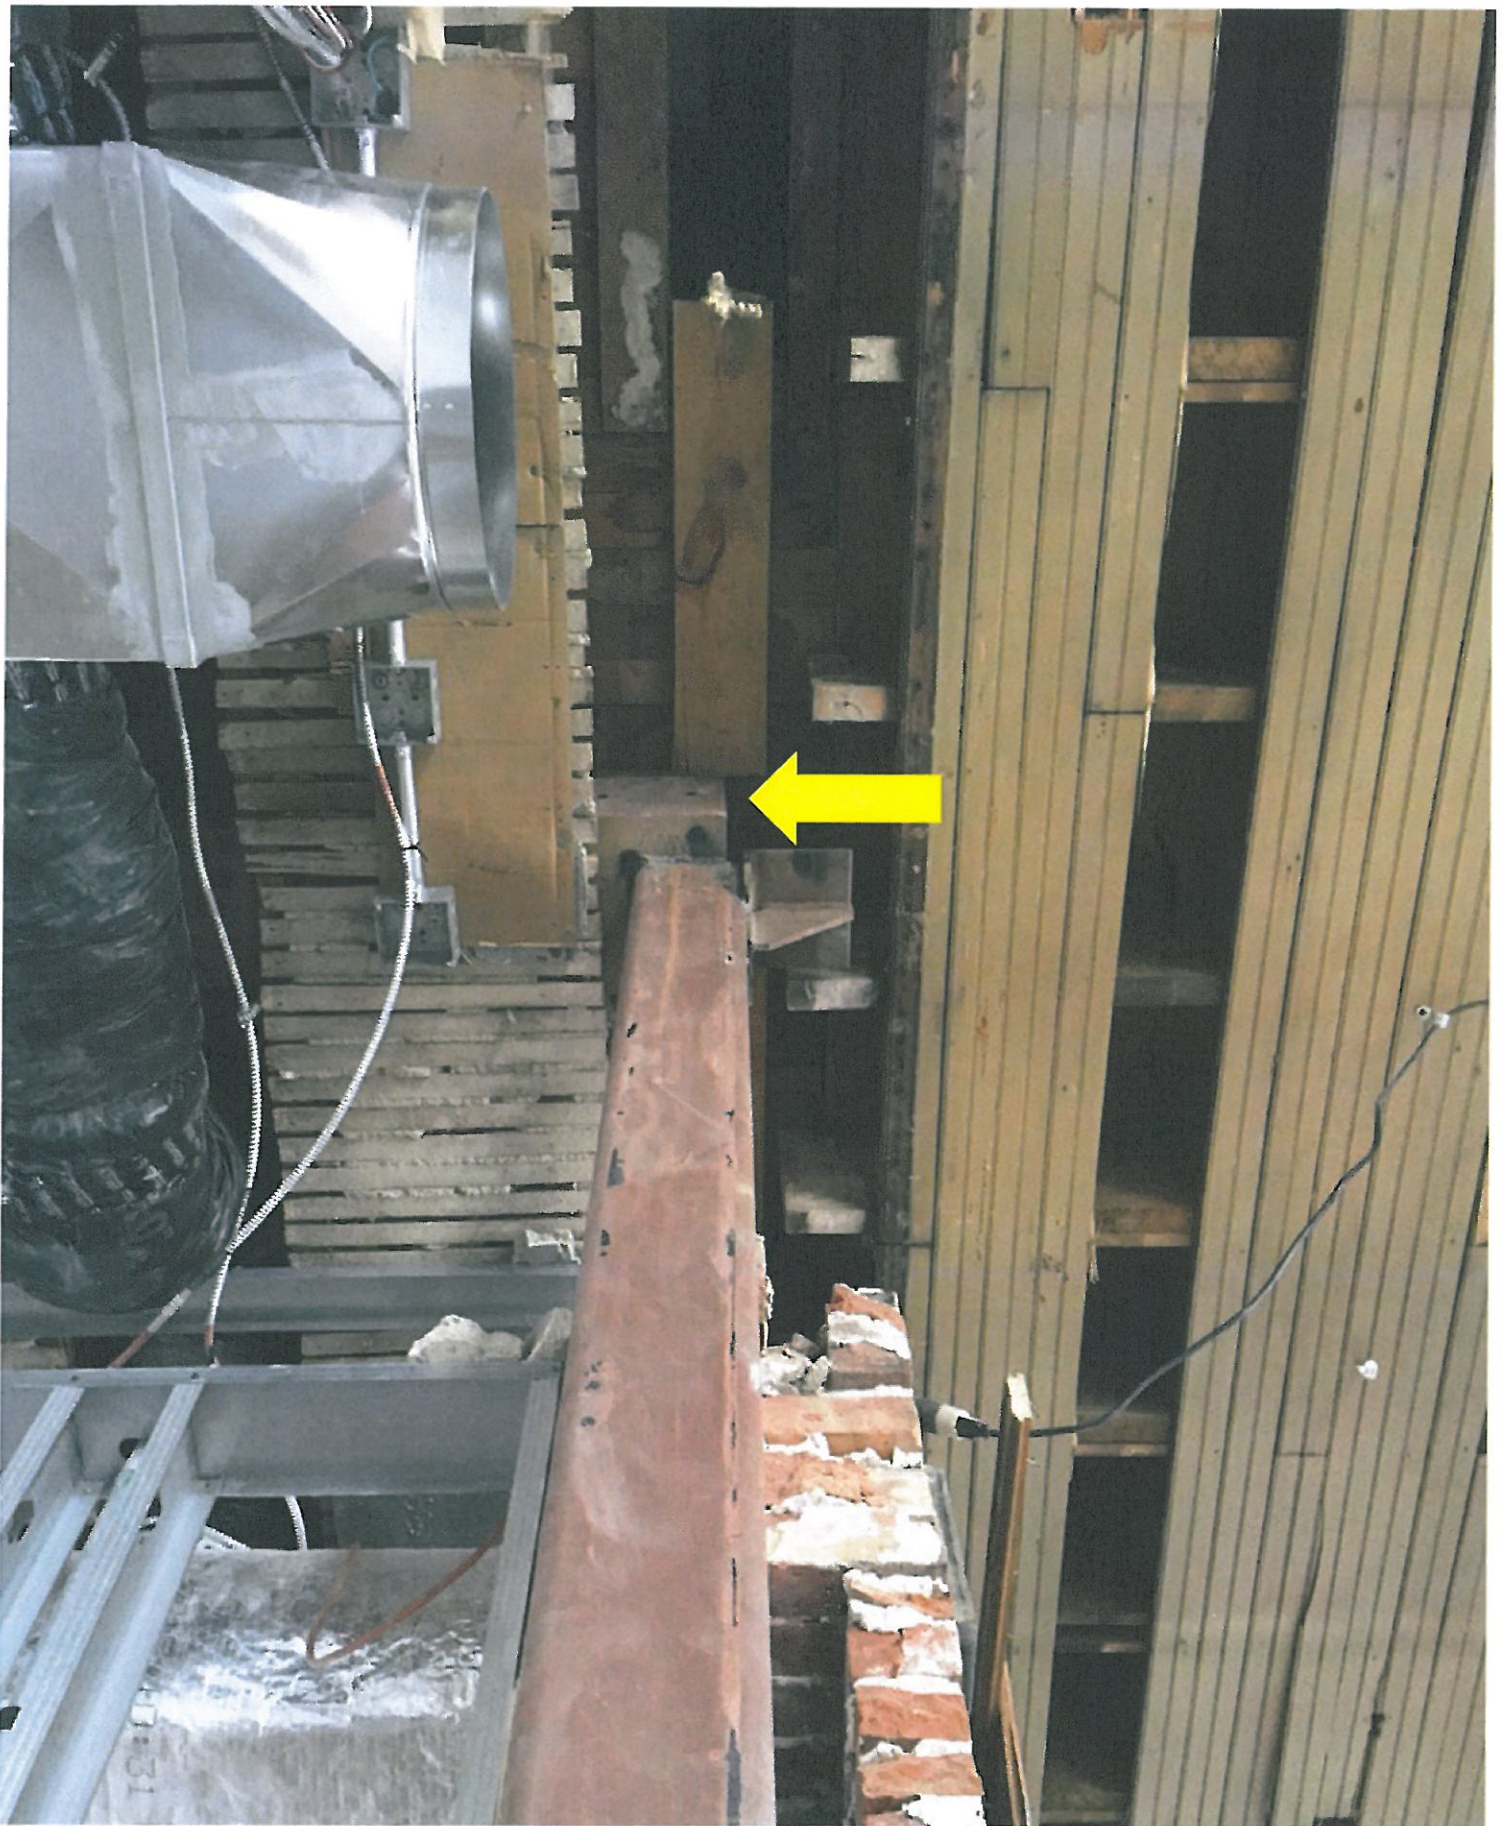
17. New Steel Tube Supports 12"x12" Wood Timber Beam

New 6"x6" steel tube with 9"x12" bent steel plate "saddle" at top, supports wood timber beam

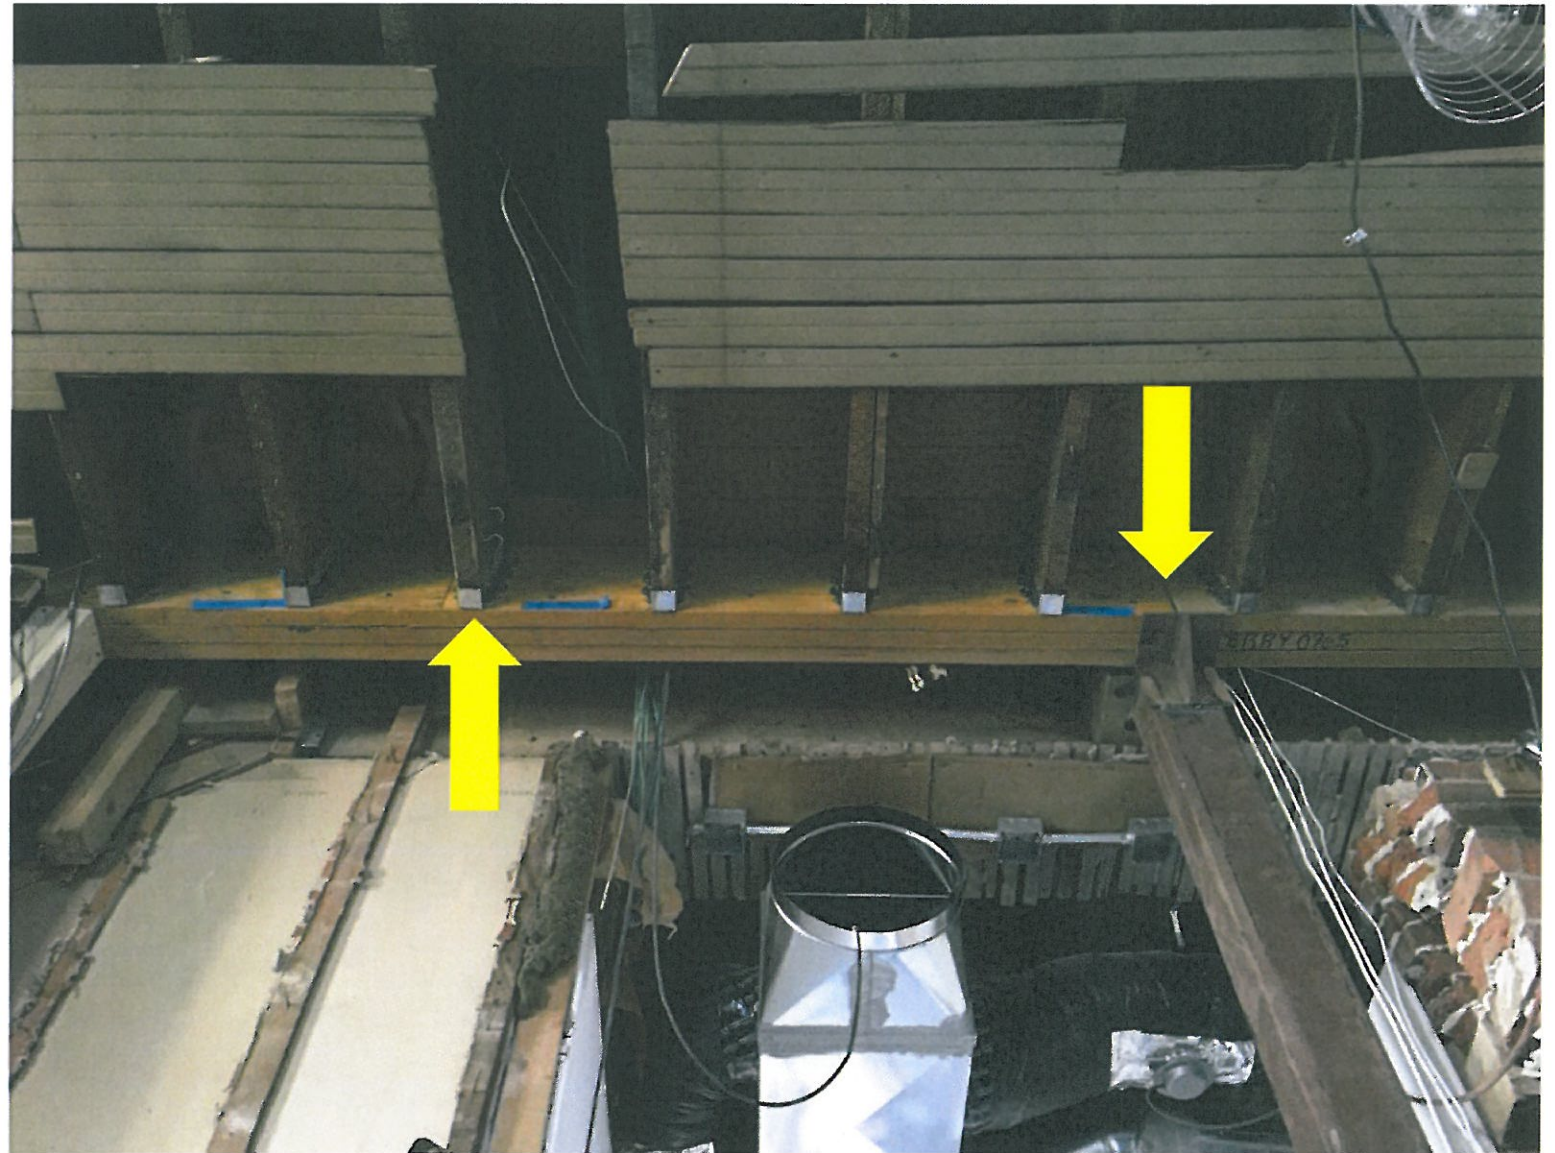
18. New LVL's Beams & Floor Joist Hangers Installed

New LVL beams installed to support floor joists above. A new steel gusset plate also supports LVL's
