JOHN MILNER ARCHITECTS
DESIGN & PRESERVATION

Re: Baldwin-Buss House – Exterior Restoration, Siding Conditions

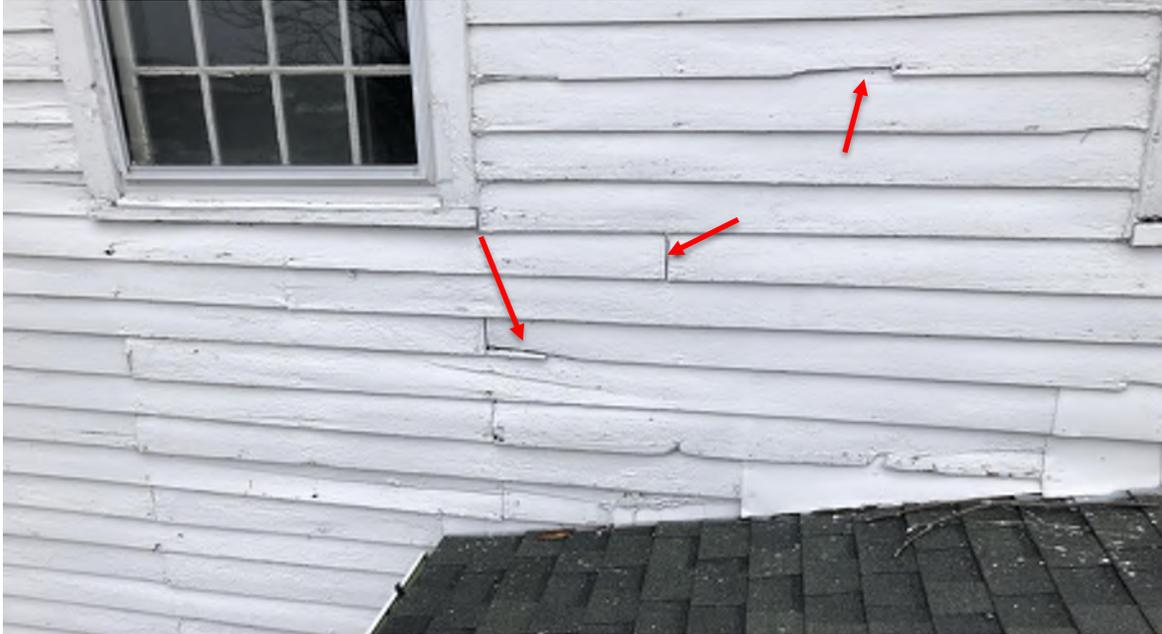
JMA determined that as a protective layer the exterior siding was in poor to fair condition, having failed in certain locations or on the verge of failing in others. Most of the deterioration is associated with areas of elevated moisture such as the joints between siding and trim boards and the intersection of walls and roofs. Numerous boards exhibited large splits, broken edges and/or isolated areas of rot. (*Figure 1*). Through paint analysis we discovered there are approximately 22 layers of paint on the exterior surface. Improper surface preparation between coats of paint has led to heavy accumulation and significantly uneven surface texture (*Figure 2 and 3*). Consistently around the perimeter of the building the bottom courses of siding were improperly flashed or in too close contact with grade. Multiple sections of siding have already been replaced with modern materials and improperly installed (*Figures 4 and 5*). In summary, we believe that after 200 years of continued exposure the siding is near the end of its expected life span.

Figure 1. Broken and split siding boards at the west elevation. Also note open butt joints, cupped boards, and improper roof flashing installation.

Generally, it is our recommendation that the siding on the north, south, and west elevations of the main block of the Baldwin-Buss House be replaced in entirety to ensure the longevity of the structure and integrity of repairs made during the renovation project. Full replacement at this time also allows for significant improvements to be made that extend the lifespan of the building. These improvements would include installation of proper flashing at roofs and sills, waterproofing at existing window openings, installation of a protective air and water barrier such as Tyvek, and repair to damaged or deteriorated sheathing boards (if necessary).

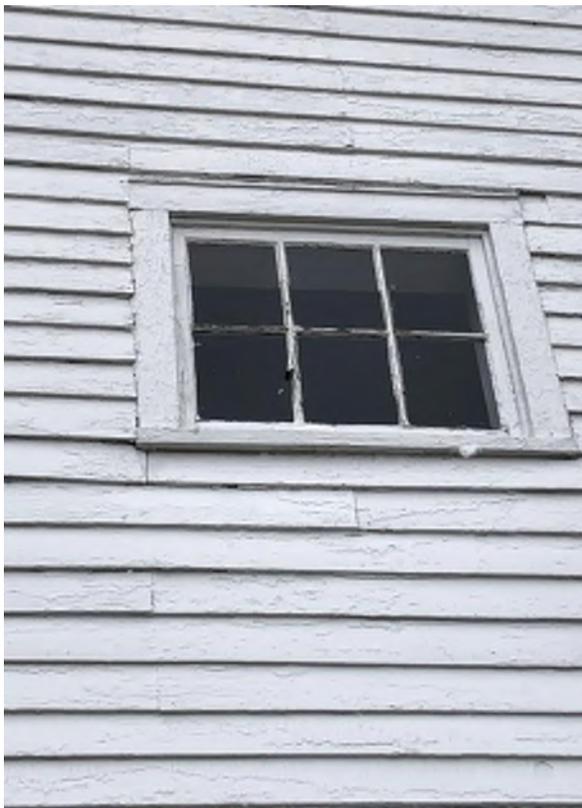
Figure 2. Overview of uneven surface texture due to heavy paint accumulation at the north elevation.

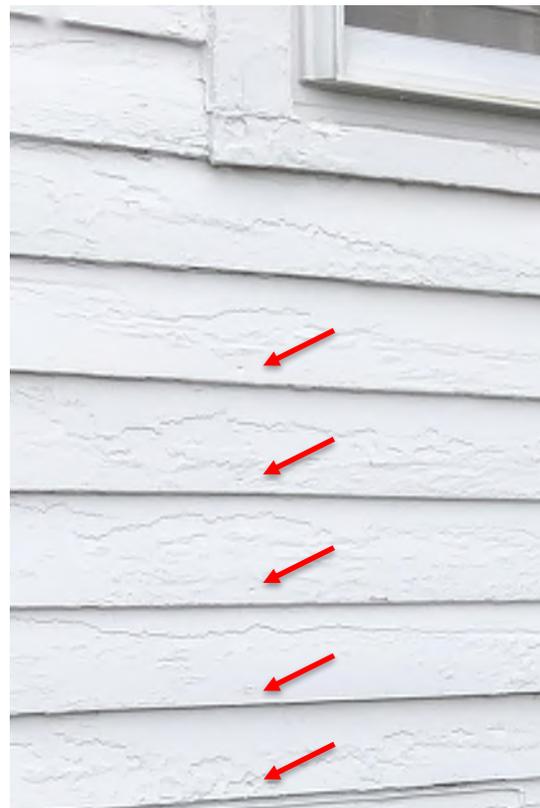
Figure 3. Original nailing pattern obscured by heavy paint accumulation.

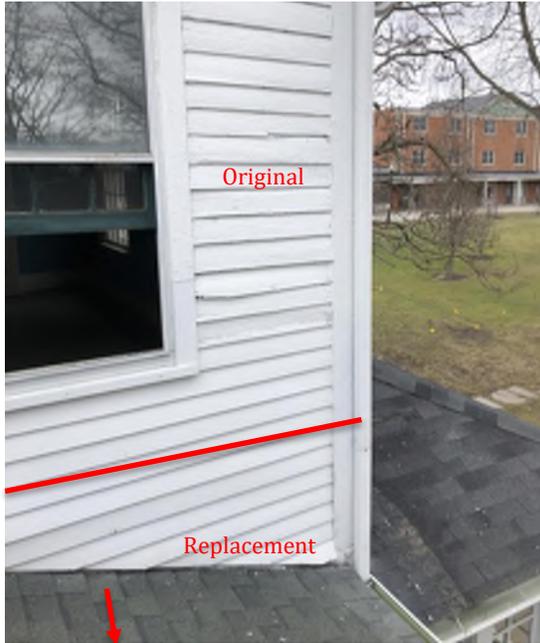
Figure 4. Section of siding below SE window previously replaced. Siding sits directly on roof surface, causing water absorption of roof runoff at the exposed end grain.

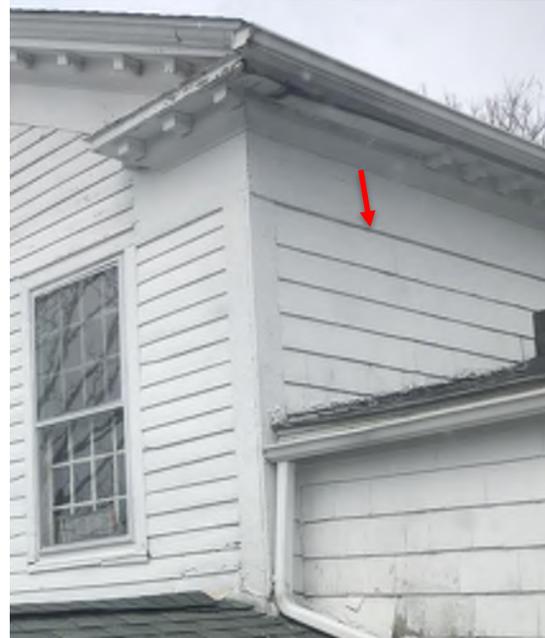
Figure 5. Siding at SW corner of main black previously replaced with shingles.

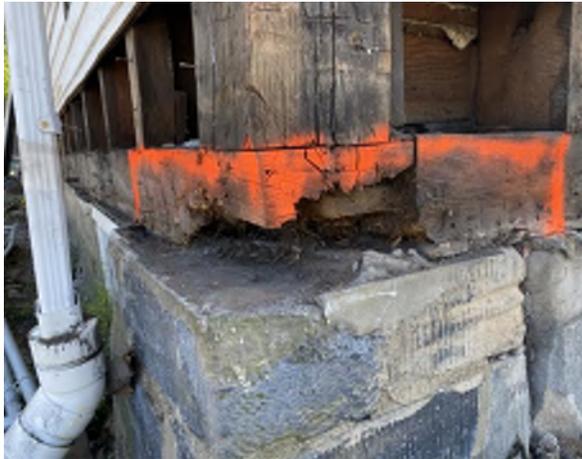
There were a number of conditions exposed during selective demolition that support the replacement of the lapped wood siding. One important discovery was that failed siding and improper flashing have allowed water to infiltrate into the timber wood structure and caused significant deterioration (*Figures 6 and 7*). Multiple sills and corner posts throughout the building have been compromised.

Figure 6. Detail of NW corner. Due to lack of sill flashing at the bottom course of siding, runoff pooled on the foundation stones and rotted the timber sills.

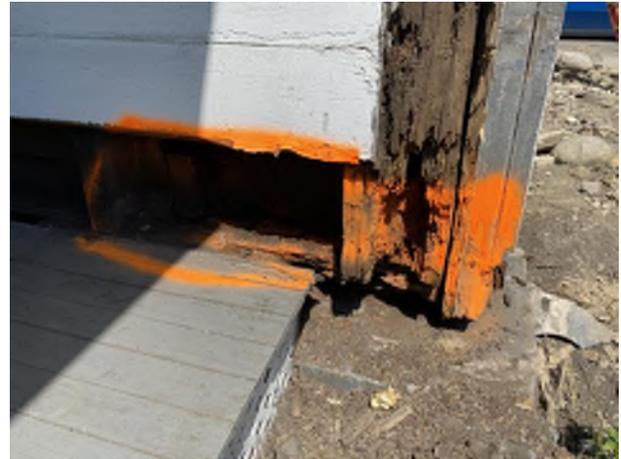
Figure 7. Water infiltration behind the SE corner board led to significant rot and post and material loss of sill.

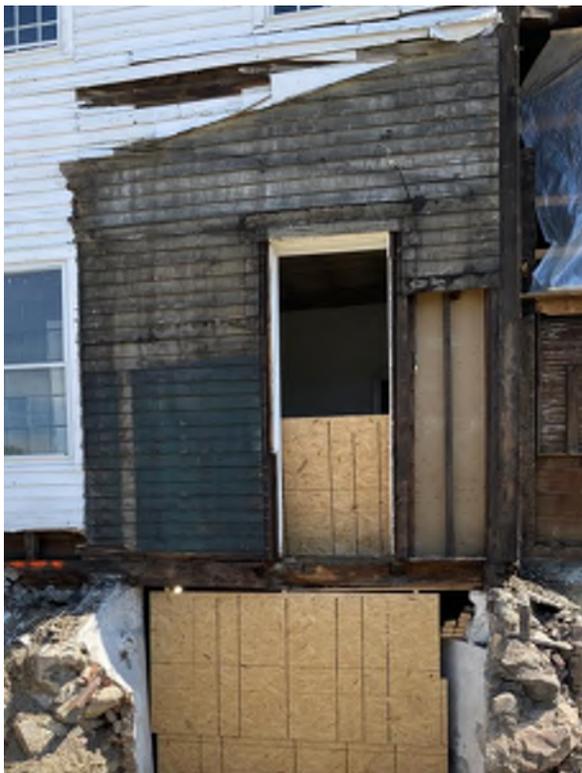
Protected by the former west addition, early siding absent of heavy paint accumulation revealed clear nailing patterns of the siding boards and typical conditions of wood that may be present beneath the usual layers of paint in other locations (*Figure 8*). The siding boards are thin, at a maximum 3/8" in thickness, and are often cracked and cupped where they meet the cornerboard (*Figure 9*).

Figure 8. Overview of siding condition where west addition was removed.

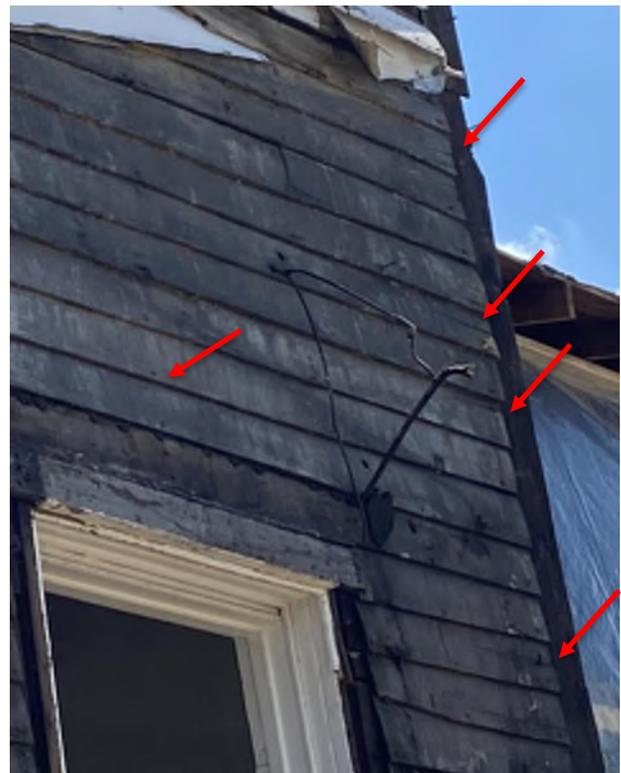
Figure 7. Boards often split or cupped at ends. Also note original nailing pattern unobscured by layers of paint.

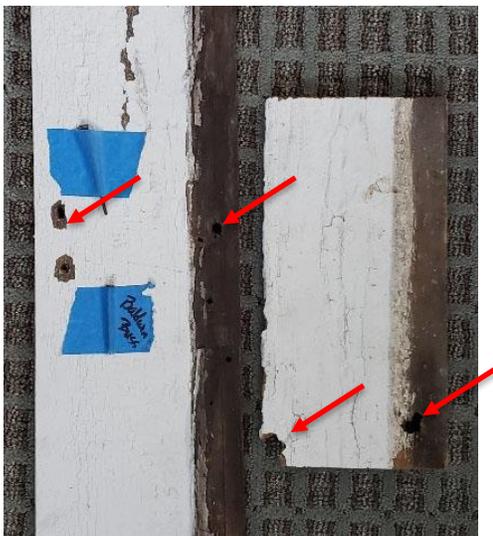
Below are images comparing the siding at Shaker Village and boards at the Baldwin-Buss House (Figures 10 and 11). Both projects had original tulip poplar siding, fastened in two locations (top and bottom), heavy paint accumulation, and overall were in similar stages of deterioration. For additional information, please see the attached summarized case study of the Meeting House at Shaker Village.

Figure 10. Comparison of face of siding boards from Baldwin-Buss (left) and Shaker Village (right). Arrows point to nail holes.

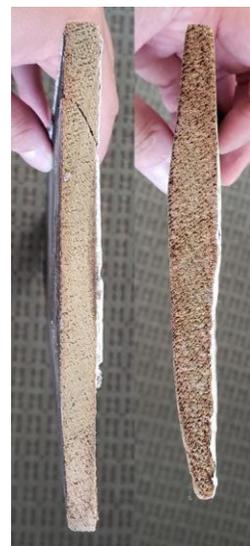
Figure 11. Comparison of siding profiles from Baldwin-Buss (left) and Shaker Village (right)

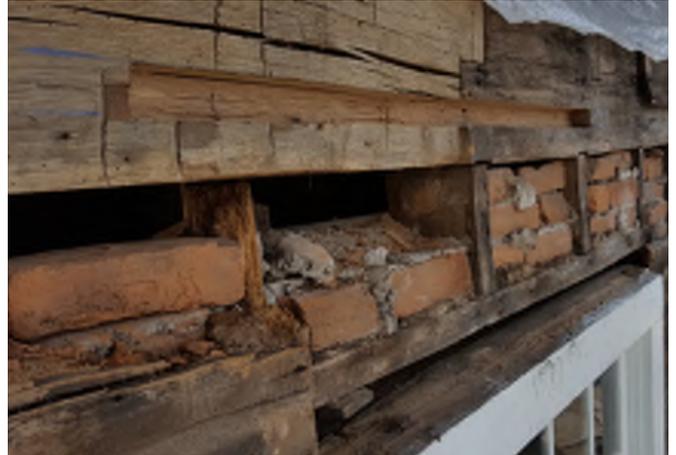
Structural repairs were made to timber frame after siding was removed.

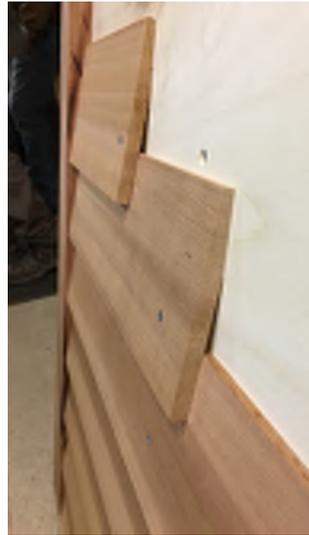
A mock-up was made to ensure proper profiles, spacing, and nailing patterns would be recreated.

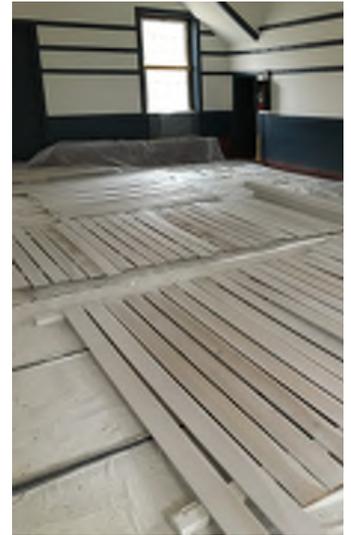
New siding was primed on all surfaces prior to installation.

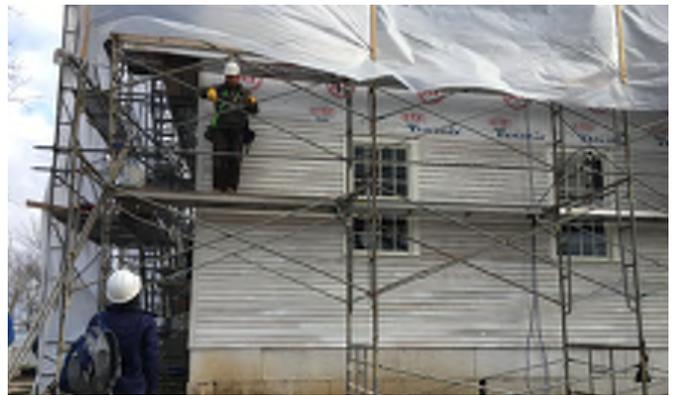
Siding was installed over new building wrap after repairs to the structure were made and new flashings installed.
