Hudson City Administration Center

Space Utilization Study

January 4, 2018

Space Utilization Study
Hudson City Administration Building
1140 Terex Road, Hudson, Ohio

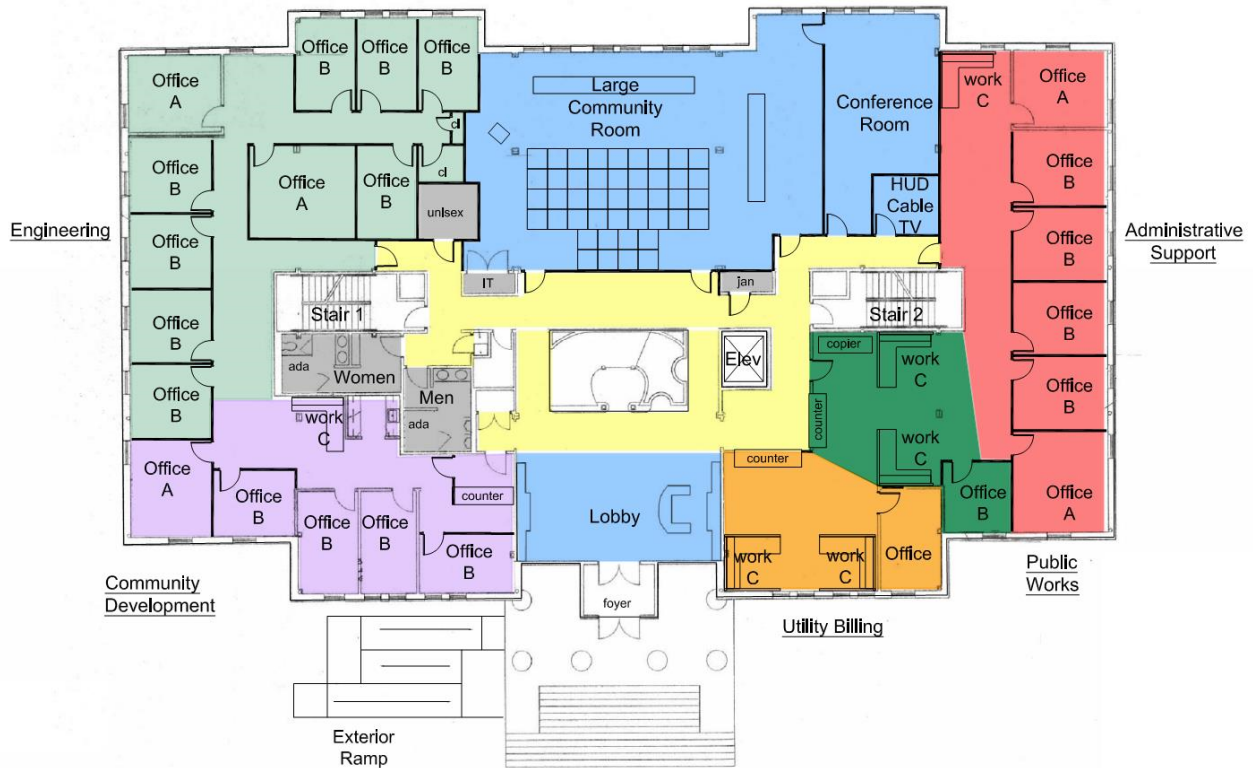
FIRST FLOOR SPACE DIAGRAM

The primary public entrance for City Administration Offices will be through the north entrance on the First Floor. An exterior ramp will be added and integrated into the landscape for wheelchair access. The two departments with the most public visitors, Utility Billing and Community Development, are located adjacent to the main lobby. Access to all other departments and a central Community Room is made via the public corridor surrounding the central stair.

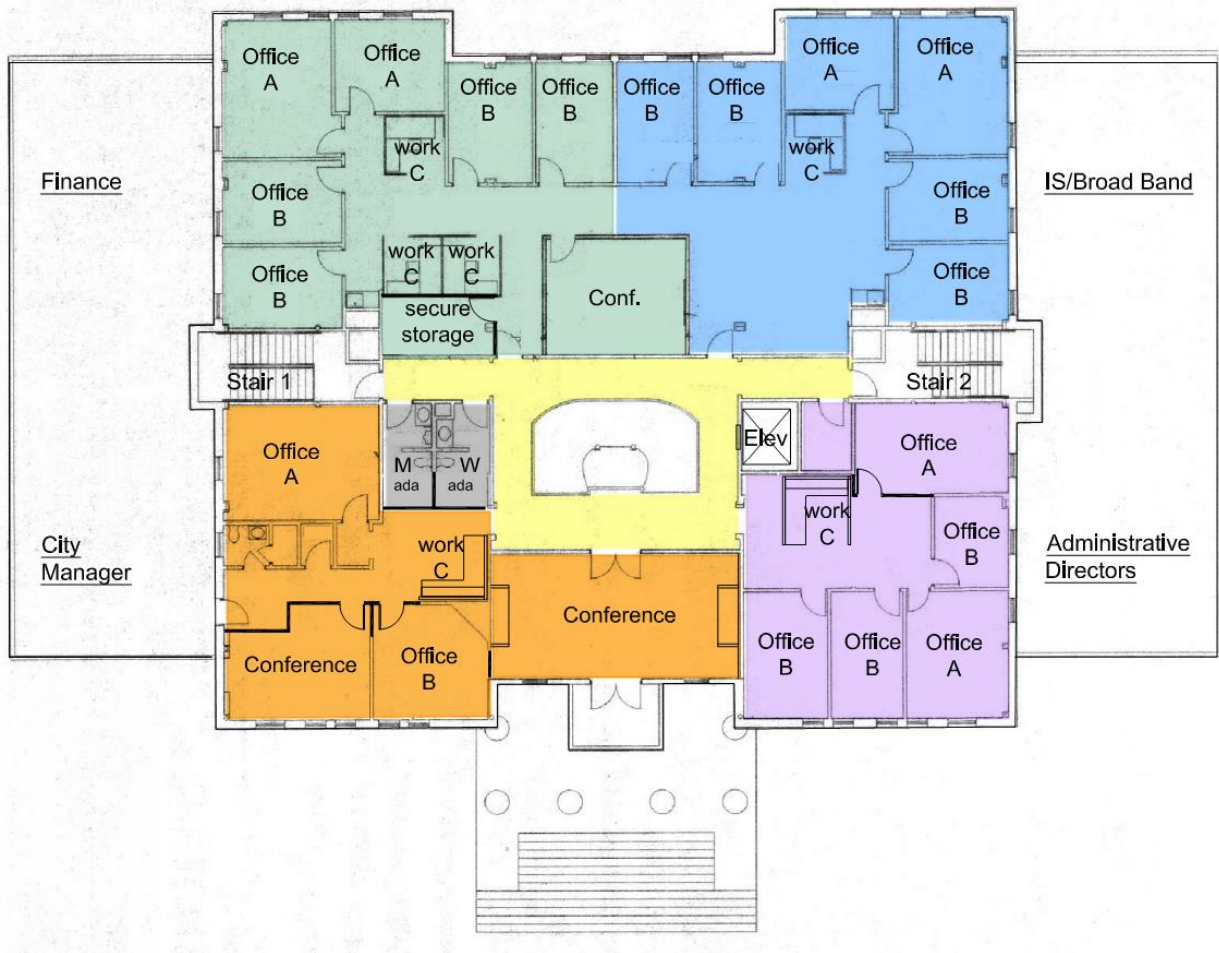
SECOND FLOOR SPACE DIAGRAM

The majority of the Second Floor contains private offices that can be utilized as is. Minor reconfiguration is needed to provide ADA restrooms and storage areas.

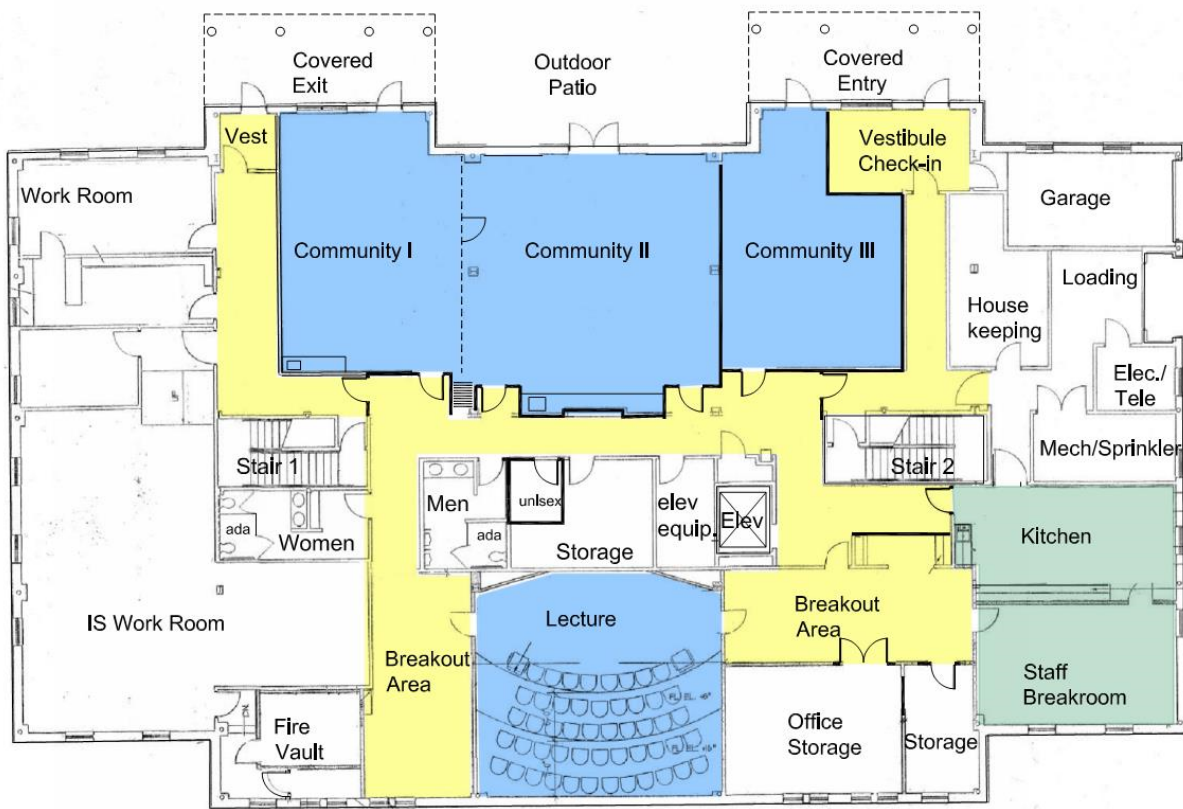
GROUND FLOOR SPACE DIAGRAM

Aside from the ADA and unisex restrooms being completed in Phase 1, all work on the Ground Floor is planned for a Future Phase. There is an opportunity on the Ground Floor to provide meeting and presentation spaces for the general community. There is a need for this type of space in Hudson that is not adequately being met. This floor is envisioned to be available for both day and evening use. Only authorized personnel will be able to access the upper floors from the Ground Level.
