PHYSICAL CONDITION REPORT

OTIC DESIGN PROJECT NO. 71-22-12 PROSPECT ROAD BRIDGE (CR 34) OVER THE OHIO TURNPIKE MILEPOST 182.1 SUMMIT COUNTY, OHIO

PHYSICAL CONDITION REPORT
Prospect Road Bridge Over the Ohio Turnpike, Milepost 182.1

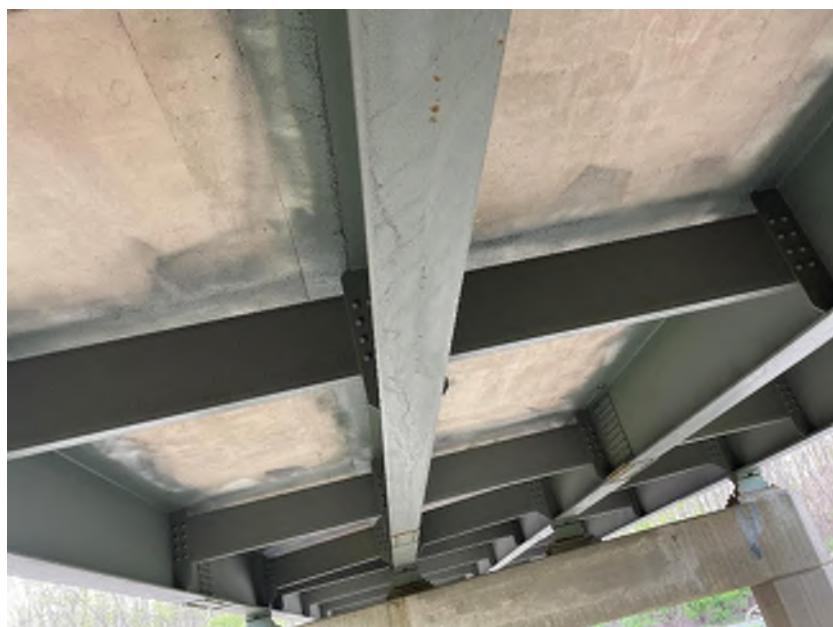
The rolled steel beams are in good condition and received a system OZEU painting in 2008. The beams exhibit localized patches of rust-stained protective coating system, and light surface rust in small patches along the bottom flange where the protective coating system has failed. These minor rust locations are small patches less than 3" wide. The moment plates and splices of the beams are in similar condition. The end diaphragms at the abutments are in good condition. The current condition of the protective coating system does not warrant replacement at this time.

Photograph #2 - Typical Beam and Intermediate Diaphragm Condition (End Spans) MP 182.1

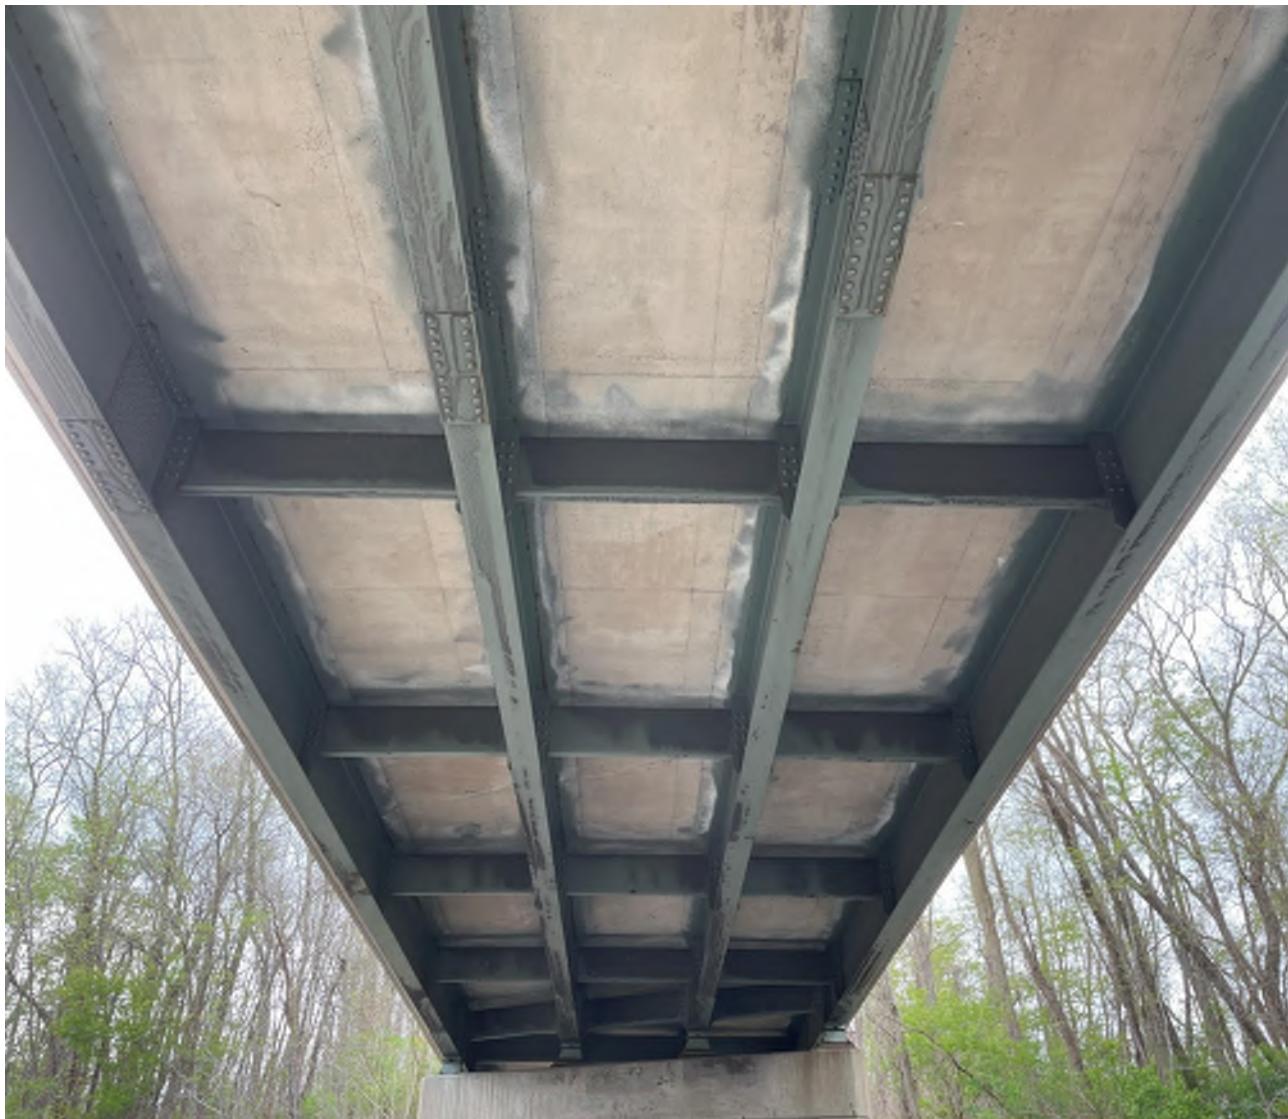
Photograph #3 - Typical Beam and Intermediate Diaphragm Condition (Main Spans) MP
182.1

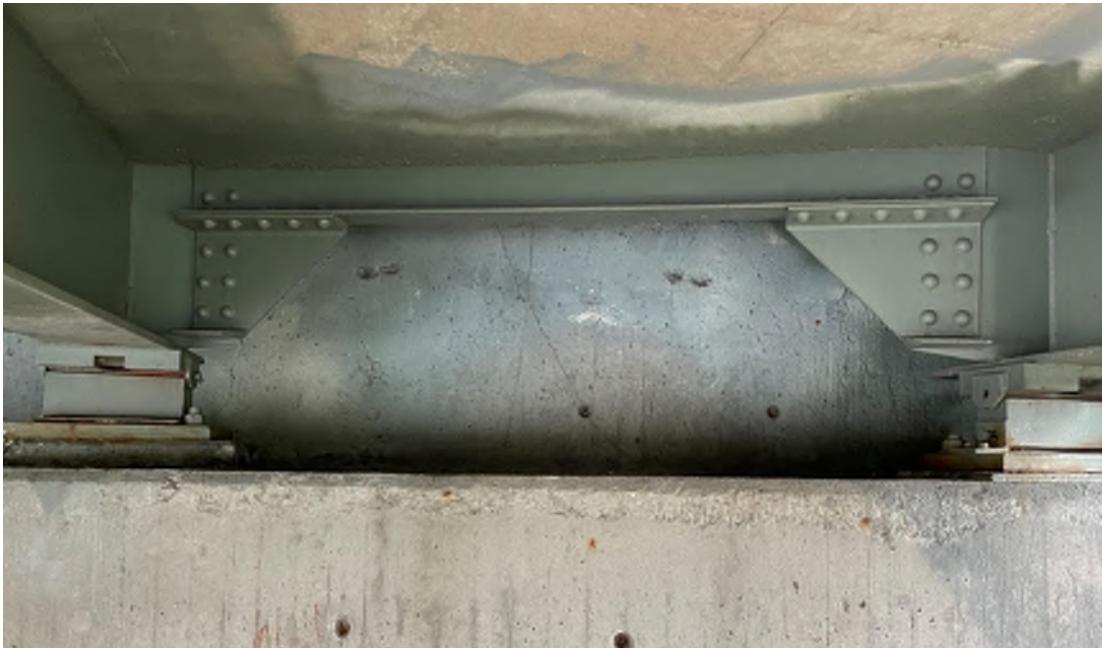
Photograph #4 - Typical End Diaphragm Condition (Main Span) MP 182.1

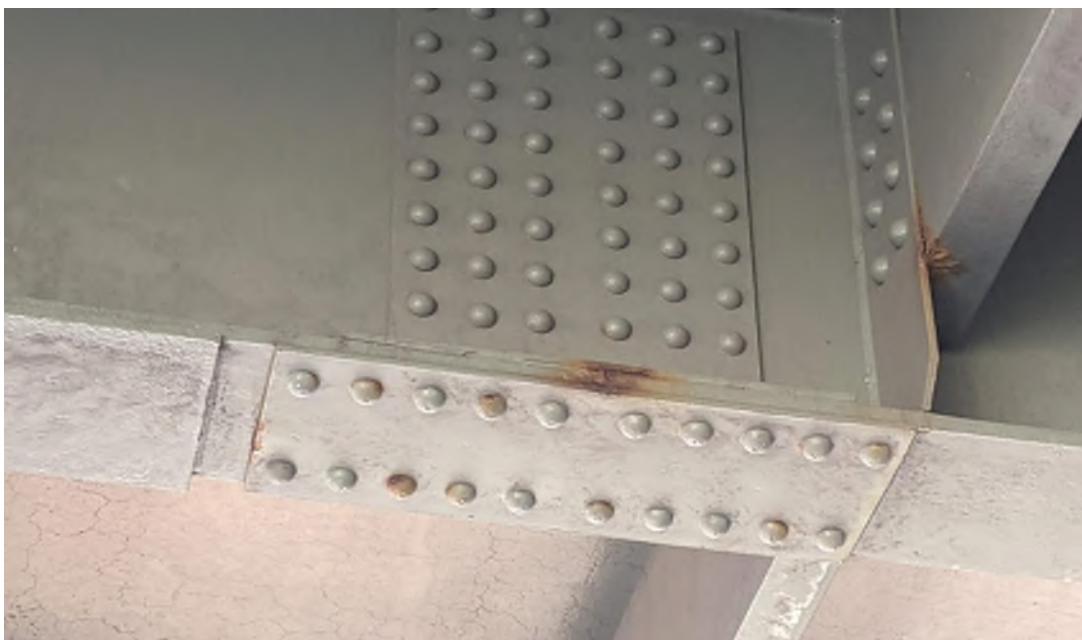
Photograph #5 - Beam 2 Splice with Light Rust, Span 1 MP 182.1

7 - Bm2 F.S. 1 minor rust
from Bot/Flange interface
with chalk

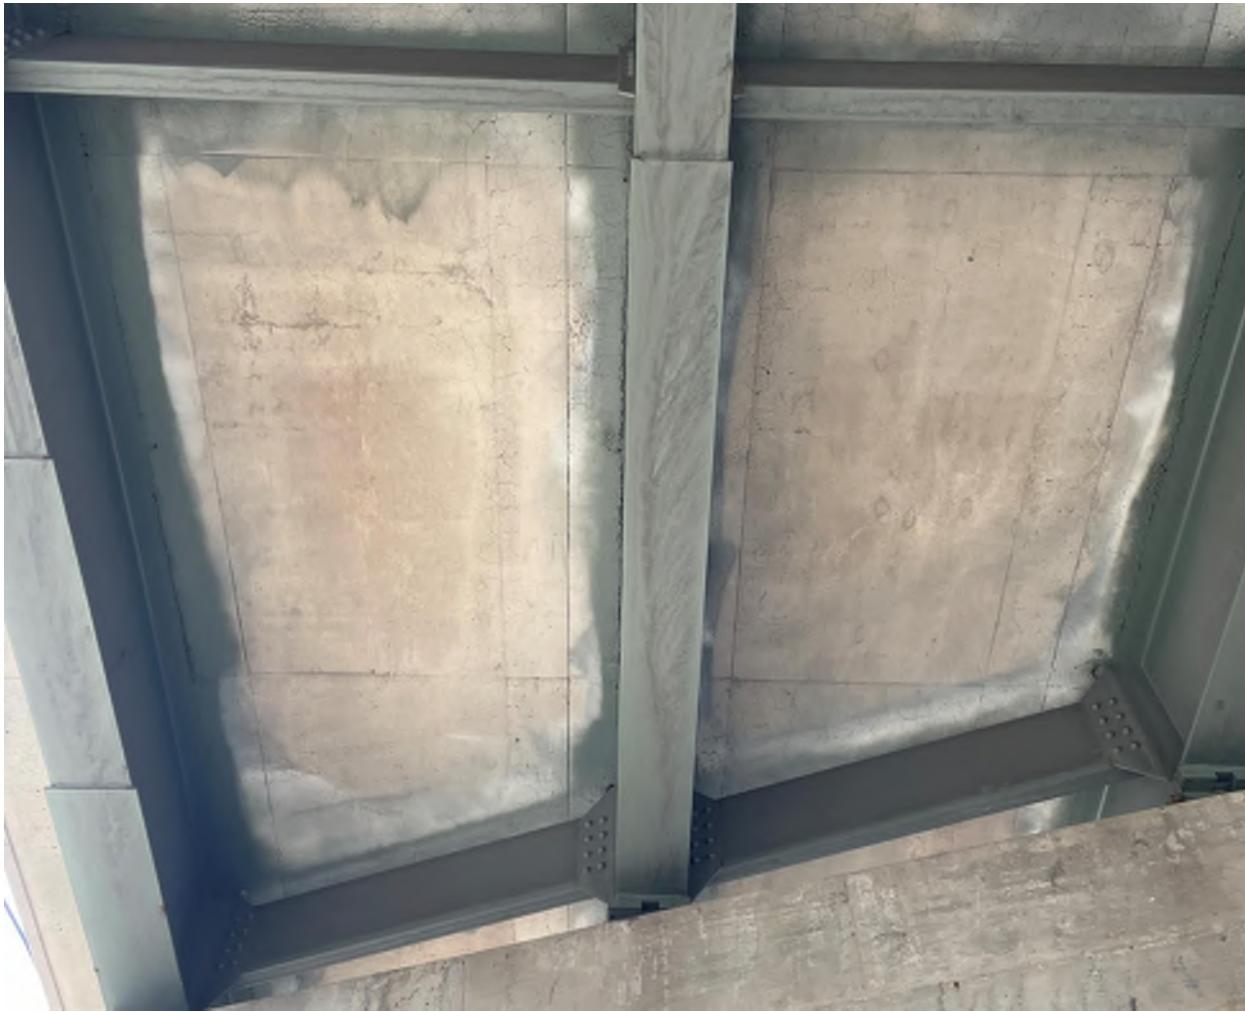
The fatigue prone connections are in good condition. For this structure the fatigue prone connections are the transverse welds at the ends of the welded moment cover plates over Pier 1, Pier 2, and Pier 3. No distress was observed in the bottom flange cover plate welds at the piers. The top flange cover plates could not be inspected because they are encased in the concrete deck and should be inspected after deck removal.

Photograph #6 - Typical Moment Plate Condition MP 182.1

6 - Moment plates have minor surface rust
Bot/Flange no section loss
welds ok

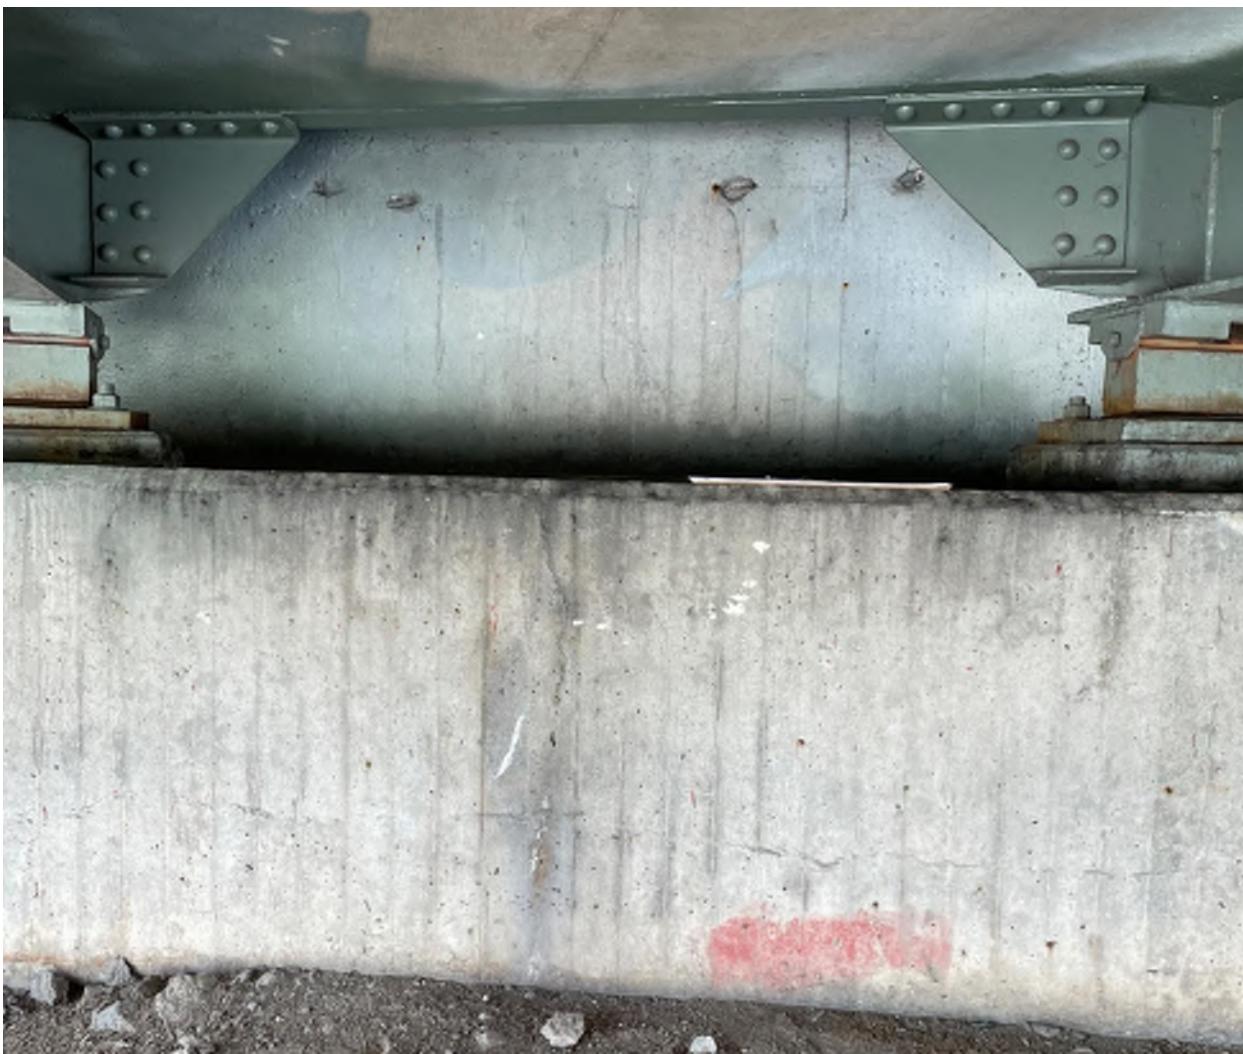
The abutments are in good condition. No spalls were observed on the exposed portions of the backwall. The exposed portions of the abutment stems are also free from spalls but do have some minor vertical cracks. No evidence of deterioration on the exposed faces of the wingwalls was observed. The catch basins at the north approach have failed. The northeast catch basin has collapsed in on itself, and the northwest catch basin has erosion and piping around the drain pipe. These drainage issues are causing the embankment along the wingwalls to erode, pulling away from the side faces of the north abutment wingwalls. The following figures and sketches indicate the limits of cracks recommended to be repaired via epoxy injection to protect against further deterioration in the future. In addition the erosion around the wingwalls should be backfilled with rock channel protection to mitigate further erosion regardless of repairs to the catch basins.

Photograph #7 - Rear (South) Abutment Vertical Crack MP 182.1

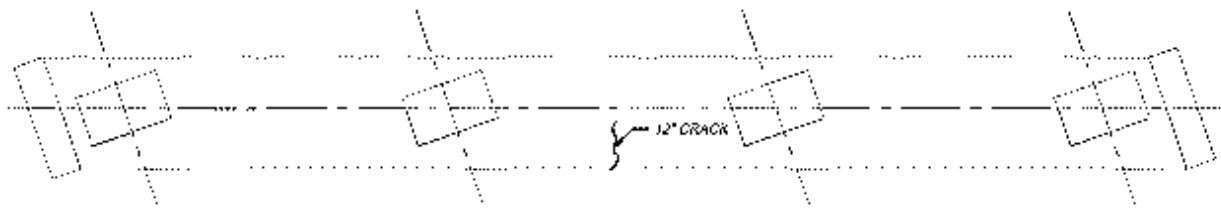
Figure 3 - Location of Proposed Concrete Repairs - Rear (South) Abutment Plan MP 182.1

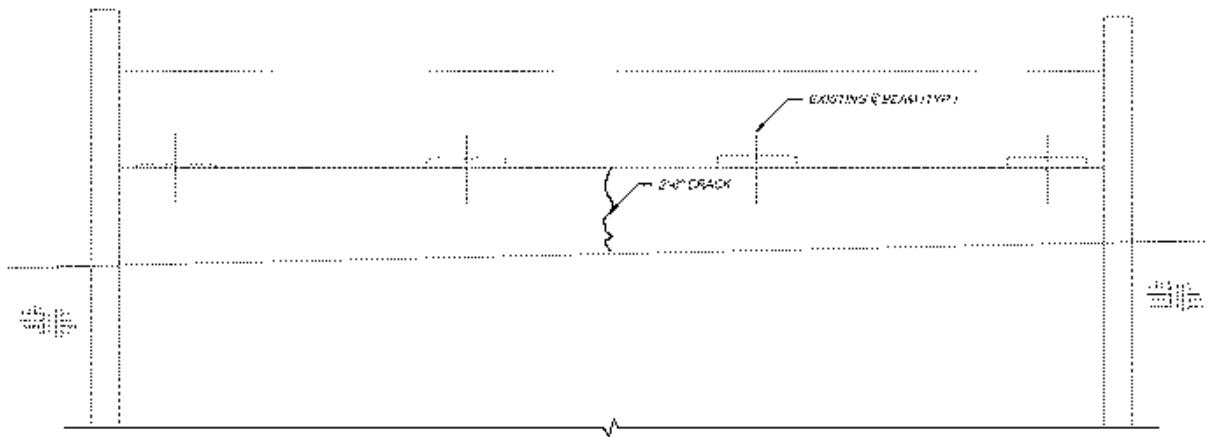
Figure 4 - Location of Proposed Concrete Repairs - Rear (South) Abutment Elevation MP 182.1

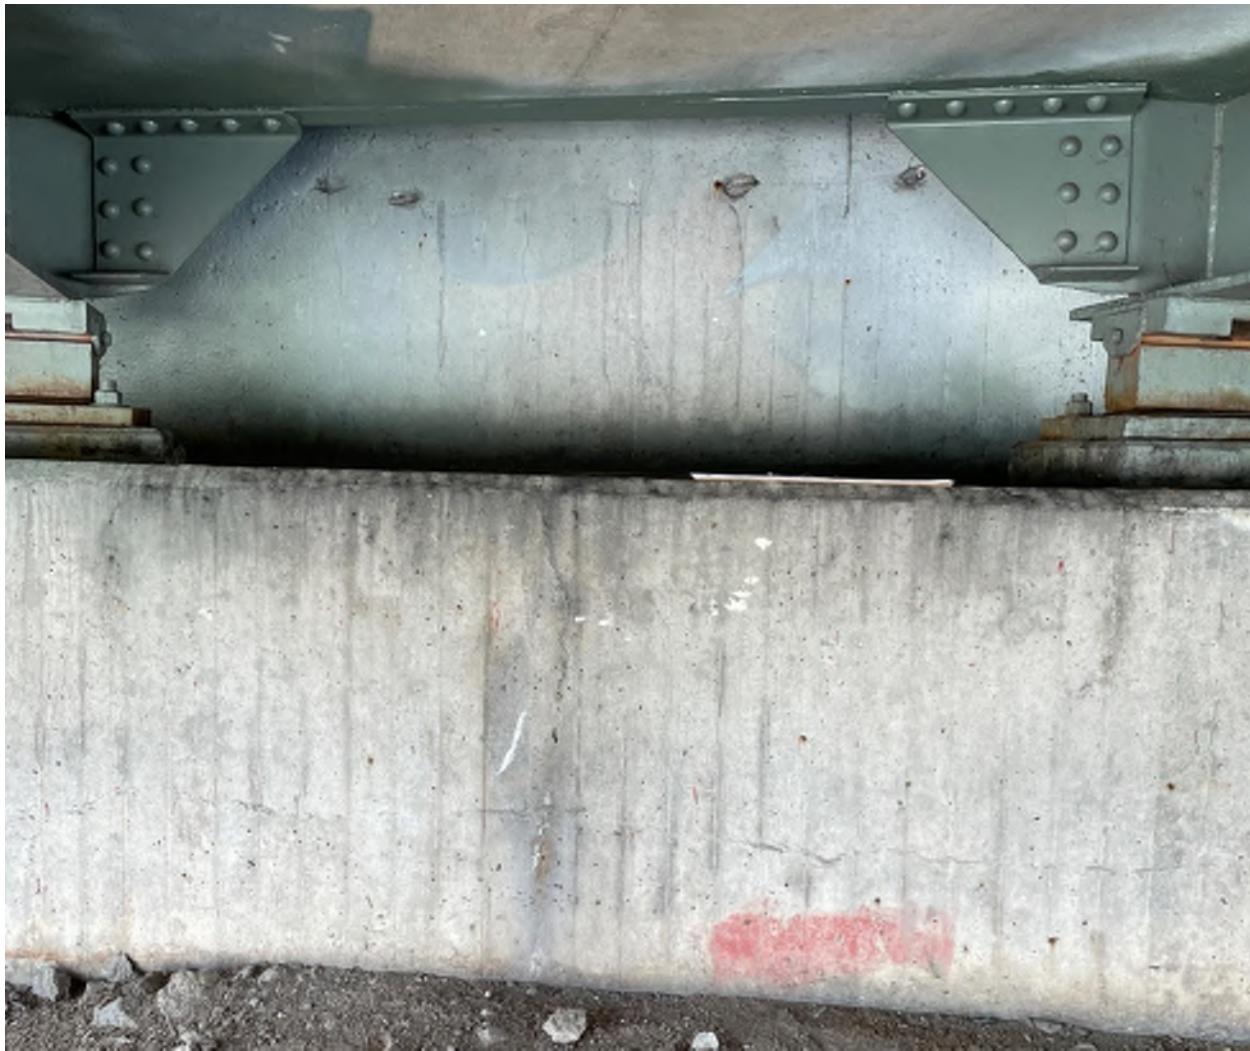
Photograph #8 - Forward (North) Abutment Vertical Crack MP 182.1

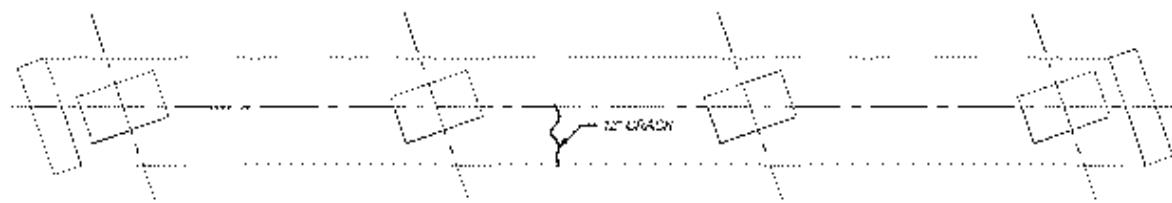
Figure 5 - Location of Proposed Concrete Repairs - Forward (North) Abutment Plan MP 182.1

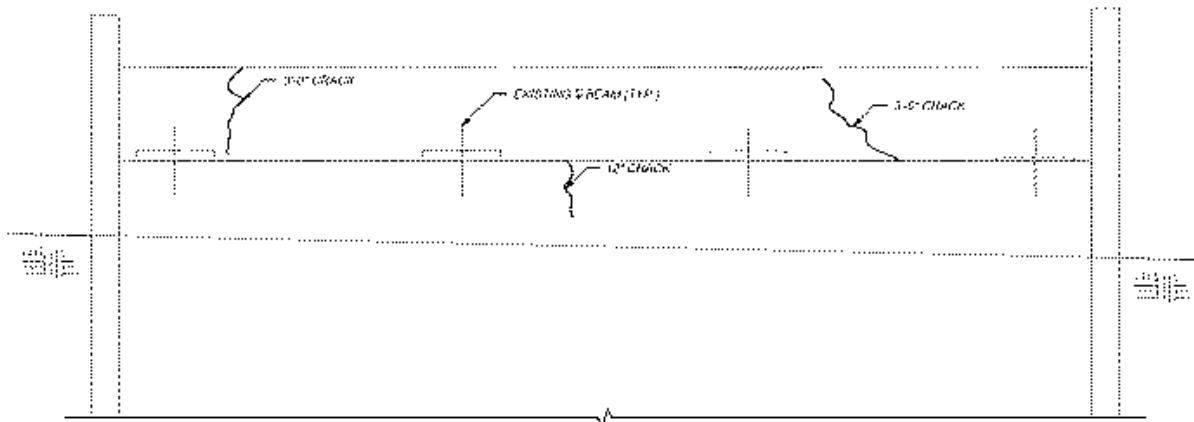
Figure 6 - Location of Proposed Concrete Repairs - Forward (North) Abutment Elevation MP 182.1

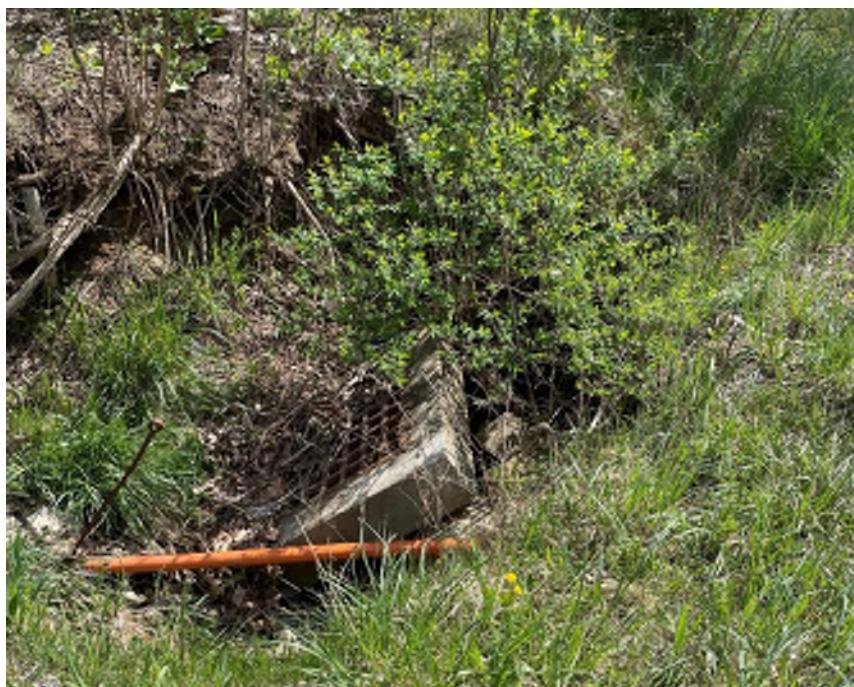
Photograph #9 - Collapsed Forward Right (Northeast) Catch basin MP 182.1

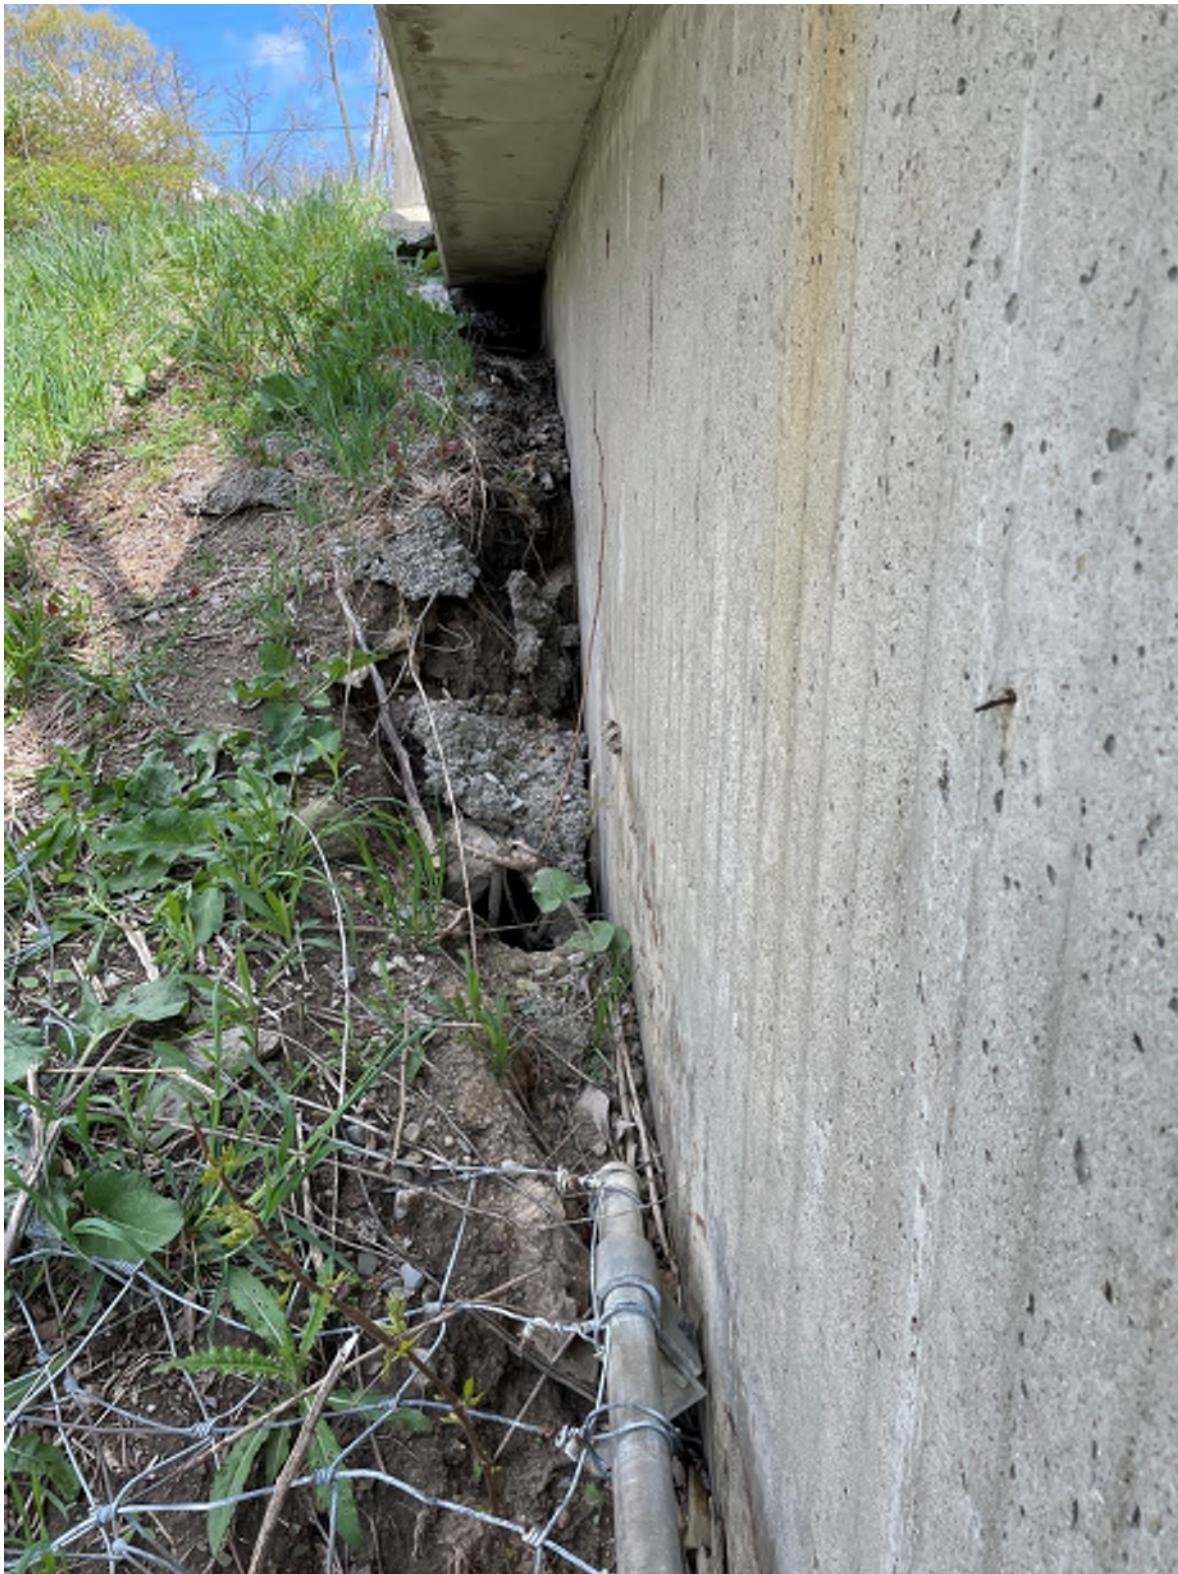
**Photograph #10 - Typical Wingwall Condition and Slope Erosion at Forward Left
(Northwest) MP 182.1**

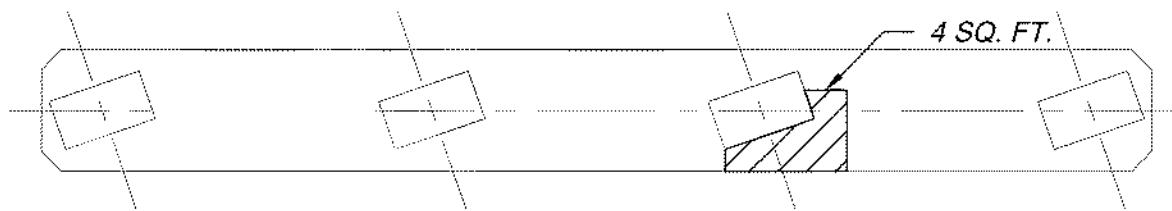
In all three pier caps, a few minor cracks were observed and measured 0.013" to 0.025" wide. Additional minor cracks exist at old patch material cold joints on both faces of Piers 1 and 3. Hammer sounding indicated localized delaminated areas on all three pier caps. The northwest corner on the cap of Pier 3 has a deep spall with reinforcing steel stirrups exposed with moderate section loss and delamination extending to the side face. This spall extends to the bearing seat pedestal, which is missing a corner of concrete extending to the bearing masonry plate with the plate overhanging 1/8".

Pier 1 Column 1 has minor delamination present on the traffic face (north face) that extends onto the west face. No deterioration was observed to Pier 2 columns. Pier 3 Column 2 has minor delamination on the traffic face (south face) that leads to the east face. Pier 3 Column 3 has a spall in the patch on the south east corner, exposing three stirrups with minor section loss. The entire patch on the west, south, and east faces and a halo around the patch are delaminated with wire mesh rust showing through on the face.

Figure 7 - Location of Proposed Concrete Repairs - Pier 1 Plan View MP 182.1

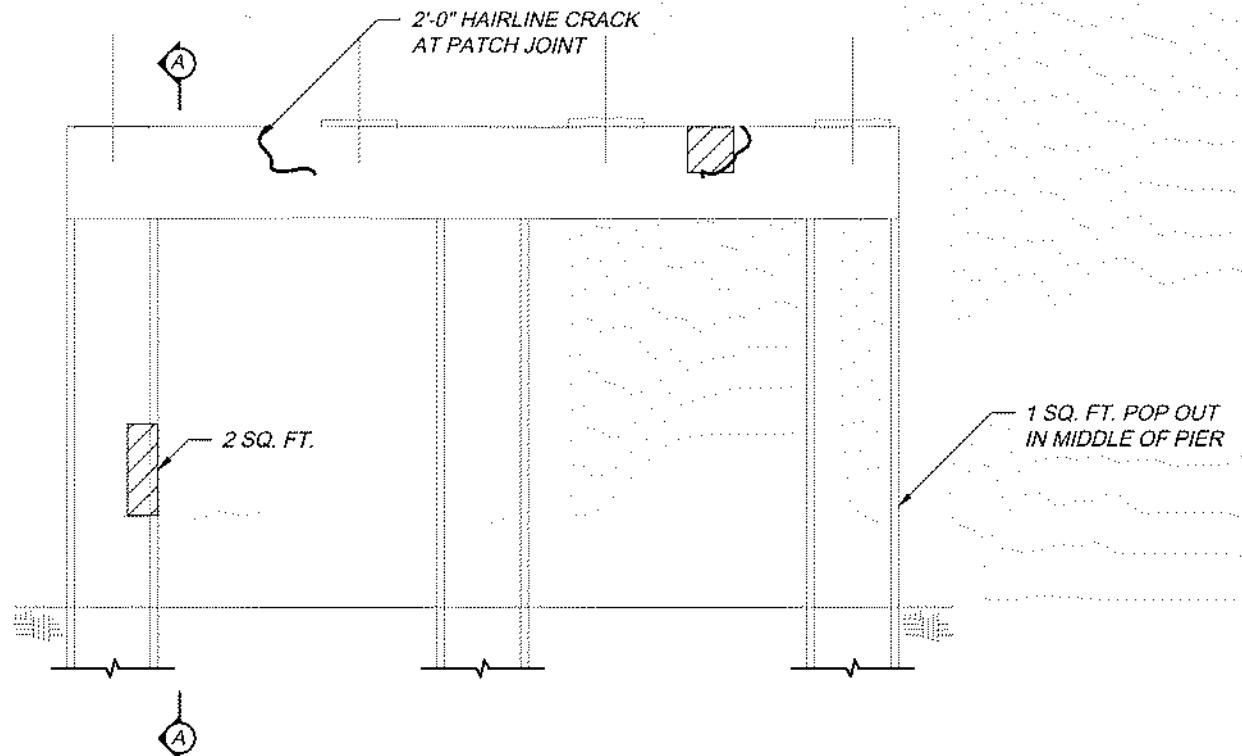
**Figure 8 - Location of Proposed Concrete Repairs - Pier 1 Downstation (North) Face
Elevation MP 182.1**

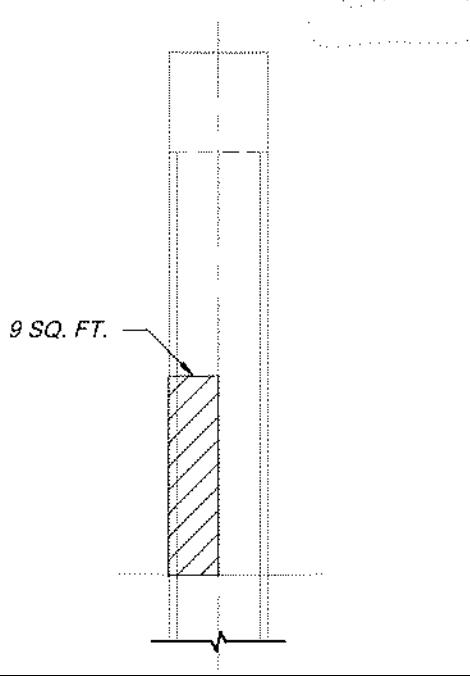
Figure 8 - Location of Proposed Concrete Repairs - Pier 1 View A-A MP 182.1

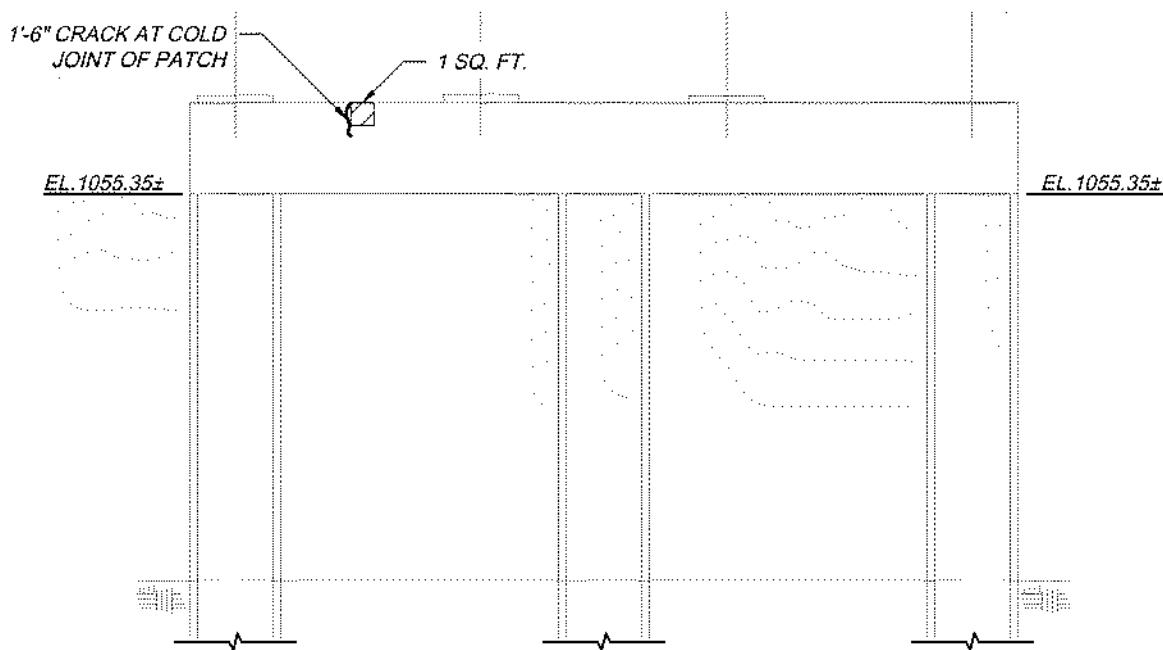
Figure 10 - Location of Proposed Concrete Repairs - Pier 1 Upstation (South) Face Elevation MP 182.1

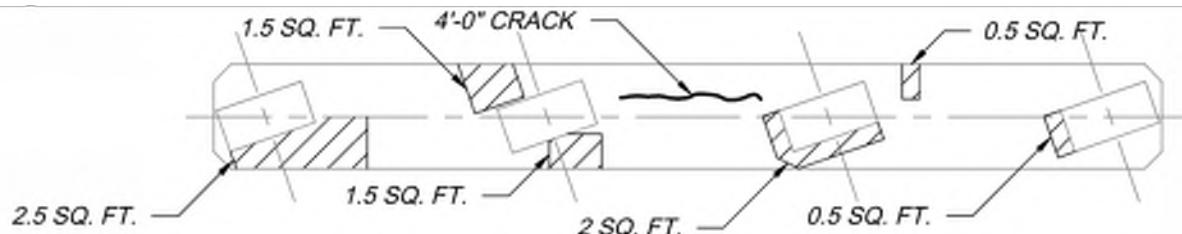
Figure 11 - Location of Proposed Concrete Repairs - Pier 2 Plan View MP 182.1

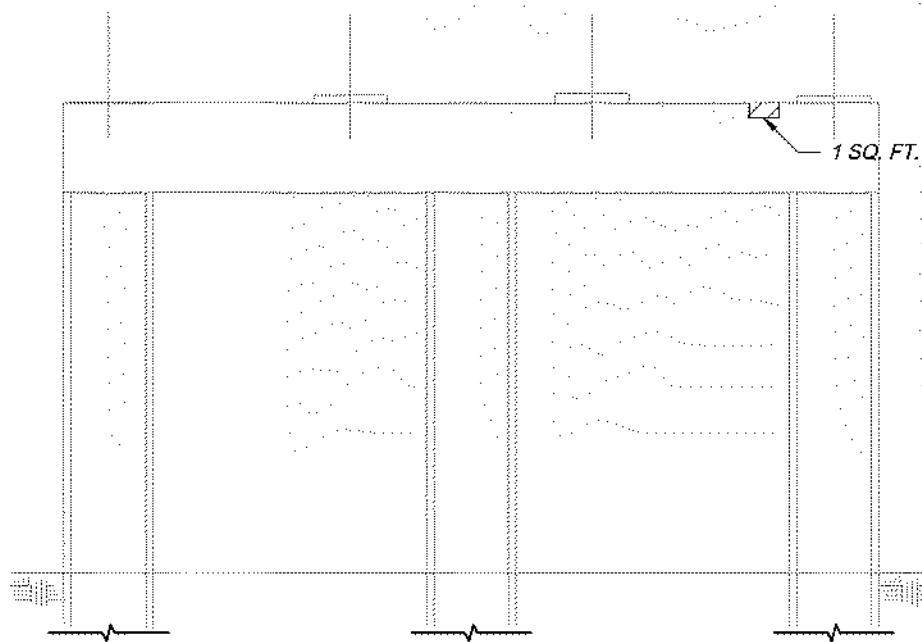
Figure 12 - Location of Proposed Concrete Repairs - Pier 2 Upstation (South) Face Elevation MP 182.1

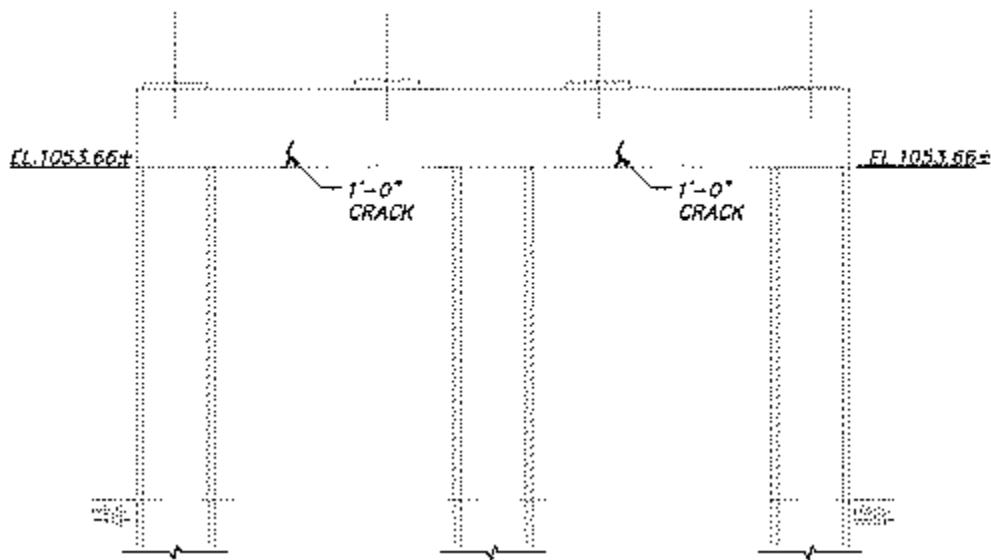
Figure 13 - Location of Proposed Concrete Repairs - Pier 2 Downstation (North) Face Elevation MP 182.1

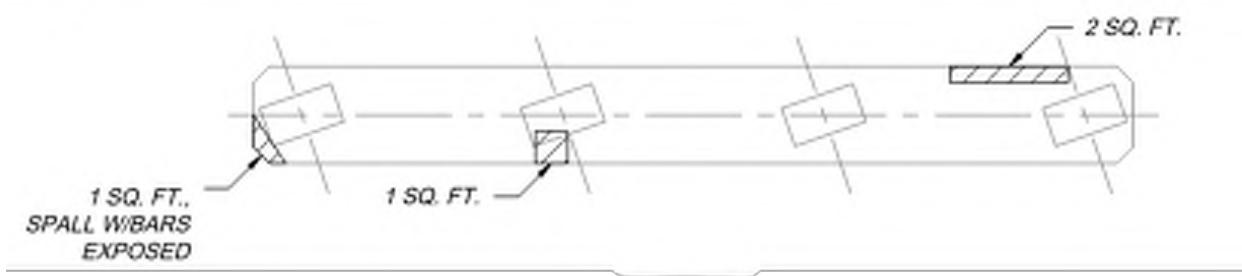
Figure 14 - Location of Proposed Concrete Repairs - Pier 3 Plan View MP 182.1

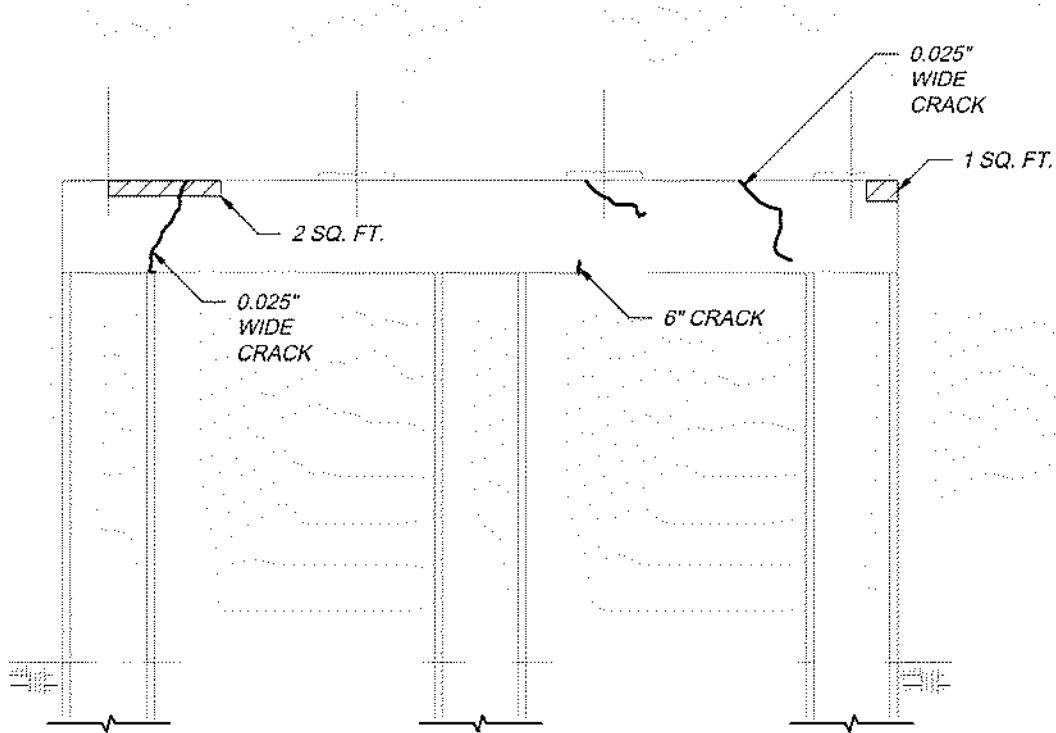
Figure 15 - Location of Proposed Concrete Repairs - Pier 3 Upstation (South) Face Elevation MP 182.1

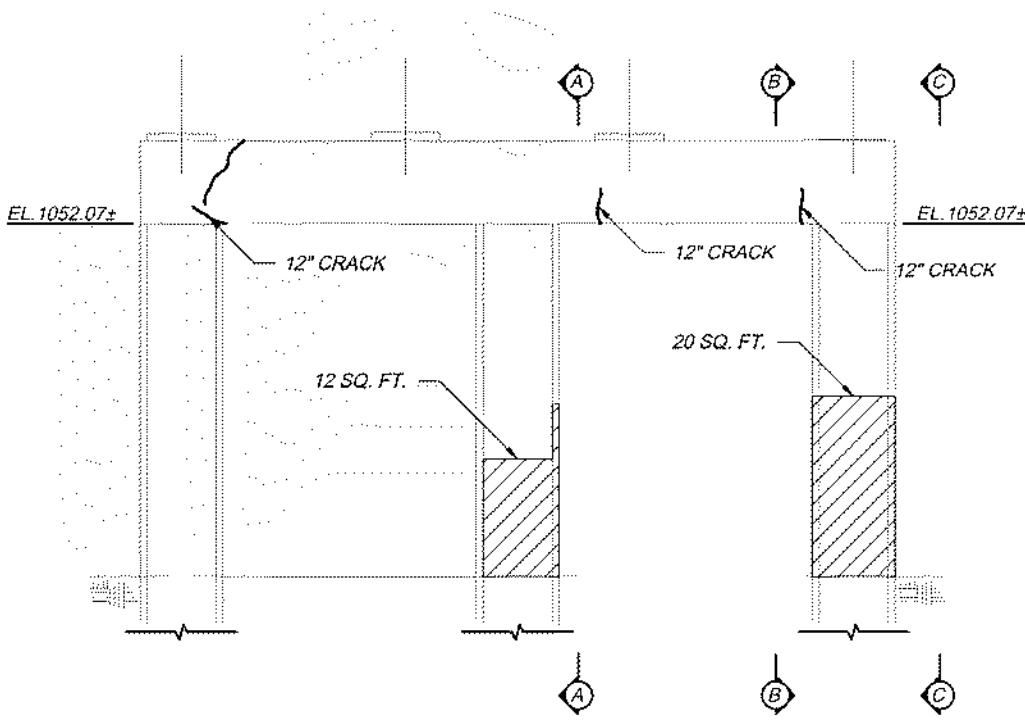
Figure 16 - Location of Proposed Concrete Repairs - Pier 3 Downstation (North) Face Elevation MP 182.1

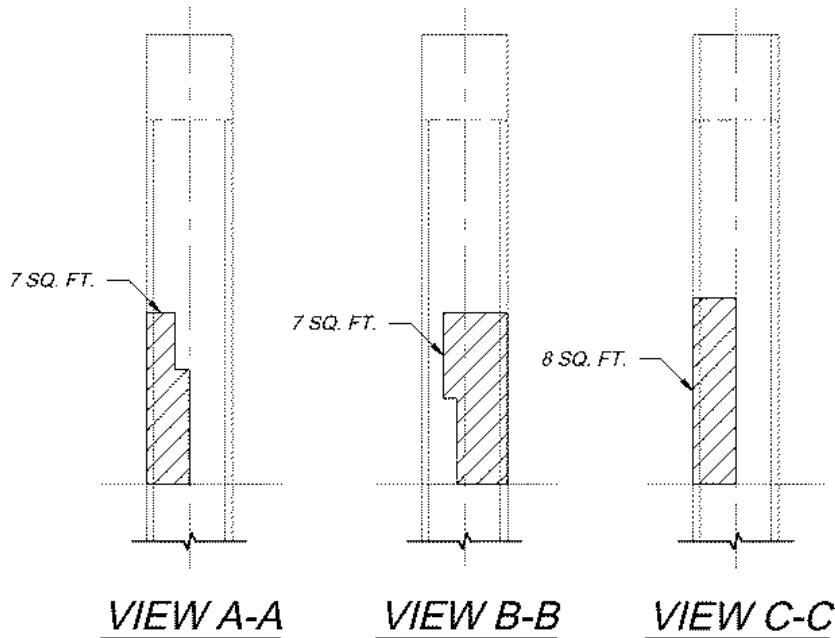
Figure 17 - Location of Proposed Concrete Repairs - Pier 3 View A-A - View C-C MP 182.1

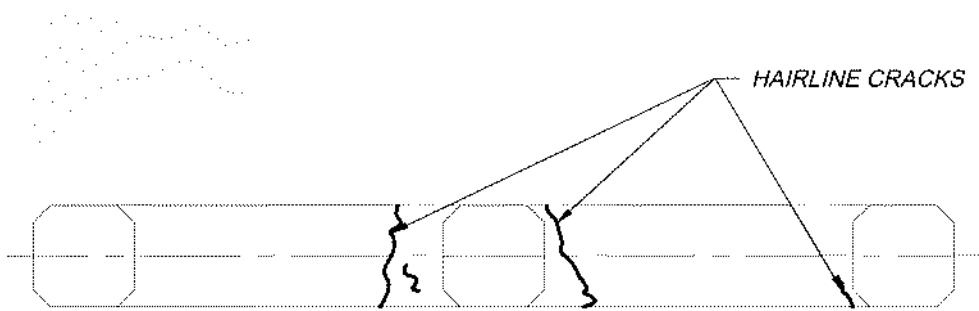
Figure 18 - Location of Proposed Concrete Repairs - Pier 3 Underside of Pier Cap MP 182.1

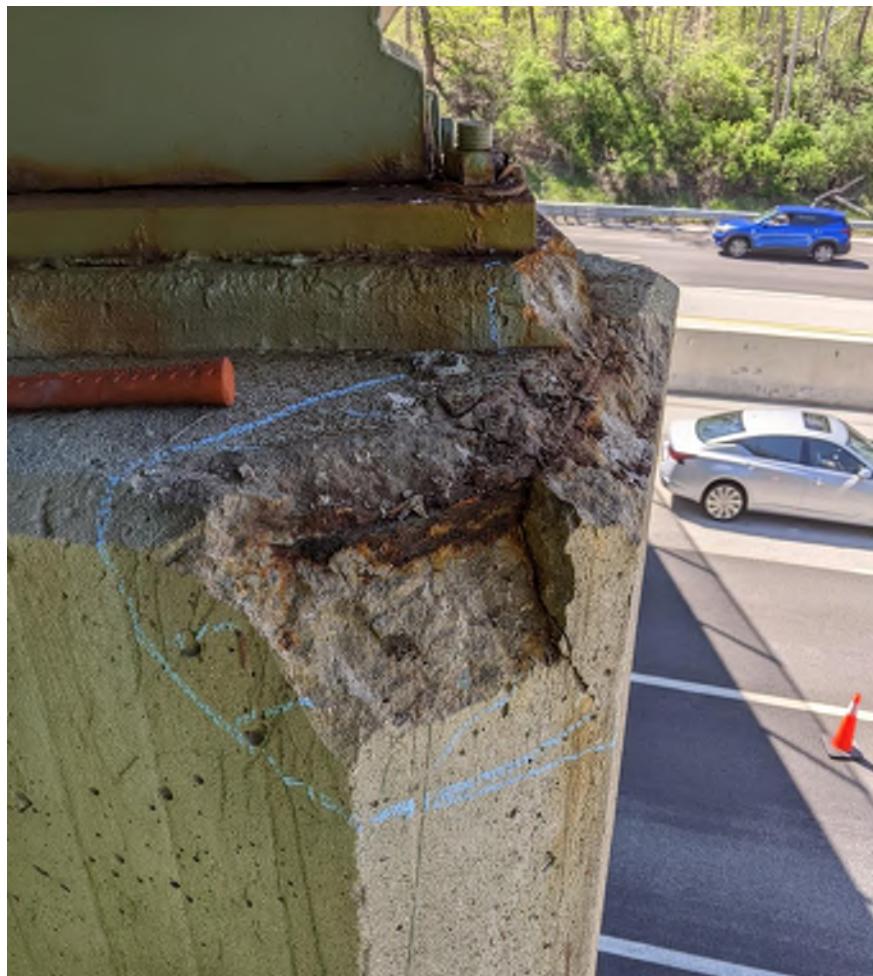
Photograph #12 - Pier 3 Column 3 Spall MP 182.1

13 - Pier 3: column 3
Spall/delam

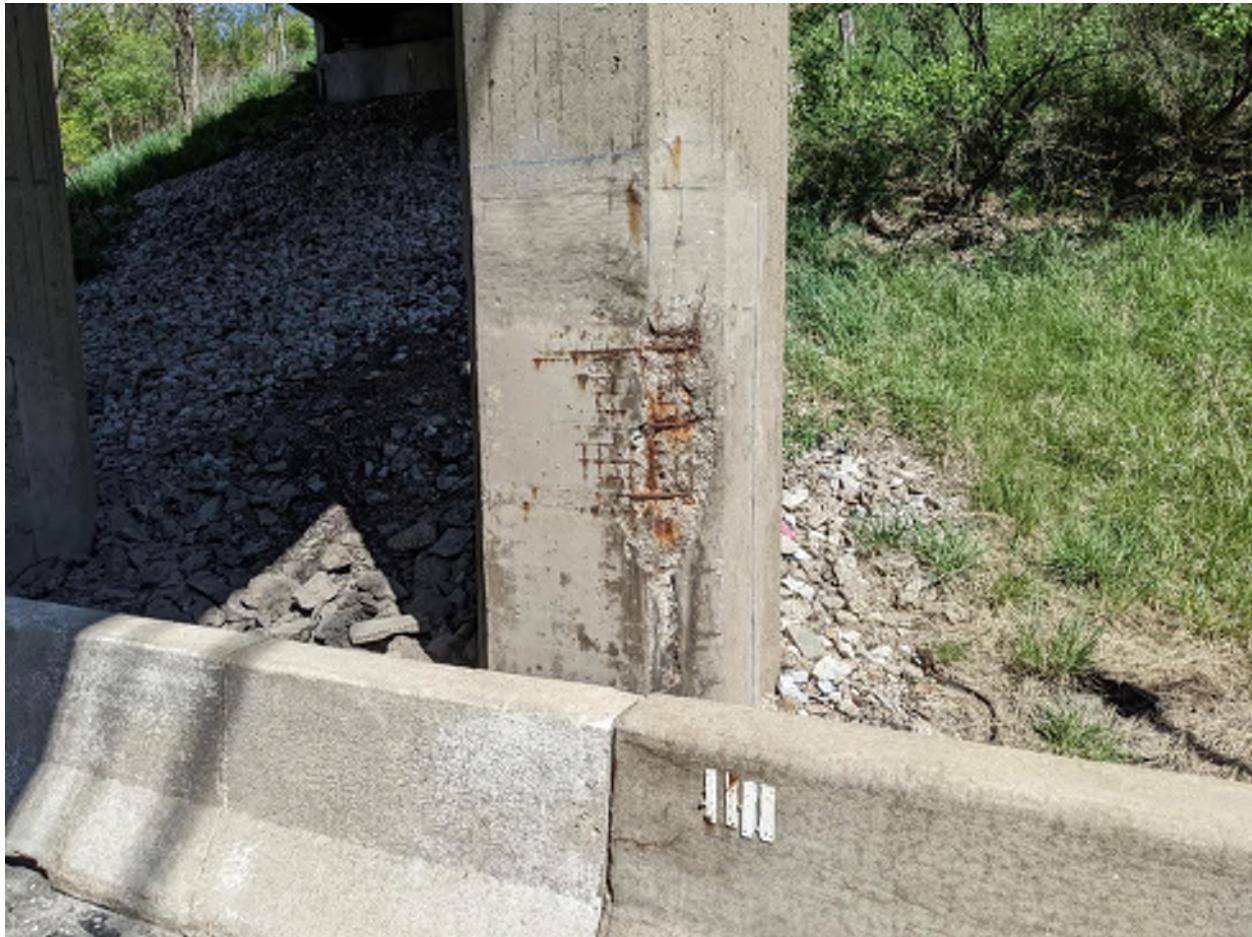
Photograph #12 - Pier 3 Column 3 Spall MP 182.1

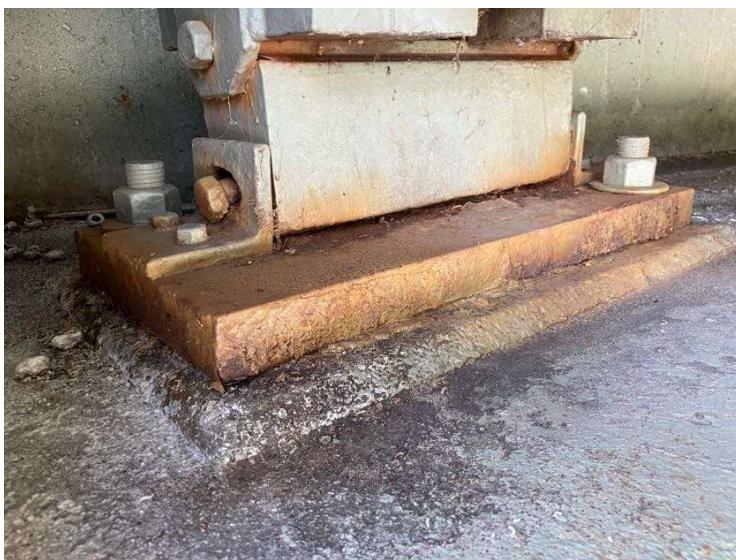
PHOTO 3
View of steel bearing. No gasketing material observed.

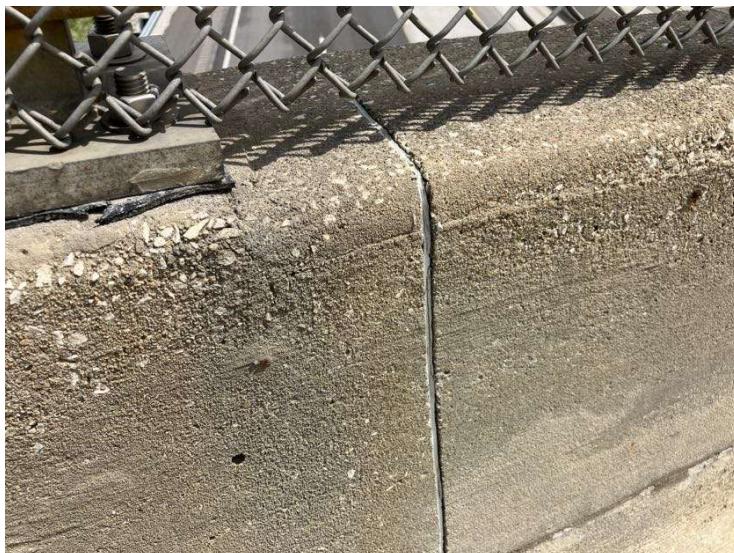
PHOTO 4
View of typical joint on parapet wall. Samples taken of caulk material.

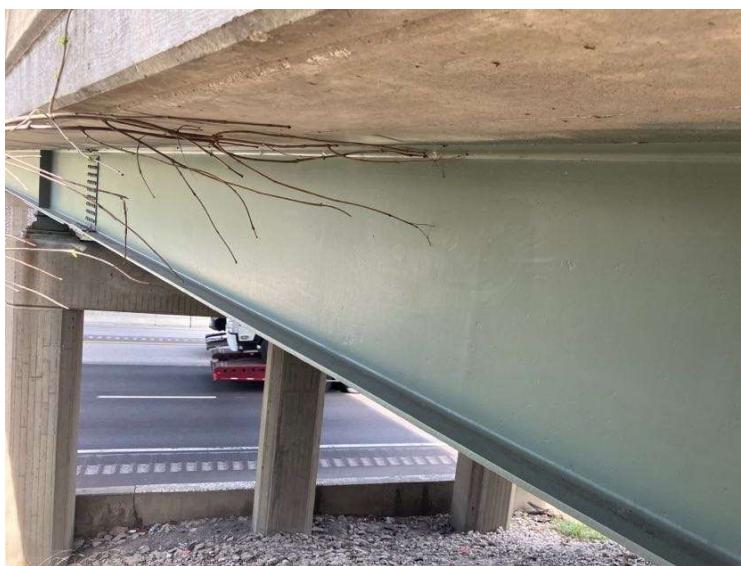
PHOTO 5
View of outer beam. Paint in good condition.

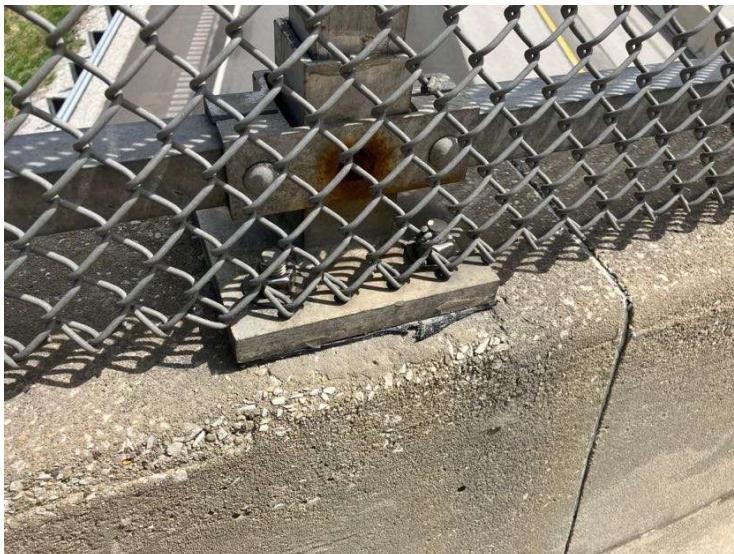
PHOTO 6
View of the vandal fence base plate. Samples taken of caulk material.
