**CITY OF HUDSON, OHIO  
FIRE & EMS  
EXISTING FACILITY CONDITION ASSESSMENT**

January 24, 2025

## Executive Summary

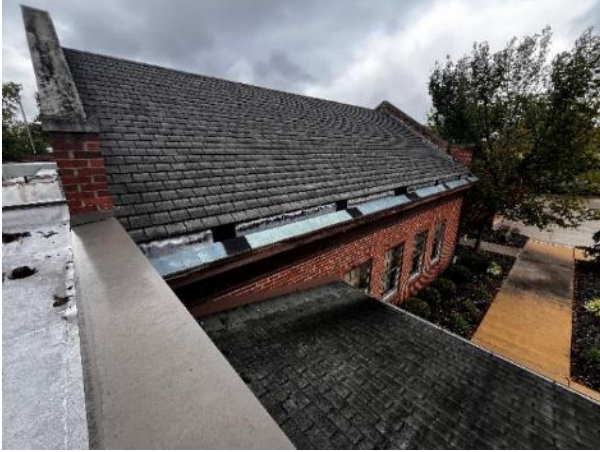
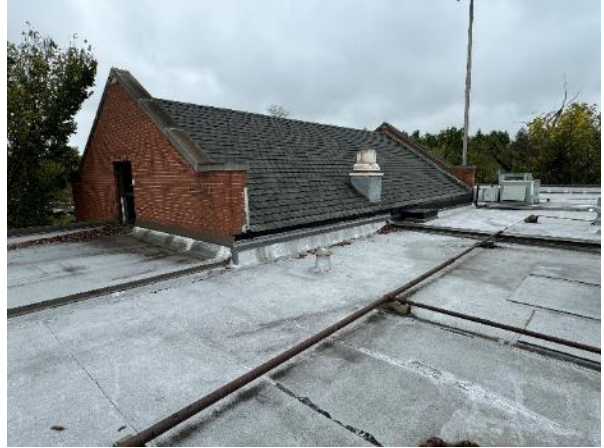
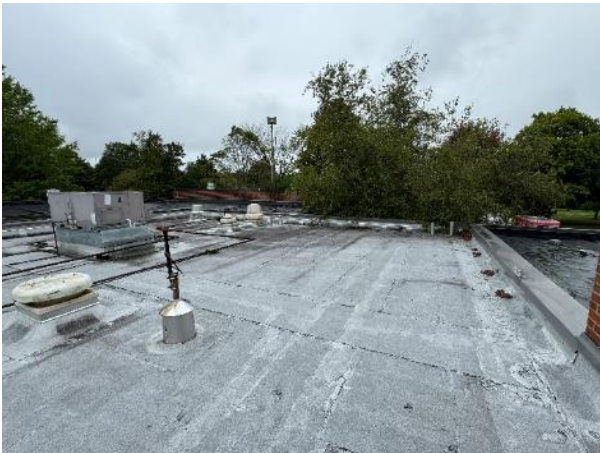
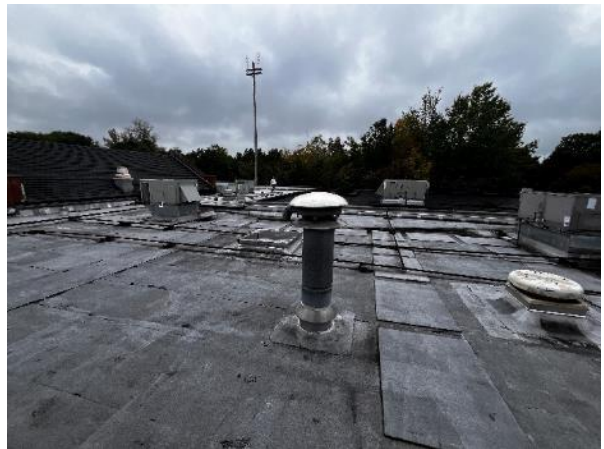
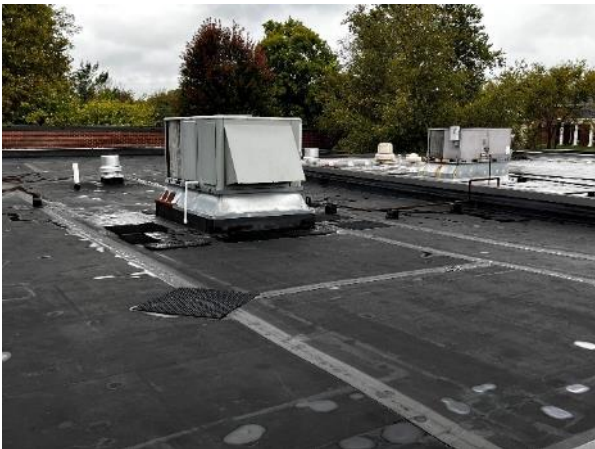
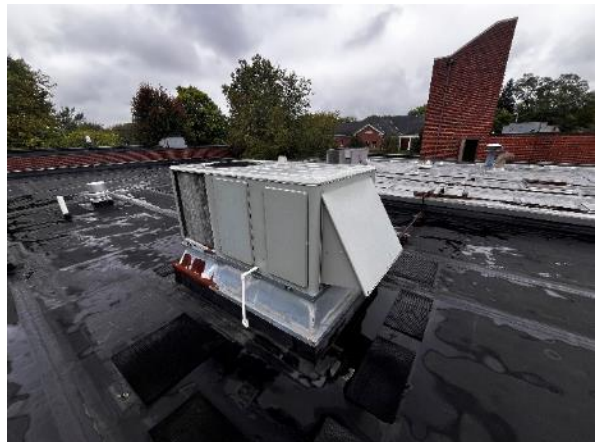
**ROOF**

- The modified bituminous roof is near its expected service life and significant wear and cracking are evident.
- The asphalt shingle roof appears to be nearing the end of its useful life with evidence of wear.
- The roof ladder to the apparatus bay roof is rusting.
- A maintenance ladder should be installed to access the roof over the EMS Vehicle Garage from the lower roof.
- Nearly all wood blocking supporting the natural gas piping on the roof are deteriorated and need immediate replacement.
- The EMS apparatus Bay roof drains and several others at the EPDM sections are completely plugged and need cleaning, along with many corners adjacent to trees. Some of the covers for the drains need to be replaced.
- There is a roof leak in the southeast corner of the apparatus bay near the gas line penetration up to the H&V unit above.

2. Roof
  - a. Clean all roof drains and roof surface. Replace broken drain covers.
  - b. Replace the modified bituminous roof.
  - c. Remove rust, paint and repair existing ladder.

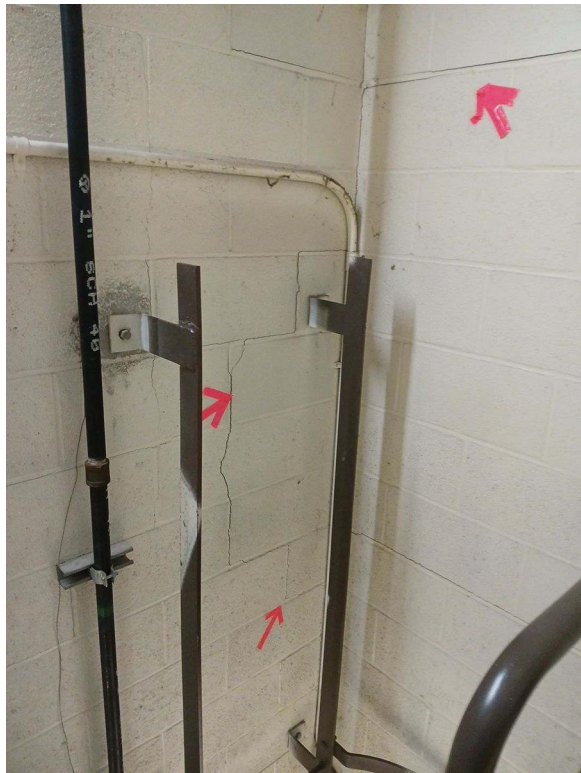
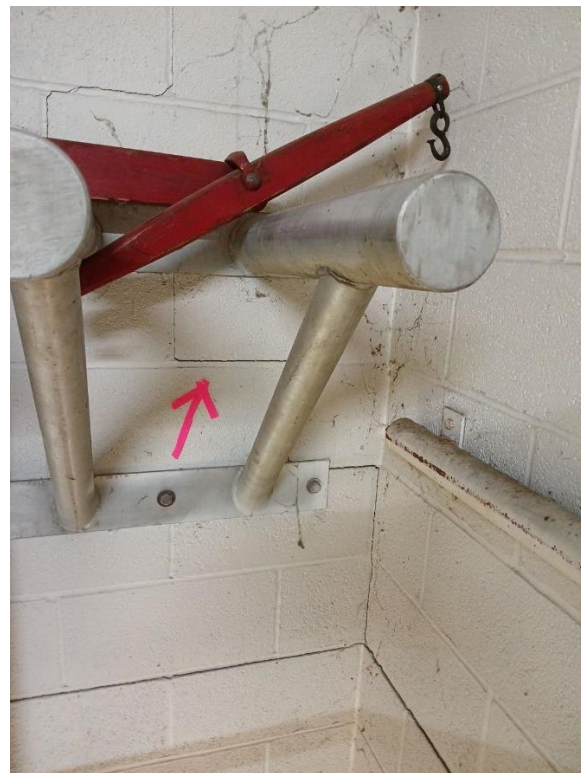
There are cracks in the CMU walls of the hose tower. The cracks are visible from inside the hose tower and run circumferentially approximately 15 to 20 feet above finished floor. These appear to be settlement cracks and do not pose a safety hazard currently. The hose tower can be used as originally intended for hanging the full allotment of hoses and for firefighter training such as tethering and repelling provided that hangers' connections to masonry walls are tested and capacity verified. The cracks should be monitored annually to verify that the number, width and length have not increased appreciably. The cracks may be patched for cosmetic purposes by cleaning out the cracks of loose dust and debris, grouting, and repainting to finish.

**HOSE TOWER SETTLEMENT CRACKS**

- b. Monitor cracks in hose tower wall on an annual basis.
  - c. Replace deteriorated CMU and waterproof underground portion and first two courses above ground.

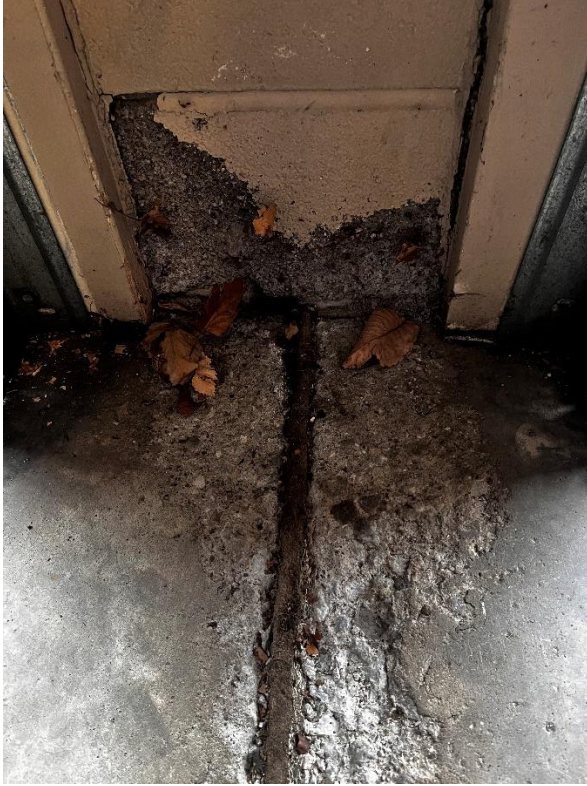
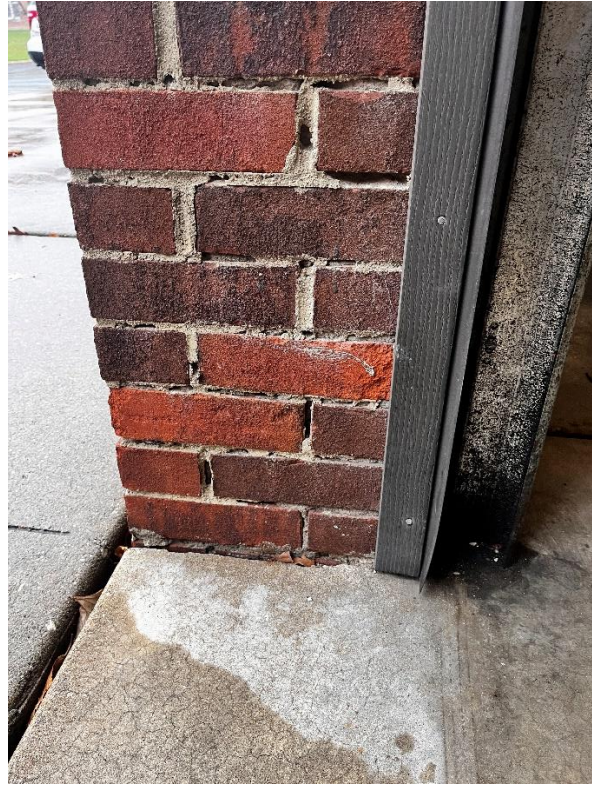
There is significant deterioration of the lower portion of the CMU wall between the overhead doors in the Apparatus Bays. This is due to the city spraying heavy amounts of salt against the apparatus bay doors.

APPARATUS BAY CMU DETERIORATION

- e. Replace the older windows as part of a larger renovation project.
4. Structure
  - a. Replace the deteriorated lower portion of the CMU wall between the overhead doors in the Apparatus Bays.

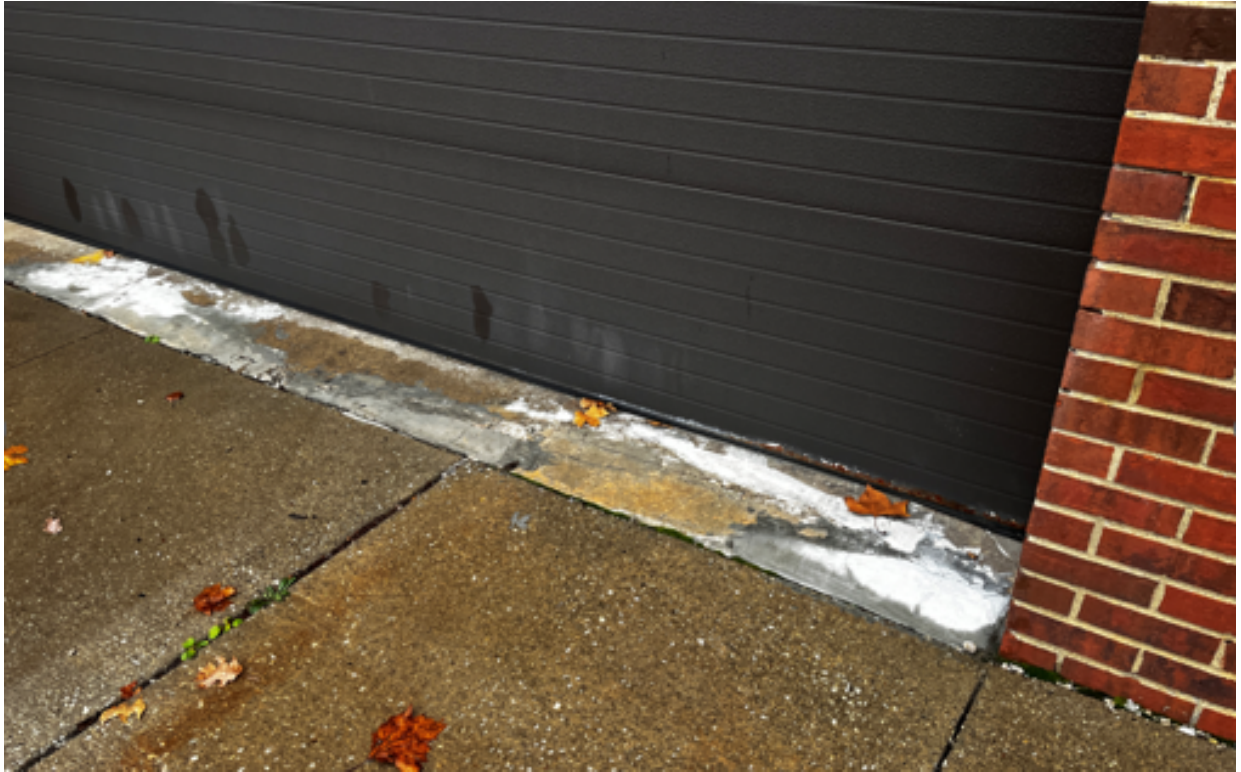
**REPAIRS FROM SALT AT APPARATUS BAY OVERHEAD DOOR**

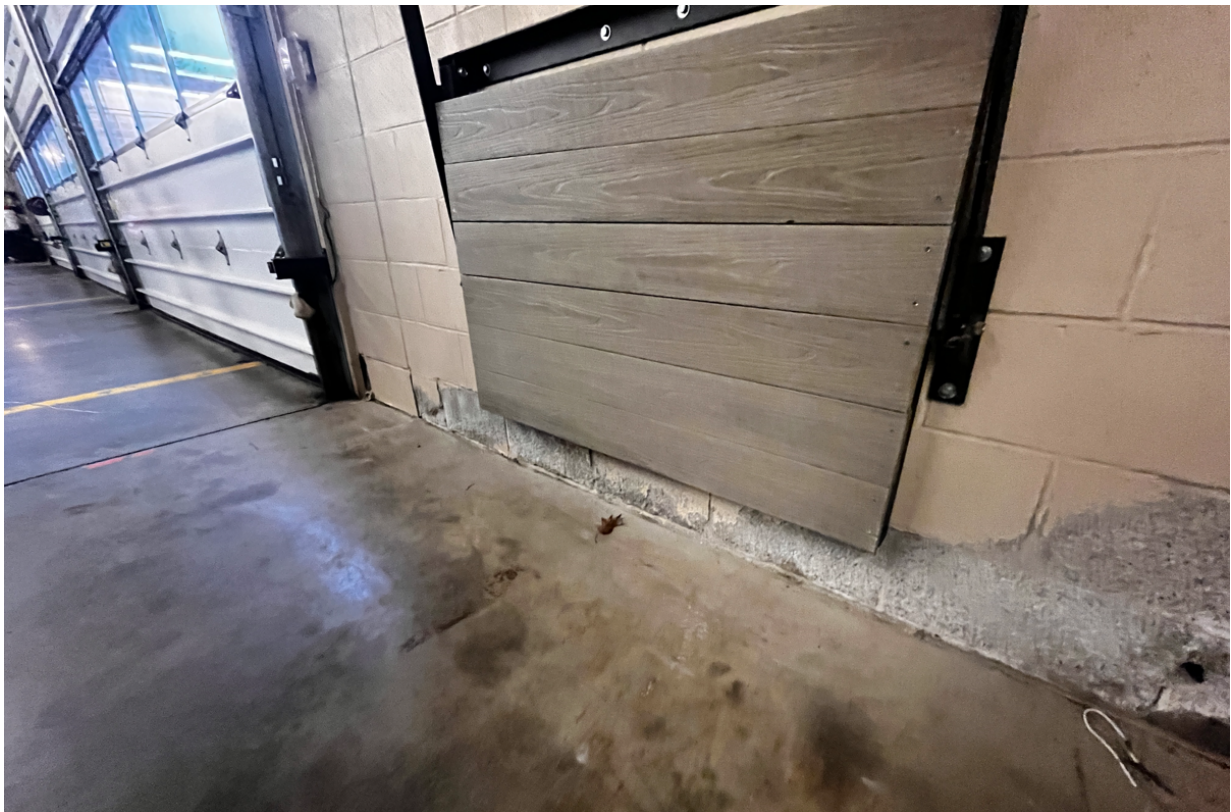
**APPARATUS BAY CMU DETERIORATION FROM SALT**

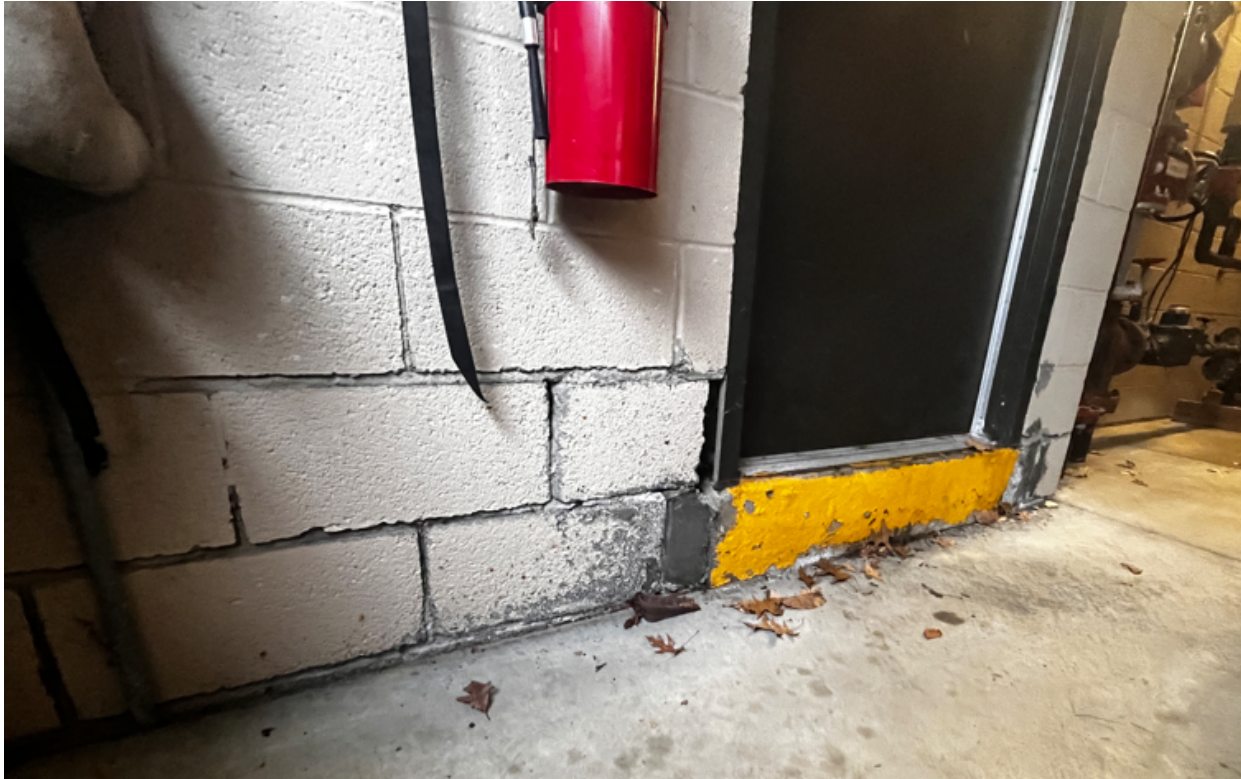
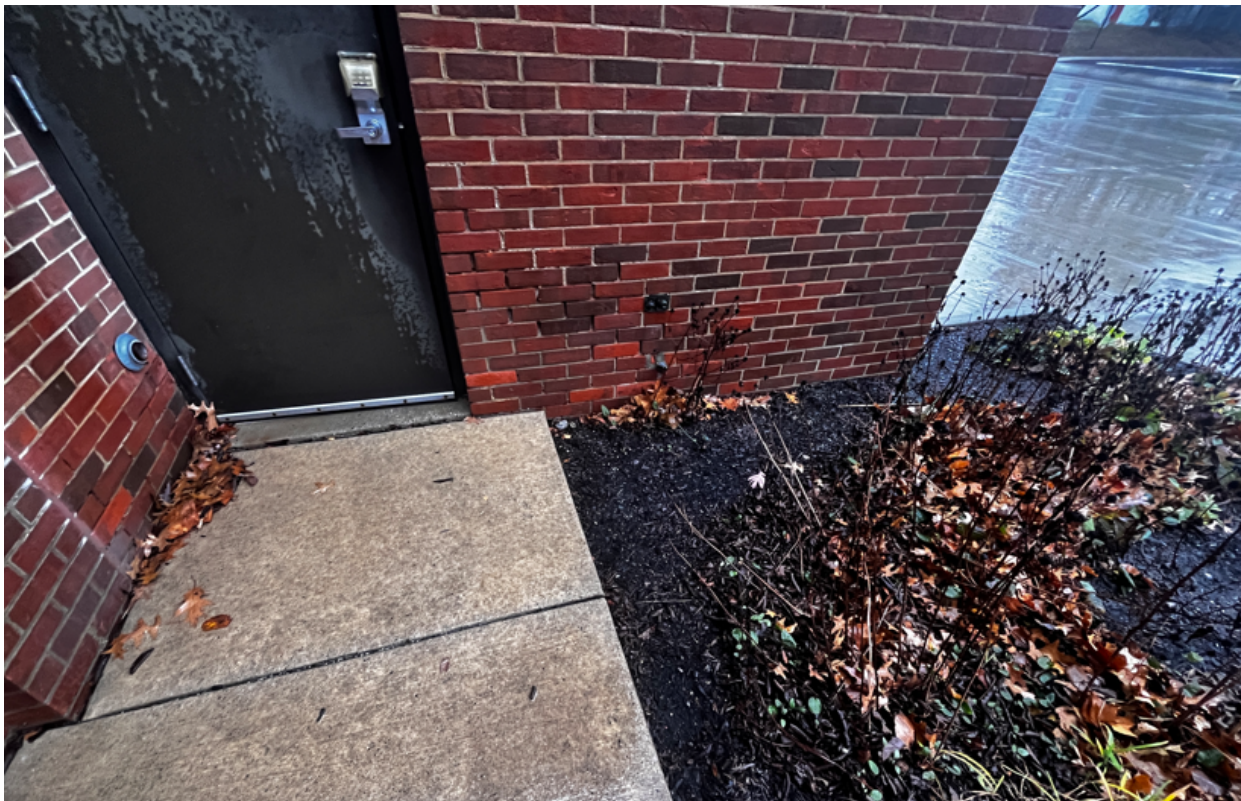
Portions of the block walls and mortar joints are deteriorating at the man door to the far northwest corner of the Apparatus Bays. This appears to be due to inadequate waterproofing of the below grade portion of the exterior wall.

**EXTERIOR WALL REPAIRS & CONTINUOUS DAMAGE DUE TO LACK OF WATERPROOFING**

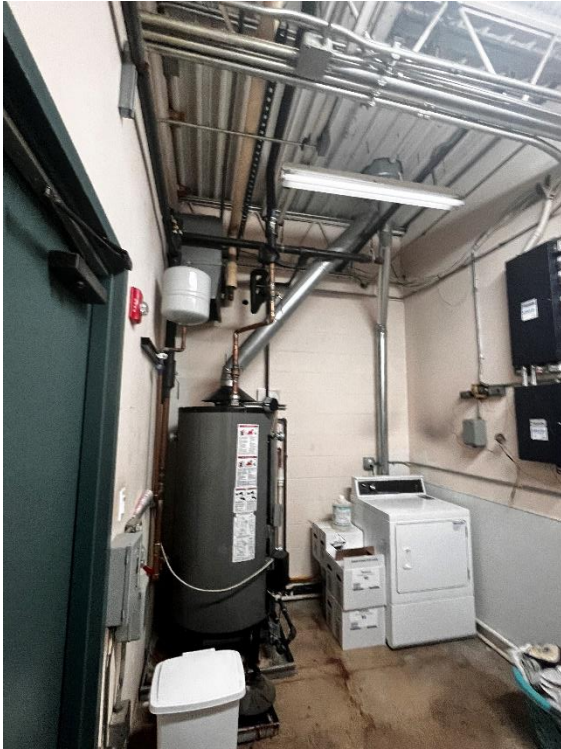
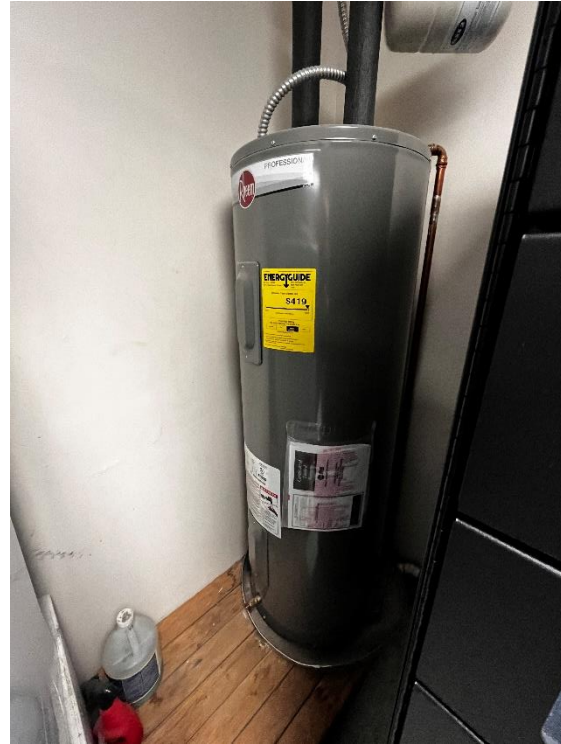
**DOMESTIC HOT WATER HEATERS**

A 100-gallon natural gas fired 199 MBH-input; standard efficiency domestic water heater is in a mechanical room across from the hose tower. A 50-gallon 4.5 kW electric water heater is in the EMS laundry room adjacent to the EMS Vehicle Garage. The water heaters were manufactured in 2020 and 2022, respectively. Both water heaters are relatively new and appear to be in good condition.

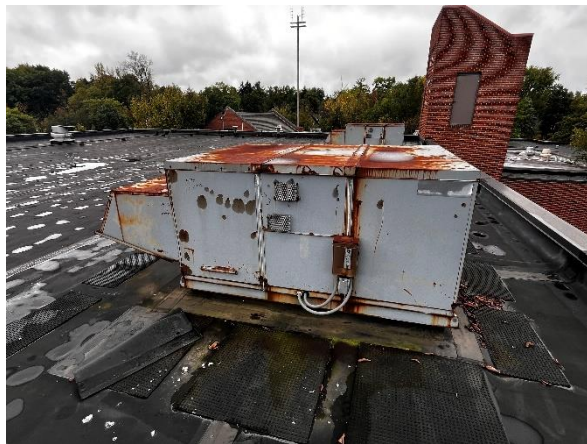
**APPARATUS BAY HEATING VENTILATING UNIT**

The Apparatus Bays and EMS Vehicle Garage are heated by natural gas fired infrared heaters. Exhaust fans and natural gas make up air units appear to be activated by a gas monitoring system in the Apparatus Bays (HV-1&2) and EMS Vehicle Garage (HV-3). The Apparatus Bays are equipped with a vehicle tailpipe exhaust capture system. The make-up air units appear to be from 1992 with signs of rust and corrosion and well past their expected useful service life of 20 years. The EMS Garage exhaust fan does not operate. The PPE area in the Apparatus Bay does not have adequate exhaust or make up air.

- b. Replace the apparatus bays trench drains and clean the lines.
7. Ventilation.
  - c. Replace the three (3) heating & ventilating units (HV-1-3) and gas monitoring systems serving the apparatus bays and EMS vehicle garage.

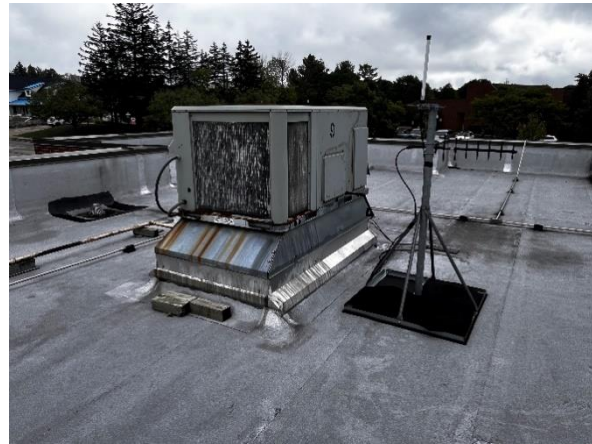
**TRANE DX ROOFTOP UNIT #9**

The HVAC system serving the office areas consists of natural gas fired single zone packaged direct expansion (DX) rooftop units (RTU-4-9). The rooftop units utilize R22 refrigerant which has been phased out, were manufactured in 2005 and appear to be in fair condition. This type of equipment has a typical useful service life of 15-20 years and their replacement should be planned for in the near future.

- a. Replace the seven (7) existing package DX rooftop units (RTU-3-9). Interface new RTUs to Tridium building automation system (BAS) and expand BAS as required to accommodate.

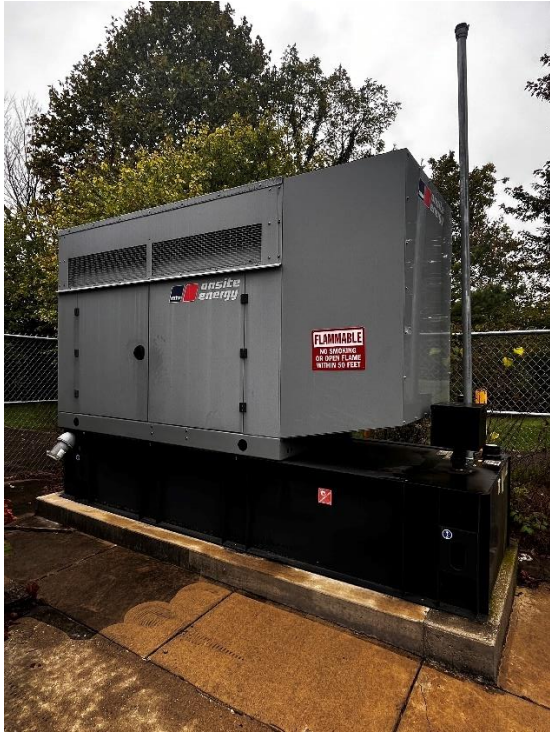
**EMERGENCY GENERATOR**

Emergency power backup for life safety and critical loads is provided by a 100-kW diesel generator with a 490-gallon belly tank and transfer switch. The emergency generator is located outside next to the utility transformer. The emergency generator and transfer switch were installed in 2013 and do not provide full building backup. This type of equipment has a typical useful service life of 20-25 years; therefore, it should have 9-14 years of remaining useful service life.

11. Normal Power. Replace the existing (original) main distribution panel and panelboards.
  12. Emergency Power. Replace existing generator and transfer switch with new sized for full building back up.

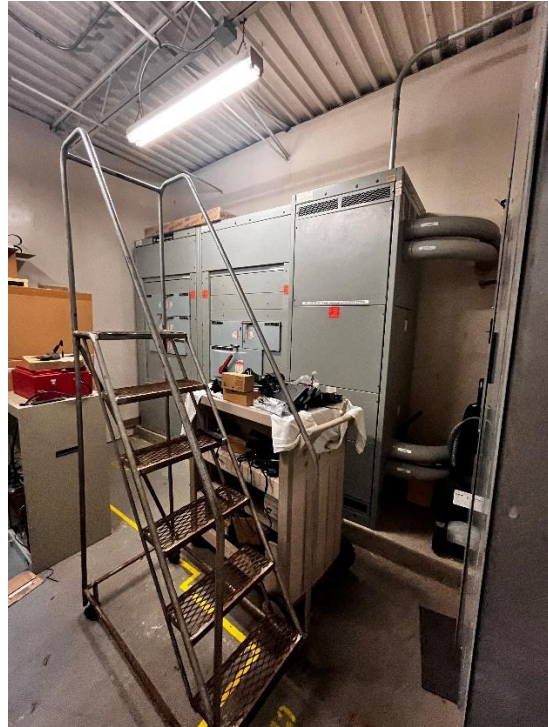
**MAIN DISTRIBUTION PANEL**

The Main Distribution Panel is 1200 Amps, 208Y / 120V, 3 phase, 4 wire. The panels and main disconnects are all General Electric and appear to be original.

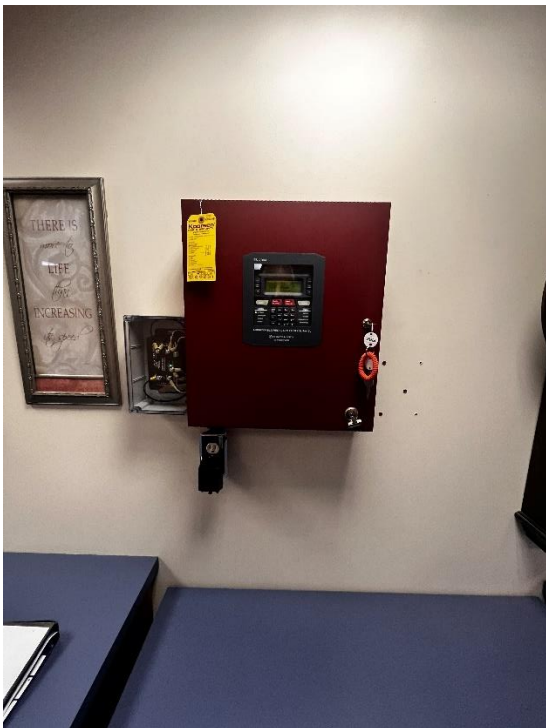
**FIRE ALARM CONTROL PANEL**

The main fire alarm control panel is located just outside of the Chief's office. It is a Honeywell FireLite Model ES-200X addressable. It appears that the system was installed in 2017. This type of equipment has a typical useful service life of 15-20 years; therefore, it should have 7-13 years of remaining useful service life.

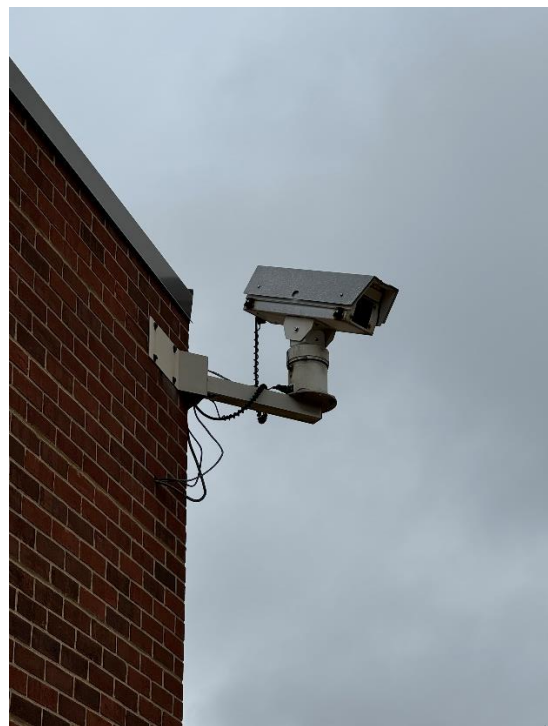
**SECURITY CAMERA**

There is minimal security electronics installed at the building. The CCTV system has a few cameras on the building exterior only. The system is insufficient for modern coverage needs at a fire station and none of the cameras are currently functional. A new system of access controls and CCTV should be considered.

13. Security. Install a new system of access controls and CCTV.
