November 30, 2022

Re: City of Hudson, Reserve at River Oaks Intersection Analysis
Preliminary Draft of Findings

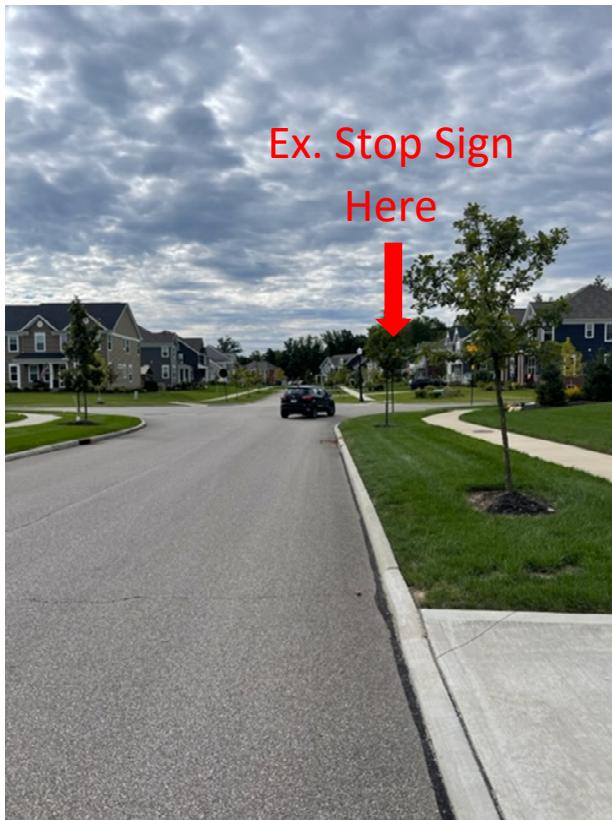
Figure 1: Timberline Trail Looking South

This intersection is controlled by a 2-way stop located along Timberline Trail. Approaching views of the stop signs are obstructed by trees located within the existing tree lawn. As these trees continue to grow, sign visibility will continue to be a problem. Figures 1 and 2 were taken on Timberline Trail in both directions during the field visit.

In Figure 1, the stop sign is completely hidden from view while approaching the intersection. The branches of the trees have completely covered the face of the sign making it difficult to see. Also, this sign was placed with an 8-foot lateral offset. ODOT standards allow a 2-foot lateral offset from the curb (SCD TC-42.20) which will improve visibility of the sign. Figure 2 shows another sign that can be seen approaching the intersection. This sign is currently visible; however, future growth of the existing tree may obstruct views of the sign. Record plans indicate both signs meet current OMUTCD standard sizes for a residential street.

- Increase the size of all stop signs from 30 inches to 36 inches to increase visibility
- Place red post reflectors on all stop signs to increase visibility
- Paint stop bars on the stop approaches and high visibility crosswalks at each intersection to increase pedestrian awareness per ODOT SDC TC-74.10
- Move the location of the stop sign on Timberline Trail on the north side of the intersection closer to the curb to increase visibility
- Continuously trim and prune trees at both intersections to provide positive sight distance and visibility of all signs.
- Consider installing STOP AHEAD (W3-1) signs ahead of the stop signs if sign visibility is limited after intermittent obstructions, such as trees, are addressed and the lateral offsets of signs are adjusted.

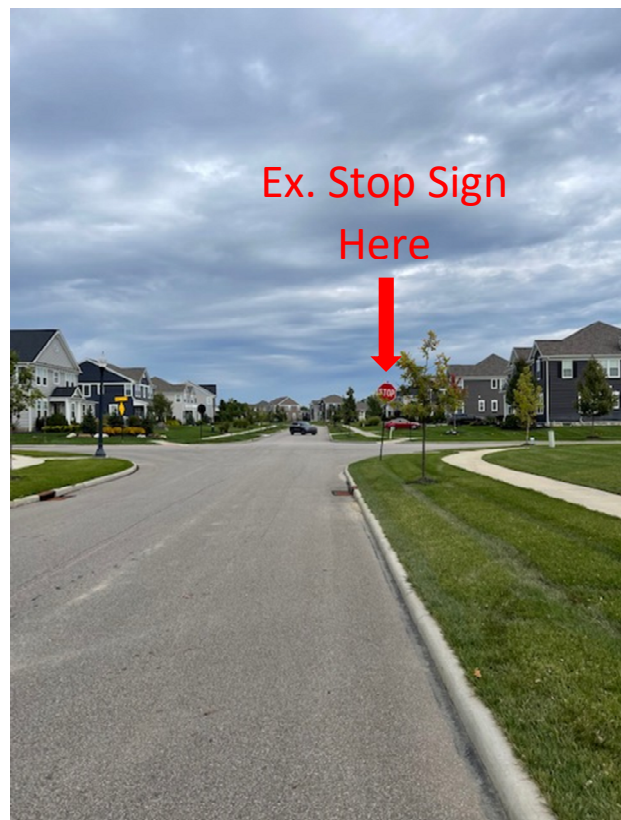
Figure 2: Timberline Trail Looking North

According to the volumes obtained from StreetLight Data, Timberline Trail constitutes the major movement, with traffic volumes that slightly exceed the volumes on Kingswood. The OMUTCD indicates that stop signs at a 2-way stop should be placed on the minor street (OMUTCD Section 2B.06). At this time, American Structurepoint does not recommend switching the stop signs due to the relatively small difference in volumes.

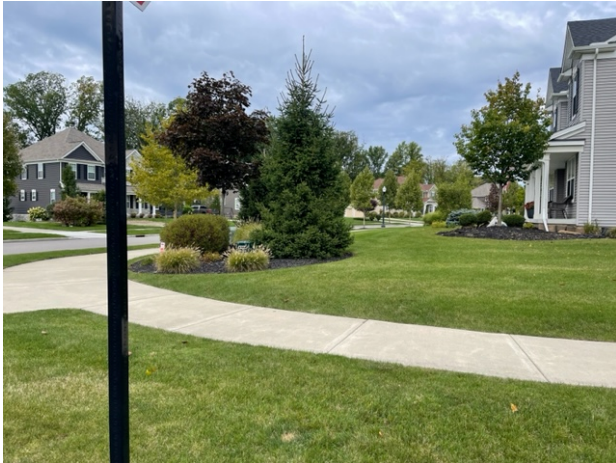
Figure 3: Regal Woods Looking North

This intersection is controlled by a 2-way stop located along Regal Woods Drive. Regal Woods Drive bisects the curve of Rosewood Trail which restricts sight distance at the intersection. The stop signs at this intersection appear to be visible along both approaches. Record plans indicate both stop signs meet current OMUTCD standard sizes for a residential street.

Intersection site distance is limited along the westbound approach to the intersection along Regal Woods Drive. When sitting at the stop sign on Regal Woods Drive, it is impossible to see traffic approaching from the right, due to the trees planted between the curb and sidewalk as well as private trees and bushes planted on the property on the northern corner of the intersection. See Figures 3 and 4 for views of each stop-controlled approach. Appendix A shows the plan view of how the sight distance is impacted by the trees sitting at the stop sign westbound on Regal Woods and looking southbound from Rosewood Trail.

Views of the intersection along the other approaches are partially blocked by the trees planted between the curb and walk. These trees should be continuously pruned to maximize sight distance at the intersection.

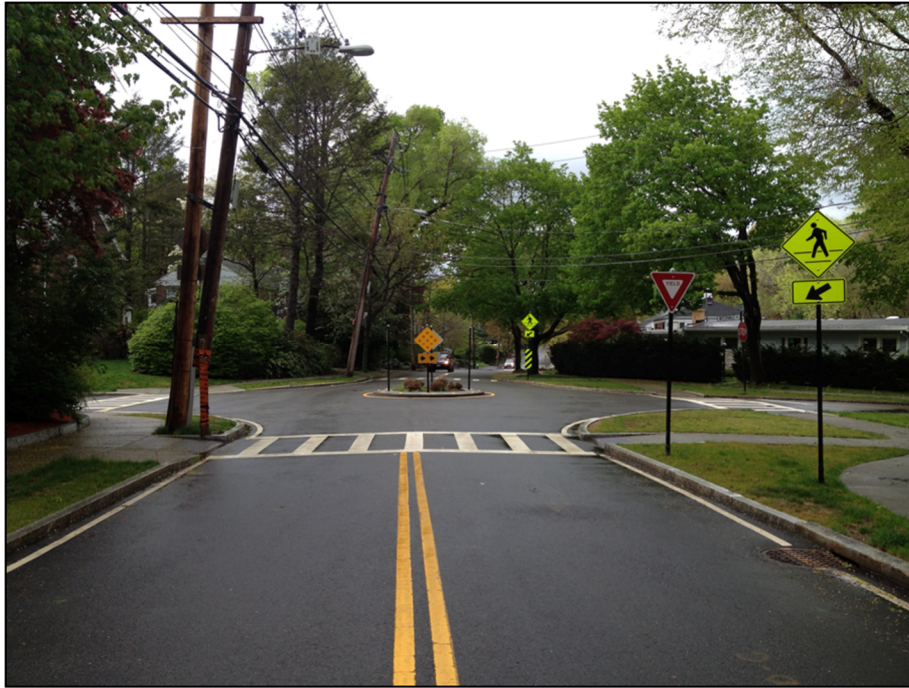
Figure 5: Example of mini roundabout within intersection

Consider installing a mini roundabout at both intersections. Instead of decreasing the turning radii and reconstructing the intersections, a mini roundabout can fit in the existing pavement. See example below in figure 5. Mini roundabouts can be constructed with just pavement markings or raised islands on the approaches and in the center of the intersection. The purpose of the mini roundabout would be to lower vehicular speeds and the associated traffic islands can provide a refuge for pedestrians crossing the street. Plowing and ice removal during the winter months is a potential maintenance issue that will need discussed with city crews prior to installation.
