**41 E. Main Street Tree Preservation Plan – TREE-13098**

**November 3, 2025**

**Tom Kiepura, City Arborist ISA #OH-6684A** *TMK*

**City of Hudson**

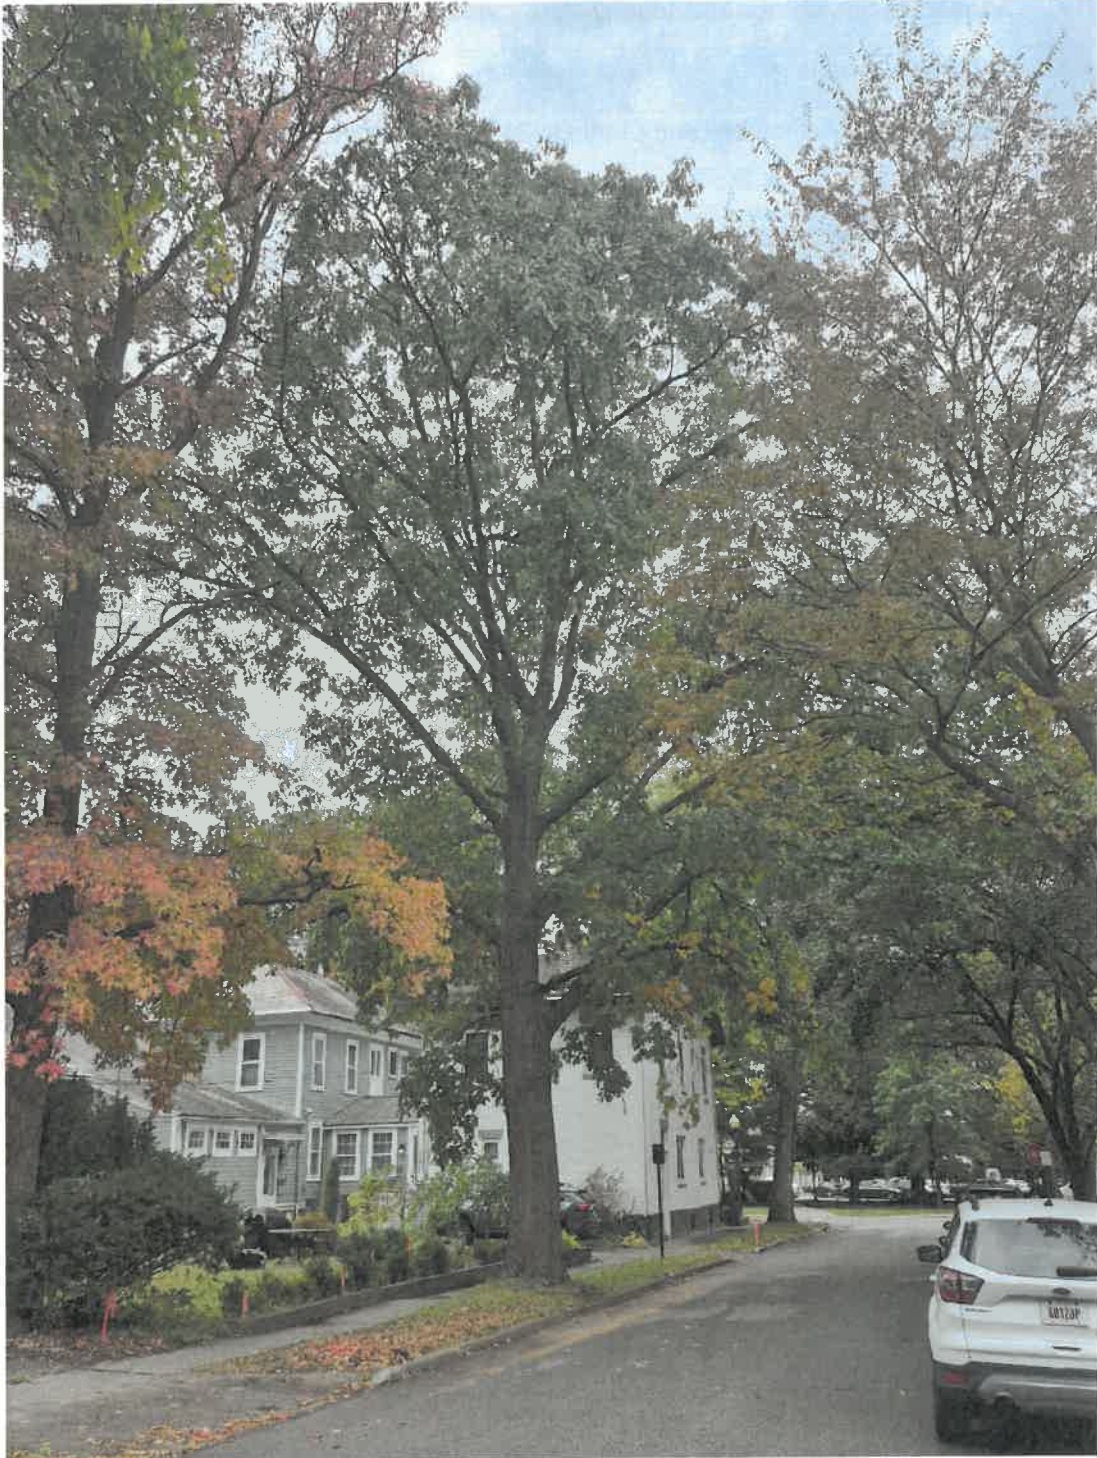
LOCATION: 41 E. Main Street – TREE-13098 (Tree is located in right-of-way on Division Street)

SPECIES: Red Oak *Quercus rubra*

SIZE: Approx. 65 feet tall, crown spread of approx. 60 feet, 33 inches DBH

AGE: *Mature* – Best Guess is 80-120 years old

CONDITION: Appears to be vigorous and healthy. Very good crown structure. No major defects.

CALCULATED TPZ: 49.5' Radius

33" DBH x 1.5 = 49.5' (Matheny and Clark 1998 methodology, multiplication factor 1.5)

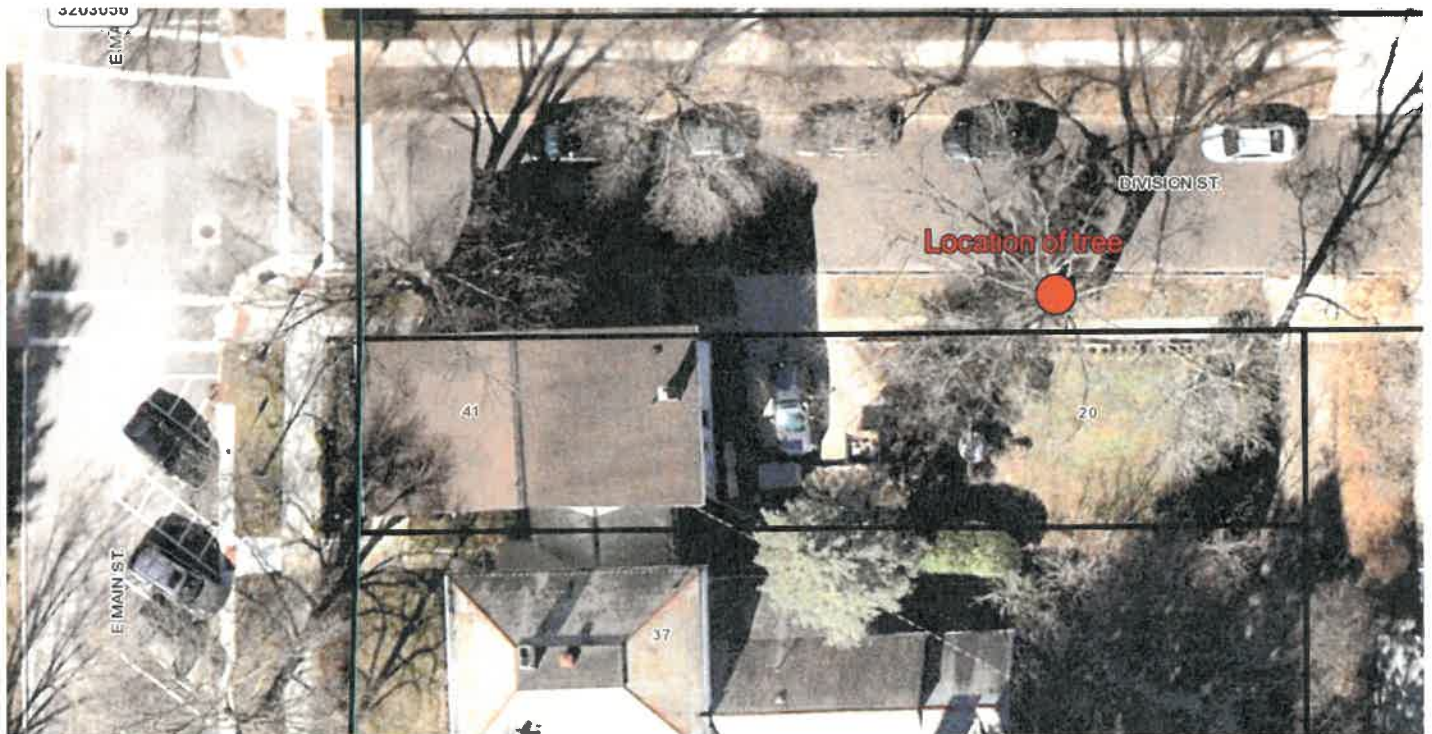
The proposed building addition at Village Dental, located at 41 E. Main Street, is likely to cause decline in the red oak (TREE-13098) located in the right-of-way on Division Street without adequate tree protection measures. Red oaks are known for being very sensitive to damage caused by construction activity. To mitigate the negative impact of this construction, I have put together a tree preservation plan that will give the tree the best chances of survival. If no tree protection measures are taken, I would expect the tree to decline slowly over a period of 3-5 years and eventually die.

**The proposed construction, according to the revised plans submitted to the Arborist, would require excavation and removal of topsoil within the limits of the calculated TPZ.** Specifically, a trench would be dug for the footer for the proposed building, and topsoil removed for the installation of a paver patio. It should be noted that most of the fine roots that provide water and nutrient uptake exist in the uppermost soil profile and will be removed along with the topsoil. It is presumed that this excavation would then be backfilled with a limestone base. The proposed patio is approximately 135 square feet.

In an effort to preserve the tree, **I recommend both a low-nitrogen fertilizer and phosphorus acid formula (such as Forti-phite) be injected into the soil under the tree up to the dripline via deep root fertilization between late fall and early spring.** This application should be made before any other tree protection measures. In addition, **I recommend the area around the root flare in a 6-foot radius be cultivated with an air knife and the soil amended with biochar, organic mulch, arborist wood chips and C20 Soil Builder.** Forti-phite, fertilizer application, and soil amendments will help prepare the tree for stress induced by loss of root volume. These applications are to be made by a Certified Arborist.

**I propose that at the limits of disturbance, prior to construction, any roots that are to be cut shall be exposed with an air spade and cut cleanly with a saw.** This root pruning should take place

between November 1<sup>st</sup> and March 1<sup>st</sup>. These cut roots shall be promptly backfilled with soil to prevent desiccation. This work is to be performed by a Certified Arborist.

I also propose a tree protection barrier be installed prior to any construction activity. This barrier (a fence) excludes access to areas within the calculated tree protection zone that are outside of the limits of disturbance. **There shall be no soil cuts or fills, or otherwise change of grade within this tree protection barrier. No construction activities, staging, storage, or otherwise utilization of this space shall occur for the duration of project. This includes trucks, heavy equipment, and construction materials. The deep root fertilization, root invigoration, root pruning, and installation of the tree protection barrier shall be subject to inspection by the City Arborist.**

I also propose that the landscape plan be revised to include as much mulch area (instead of lawn) as possible under the dripline of the tree. Turfgrass competes for resources (water and nutrients) and a reduction in lawn area will reduce said competition. The area underneath the dripline of the tree should be irrigated with an appropriate amount of water (1 inch per week) during times of drought so as not to further stress the tree. Irrigation should be deep and infrequent. This practice should continue until the tree has adjusted to any root loss it has experienced. This can take several years.

Additionally, some limbs will need to be removed above the proposed structure. This pruning shall be done by a Certified Arborist between October 15<sup>th</sup> and April 15<sup>th</sup> to minimize the chances of oak wilt infection. Pruning shall be kept to a minimum and only remove what is necessary.
