41 E. Main Street Tree Preservation Plan – TREE-13098 November 3, 2025

Tom Kiepura, City Arborist ISA #OH-6684A

TREE PRESERVATION PLAN

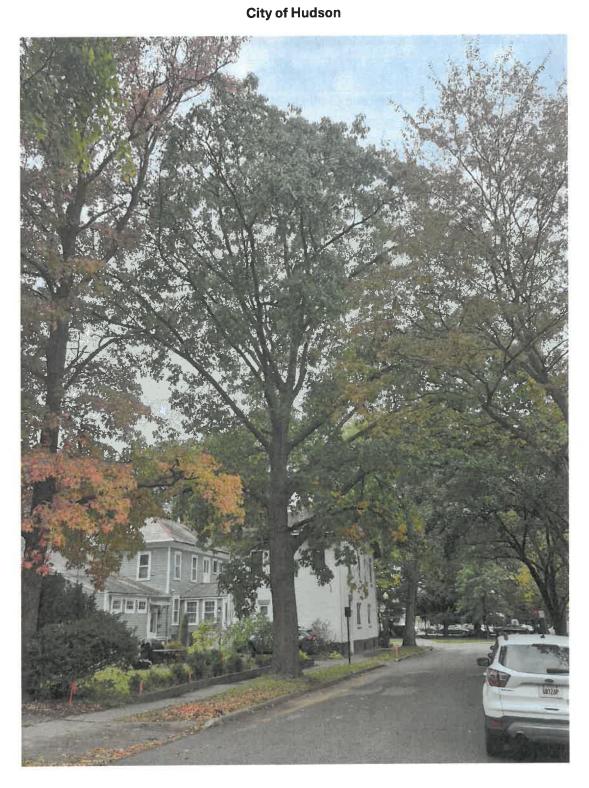
LOCATION: 41 E. Main Street - TREE-13098 (Tree is located in right-of-way on Division Street

SPECIES: Red Oak Quercus rubra

SIZE: Approx. 65 feet tall, crown spread of approx. 60 feet, 33 inches DBH

AGE: Mature - Best Guess is 80-120 years old

CONDITION: Appears to be vigorous and healthy. Very good crown structure. No major defects.

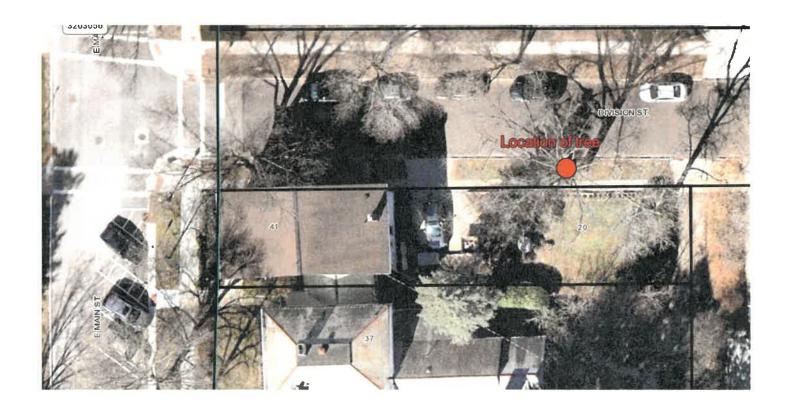
CALCULATED TPZ: 49.5' Radius

33" DBH x 1.5 = 49.5' (Matheny and Clark 1998 methodology, multiplication factor 1.5)
