From: Preview View <jdfield23@aol.com>
Sent: Wednesday, January 31, 2024 11:09 AM
To: Amanda Krickovich
Cc: Eric Chupack; Laurie Frankino; Wendy Hess; Mark Schildhouse; Jean Rhodes; Amy McCormick; Michael Ross
Subject: Temple Beth Shalom Security Door Application Follow-up
Attachments: Metal Door Photo.jpg; Temple Beth Shalom, Hudson Security Assessment 2023 - FINAL 3.30.2023.docx

SECURITY ASSESSMENT FOR TEMPLE BETH SHALOM

On March 7, 2023, a security assessment was conducted by writer at Temple Beth Shalom at 50 Division Street, Hudson, OH, 44236.

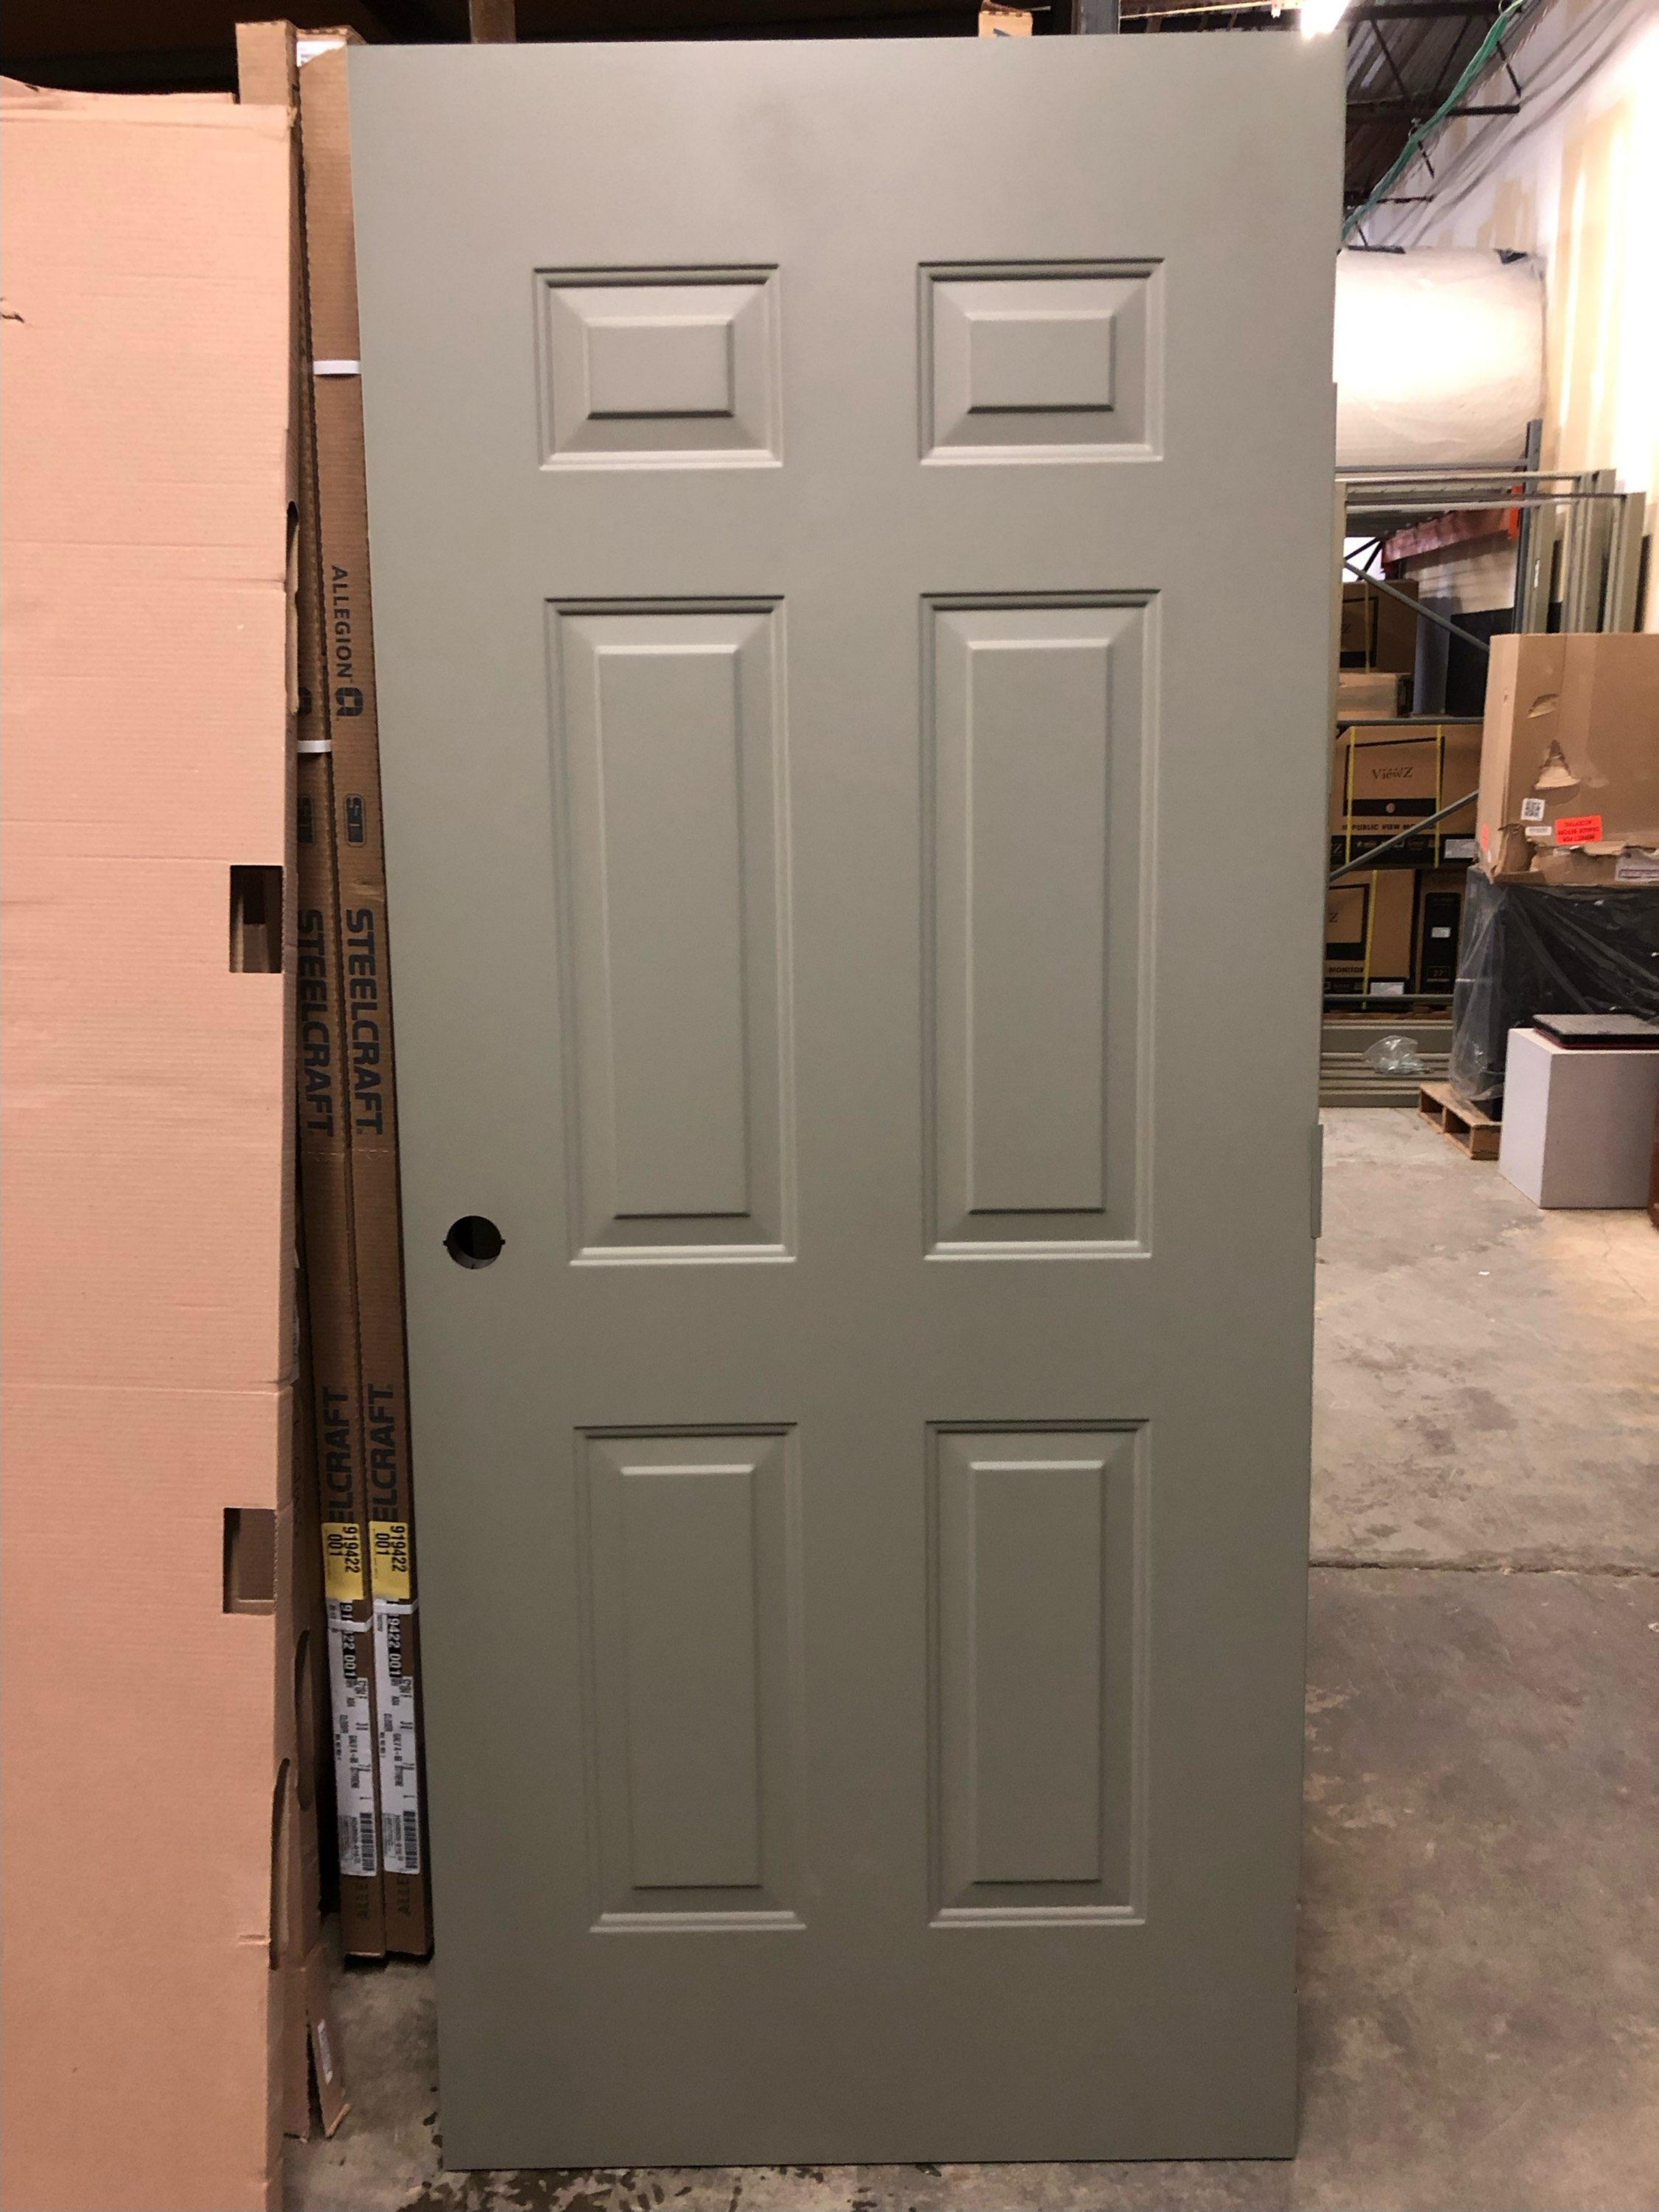
- **Send photos (vs renderings) of the metal 6 panel door before modification for Lites.**
 - The photo of the door is attached. My own perspective is that it has a very similar appearance to our current door.
- **Send a copy of the Temple Beth Shalom Security Assessment**
 - Attached

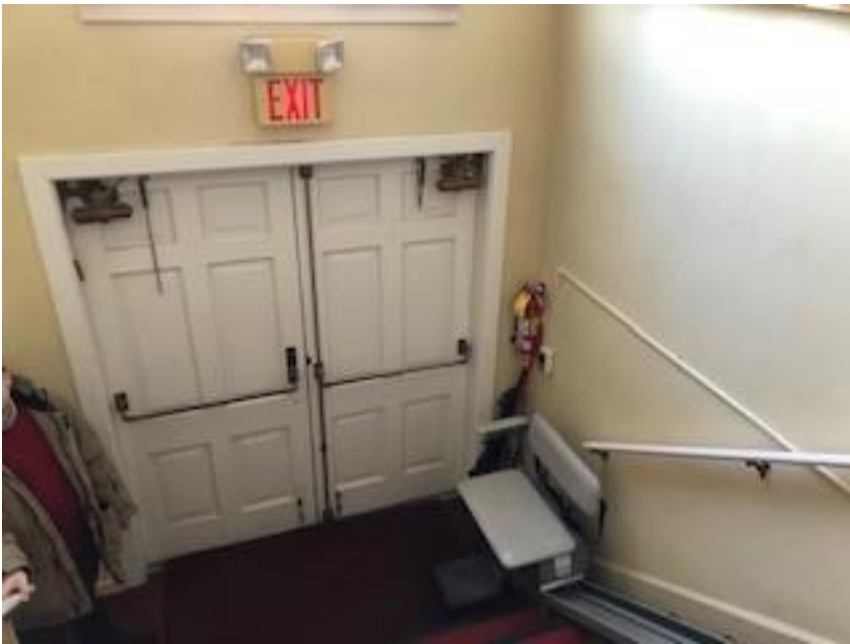
Figure 3 interior front door entrance

Replacement of the front entrance door and side door is recommended and should include a changeable lock code system and should include a window. Create standoff from potential vehicle attacks by placing aesthetic concrete bollards/planters or landscape boulders/shrubbery at the front drive entrance as well as around the perimeter and side entrance of the facility. This will prevent potential assailants from driving/attacking with a vehicle at the main entrance door.

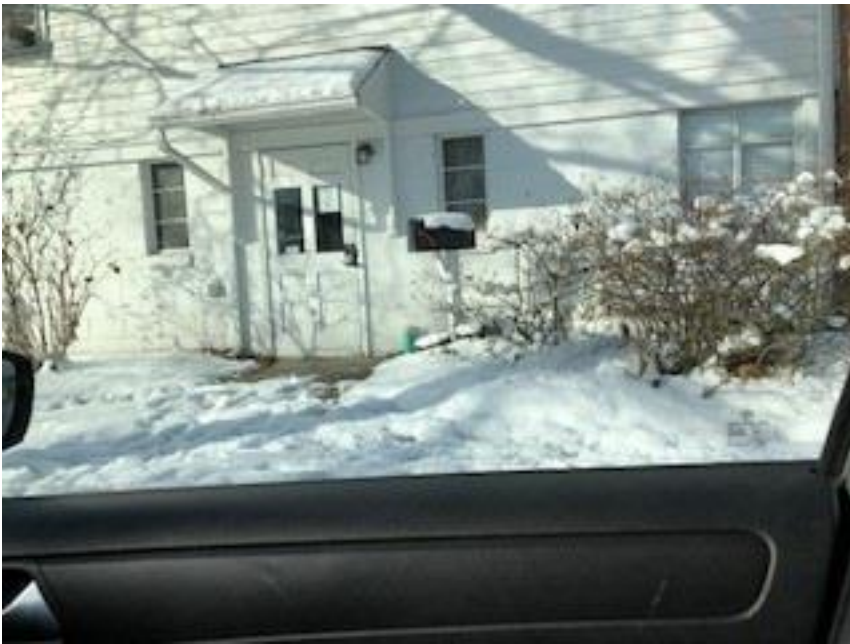
Figure 5 exterior entrance on College Street - side door

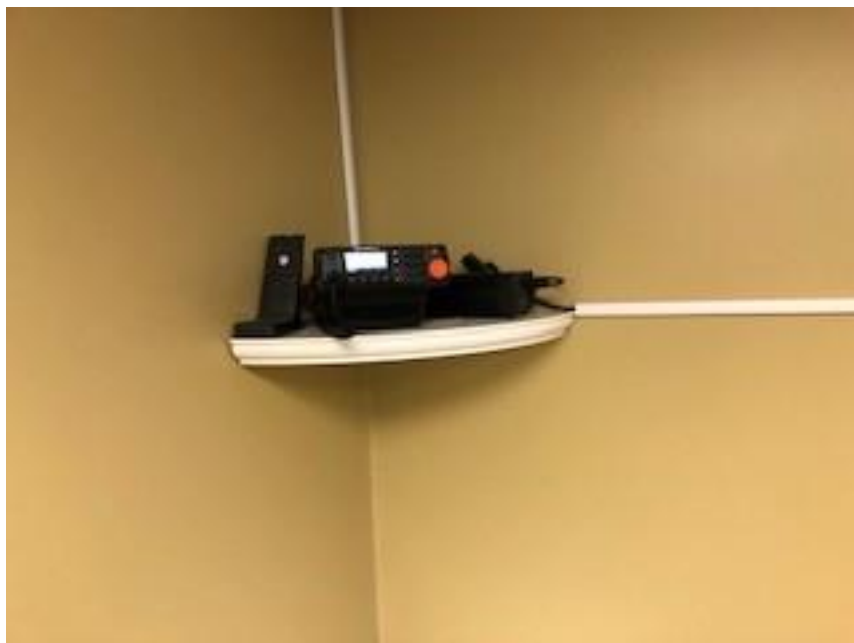
The Temple does not have an alarm system. There is one (1) panic alarm in the building. There are no audible door alarms to alert if propped open or not shut properly. Contact with the area police department is only by landline or cell phone.

Figure 8 panic alarm

All exits should have an alarm to prevent doors from being propped open and unattended. Install an alarm system with monitoring capabilities as well as a direct method of communication to the area police department in the event of an emergency. Additionally, install a series of panic alarms in the office assigned to the Rabbi, in classrooms, in the sanctuary and at both the rear entrance as well as the main entrance. Ensure that all the buildings panic alarms when activated trigger a text/email notification to police, staff and congregants to alert them to the threat in the building.

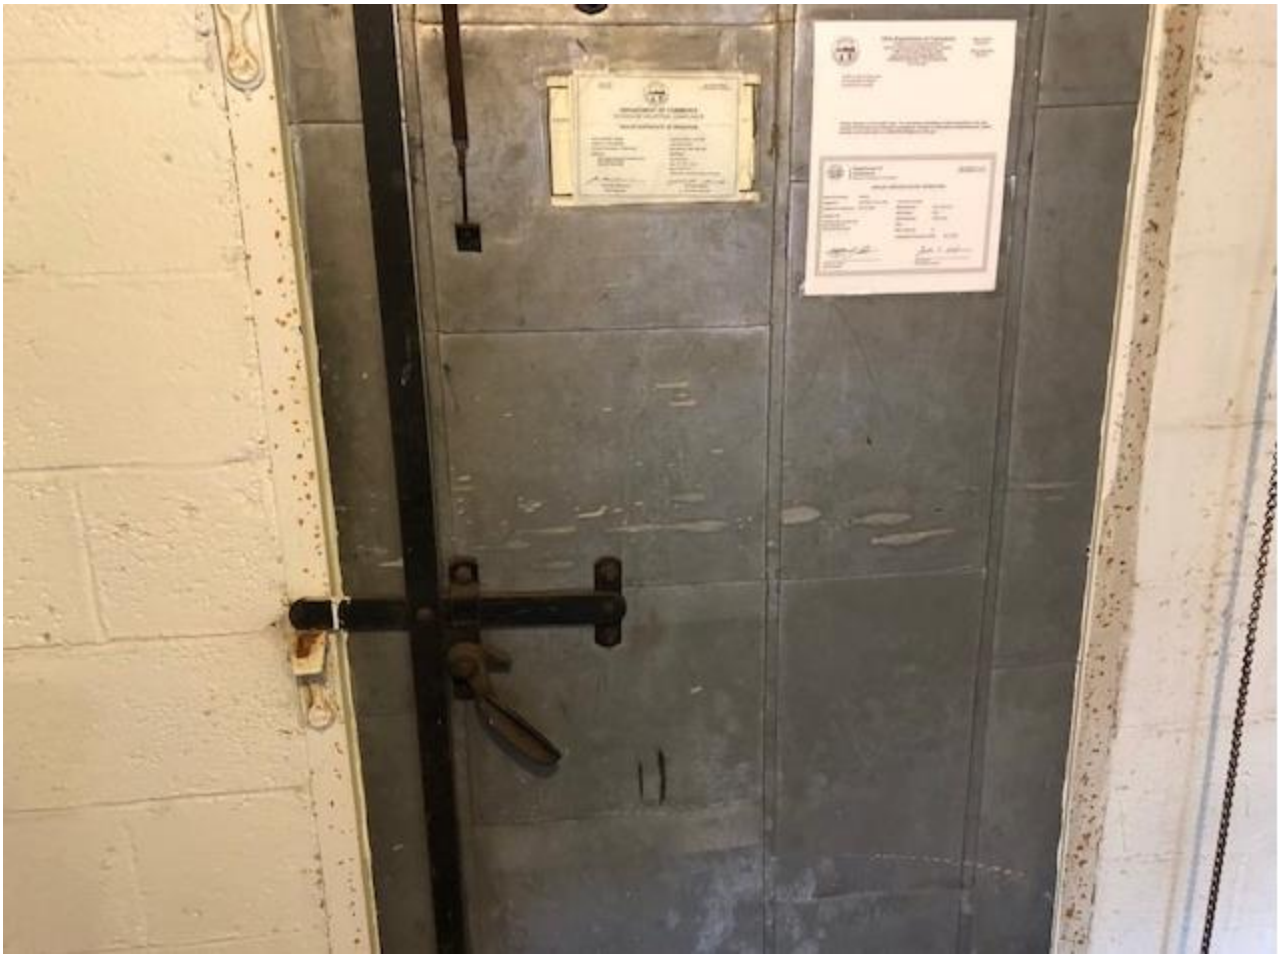
Figure 9 - possible SAFE ROOM - Boiler room
