# OHIO HISTORIC INVENTORY

| 1. No. | | 4. Present Name(s)<br>Residence, Ada Cooper Miller | | 1. No. | |
| 6. Specific Location<br><br>139 Franklin Street | | 16. Thematic Category<br>C | | 28. No. of Stories 1½ | |

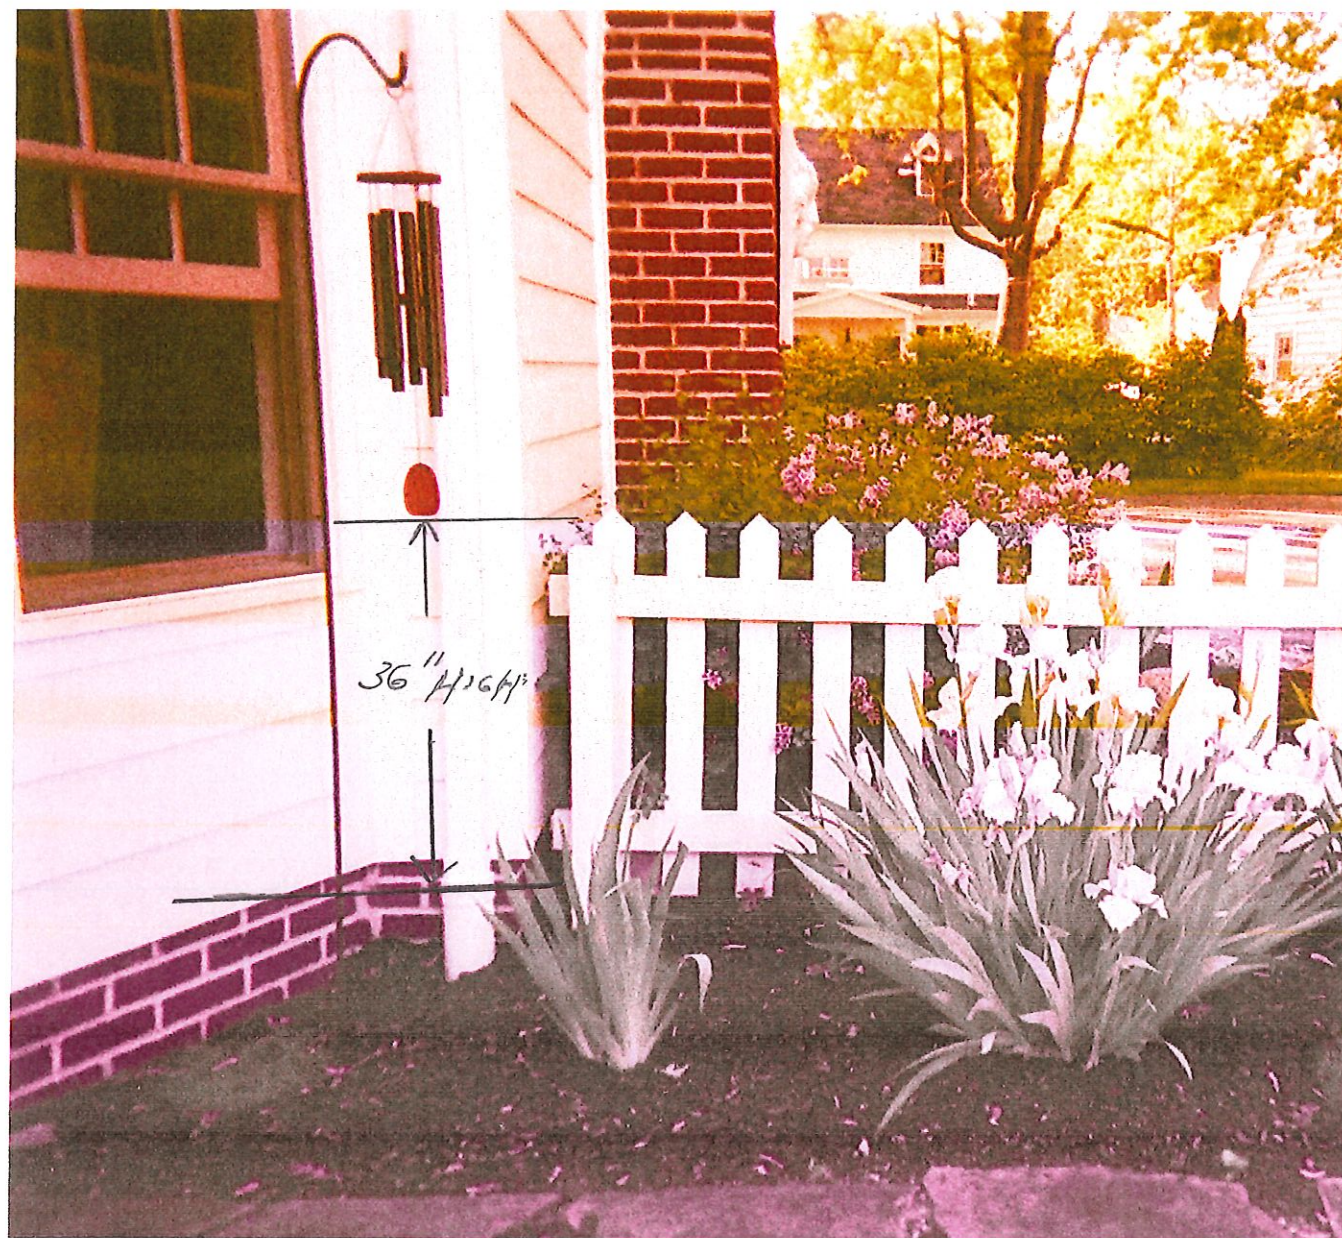
FENCE TO BE BUILT WILL DUPLICATE EXISTING ON LOT LINE  
IN FRONT OF GARAGE

36" HIGH, 90 FEET LONG ALONG LOT LINE  
MADE OF WOOD.

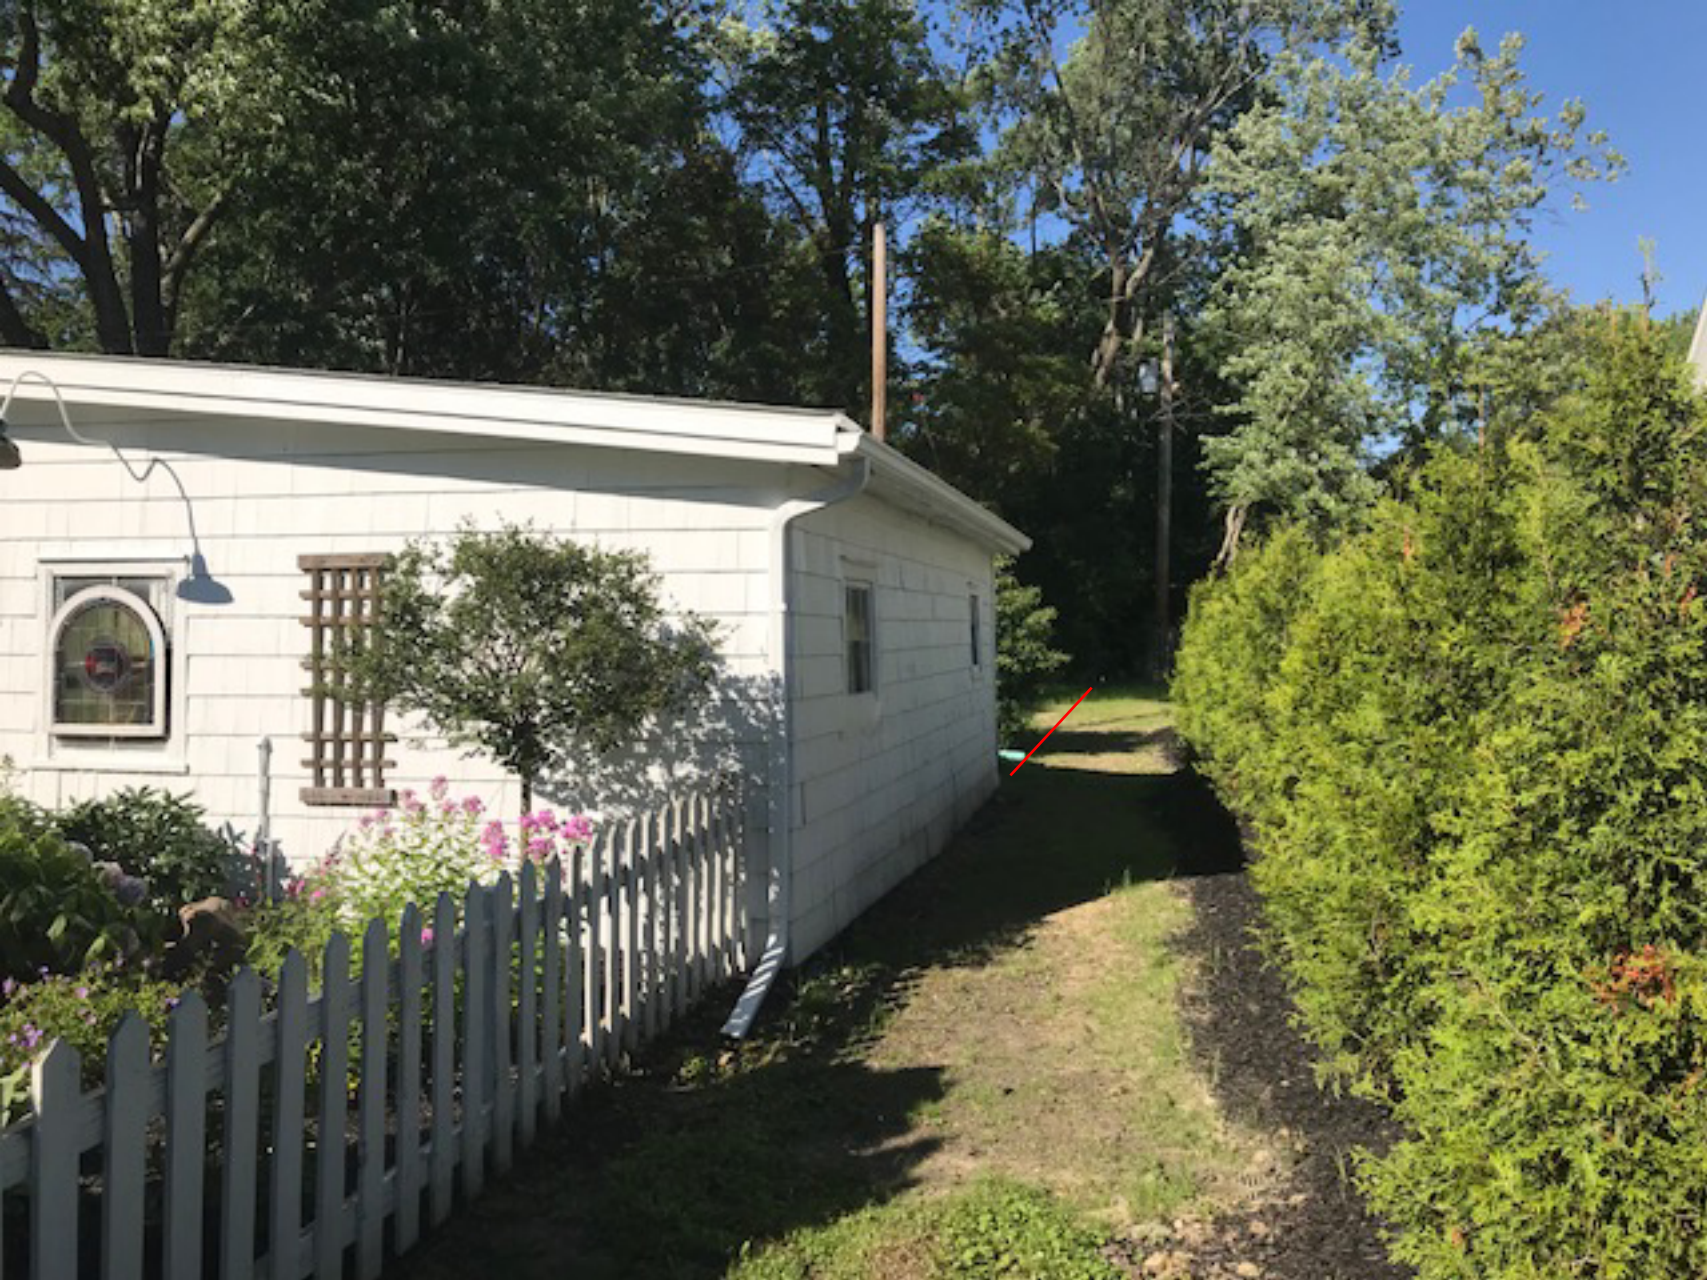
Southeast Corner of Lot

Proposed Fence
