To: Nick Sugar, City Planner and Amanda Krickovich, Community Development, City of Hudson
From: Olivia Zepp, AIA | Historic Architecture, Perspectus
Date: October 19, 2023
Re: 201 N. Main Street
CC: Lauren Pinney Burge, AIA, Principal & Alice Sloan, Assoc. AIA, APT-RP | Historic Architecture, Perspectus

SUBJECT PROPERTY: 201 N. Main Street

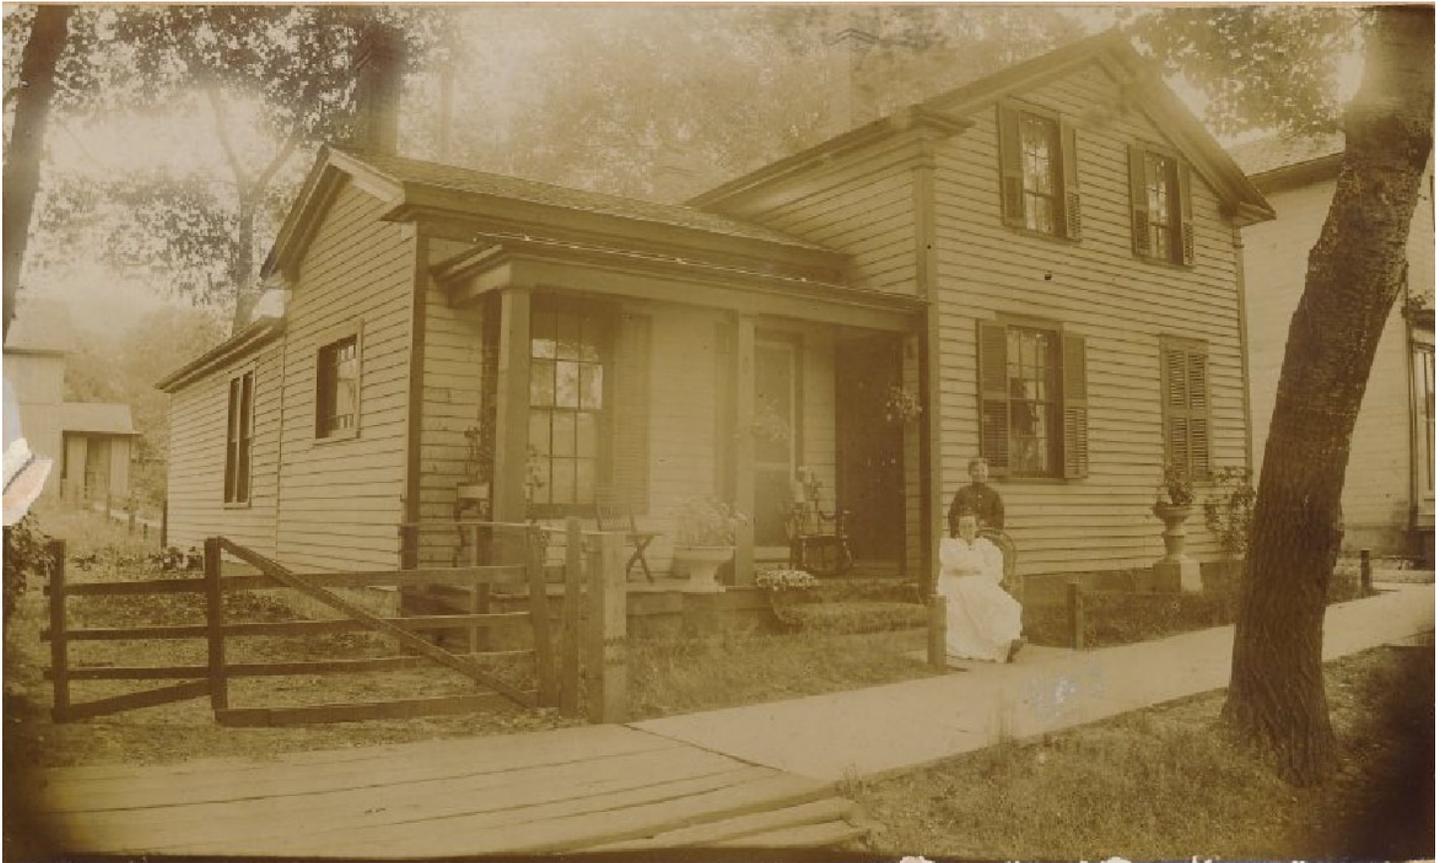
Image 1: Date c.1900. Courtesy of the Hudson Historical Society. Front (west) and side (north) elevation. Note the Gable-Front-and-Wing configuration of the house, the 6 over 6 double hung windows on the first floor, the exposure width of the siding, the two chimneys appear to be brick, and the foundation appears to be stone. The door appears to be under the porch on the north return wall.

- b. **Change #3:** The lap exposure of the siding is not indicated on the drawings, it should match the lap exposure as it appears in the c1900 image (see image 1).

- e. **Change #6:** The location of the faux chimney should be based on the c.1900 image (see Image 1). Note the chimney in the c.1900 image appears to be brick and the foundation appears to be stone. Codified Ordinances Appendix D – Architectural Standards Section III-1 states chimney material should match foundation material, but consider the note about the c.1900 image and building materials.

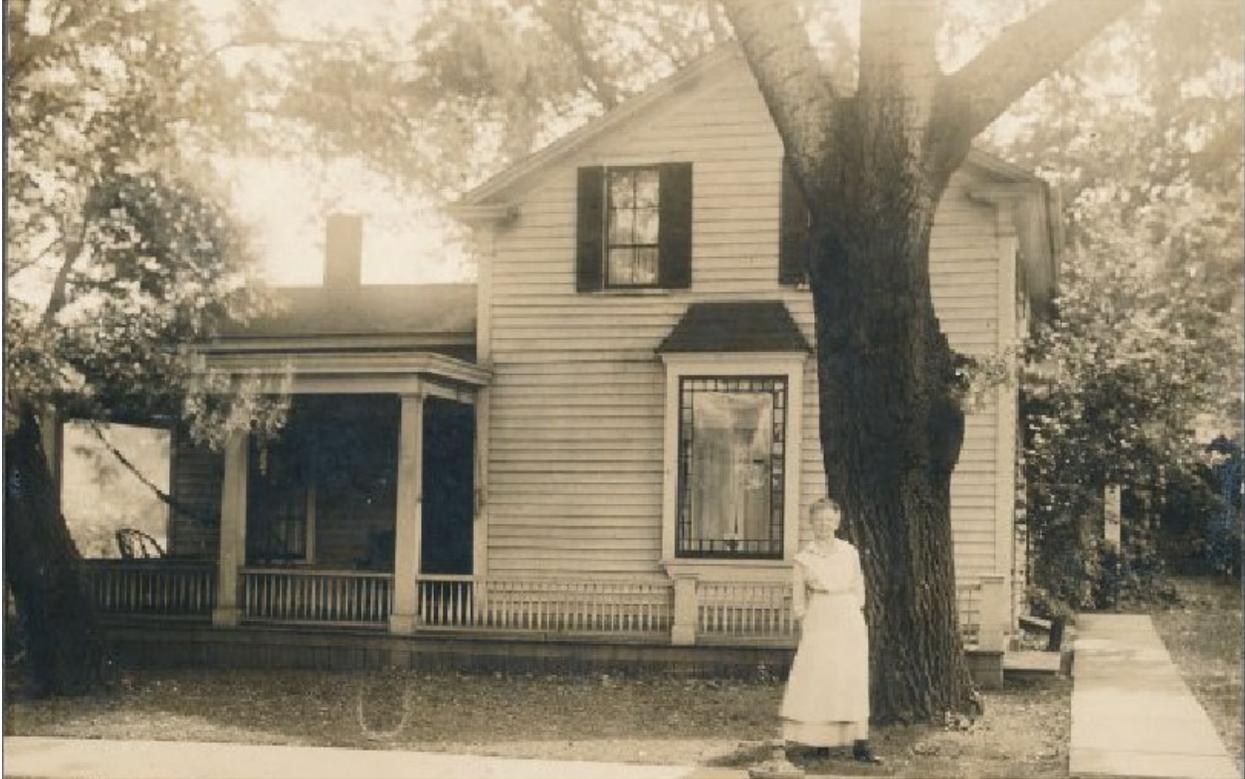
Image 2: Appears to date to c.1916. Courtesy of the Hudson Historical Society. Front (west) elevation. Note the front porch changes and the bay window.

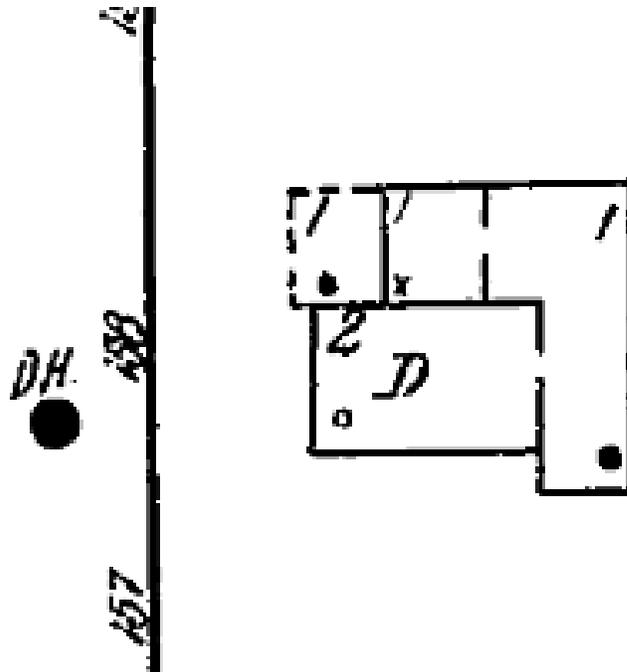
Image 3: 1916 Sanborn Map, Ohio Web Library. Note the configuration of the structure with a portion of the current rear (east) addition is existing by 1916. (North is up)

7. Demolition of the one-story rear additions, a portion of which appears in the 1916 Sanborn map (see Image 3). The additions appear to have been altered since their original construction.

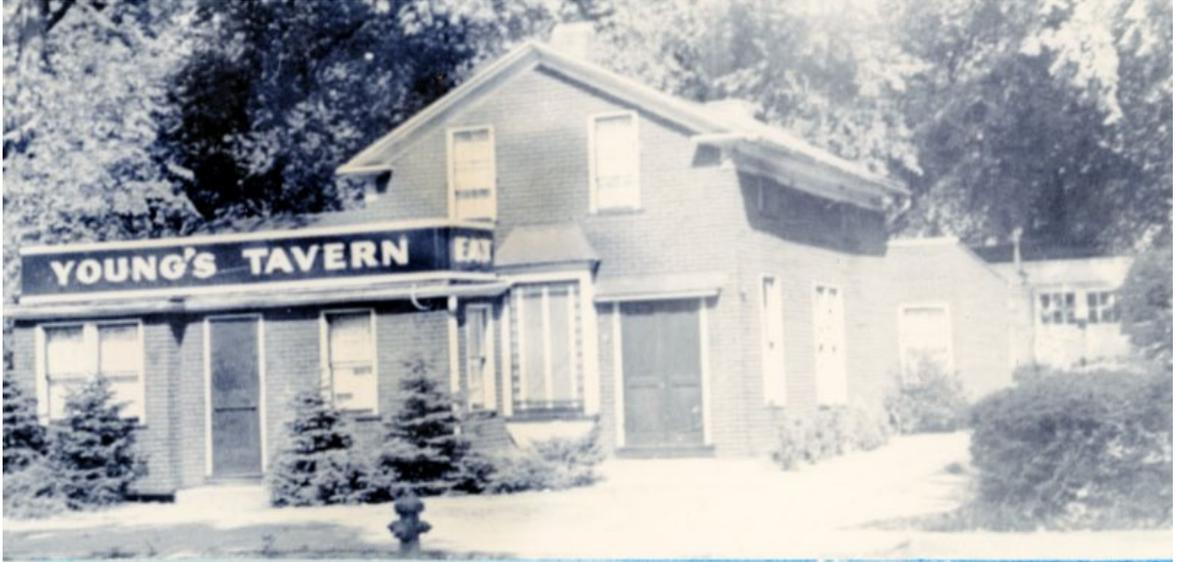
Image 4: Date c.1950. Courtesy of the Hudson Historical Society. Front (west) elevation. Note the elevation reconfiguration, the second story replaced windows, the front door on the two-story portion, and the one-story rear addition.

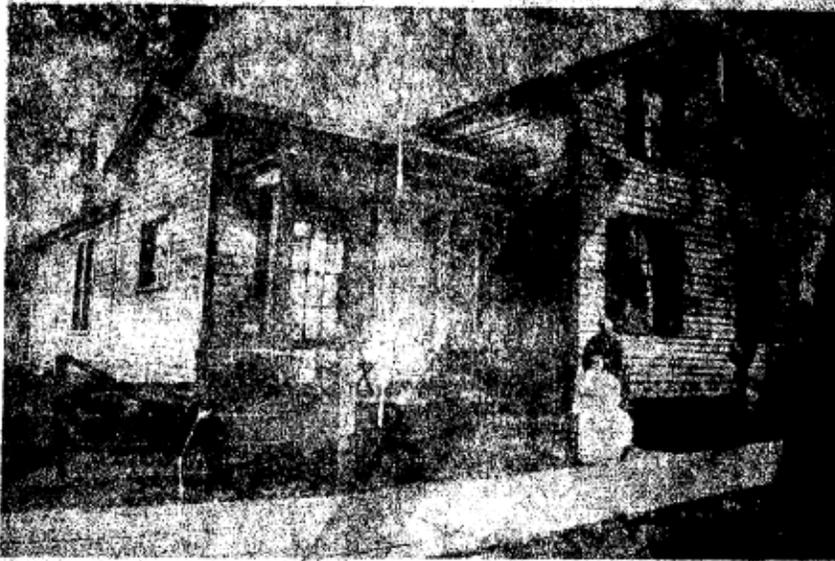
Restored Along Lines Of Early Hudson Home

This is a picture of the Hudson Village Realty and Hudson Homes Inc. building as it was originally built. It has been restored as nearly as possible. See picture of the restored building on page two. It was once occupied by the grandparents of Mrs. Louella Dodds.

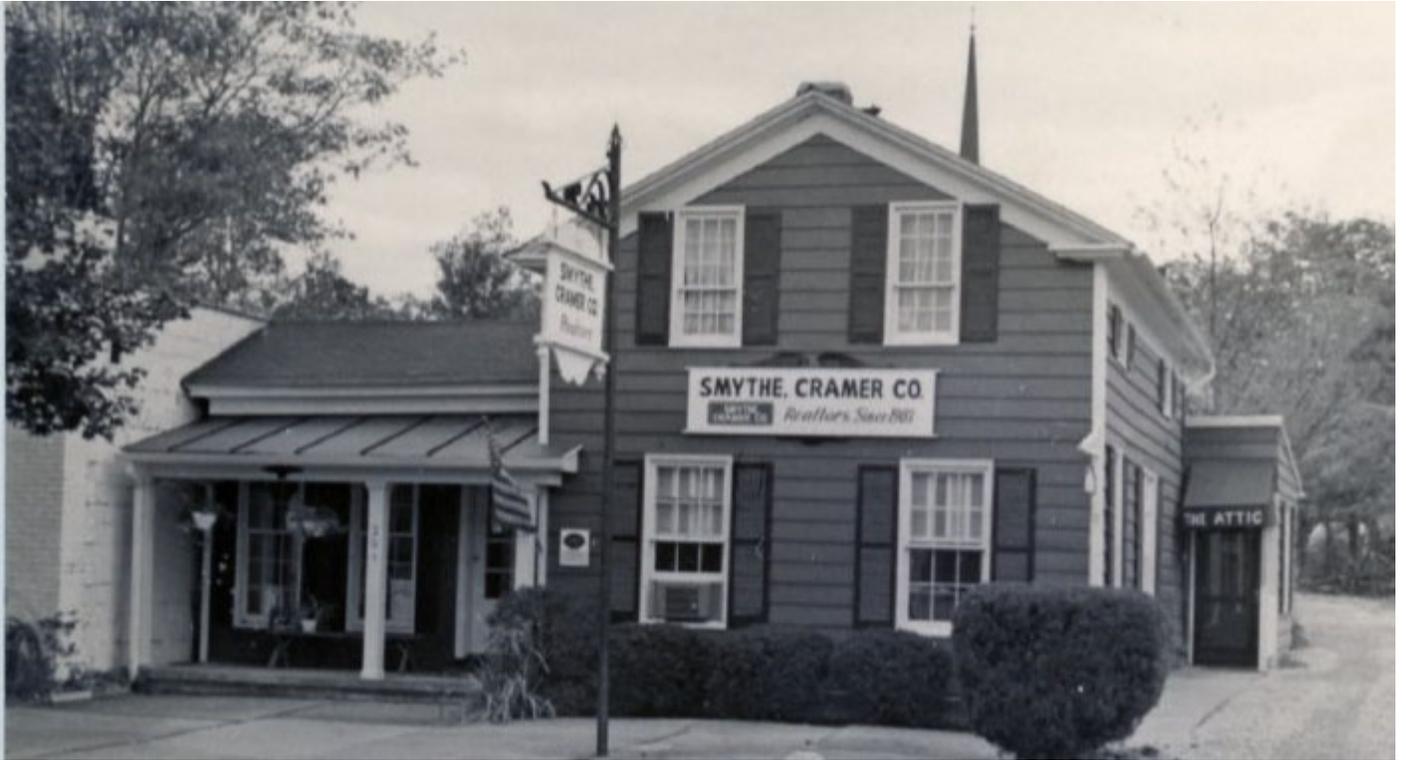
Image 6: Date c.1970. Courtesy of the Hudson Historical Society. This is the presumed configuration from the 1954 restoration. Front (west) elevation. Note the front porch reconfiguration, the window replacements on the two-story portion, the replaced windows at the porch, and the one-story rear addition.

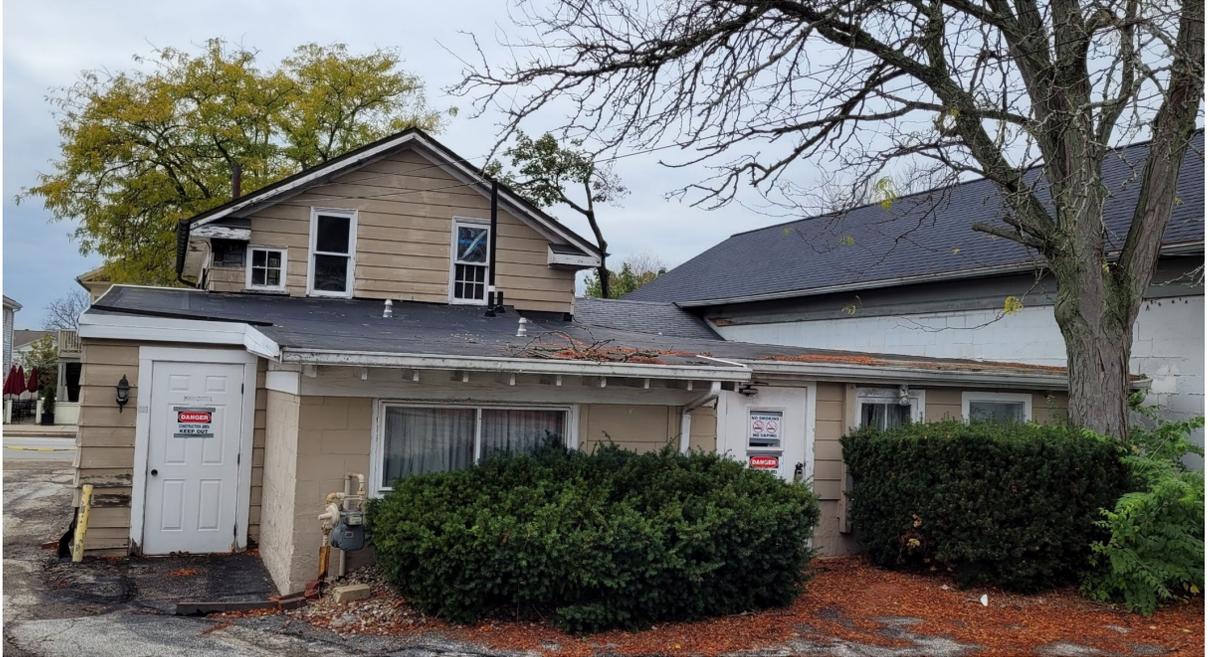
Image 8: Rear (east) elevation. One-story rear addition to be removed, including presumed addition that existed by 1916 according to the Sanborn map in Image 3.

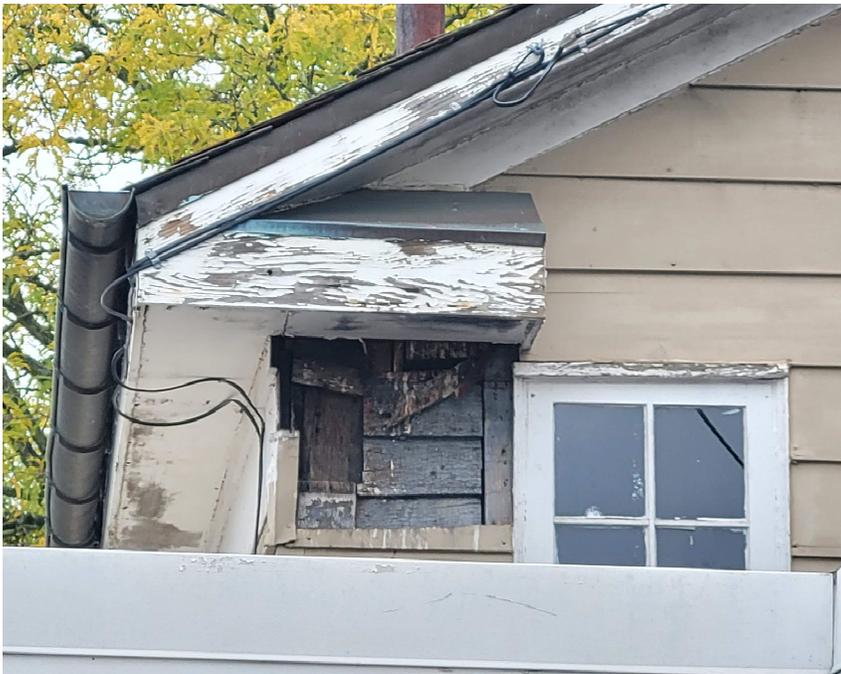
Image 9: Rear (east) elevation. Detail showing siding under existing siding. Outer layer of front elevation siding should be removed to see if another layer of wood siding exists. If so, this should be evaluated per historic photos to determine if this is the historic lap exposure width.

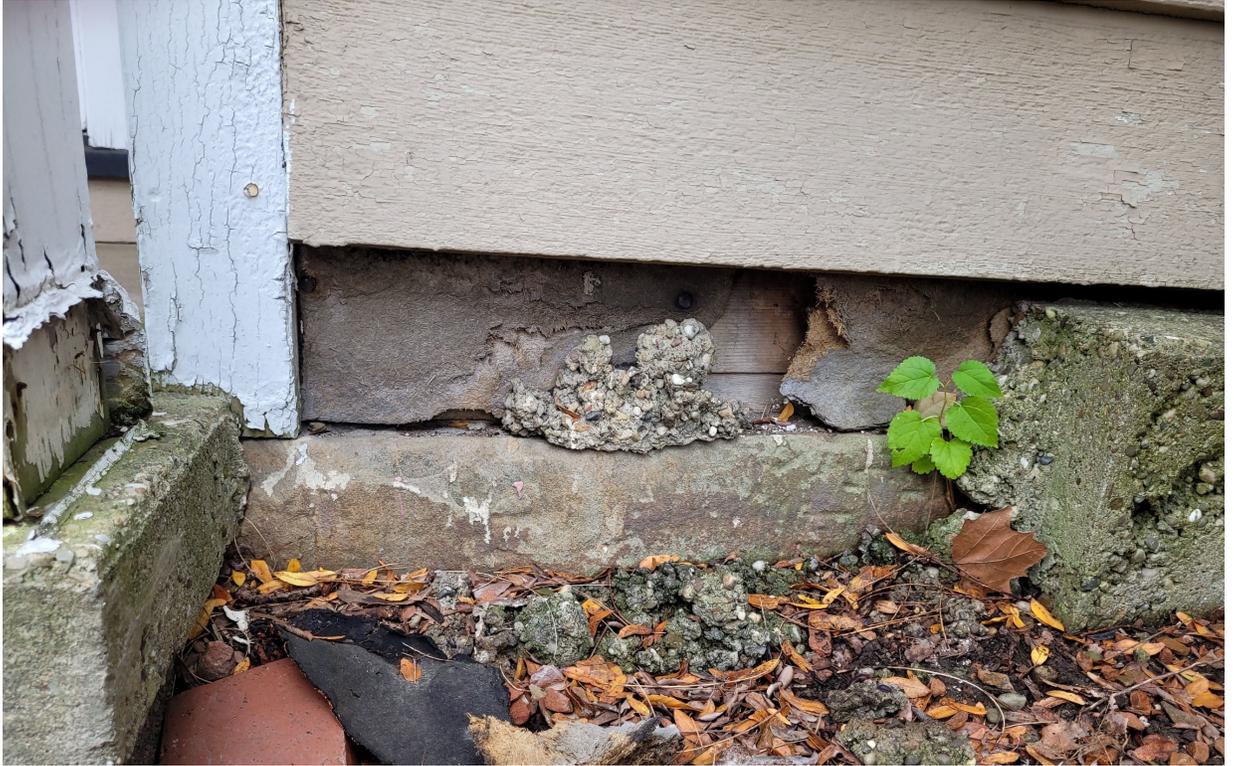
Image 10: Front (west) elevation. Detail at two-story portion showing sandstone foundation behind concrete. Also note wood siding behind the existing siding and mineral wool.

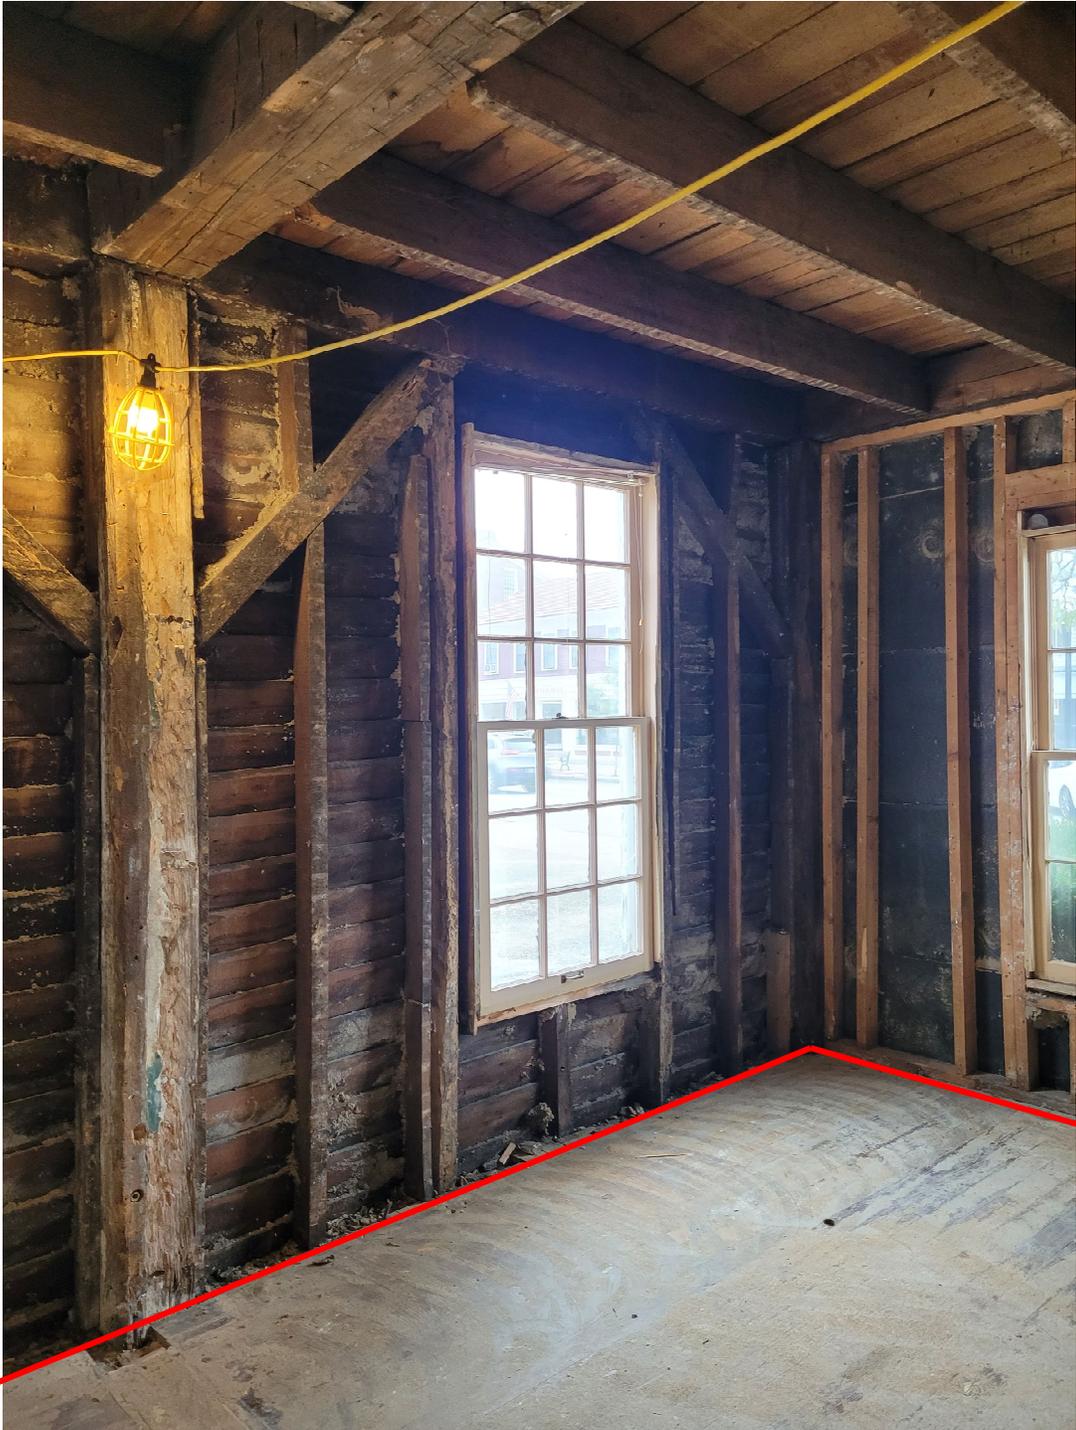
Image 11: Interior, southwest corner of the two-story structure. Red line indicates where structure will be cut to be lifted.

1. Demolishing the one-story portion and porch (north of the two-story portion) and rebuilding with new materials.
2. Cutting the framing of the historic two-story structure between the first-floor finished floor and sill plate (see Image 11), lifting the entire two-story structure, and moving the building. Replacing the foundation walls with CMU block and an exterior brick veneer. The new foundation walls will match the footprint of the existing structure. Rebuilding the first-floor structural members and placing the two-story structure on the new foundation.

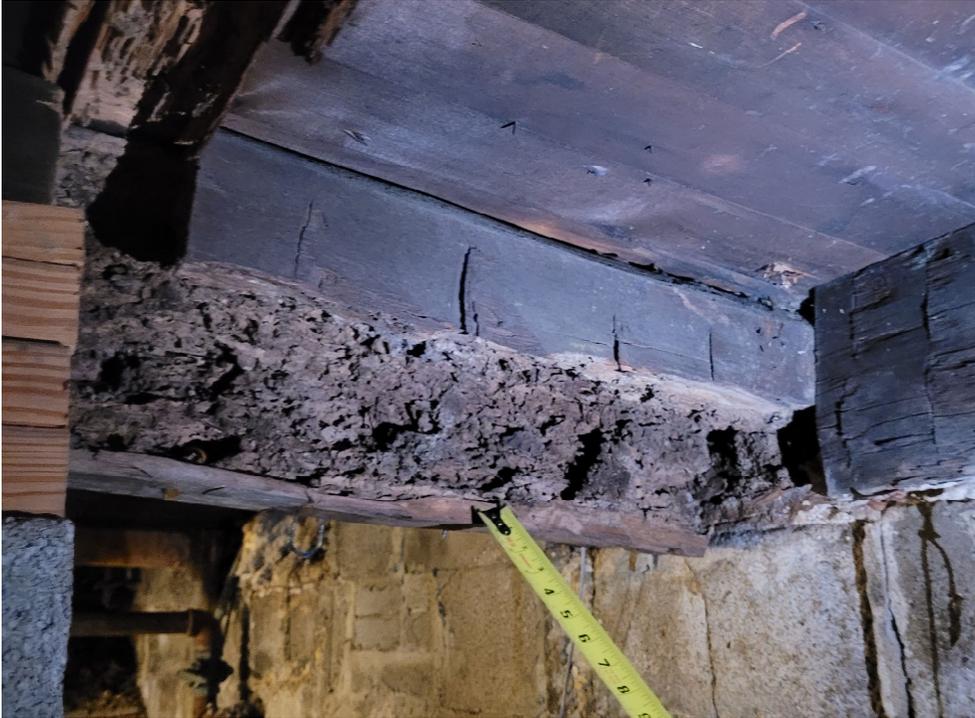
Image 12: Image taken in basement showing termite damage to the north-south structural member in the two-story portion.

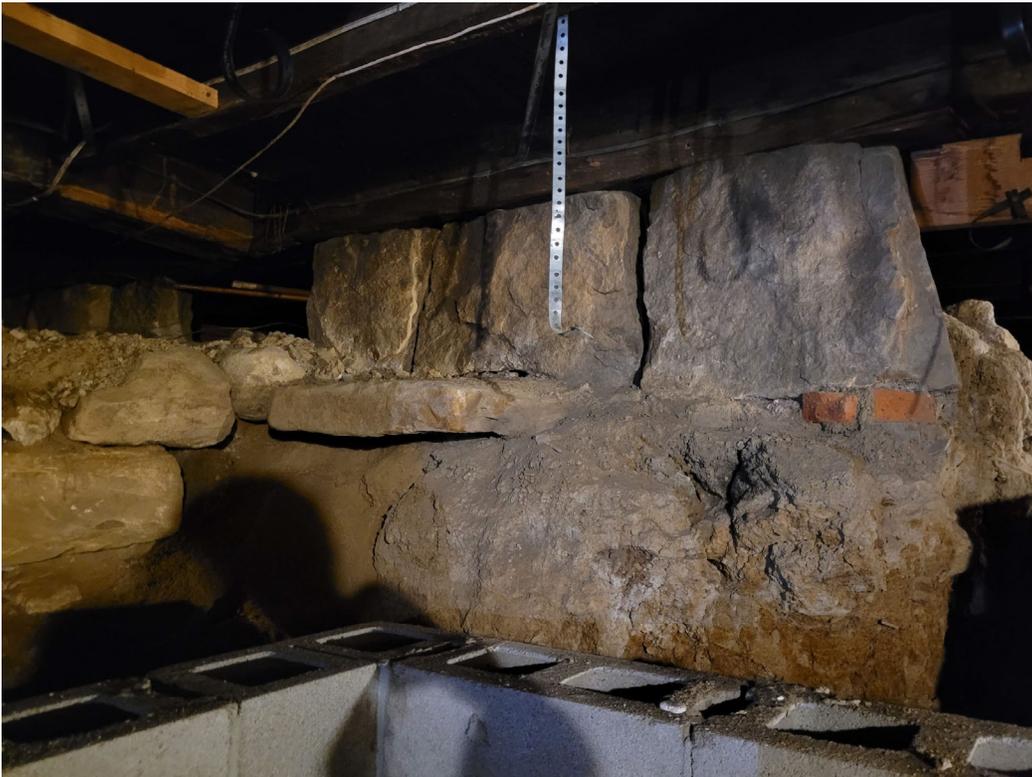
Image 13: Image taken in basement showing sandstone foundation at the north wall of the two-story portion.
