OHIO HISTORIC INVENTORY

1. No.		4. Present Name(s)	
2. County Summit		Residence, G. D. Davis	
3. Location of Negatives HHA 32-23		5. Other Name(s)	
6. Specific Location 90 Oviatt Street		16. Thematic Category D	28. No. of Stories 1

2. Detailed Explanation of Project *

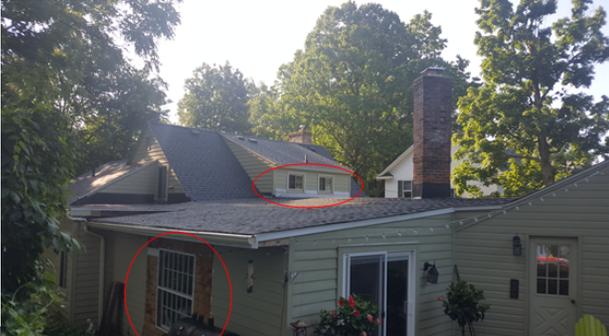
B

Board damage, second floor, North side of dwelling below windows. Damage occurred from roof replacement in 2015 and flashing was extended for better protection. Replaced boards with like 8' clapboard cedar siding and prime and paint.
