OHIO HISTORIC INVENTORY

<p>1. No.</p> <p>2. County SUMMIT</p> <p>3. Location of Negatives HHA 49-35</p>	<p>4. Present Name(s) Residence, Gretchen Walker</p> <p>5. Other Name(s)</p>	1. No.				
<p>6. Specific Location 126 Aurora Street</p>	<p>16. Thematic Category D</p> <p>17. Date(s) or Period c. 1930</p>	<p>28. No. of Stories 1</p> <p>29. Basement? Yes <input checked="" type="checkbox"/> No <input type="checkbox"/></p>	2. County SUMMIT			
<p>7. City or Town Hudson <small>If Rural, Township & Vicinity</small></p>	<p>18. Style or Design Colonial Revival</p>	<p>30. Foundation Material brick faced</p> <p>31. Wall Construction wood frame</p>	4. Present Name(s) Residence, G. Walker			
<p>8. Site Plan with North Arrow</p>

Step Detail

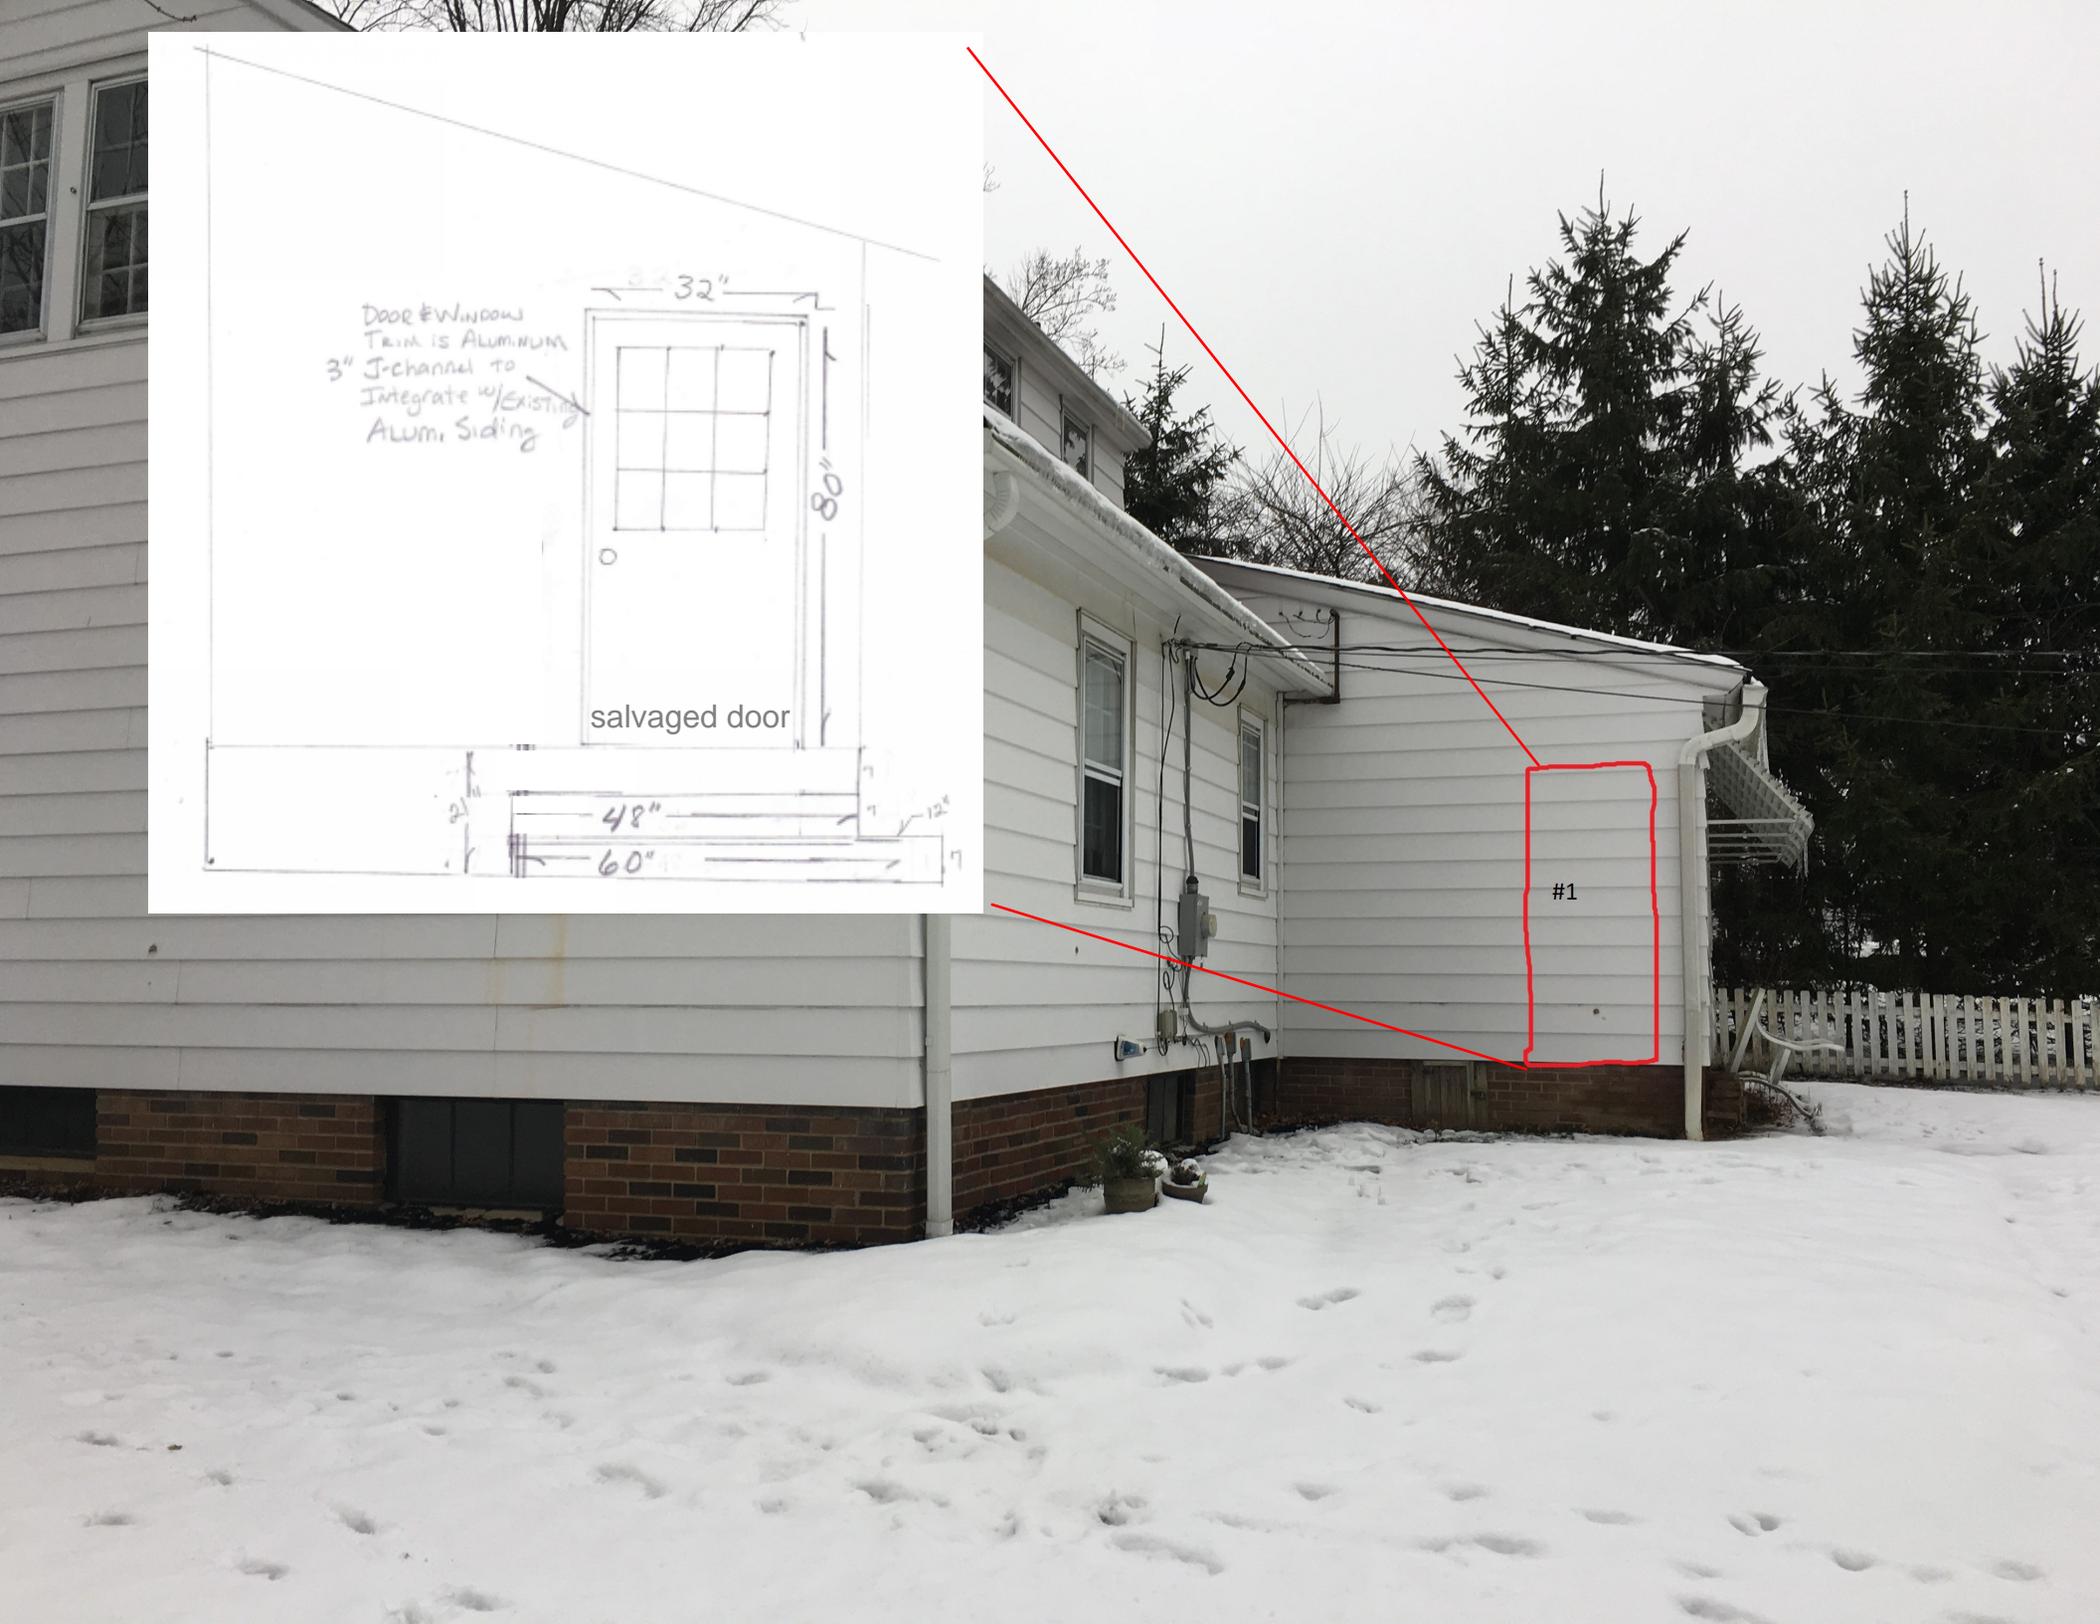
3" Sandstone Landing

12" STEP

4x8x2 BRICK & MORTAR

7" RISE

PAVER SAND 2"
PAVER STONE 2"

4" 1/2 Aggregate (STONE)

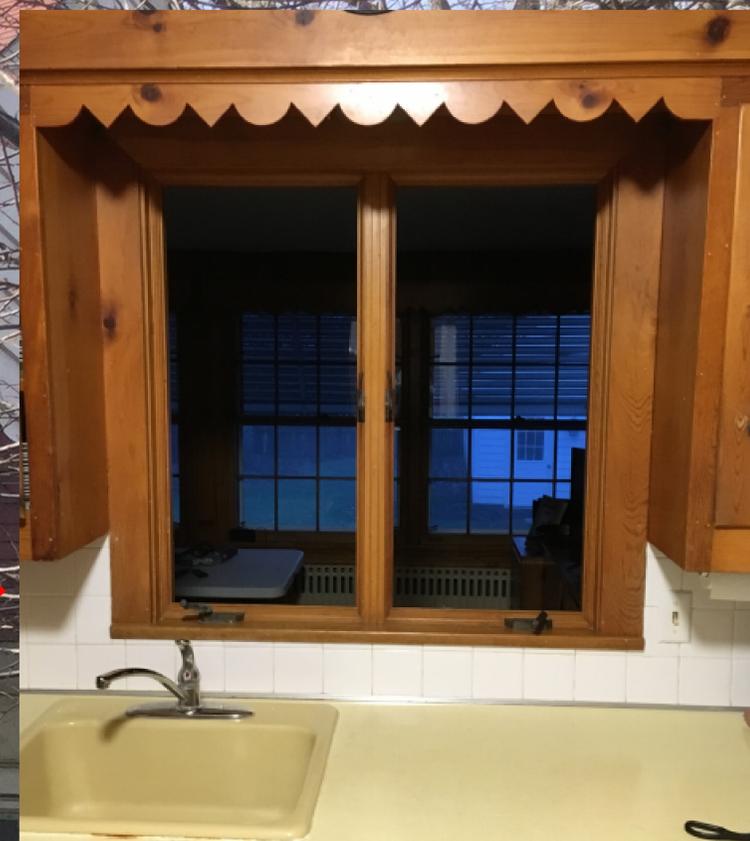
- Measurements: 36w x 38ht
- Construction: Solid wood
- Finish: Natural interior and exterior finish (will paint exterior white to match house)
- Trim: Using Aluminum J-Channel to integrate with existing Aluminum siding.
- Style: This is a 2 bay crank casement window with 8 lite grids (1 right and 1 left)
- This window is currently still installed above our sink and left in place after the addition was added.
- It will replace the existing casement to allow space underneath for cabinets and sink.

- It is an existing window that was installed in the 1930s.
- Mfg is unknown
- Measurements: 36w x 38ht
- Construction: Solid wood
- Finish: Natural interior and exterior finish (will paint exterior white to match house)
- Trim: Using Aluminum J-Channel to integrate with existing Aluminum siding.
- Style: This is a 2 bay crank casement window with 8 lite grids (1 right and 1 left)
- This window is currently still installed above our sink and left in place after the addition was added.
- It will replace the existing casement to allow space underneath for cabinets and sink.

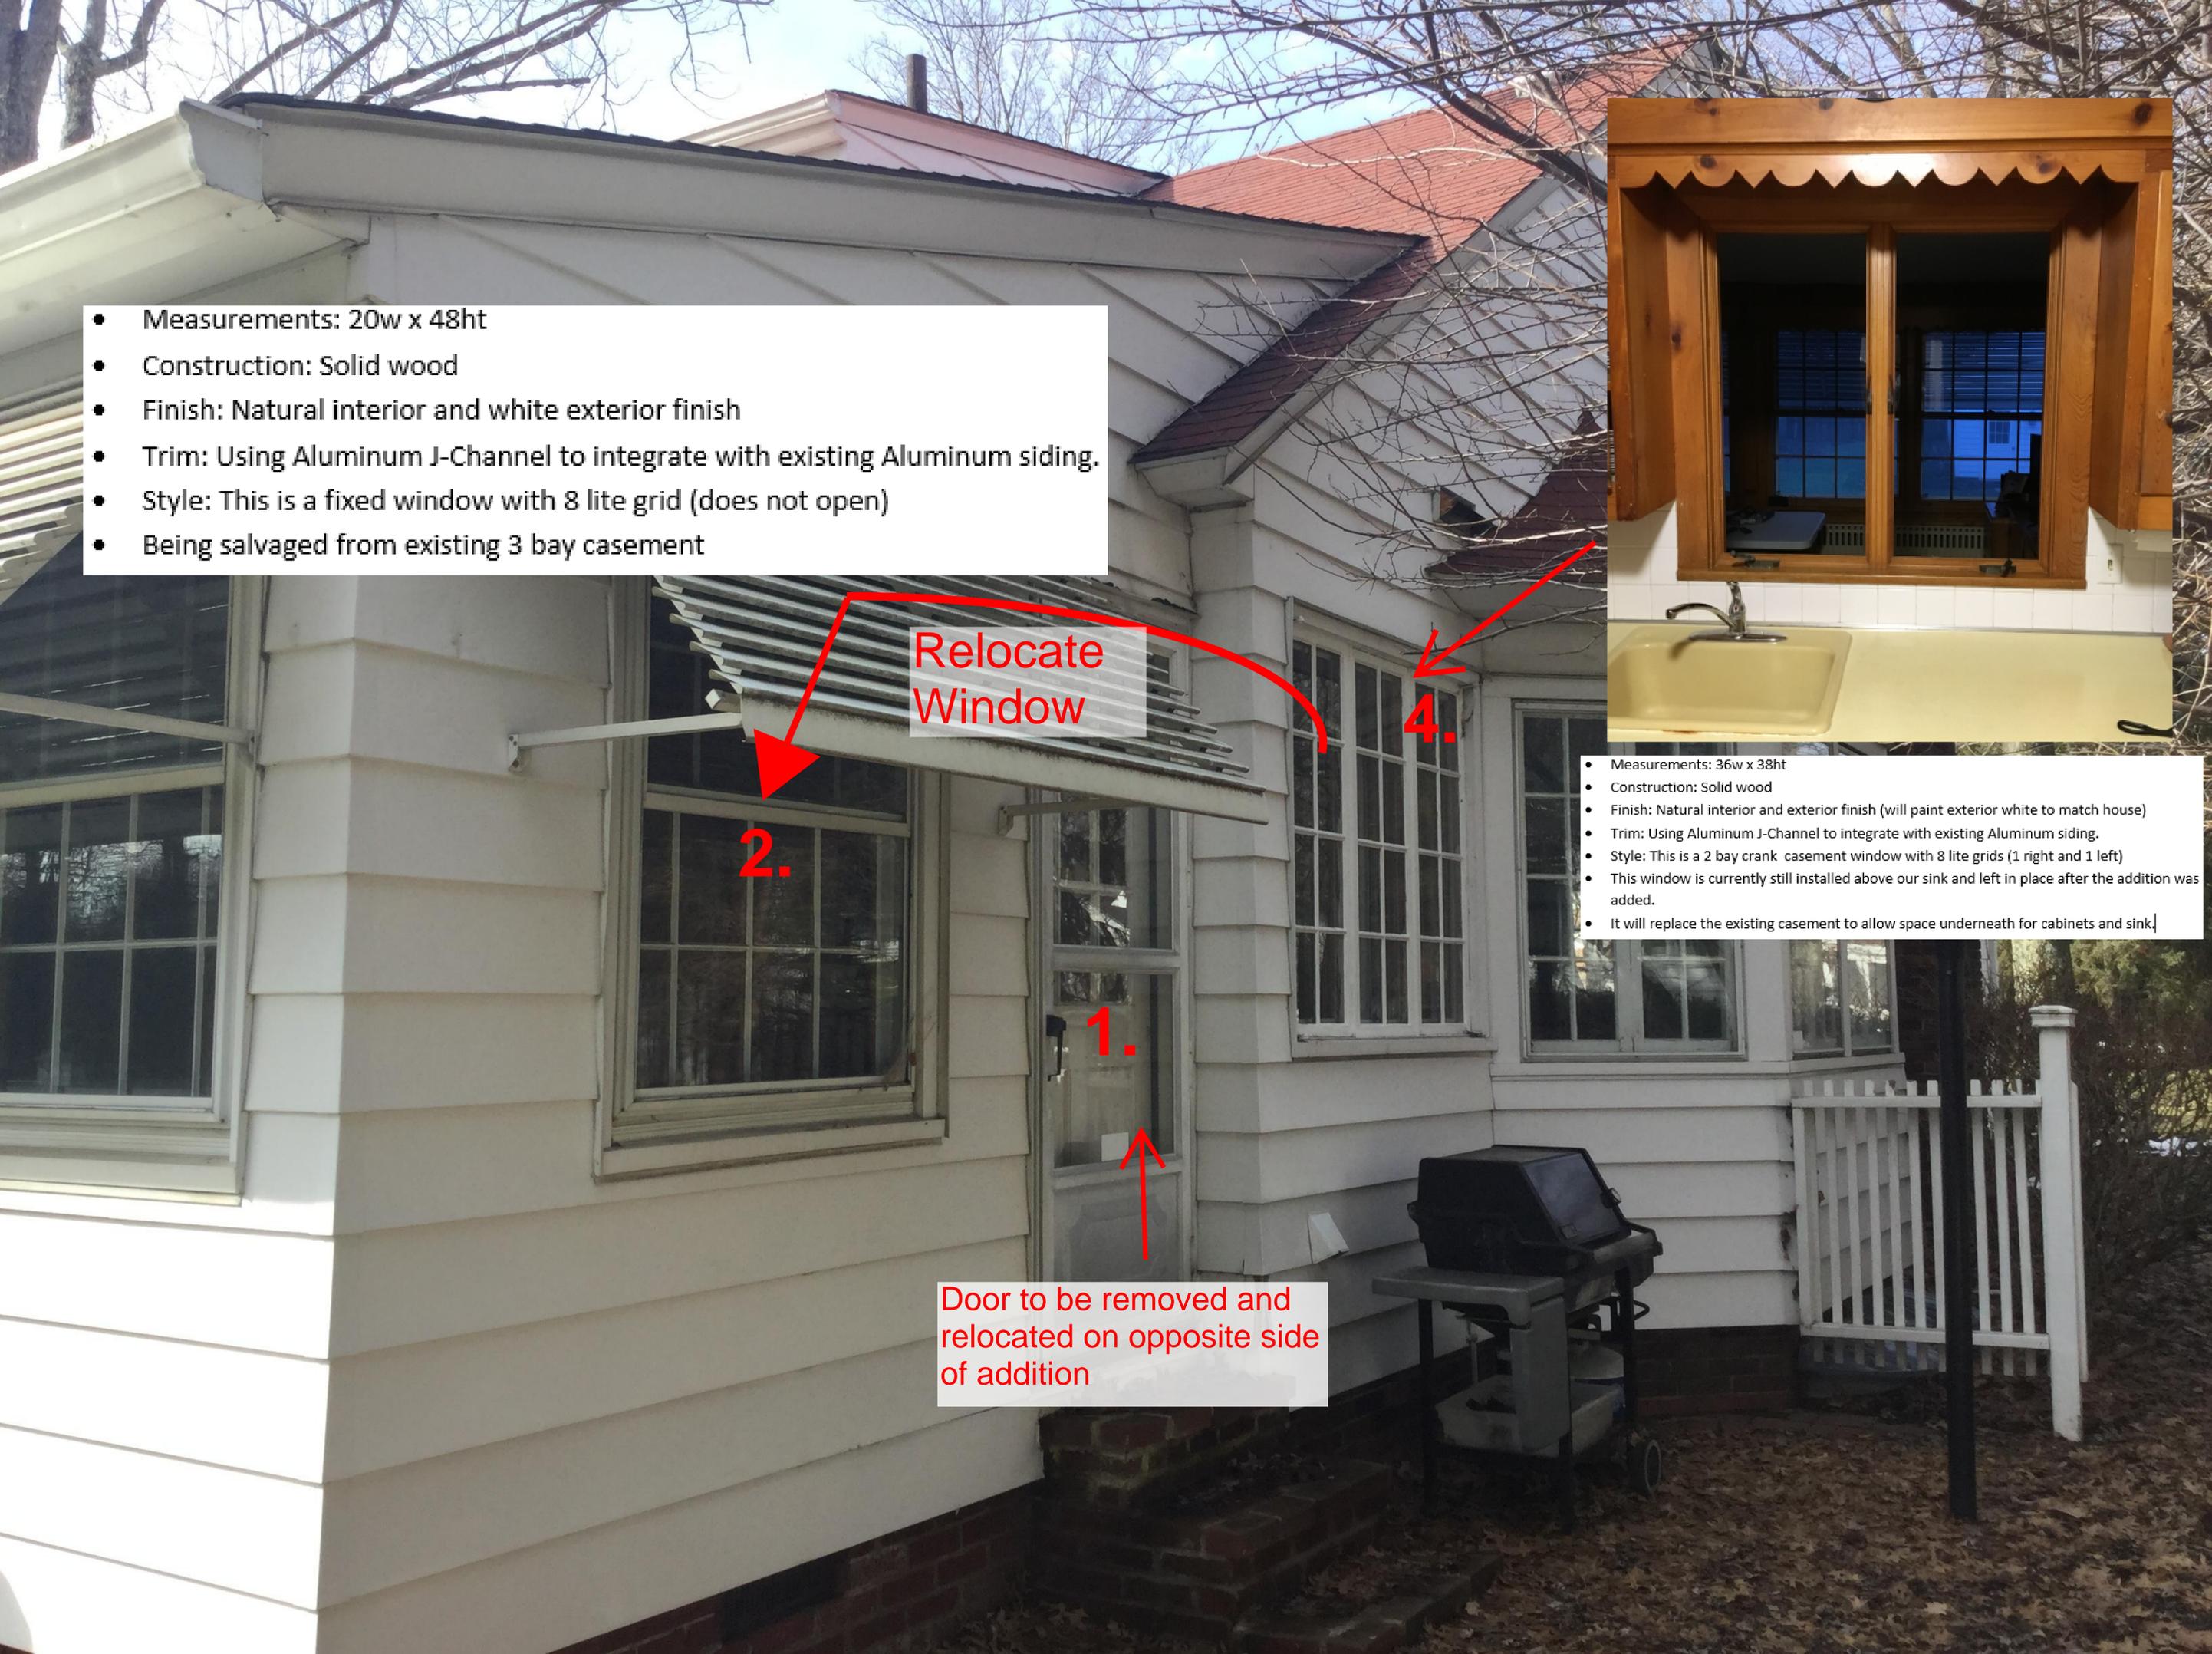
Relocate Window

Door to be removed and relocated on opposite side of addition

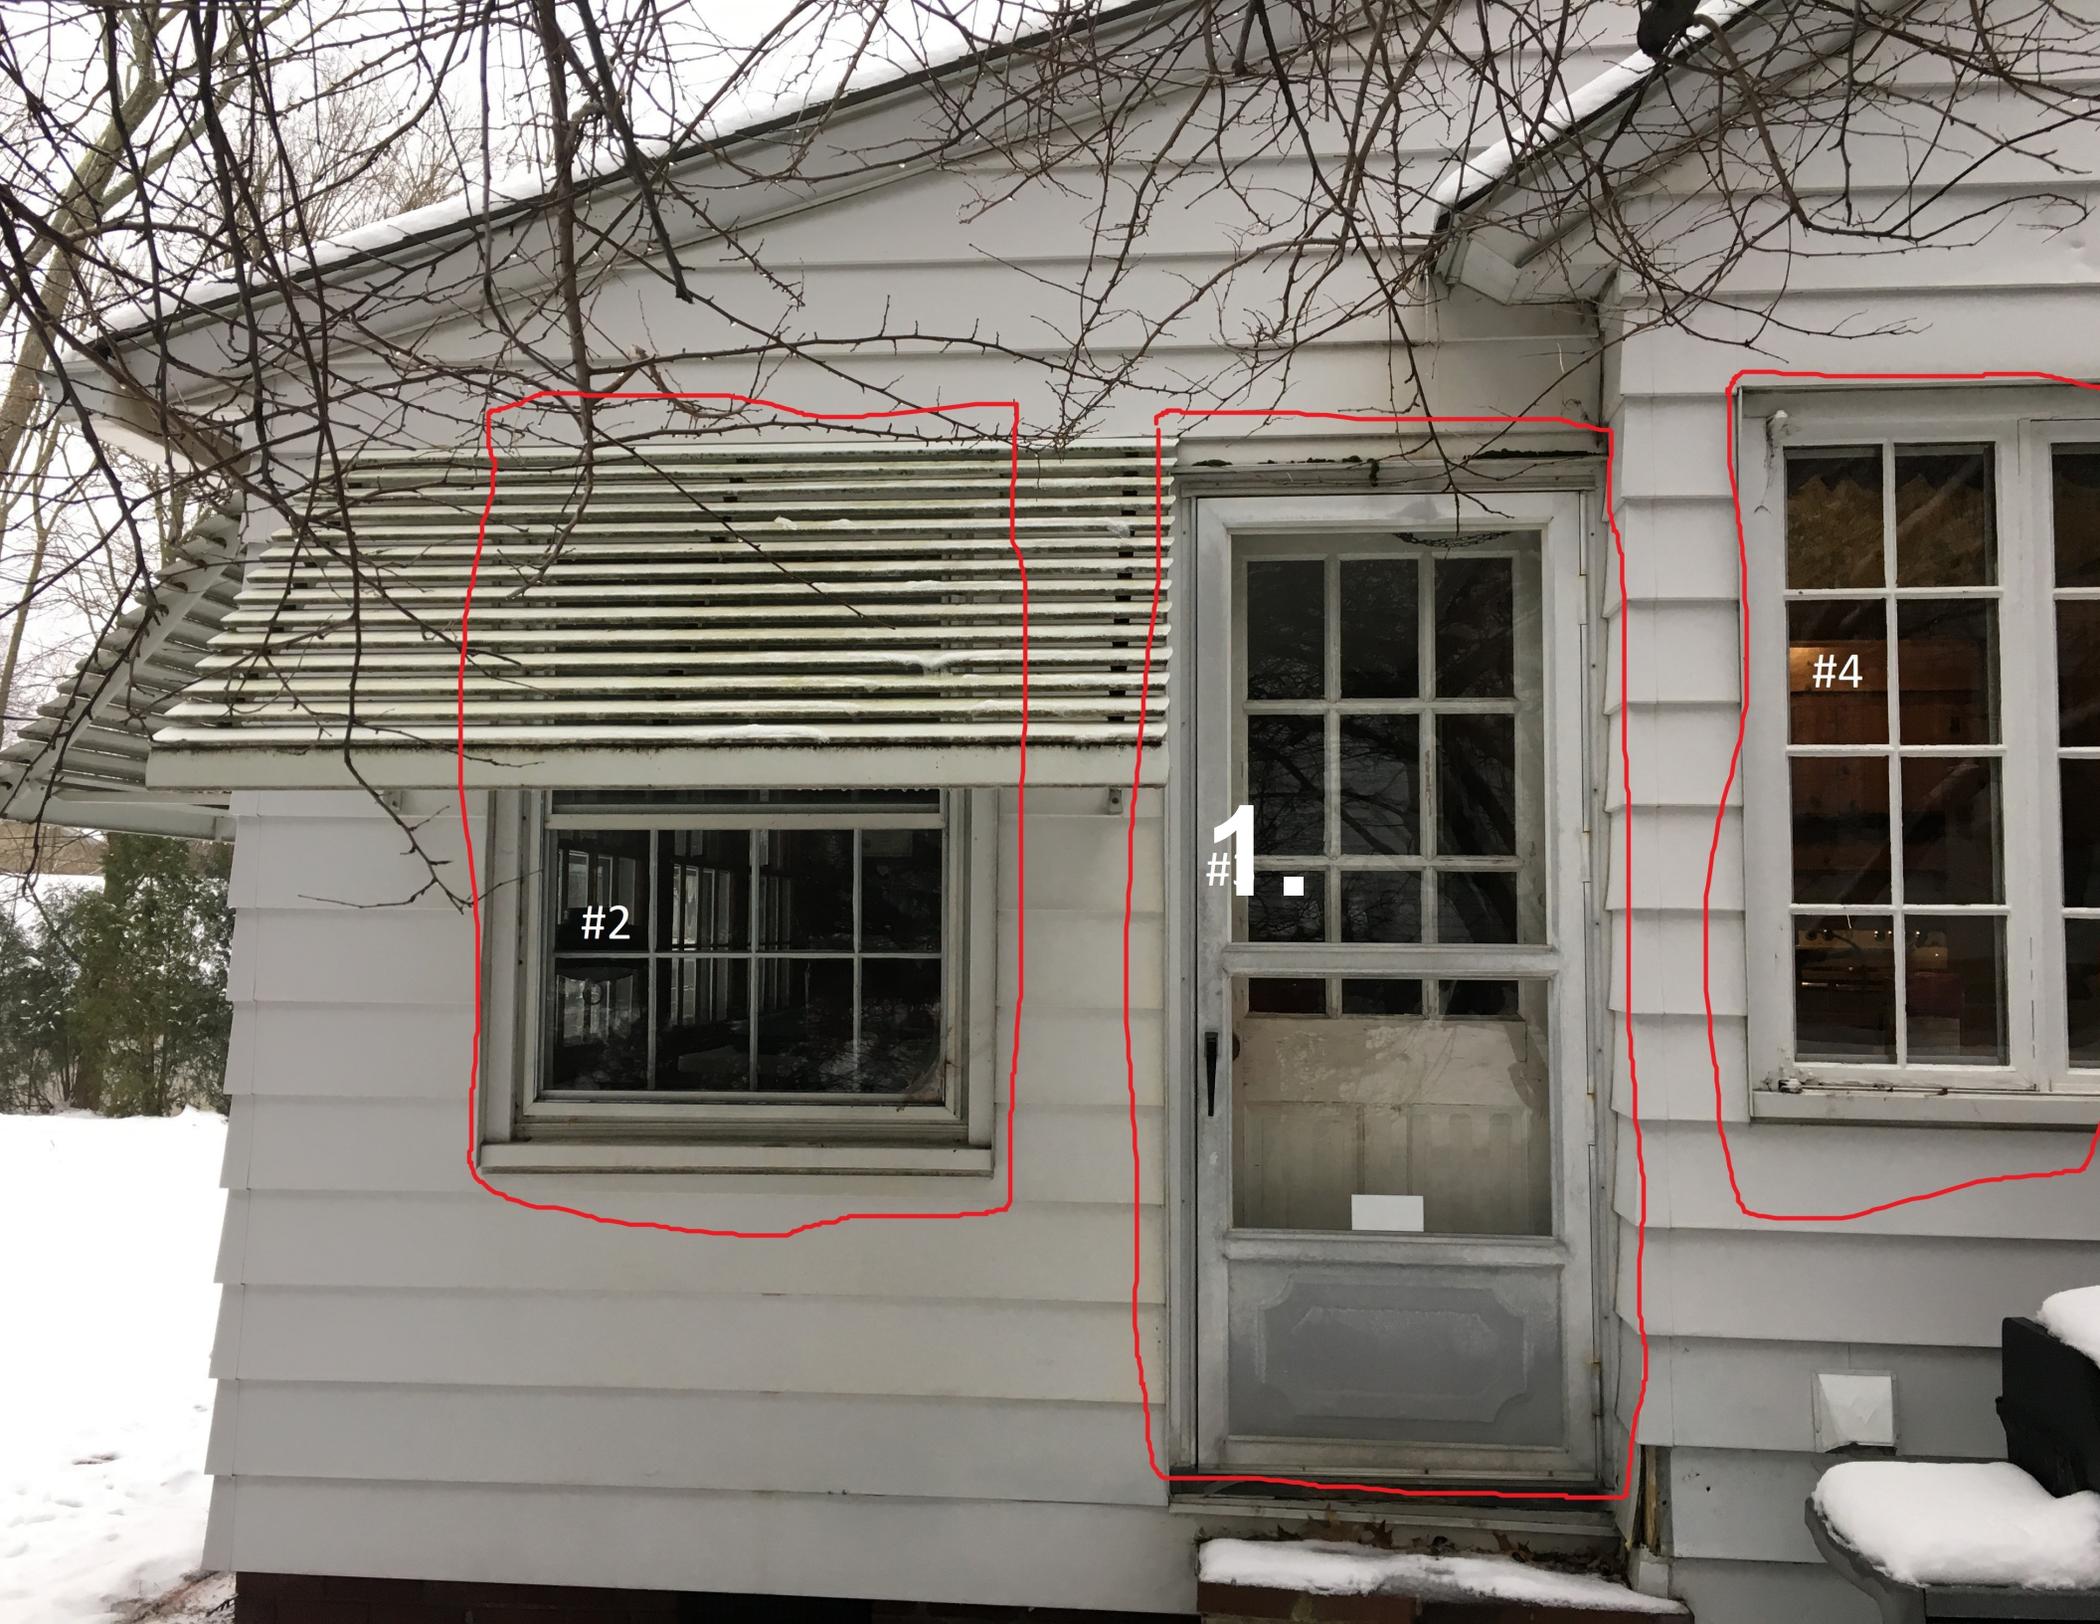
Measure details

Door (#1)

- It is existing door that was installed in the 1930s.
- Mfg is unknown.
- Measurements: 32w x 80ht
- Construction: Solid Wood
- Finish: Natural interior and White Paint Exterior
- Trim: Using Aluminum J-Channel to integrate with existing Aluminum siding.
- Style: 9-lite grid Colonial

Window (#2)

- It is an existing window that was installed in the 1930s.
- Mfg is unknown
- Measurements: 20w x 48ht
- Construction: Solid wood
- Finish: Natural interior and white exterior finish
- Trim: Using Aluminum J-Channel to integrate with existing Aluminum siding.
- Style: This is a fixed window with 8 lite grid (does not open)
- Being salvaged from existing 3 bay casement

Window (#4)
