# 45 PRESERVATION BRIEFS

## Preserving Historic Wood Porches

Aleca Sullivan and John Leeke

National Park Service  
U.S. Department of the Interior  
Heritage Preservation Services

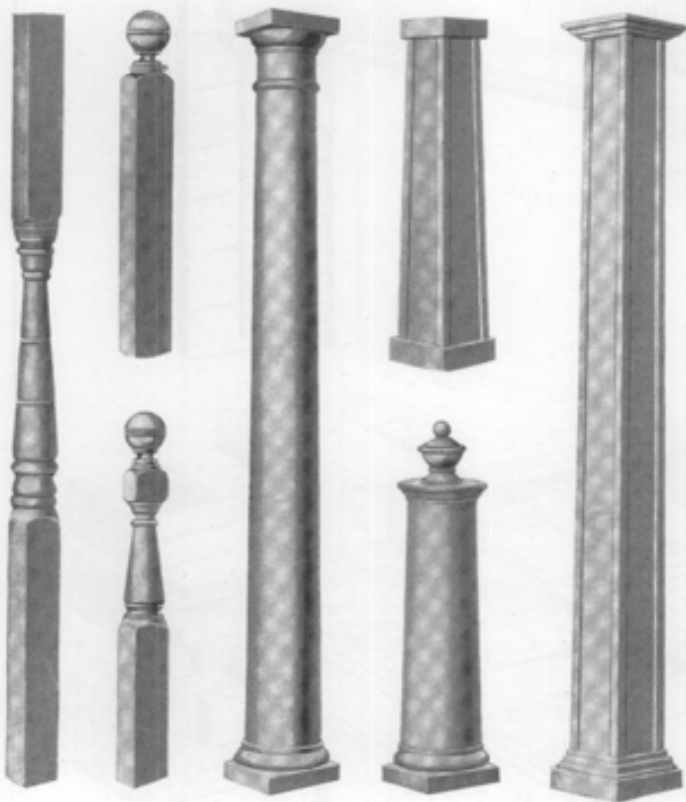
Figure 3. Throughout the late nineteenth and early twentieth centuries, millwork catalogues offered a wide variety of designs for porch parts, including columns, newels, balusters, spindles and brackets. As extolled in the Cedar Rapid Sash & Door Company's Standards Design Book, stock parts made embellishments to porches affordable both for new construction and "updating" existing homes. Courtesy of Charles Fisher.

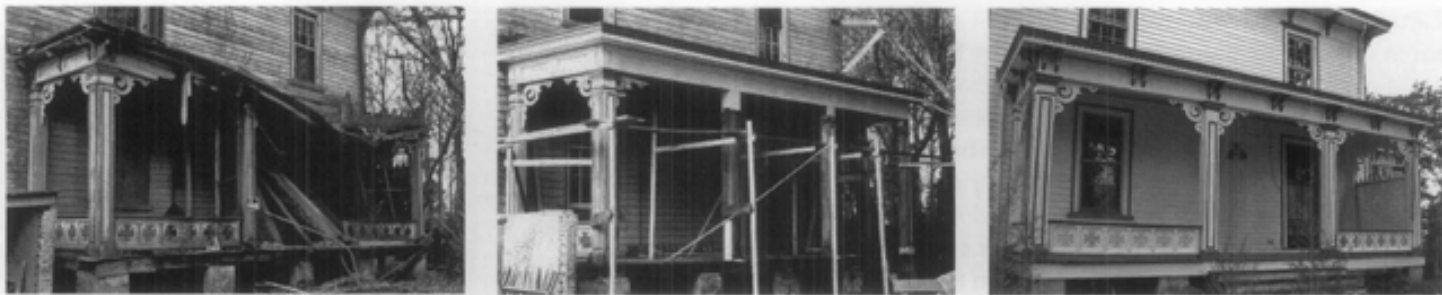
Figure 5. Even historic porches that appear to be in total disrepair may be repairable. While the roof needed replacement, much of this porch was repaired, including such features as the decorative columns, ornamental brackets, and balustrade. Photos: John Leeke.

engineer or building contractor familiar with old buildings. For an adequate assessment, it may be necessary to remove facing boards to check for potential decay in the structural sill behind (Fig 5).

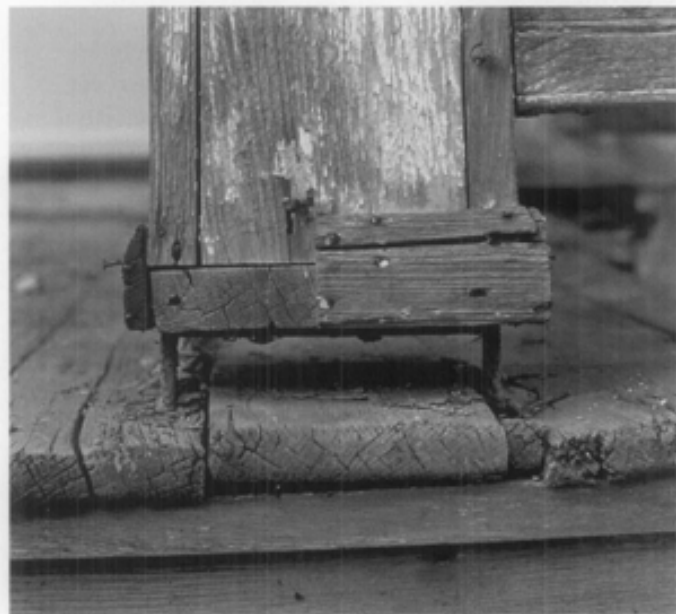
Figure 6. A traditional way to extend the life of porch posts was to place posts on metal feet, thereby providing a separation between the wood post and wood deck. This helped to prevent the wood post from rotting at the base. Early post feet were simple iron bars bent unto a stirrup shape. By the late nineteenth century manufactured cast-iron feet were common, consisting of a pair of disks separated by a short pipe. Post feet are still available today. Courtesy of Old-House Journal/Brian McNeil.

are made of and how they are constructed will aid in understanding how they function and may deteriorate over time (Fig.6). Although the posts on a wood porch are commonly made of wood, they may be of masonry or metal or a combination of materials. Large round columns usually are made of wood staves similar to the way barrels are constructed; smaller diameter columns may be solid. A sag in the deck below or a faltering foundation can impact the supporting role of a column or post above. Wood columns and posts are prone to water seeping into open joints, particularly in the base and the lower end of the shaft. It is not uncommon to find that older columns have had patches and replacement bases.

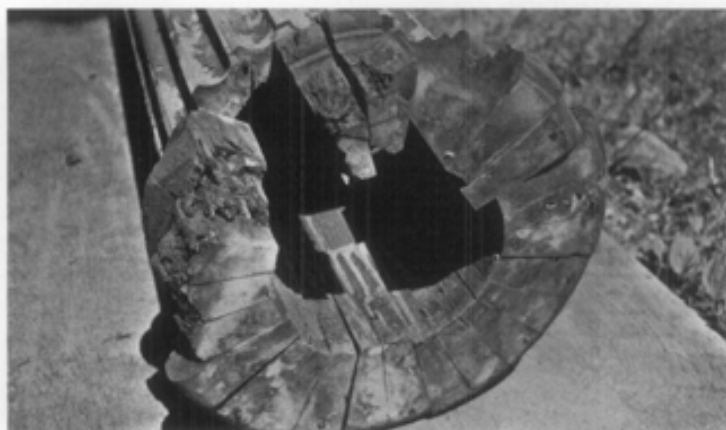
Figure 10. This nineteenth century porch column is made of wood staves, similar to the way a wood barrel is put together. After replacing the torus and making dutchman repairs to the apophyge along the base, the column and pedestal are ready to be reinstalled on the porch. Photos: NPS files.

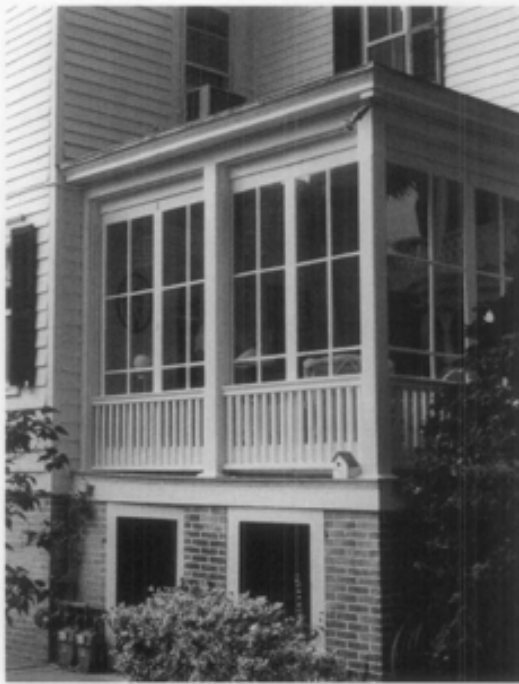
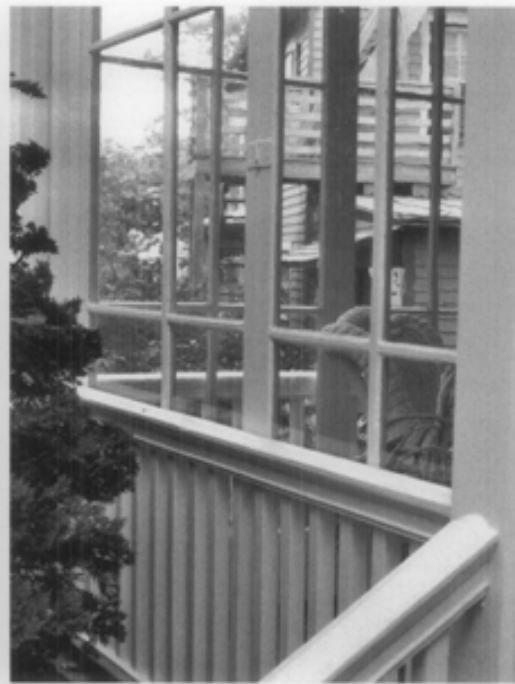
Figure 12. This old porch enclosure, located on the back side of a house, has acquired significance over time and is remarkable both in the appropriateness of its detailing for use by others today, as well as its high degree of maintenance. The enclosure is set behind the columns; the balustrade has been retained; and the light divisions and the size of the glass panes echo that of the windows above. Within each bay there are two well-crafted, inward swinging doors, providing for greater seasonal use of the porch. Photos: Charles Fisher.

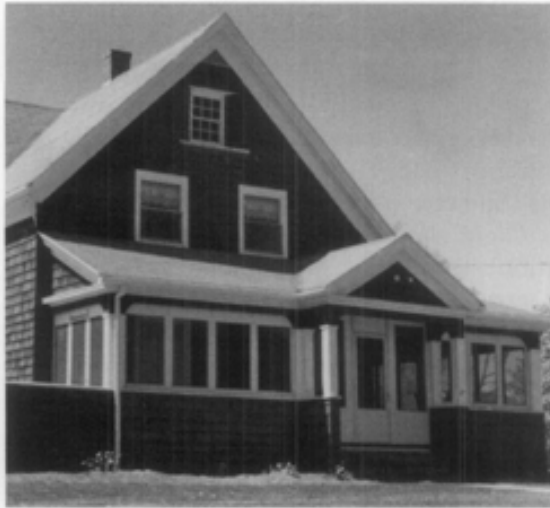
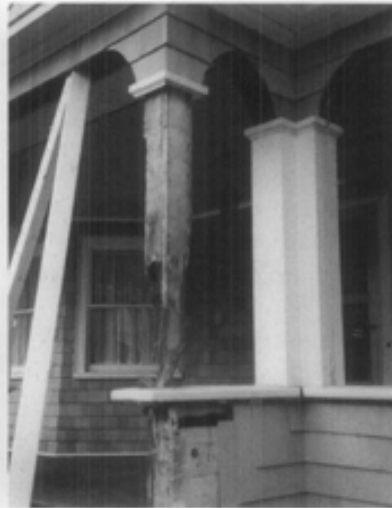
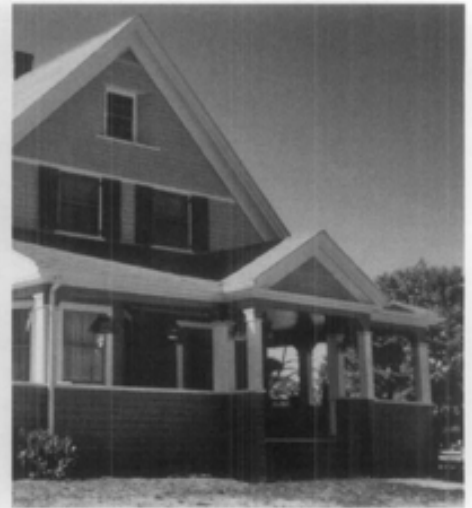
*Figure 14. The enclosure of a prominent porch can dramatically change the historic character of a building. The L-shaped porch on this 1896 Shingle-style New England residence was later enclosed with aluminum windows and screens. Recent owners elected to reopen the historic porch. Among the other work, it was necessary to correct structural damage, as with this post, where beneath the wood casing carpenter ants had done serious damage. In reopening the porch, the historic character of the residence has been brought back and the traditional use of the porch is once again enjoyed. Photos: Mark Landry, Landmark Services.*

**Is the enclosure necessary?** An enclosure will undoubtedly change the porch as a historic feature and may result in damage or loss of historic materials. Depending on the significance of the porch and the nature of the building, a new porch enclosure may also change the historic character of the building. Consideration should be given to alternate solutions such as recapturing underutilized space in an attic or basement (Fig 14).

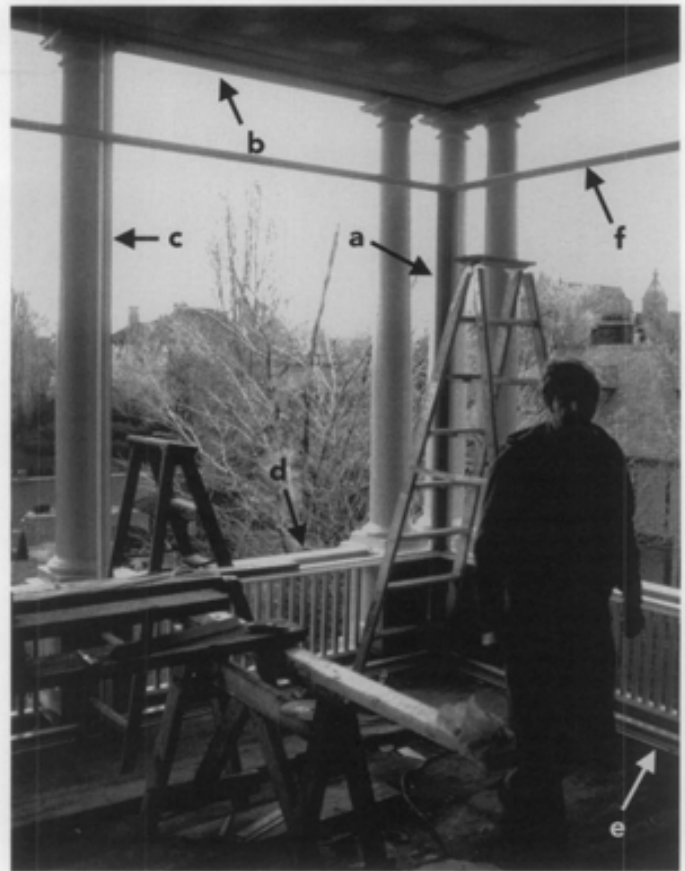
Figure 16. The use of near full glazing to enclose a porch may be appropriate depending upon the historic character of the building, location of the porch, how the interior space is to be treated, and other factors. This enclosure of a rear porch to create a conference room successfully utilizes large expanses of glass and narrow metal framing set behind existing porch elements (a through e). Where an additional horizontal support was needed (f), the frame was placed at a location that is found in many traditional insect screen enclosures. Photo: Charles Fisher.

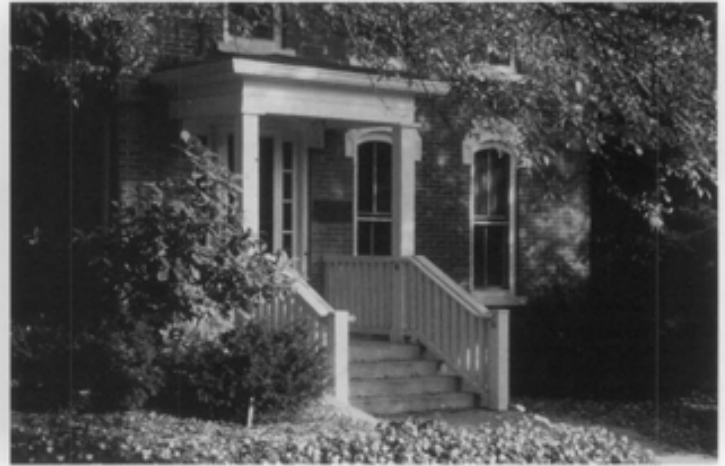
Figure 18. When a porch is used as a wheelchair accessible entrance, it may be possible to retain the historic stairs by adding a ramp parallel to the building. Through plantings and some re-grading, the new ramp built parallel to the building (left) allows retention of the historic stairs and does not impact the historic character of the entrance (right). Photo: Iowa State University Extension.

entrance alternative. It may be possible to retain the historic stairs by adding another entrance to the porch with the construction of a ramp parallel to the building (Fig. 18).
