**To:** Nick Sugar, City Planner and Amanda Krickovich, Community Development, City of Hudson  
**From:** Olivia Zepp, AIA | Historic Architecture, Perspectus  
**Date:** October 19, 2023  
**Re:** 201 N. Main Street  
**CC:** Lauren Pinney Burge, AIA, Principal & Alice Sloan, Assoc. AIA, APT-RP | Historic Architecture, Perspectus

**SUBJECT PROPERTY: 201 N. Main Street**

At the request of the City of Hudson, Ohio and per their Codified Ordinances Section 1202.04(b)(3), Perspectus is providing this advisory report to assist the Architectural and Historic Board of Review (AHBR) in their review of the Owner Application requesting alterations to the designated historic property. The following were applied as it pertains to this application under the Codified Ordinances Appendix D. - Architectural Design Standards Section III-2.b.(1):

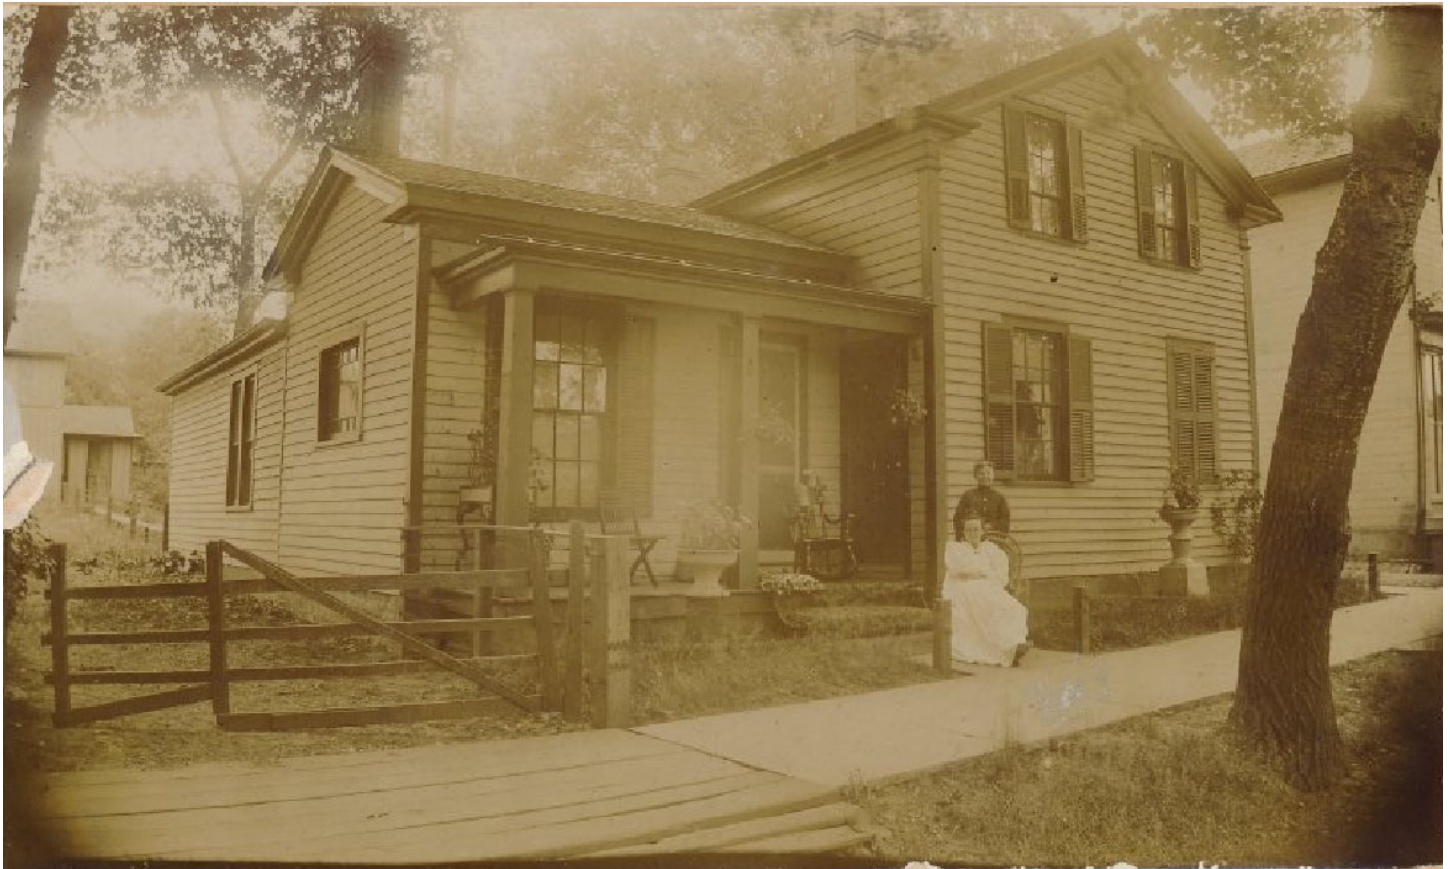
**Image 1:** Date c.1900. Courtesy of the Hudson Historical Society. Front (west) and side (north) elevation. Note the Gable-Front-and-Wing configuration of the house, the 6 over 6 double hung windows on the first floor, the exposure width of the siding, the two chimneys appear to be brick, and the foundation appears to be stone. The door appears to be under the porch on the north return wall.

- b. **Change #3:** The lap exposure of the siding is not indicated on the drawings, it should match the lap exposure as it appears in the c1900 image (see image 1).

- e. **Change #6:** The location of the faux chimney should be based on the c.1900 image (see Image 1). Note the chimney in the c.1900 image appears to be brick and the foundation appears to be stone. Codified Ordinances Appendix D – Architectural Standards Section III-1 states chimney material should match foundation material, but consider the note about the c.1900 image and building materials.

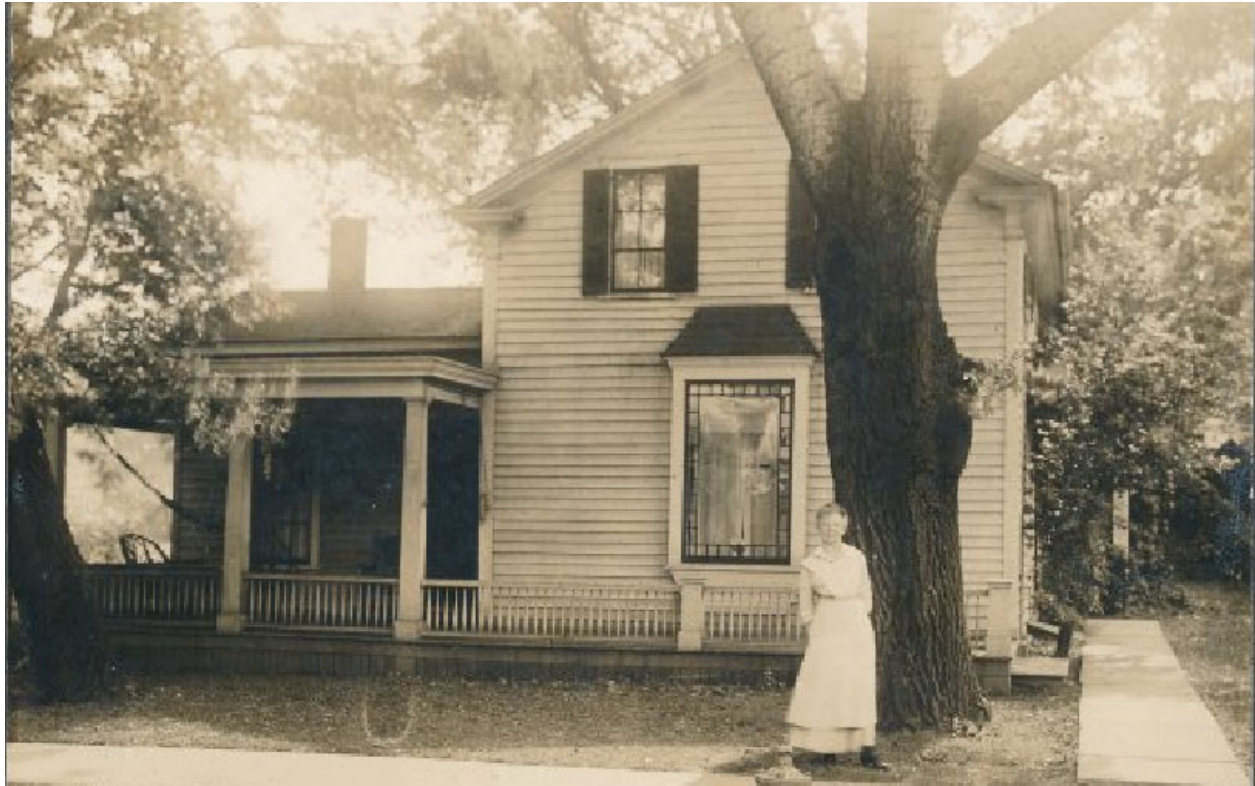
**Image 2:** Appears to date to c.1916. Courtesy of the Hudson Historical Society. Front (west) elevation. Note the front porch changes and the bay window.

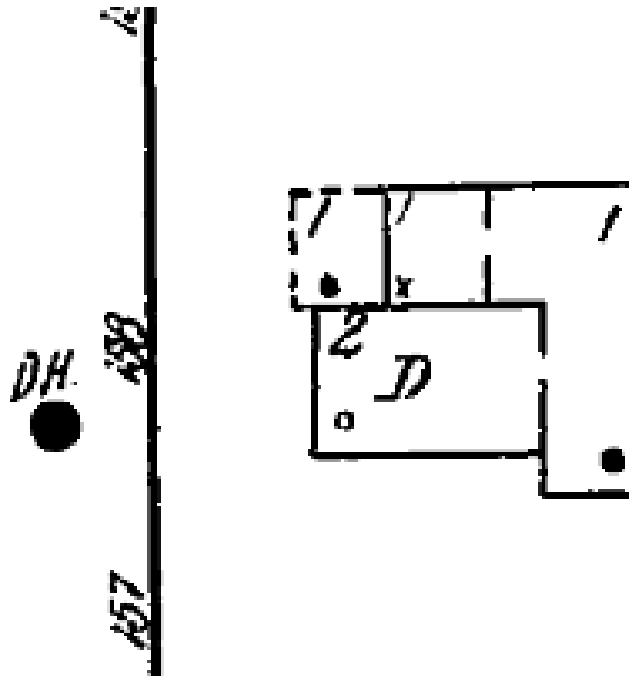
**Image 3:** 1916 Sanborn Map, Ohio Web Library. Note the configuration of the structure with a portion of the current rear (east) addition is existing by 1916. (North is up)

7. Demolition of the one-story rear additions, a portion of which appears in the 1916 Sanborn map (see Image 3). The additions appear to have been altered since their original construction.

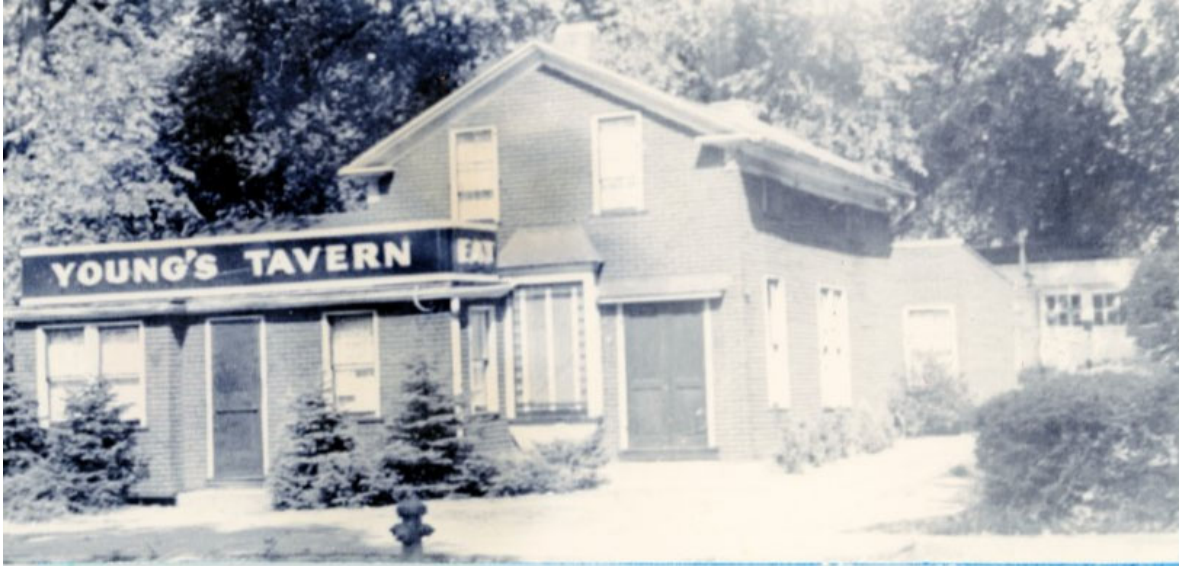
**Image 4:** Date c.1950. Courtesy of the Hudson Historical Society. Front (west) elevation. Note the elevation reconfiguration, the second story replaced windows, the front door on the two-story portion, and the one-story rear addition.

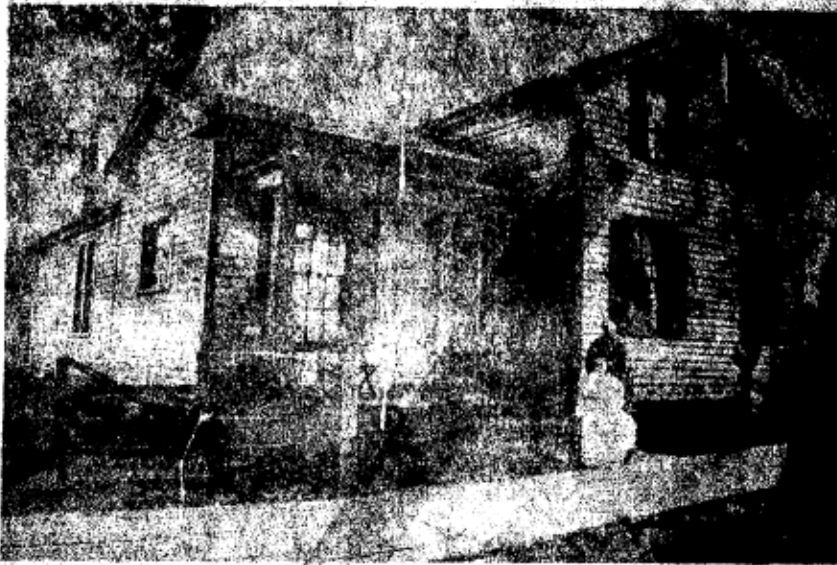
This is a picture of the Hudson Village Realty and Hudson Homes Inc. building as it was originally built. It has been restored as nearly as possible. See picture of the restored building on page two. It was once occupied by the grandparents of Mrs. Louella Dodds.

Image 5: 1954. Courtesy of the Hudson Historical Society. Article stating the restoration of the exterior of the building. The article references the c.1900 photo as being what was originally built and the structure was, "restored as nearly as possible."

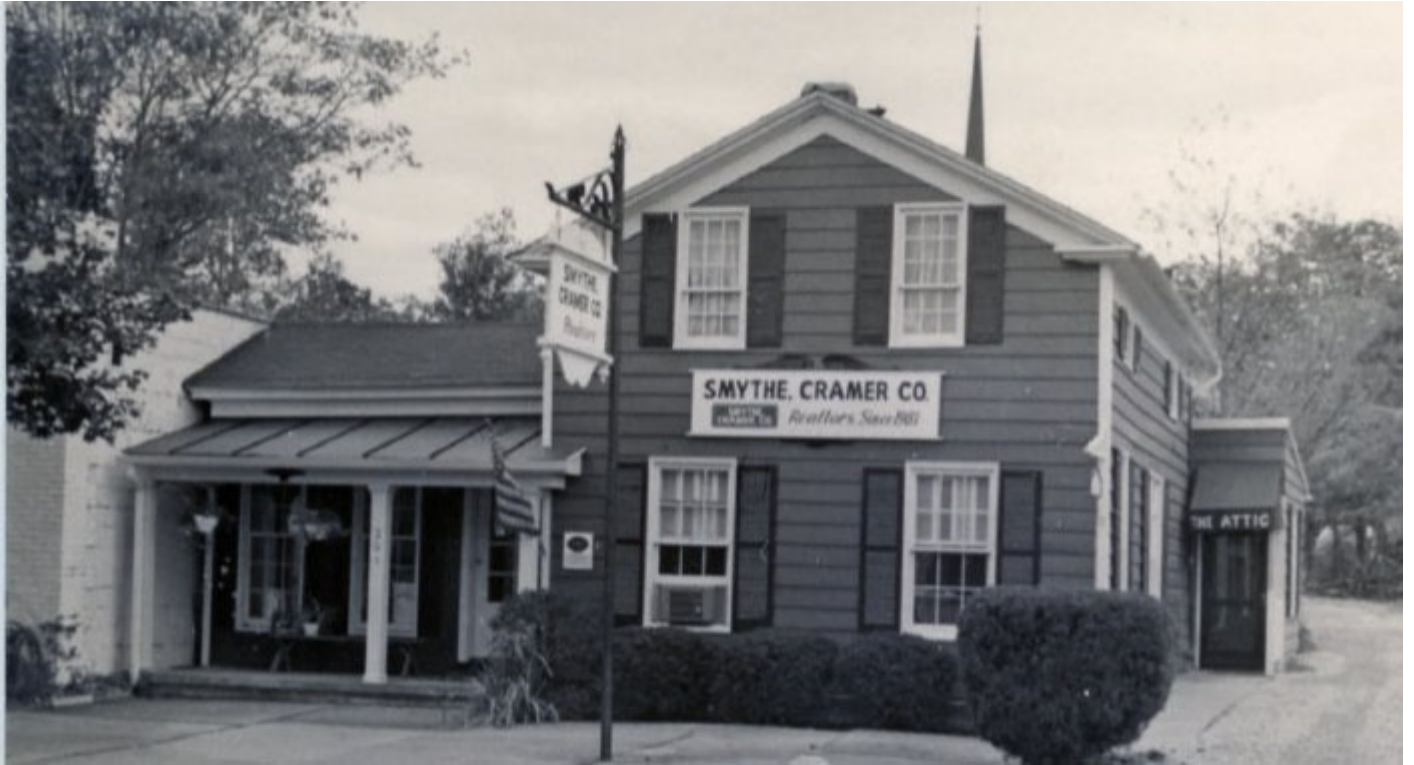
**Image 6:** Date c.1970. Courtesy of the Hudson Historical Society. This is the presumed configuration from the 1954 restoration. Front (west) elevation. Note the front porch reconfiguration, the window replacements on the two-story portion, the replaced windows at the porch, and the one-story rear addition.

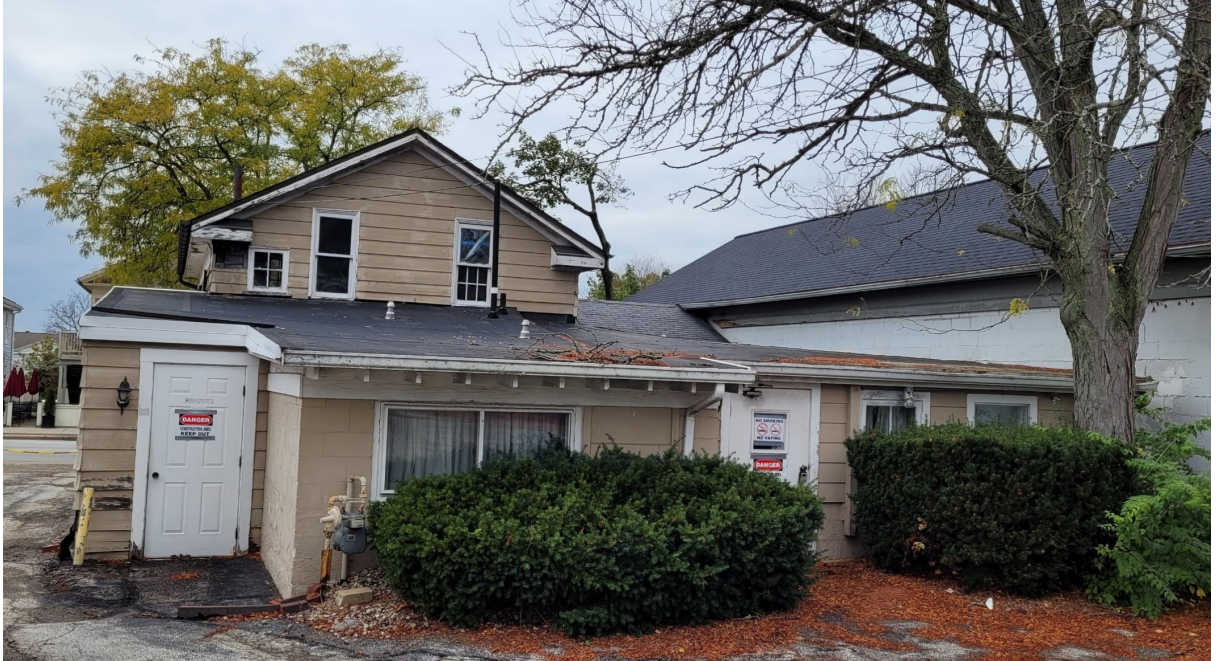
**Image 8:** Rear (east) elevation. One-story rear addition to be removed, including presumed addition that existed by 1916 according to the Sanborn map in Image 3.

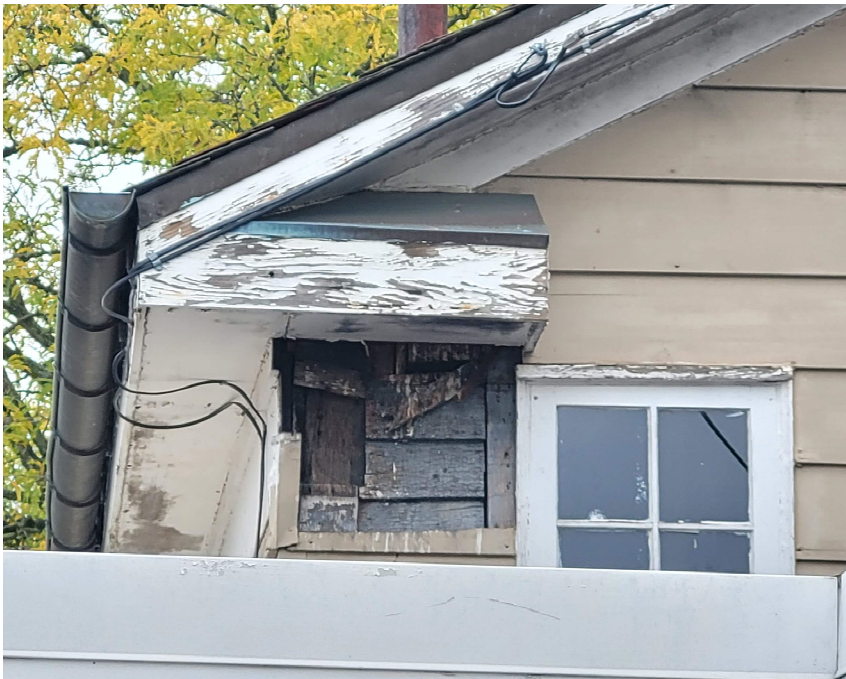
**Image 9:** Rear (east) elevation. Detail showing siding under existing siding. Outer layer of front elevation siding should be removed to see if another layer of wood siding exists. If so, this should be evaluated per historic photos to determine if this is the historic lap exposure width.

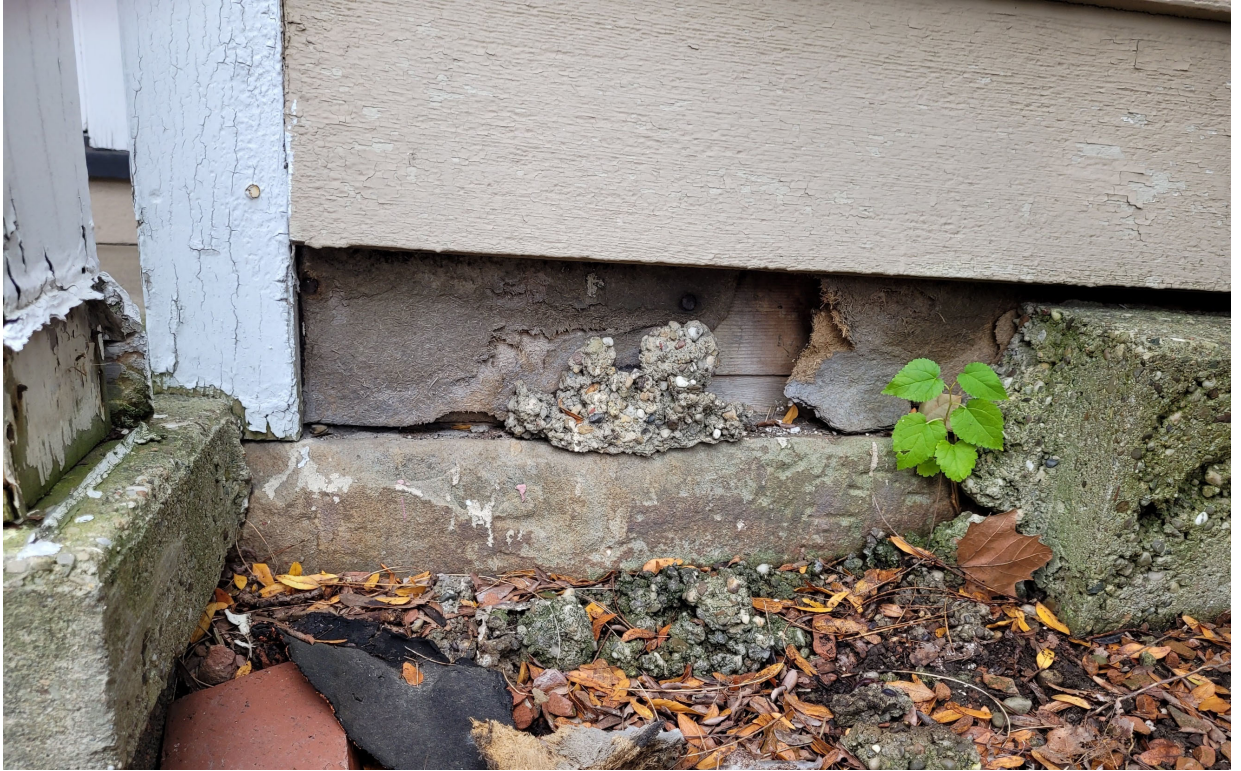
**Image 10:** Front (west) elevation. Detail at two-story portion showing sandstone foundation behind concrete. Also note wood siding behind the existing siding and mineral wool.

2. **Proposed changes #'s 2-6: can become appropriate** with the following alterations to the design:
  - a. **Change #2:** The submitted drawings do not indicate an exterior finish for the new foundation walls, but brick veneer was discussed on-site. A sandstone veneer that matches the substantial scale as it appears in the c1900 image (see Image 1) would be appropriate. SIS #3 states that “Each property will be recognized as a physical record of its time, place, and use. Changes that create a false sense of historical development, such as adding conjectural features or elements from other historic properties, will not be undertaken.”

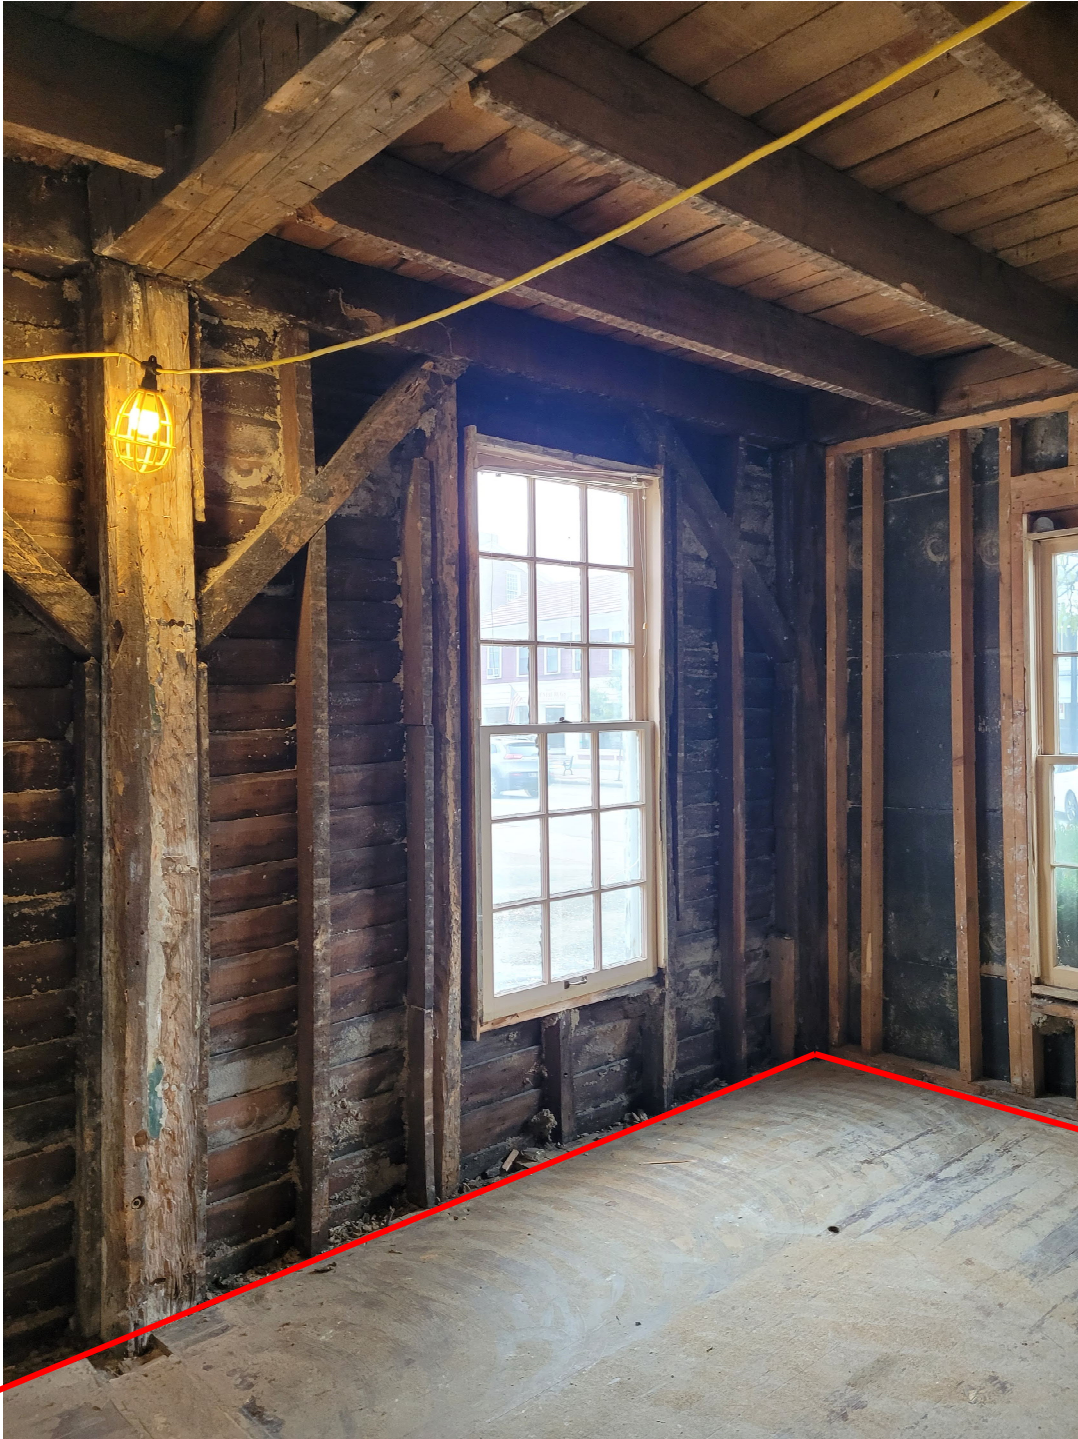
**Image 11:** Interior, southwest corner of the two-story structure. Red line indicates where structure will be cut to be lifted.

1. Demolishing the one-story portion and porch (north of the two-story portion) and rebuilding with new materials.
2. Cutting the framing of the historic two-story structure between the first-floor finished floor and sill plate (see Image 11), lifting the entire two-story structure, and moving the building. Replacing the foundation walls with CMU block and an exterior brick veneer. The new foundation walls will match the footprint of the existing structure. Rebuilding the first-floor structural members and placing the two-story structure on the new foundation.

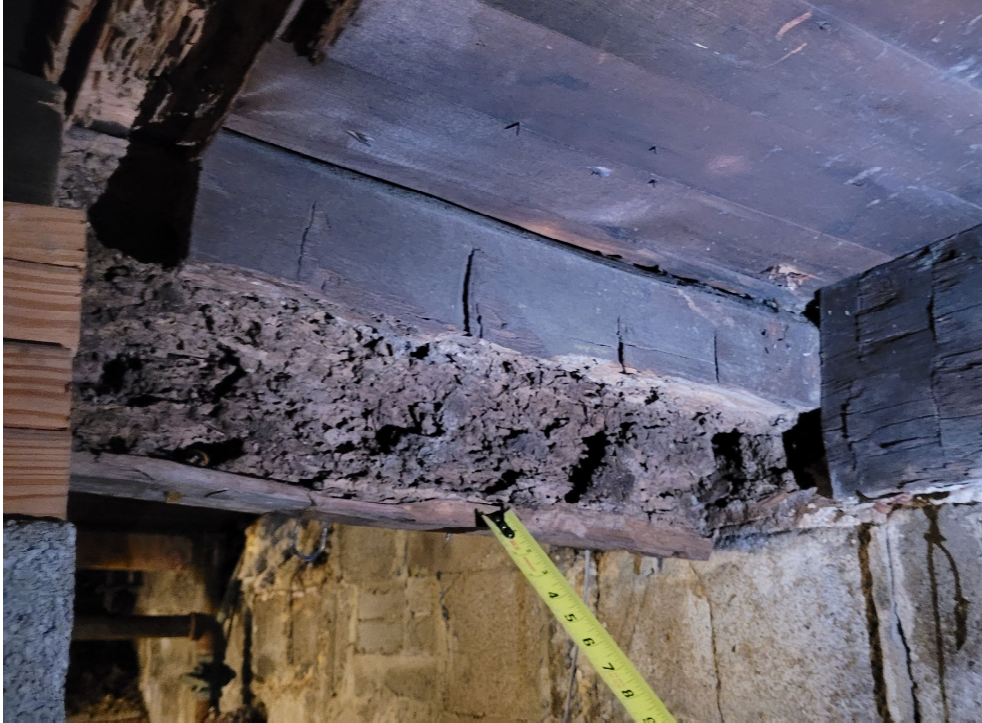
**Image 12:** Image taken in basement showing termite damage to the north-south structural member in the two-story portion.

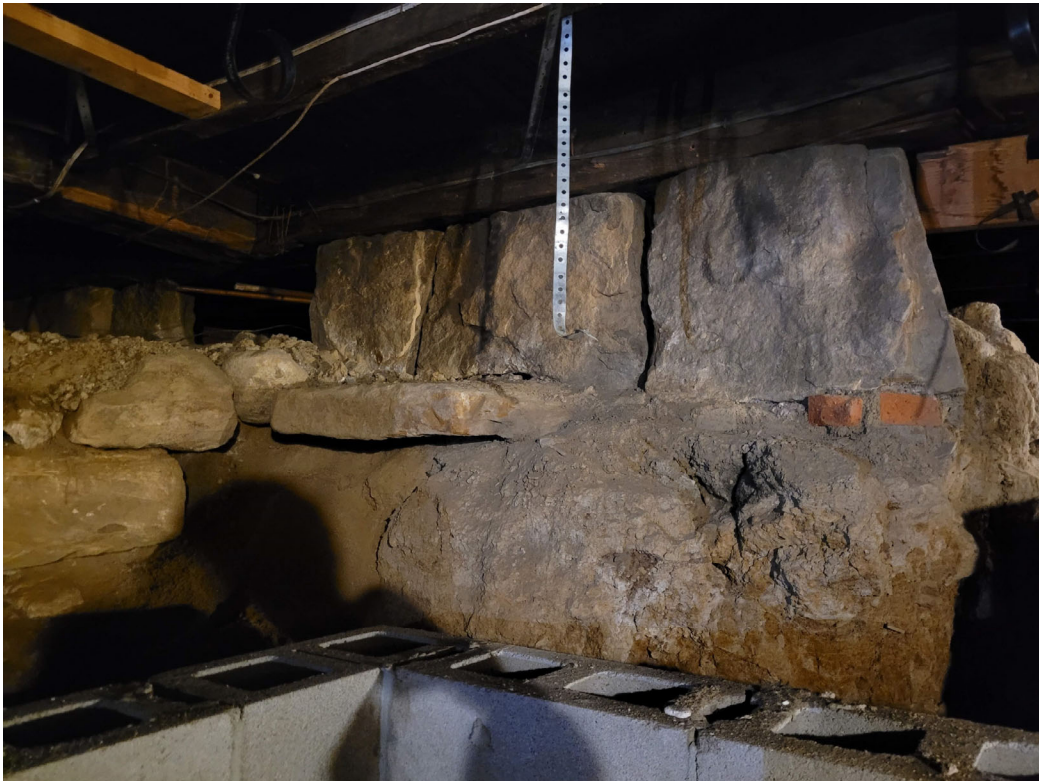
**Image 13:** Image taken in basement showing sandstone foundation at the north wall of the two-story portion.
