| | | | | | | | | | | | | | | | |
|--|---|---|---|---|---|---|---|---|---|--|---|--|--|--|--|
| No. _____ County <u>Summit</u> Location of Negatives <u>HHA 51-35,36</u> | 4. Present Name(s) <p style="text-align: center;">The Peck-Trowbridge House</p> 5. Other Name(s) | | | | | | | | | | | | | | |
| Specific Location <u>E</u> 96 Streetsboro Street, at Oviatt | 16. Thematic Category <p style="text-align: center;">C</p> | | | | | | | | | | | | | | |
| City or Town If Rural, Township & Vicinity Hudson | 17. Date(s) or Period <p style="text-align: center;">1844/1887</p> | | | | | | | | | | | | | | |
| Site Plan with North Arrow

MORTGAGE LOCATION SURVEY

Archer Residence
96 East Streetsboro Rd
Hudson, Ohio

Archer Pergola hardware detail

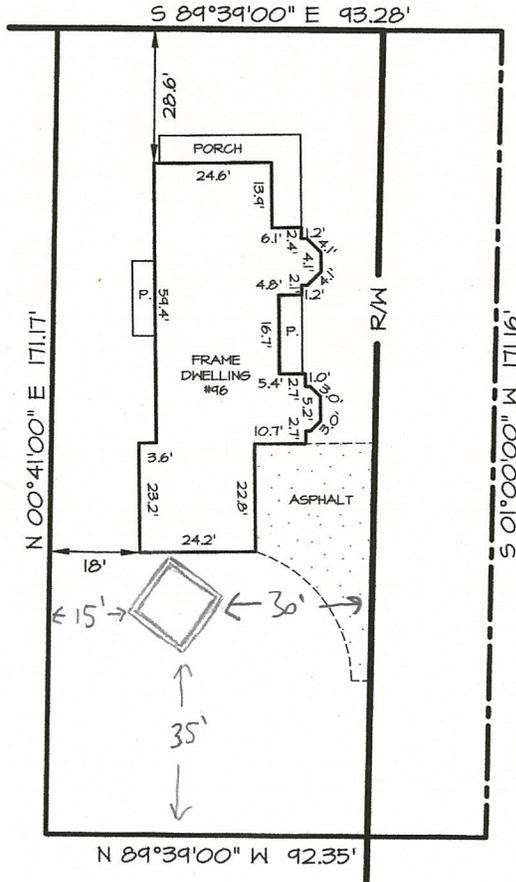
that a visual inspection of the property and buildings shown (if any) has been made and there are no apparent encroachments or visible easements unless otherwise shown. This service was not performed for the purpose of establishing boundary lines, and is not to be used for that purpose.

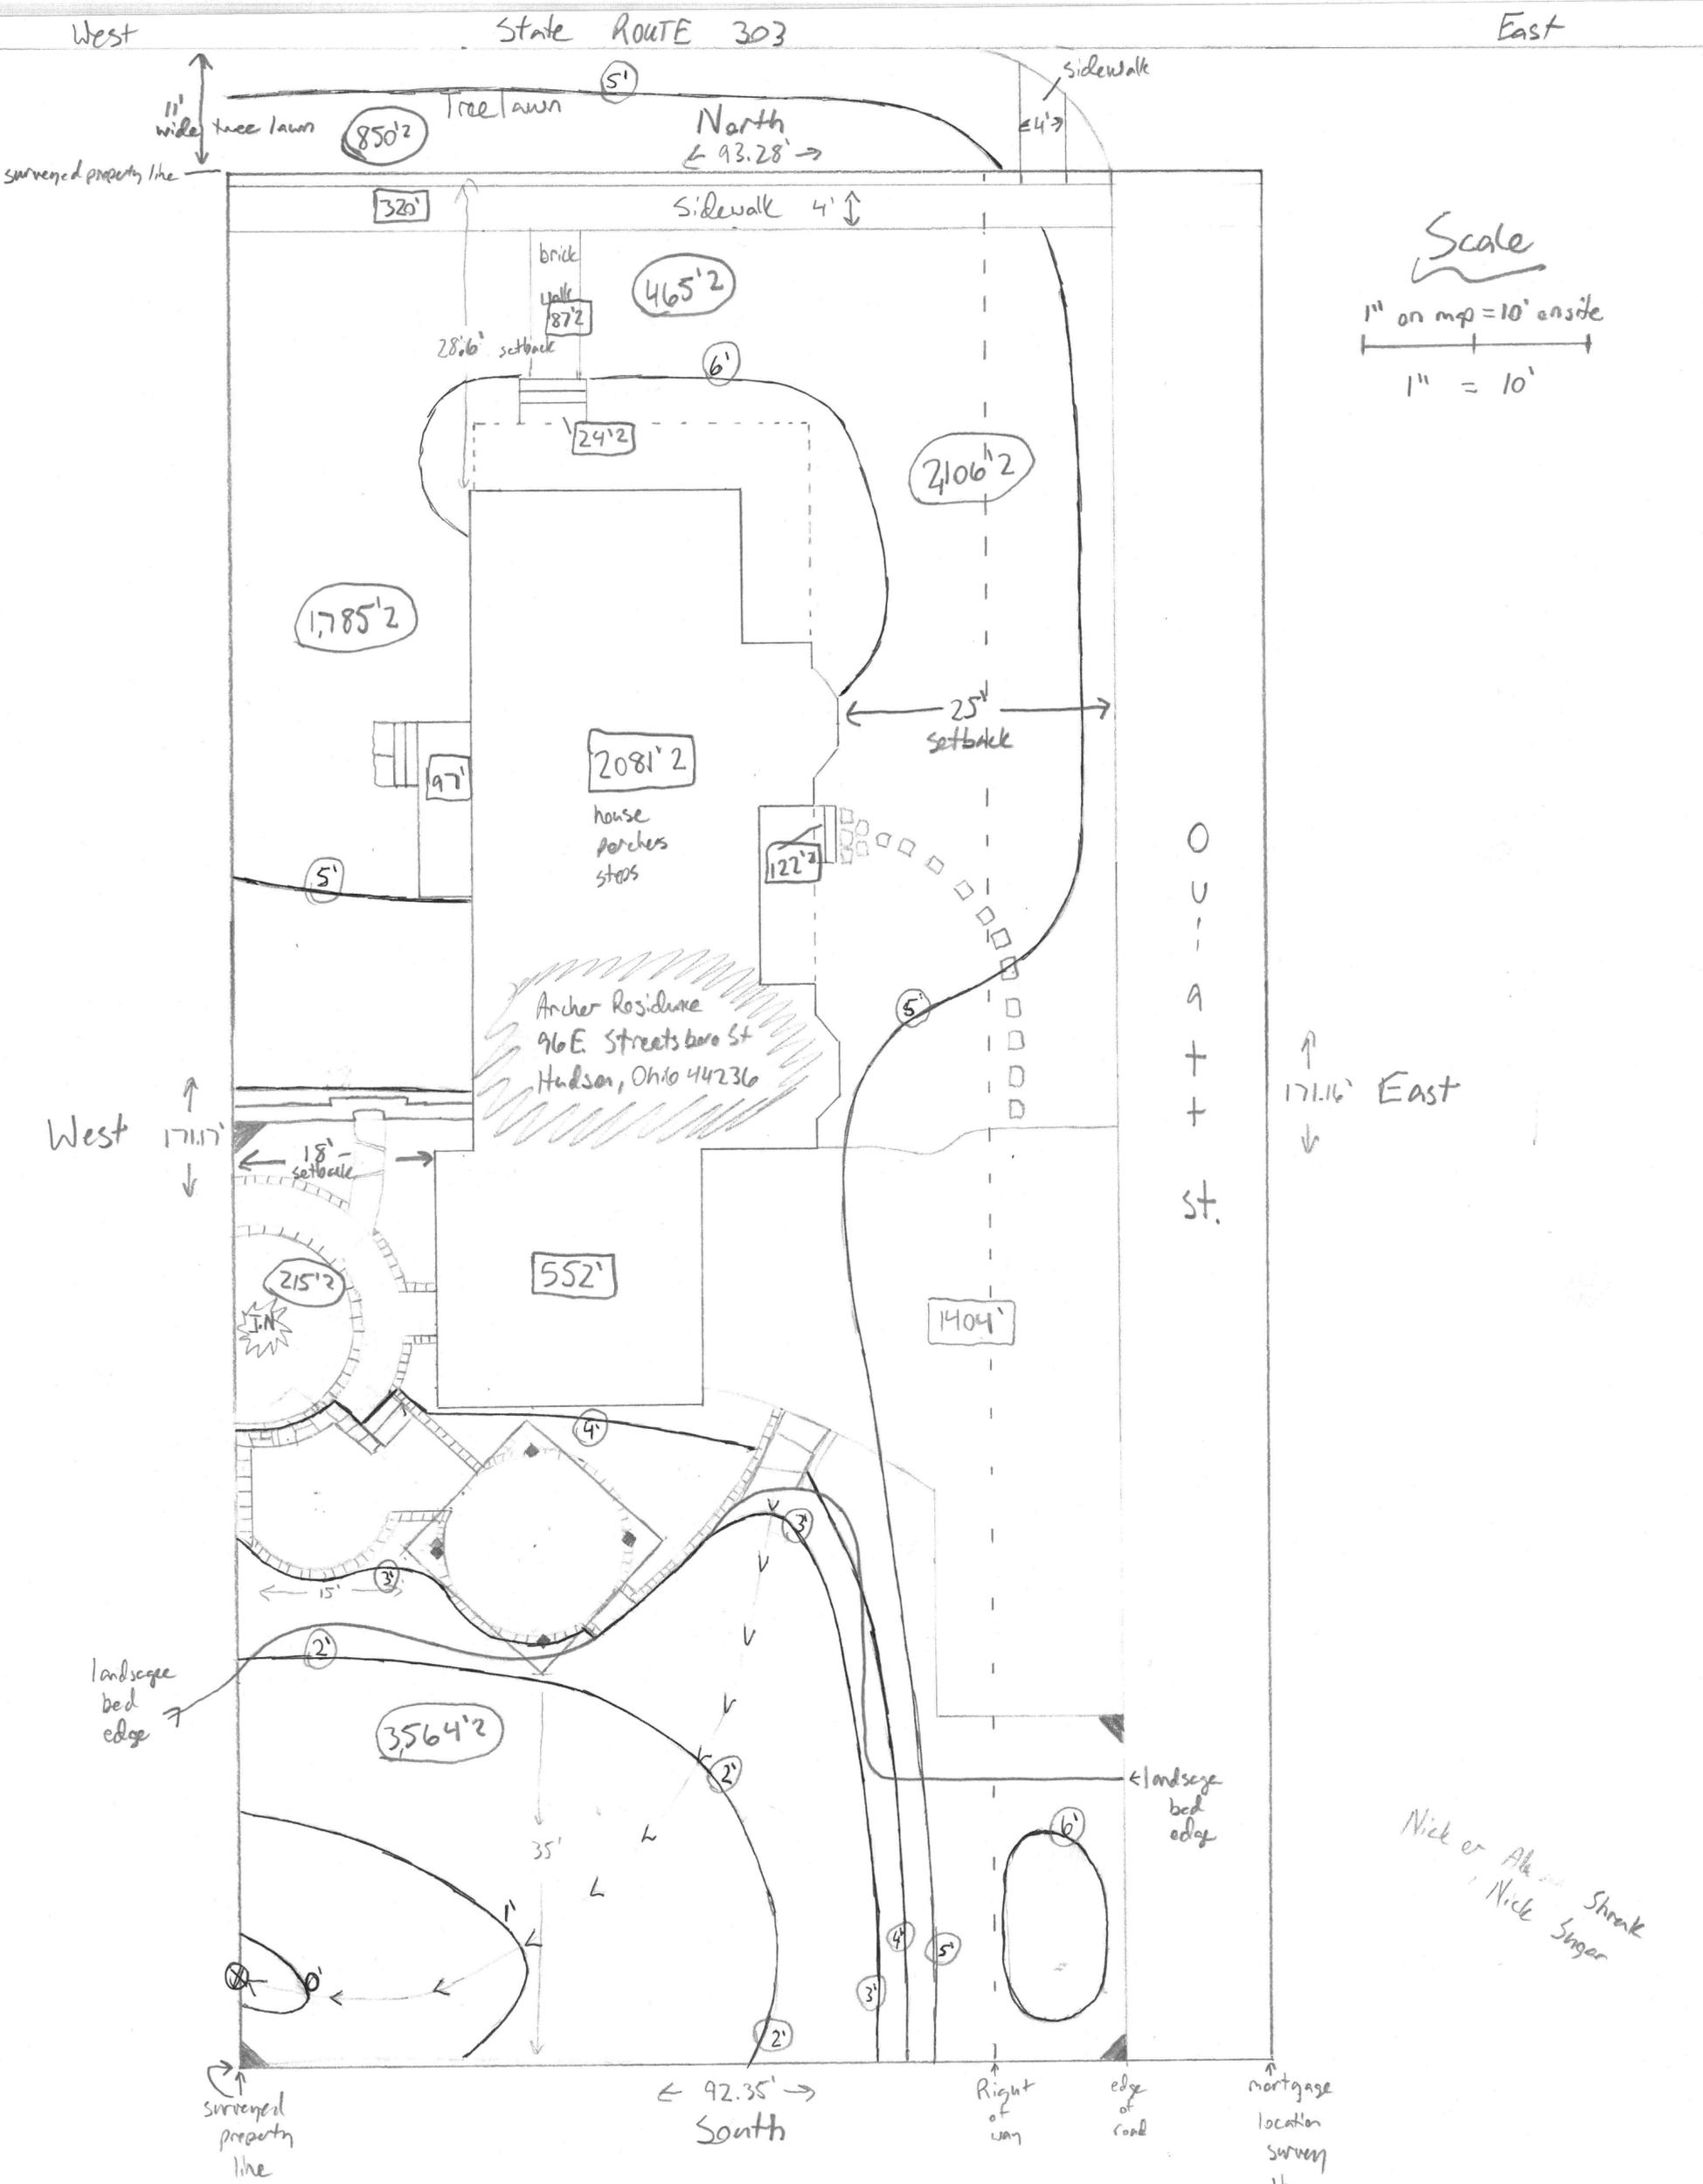
Contour lines 0' at (X), 1', 2', 3', 4', 5', 6'
 ← ← ← ← ← natural H₂O flow off driveway.

Pre-construction
 Impervious SA
 = 516'²

760'² all patio, retaining, steeper + pergola post SA.
 450'² existing stone work in proposed renovation area.

- 650'² all new construction
 - 320'² sidewalks, concrete
 - 24'² + 87'² brick front walkway + steps
 - 122'² + 97'² west porch + steps + E. steps + walkway
 - 552'² Garage
 - 2081'² House attachments
 - 1404'² asphalt driveway
- 5,337'² Total**
 37%

- Tree lawn = 850'²
- NW Lawn = 1785'²
- North front lawn = 465'²
- NE lawn + bed = 2,106'²
- Landscape bed adjacent garage = 215'²
- All landscape beds + lawn within corners = 3564'²

62% 8,985 total Permeable SA

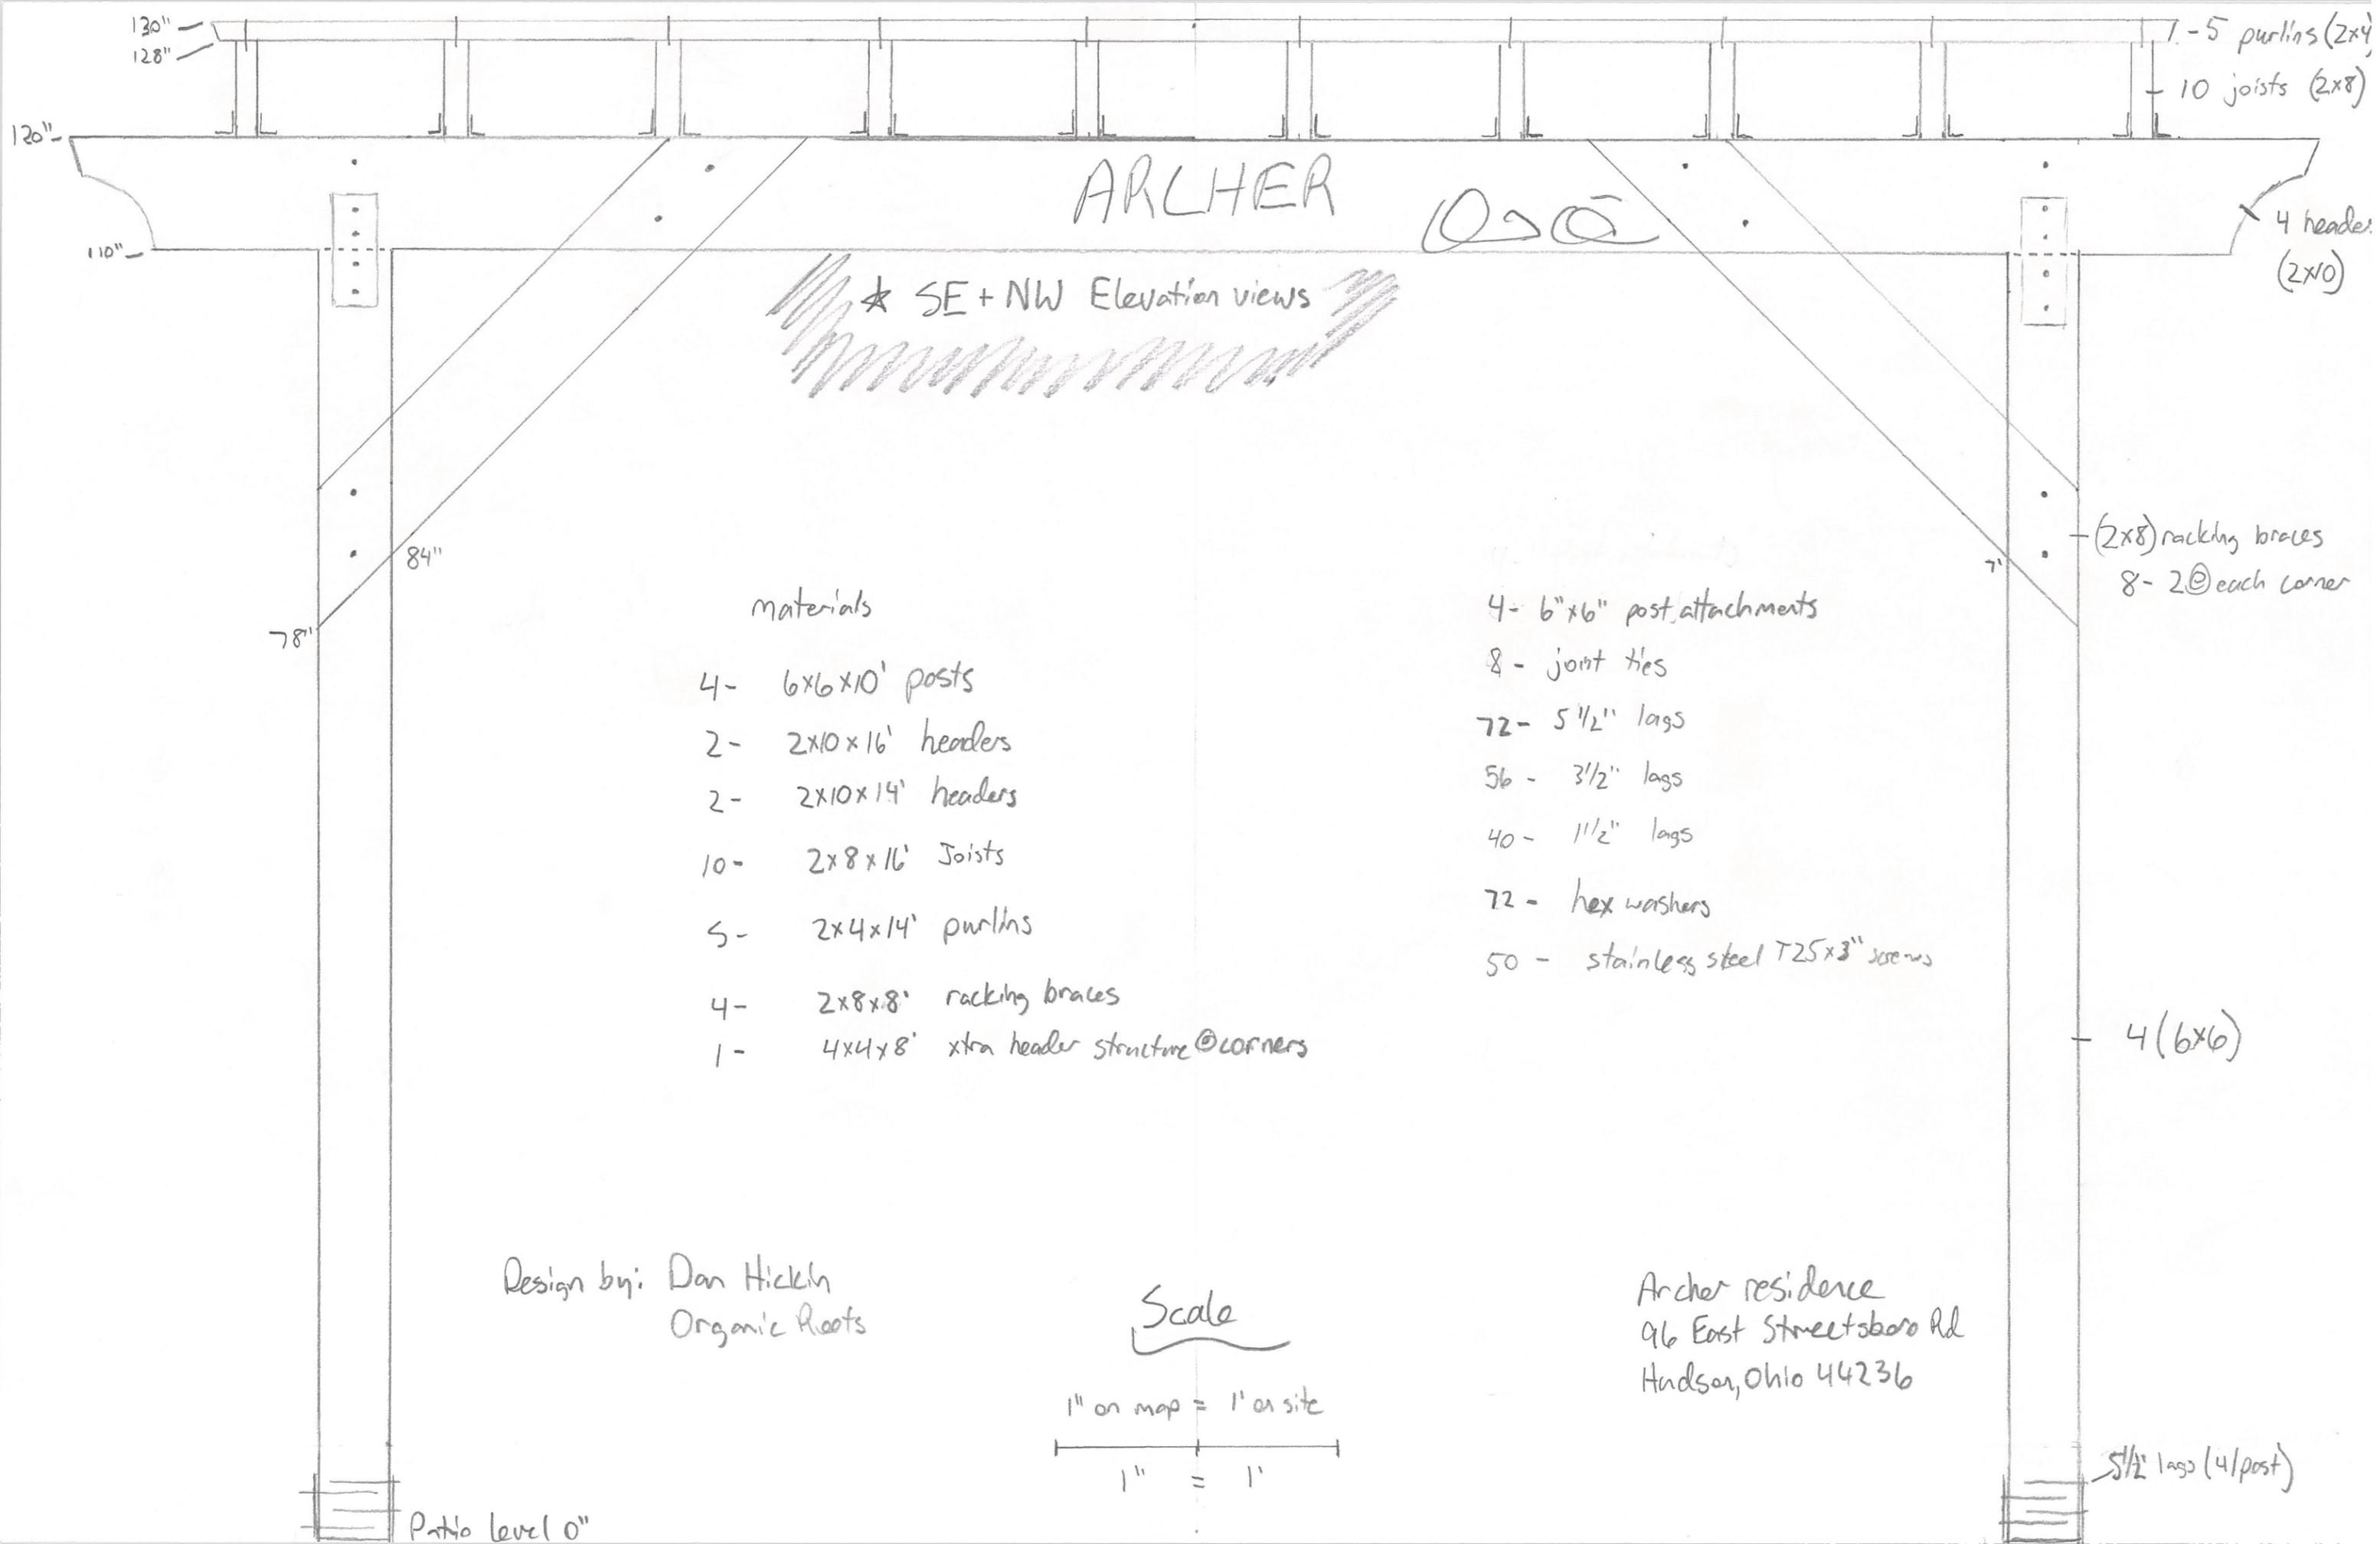
★ SE + NW Elevation views

1 - 5 purlins (2x4)
- 10 joists (2x8)

4 headers (2x10)

(2x8) racking braces
8 - 2 @ each corner

materials

- 4 - 6x6x10' posts
- 2 - 2x10x16' headers
- 2 - 2x10x14' headers
- 10 - 2x8x16' Joists
- 5 - 2x4x14' purlins
- 4 - 2x8x8' racking braces
- 1 - 4x4x8' xtra header structure @ corners

- 4 - post attachments
- 4 - 6"x6" post attachments
- 8 - joint ties
- 72 - 5 1/2" lags
- 56 - 3 1/2" lags
- 40 - 1 1/2" lags
- 72 - hex washers
- 50 - stainless steel T25x3" screws

4 (6x6)

Patio level 0"

5 1/2" lags (4/post)

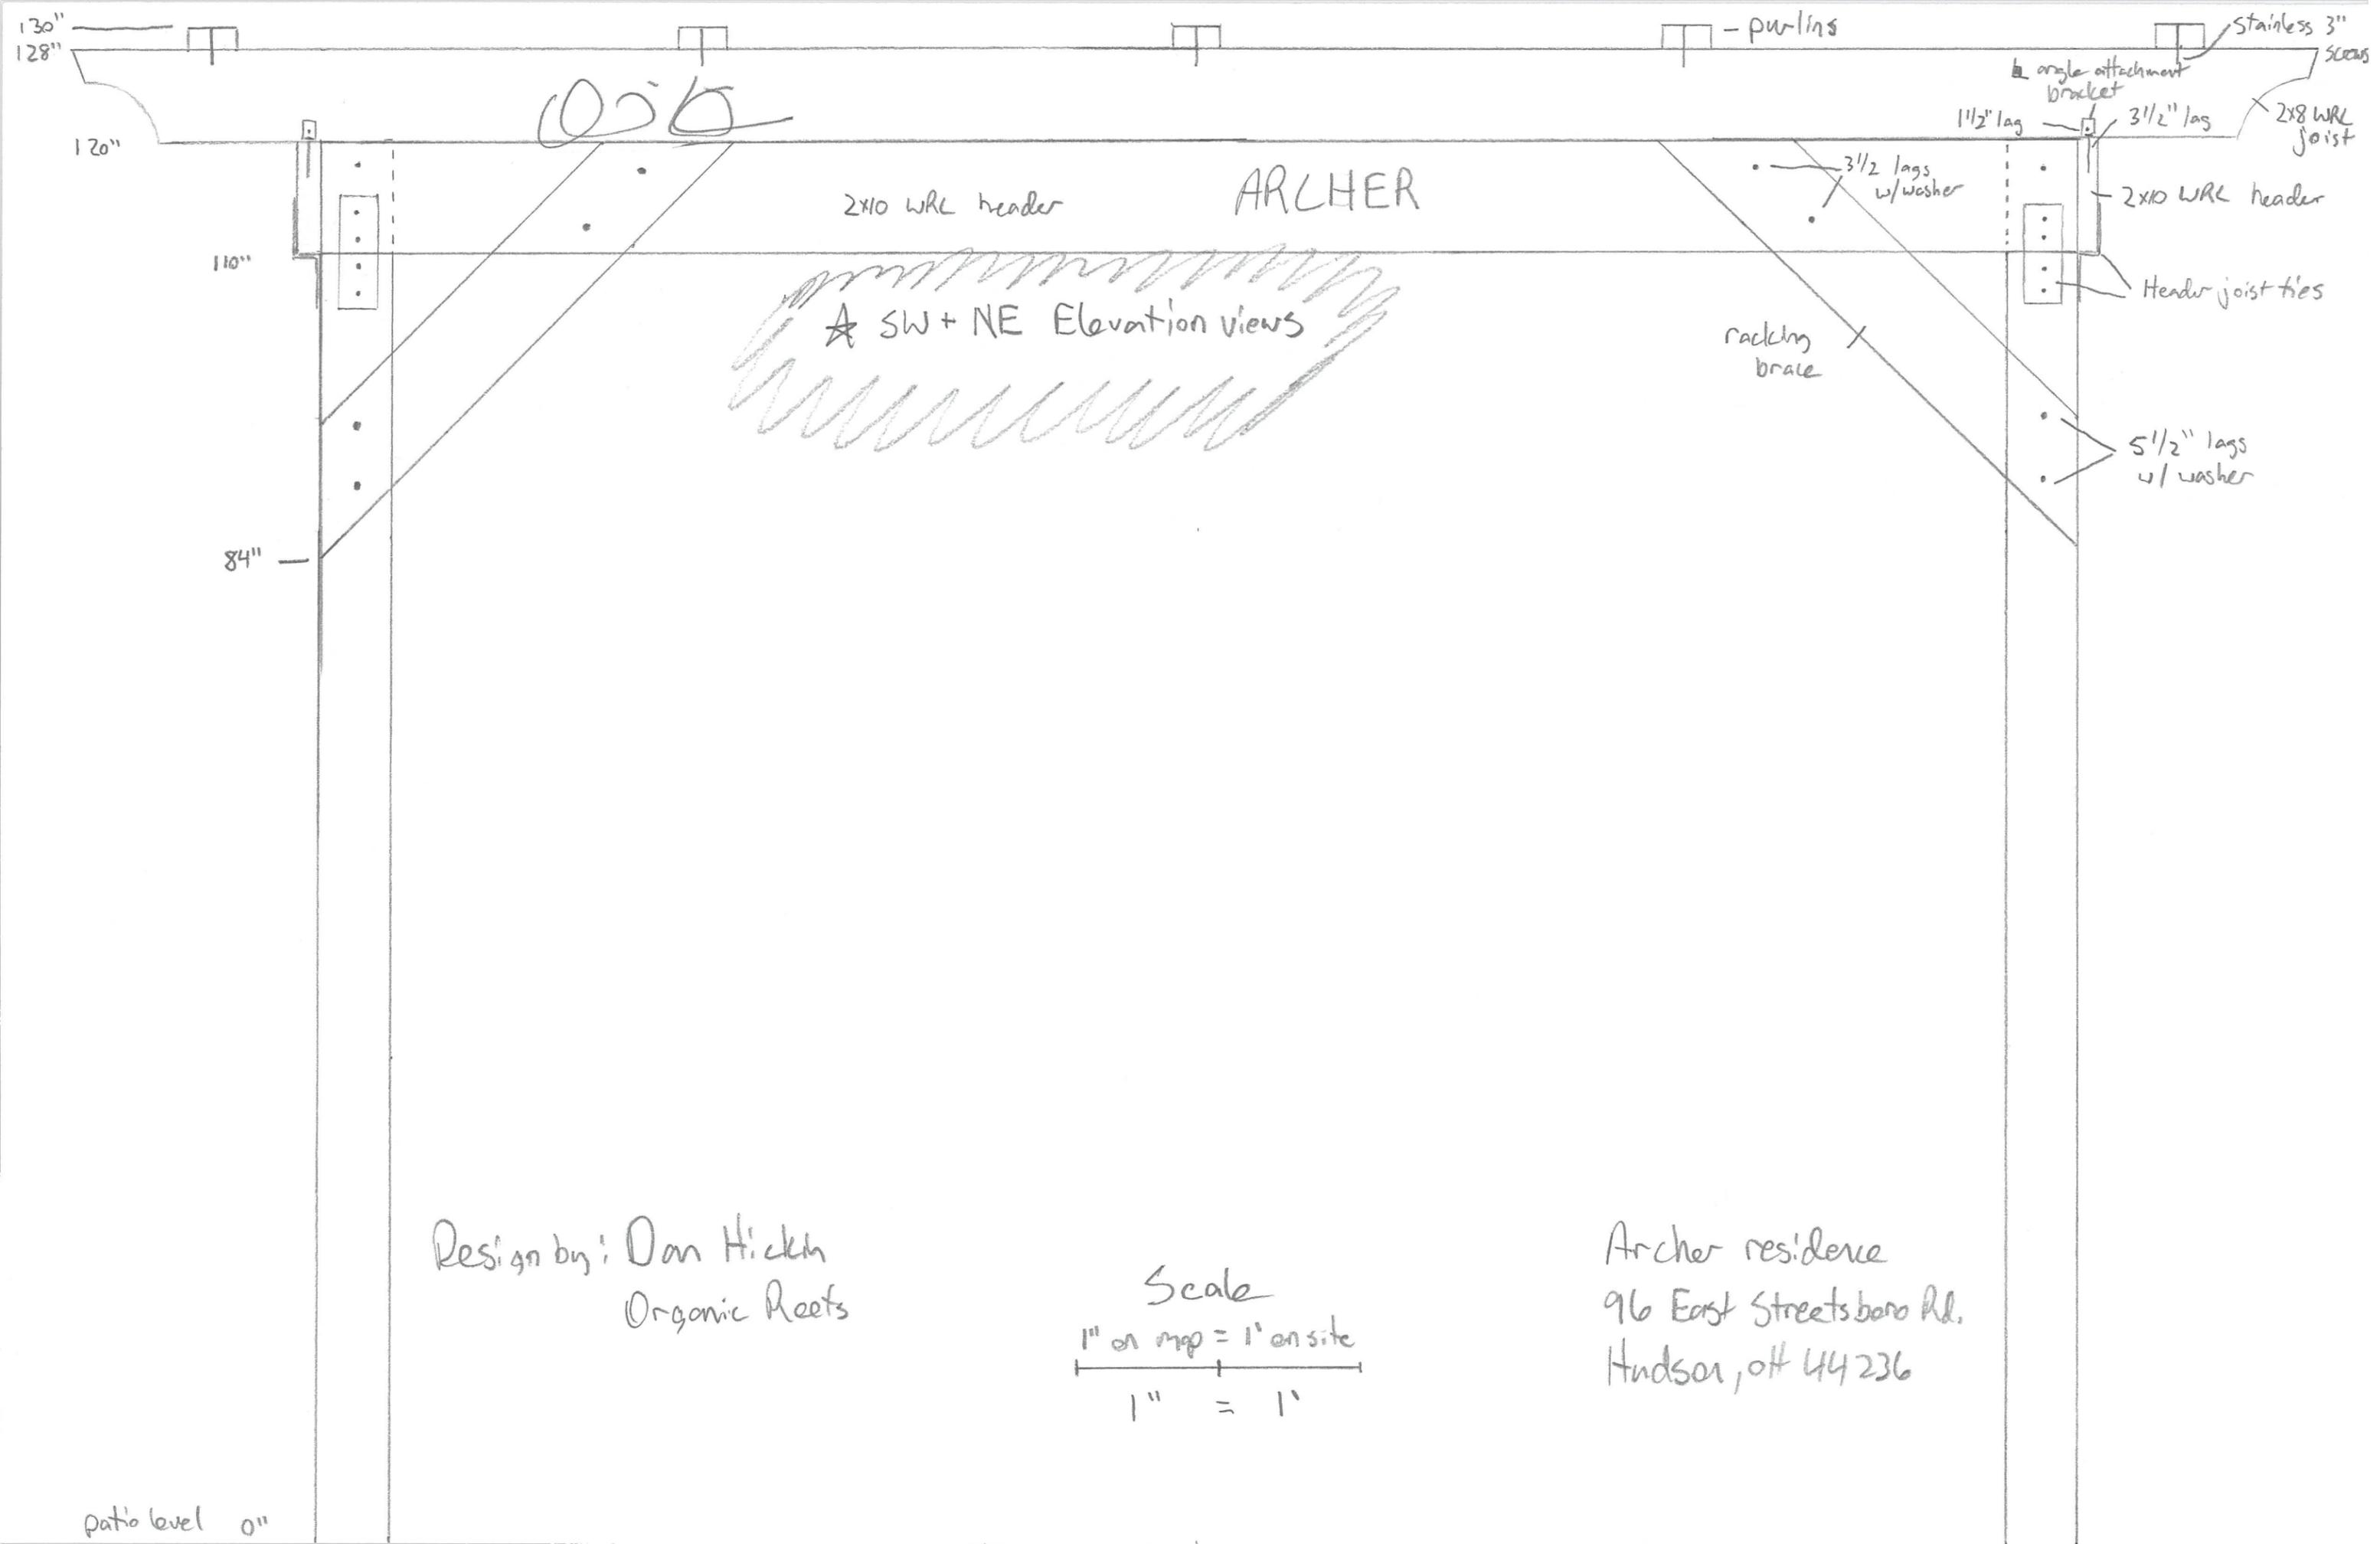
★ SW + NE Elevation views

OSB

2x10 WRL header

racking brace

angle attachment bracket

stainless 3" screws

1 1/2" lag

3 1/2" lag

2x8 WRL joist

3 1/2 lags w/washer

Header joist ties

5 1/2" lags w/washer

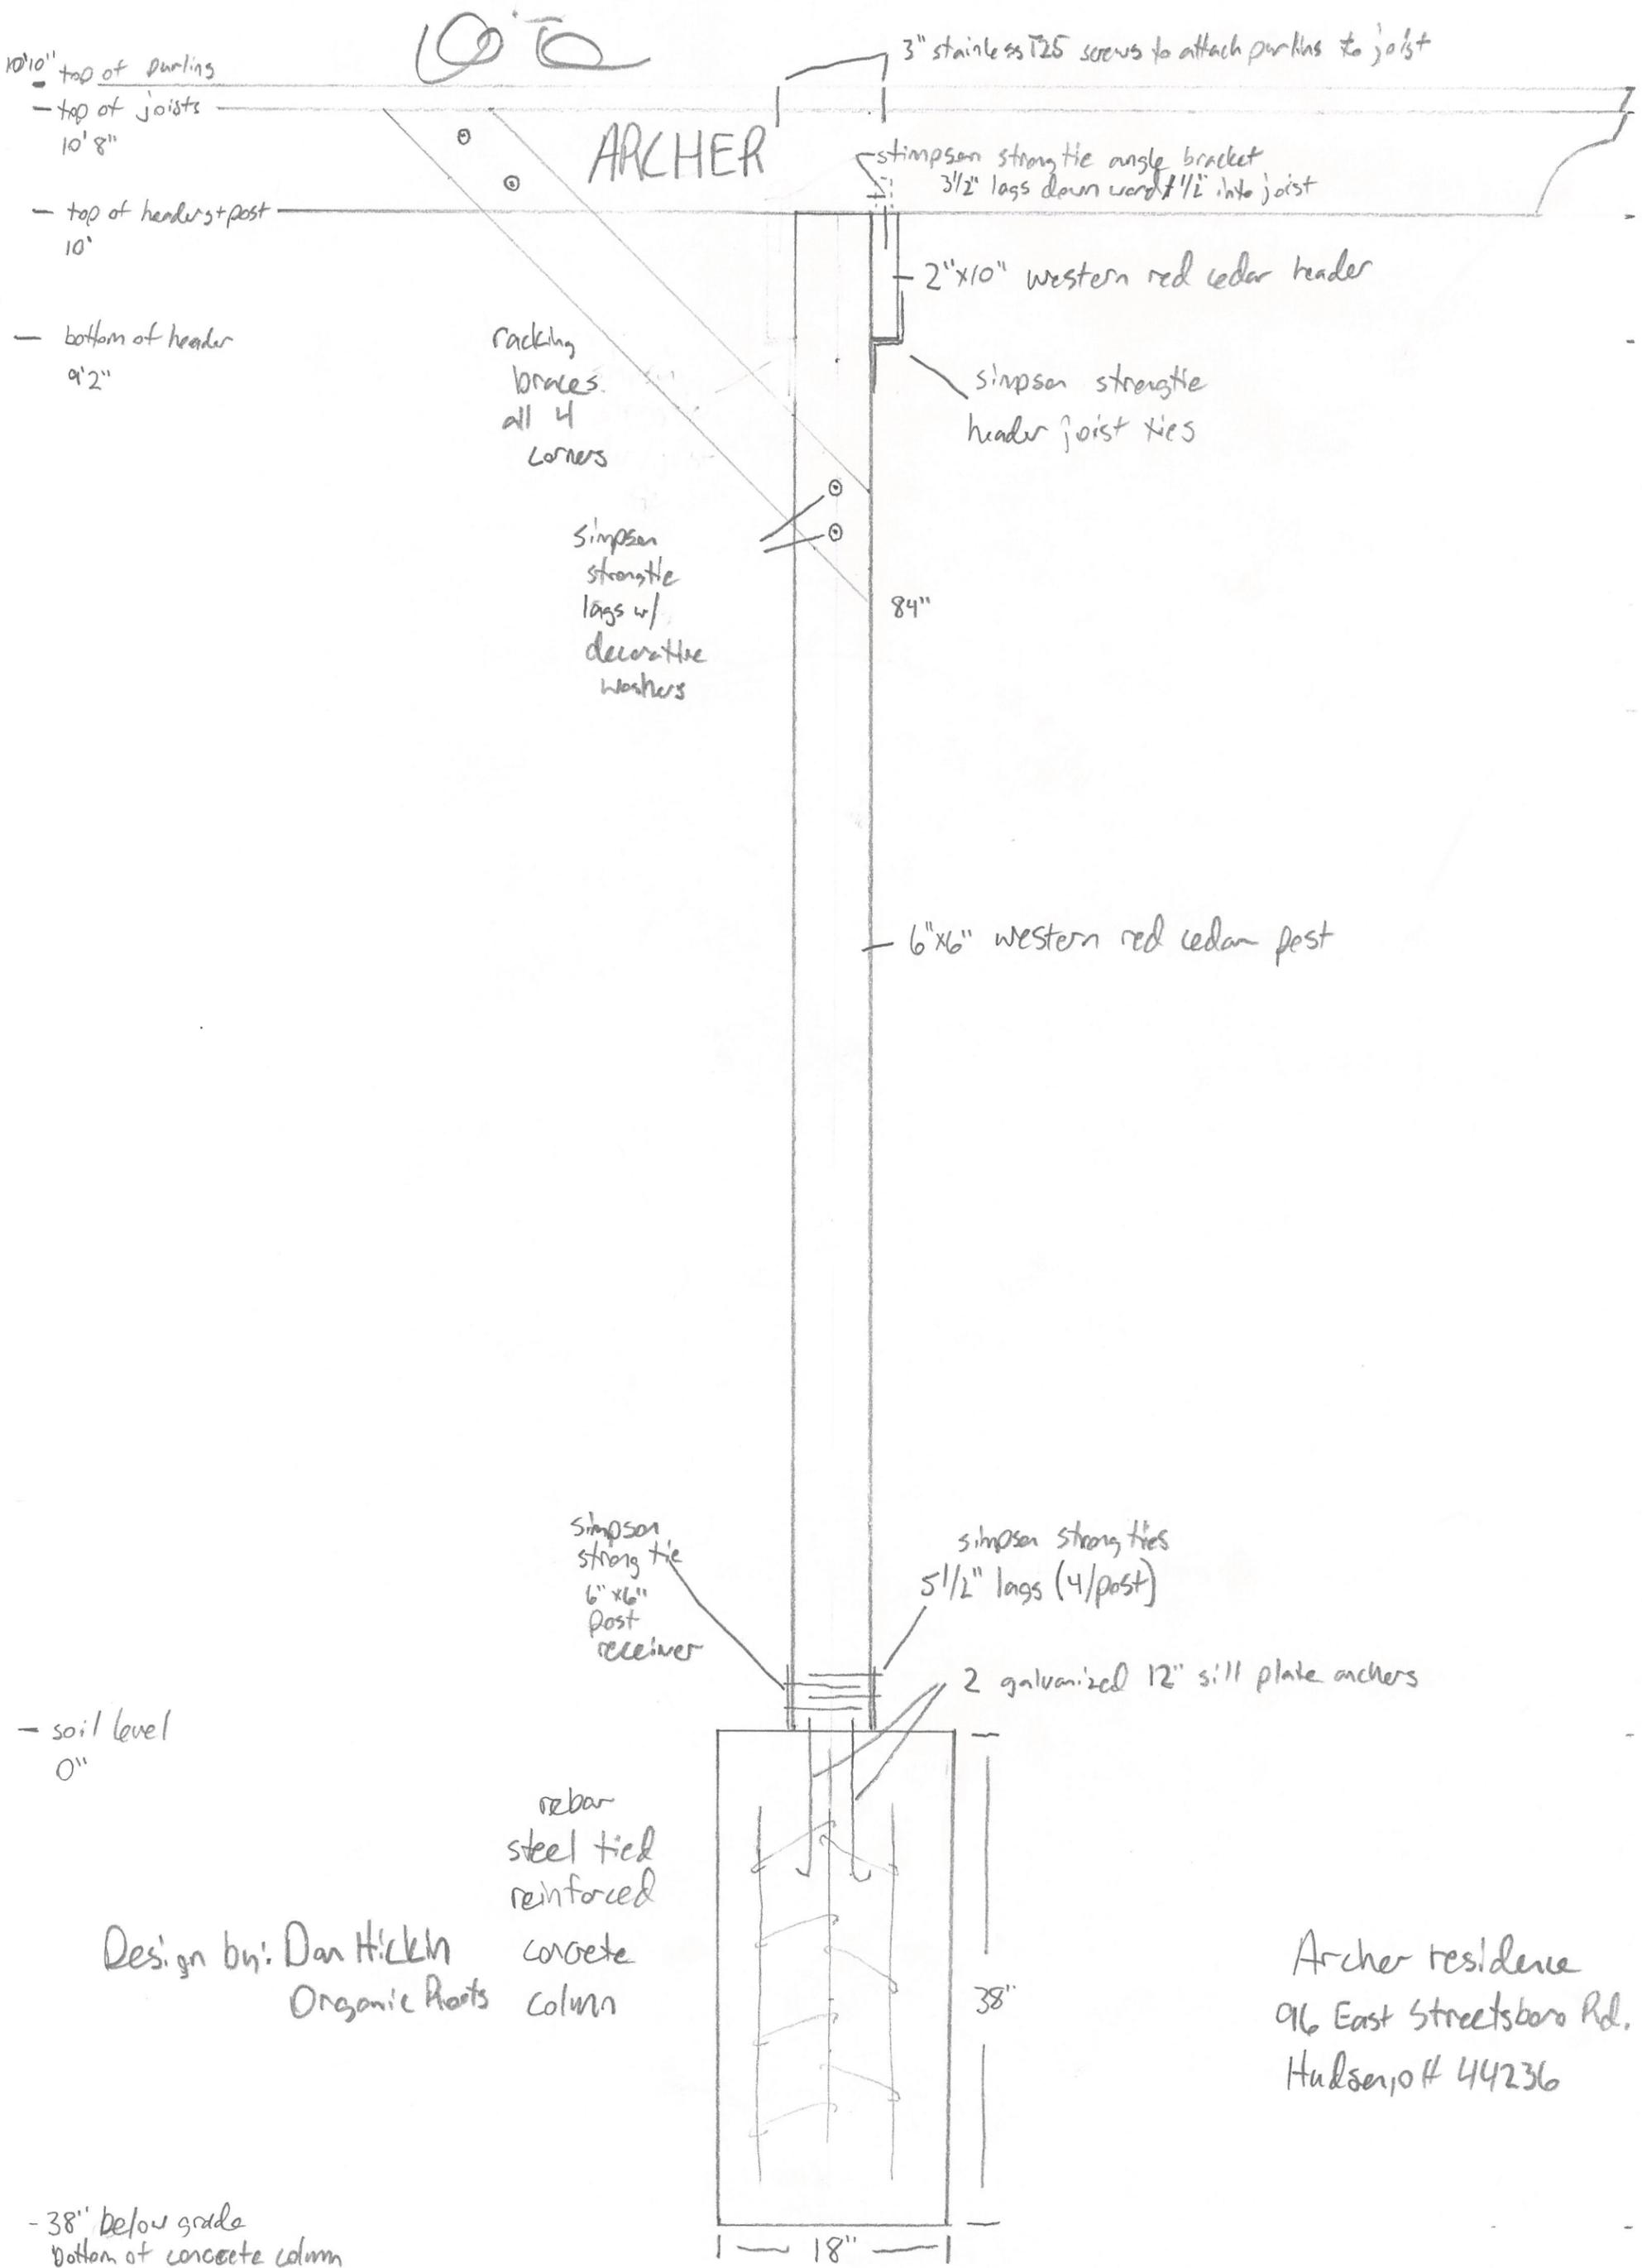
rebar
 steel tied
 reinforced
 concrete
 column

- 38" below grade
 bottom of concrete column
