Re: **Barlow Court Townhomes**
Engineering Preliminary Concept Review - Viewpoint #21-539

RE: Environmental Condition Assessment Report
Vacant Parcel 30-10258
Barlow Road
Hudson, Ohio
SME Project No. 087356.00.001

WETLAND DELINEATION

Parcel Number 3010258
City of Hudson, Summit County, Ohio
(H21244-01)

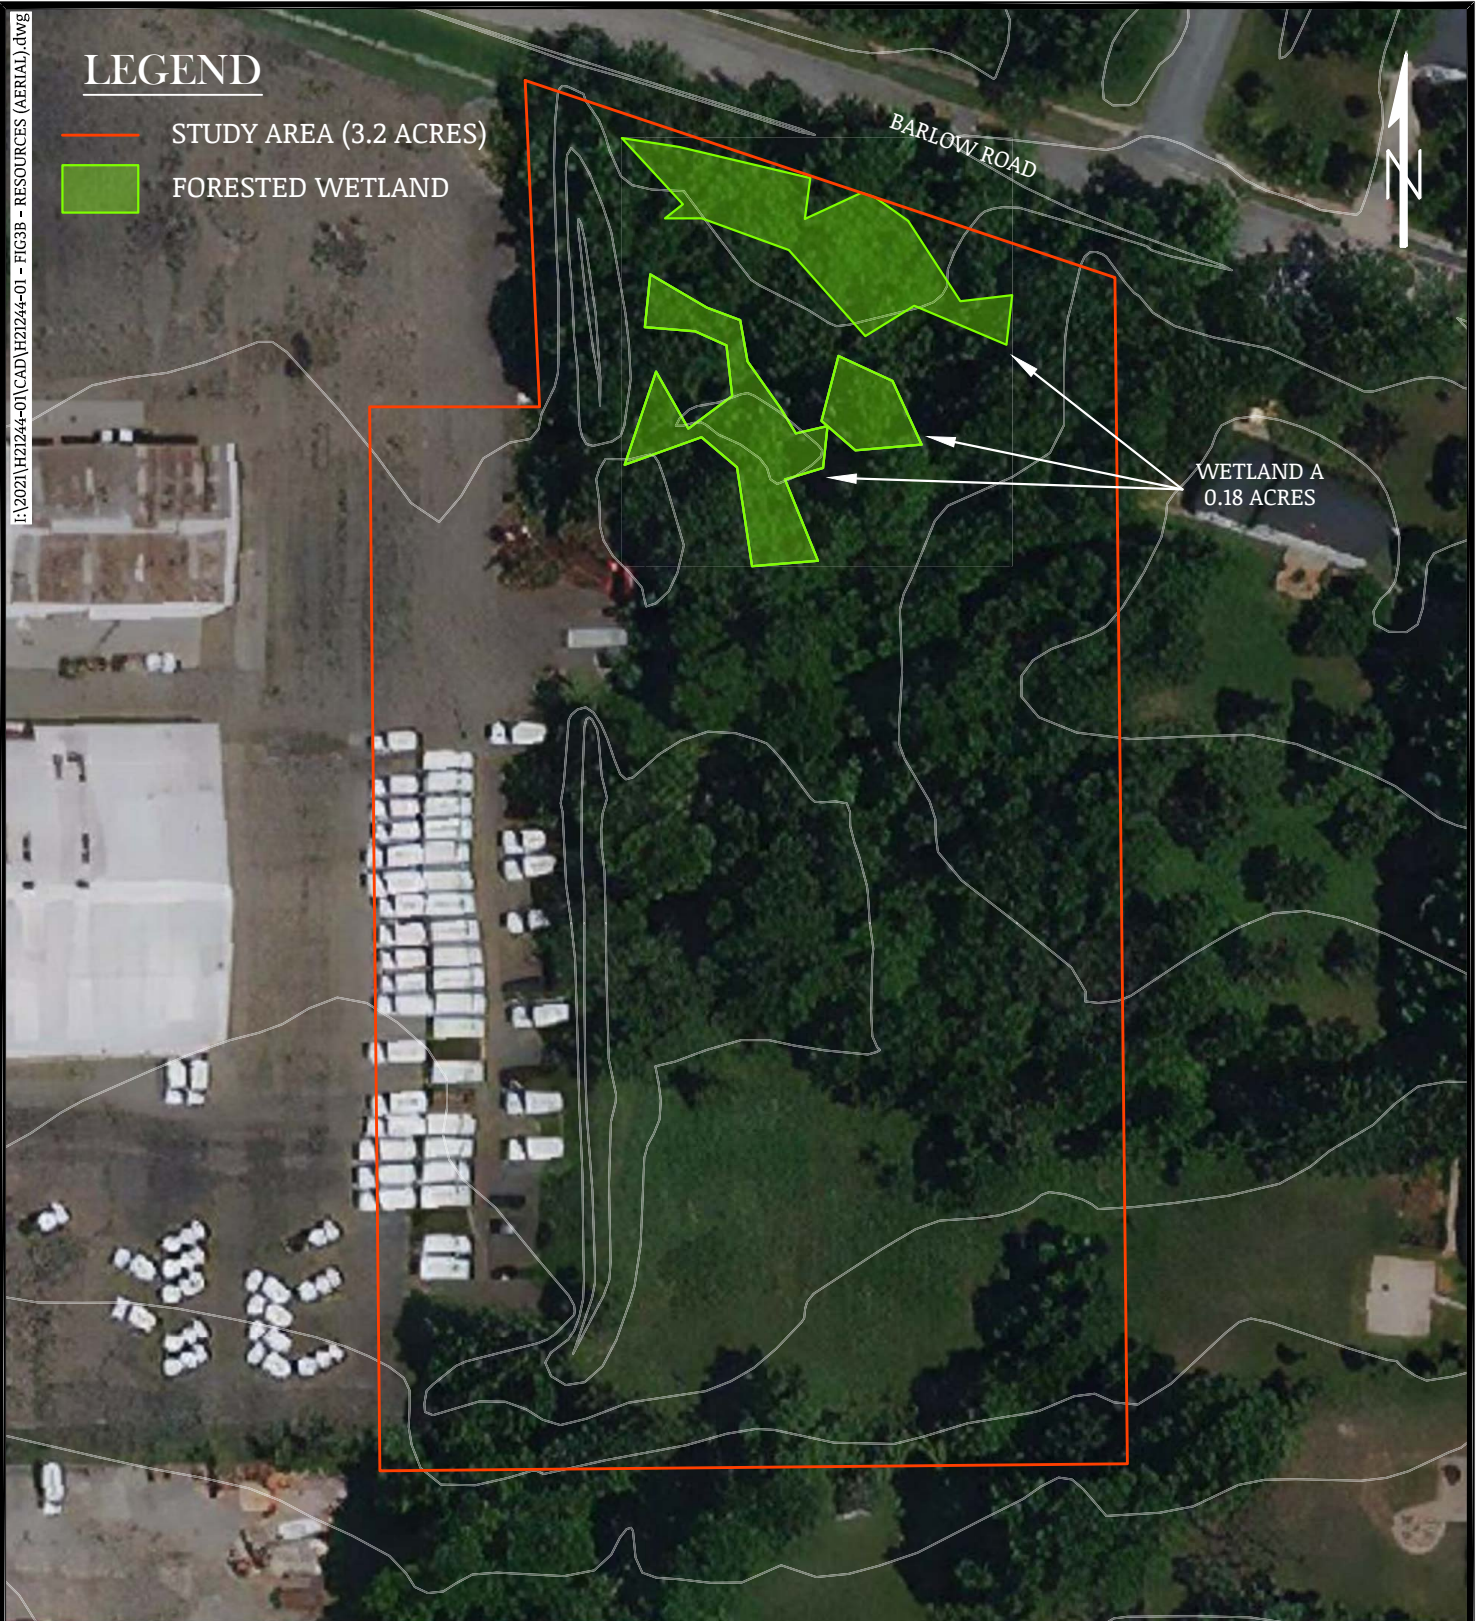
Figure 3B – Aquatic Resources Map- Aerial

- STUDY AREA (3.2 ACRES)
- FORESTED WETLAND

The data collected at the remaining data points, DP2, DP3, and DP4, did not meet all of the criteria of a wetland; therefore, these areas are considered non-wetland. Refer to the aquatic resources map presented as **Figure 3A** in **Appendix A** for the location of DP2, DP3, and DP4, and the wetland determination data forms included as **Appendix C** for more detailed information regarding the hydrology, soils, and vegetation found at the non-wetland data points.

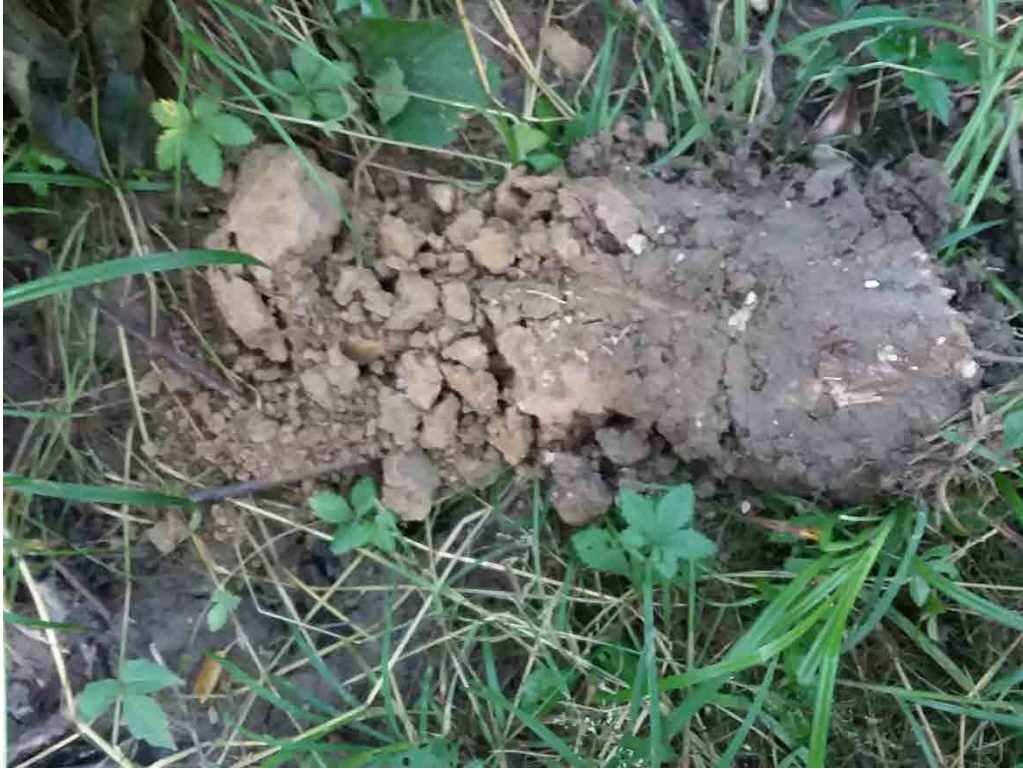
Photograph 1
View of soil profile at Data Point 1 (Wetland A).

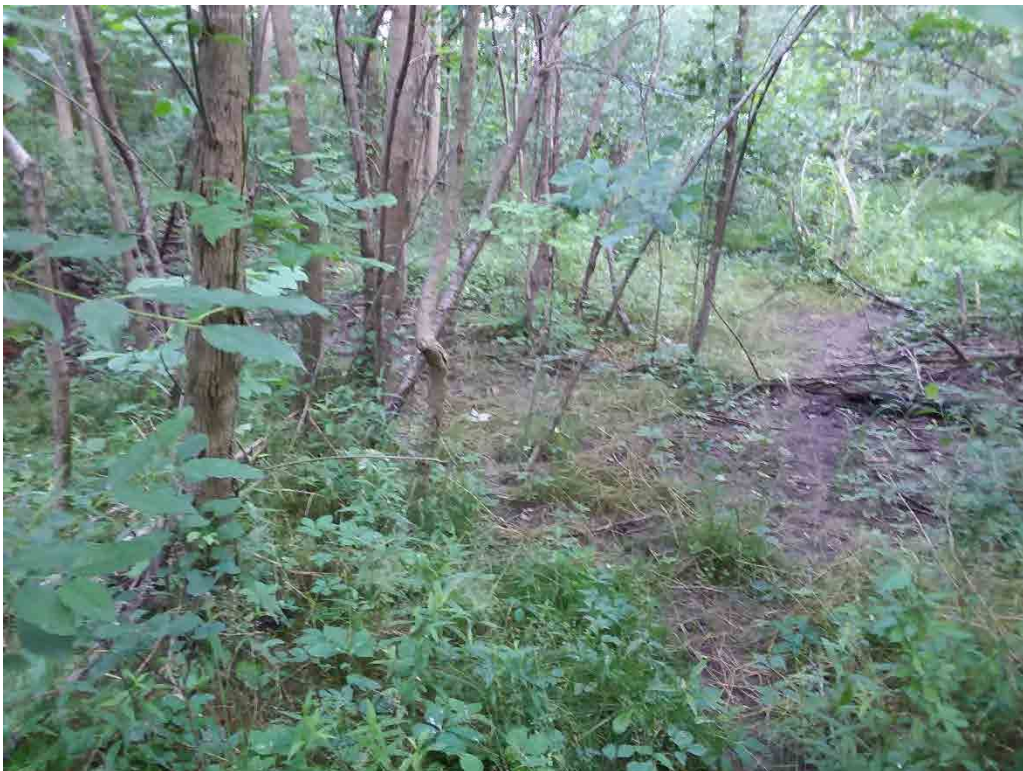
Photograph 2
View facing east depicting site conditions at Data Point 1 (Wetland A).

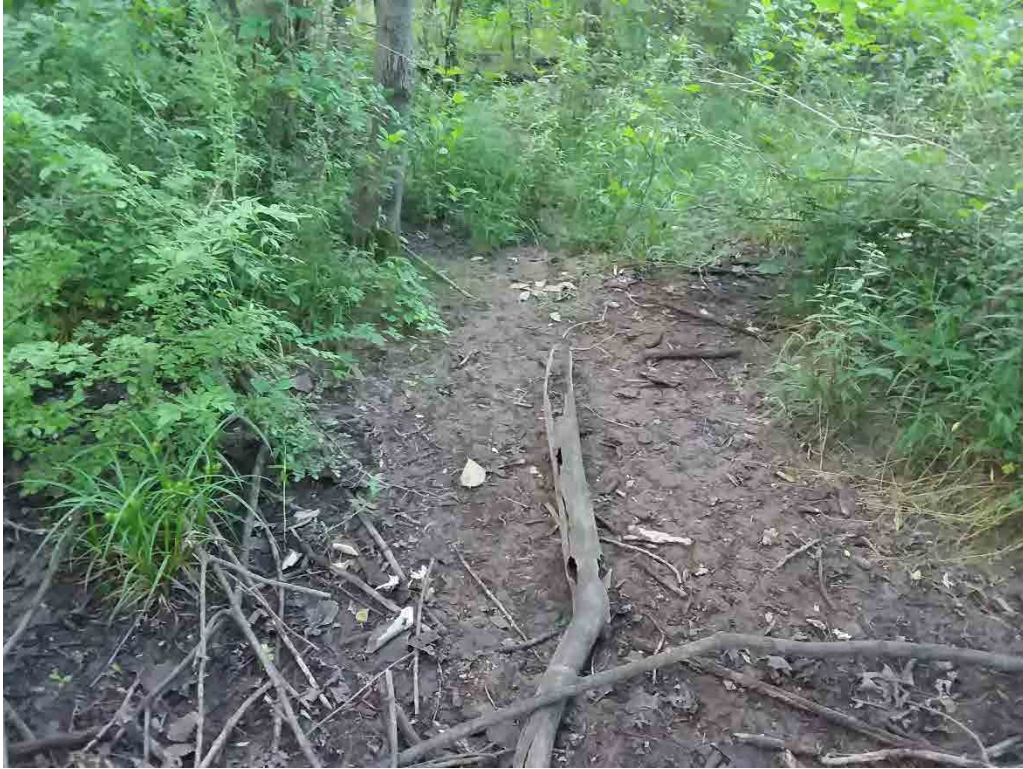
Photograph 3
View of Wetland A facing east.

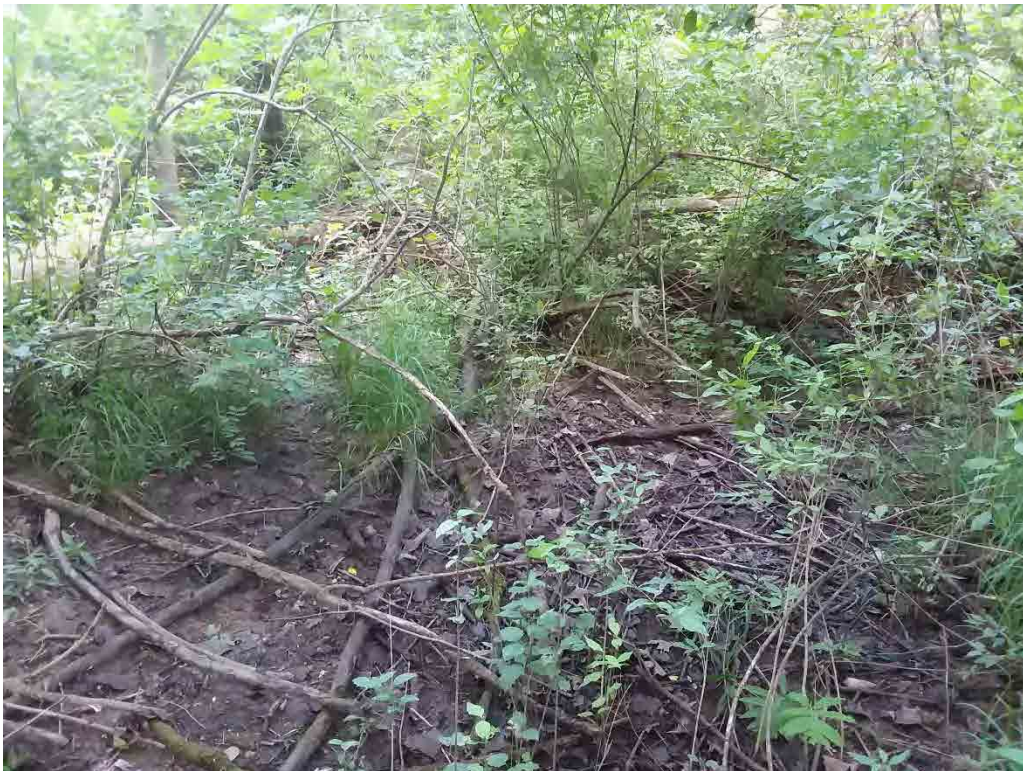
Photograph 4
View of Wetland A facing north.

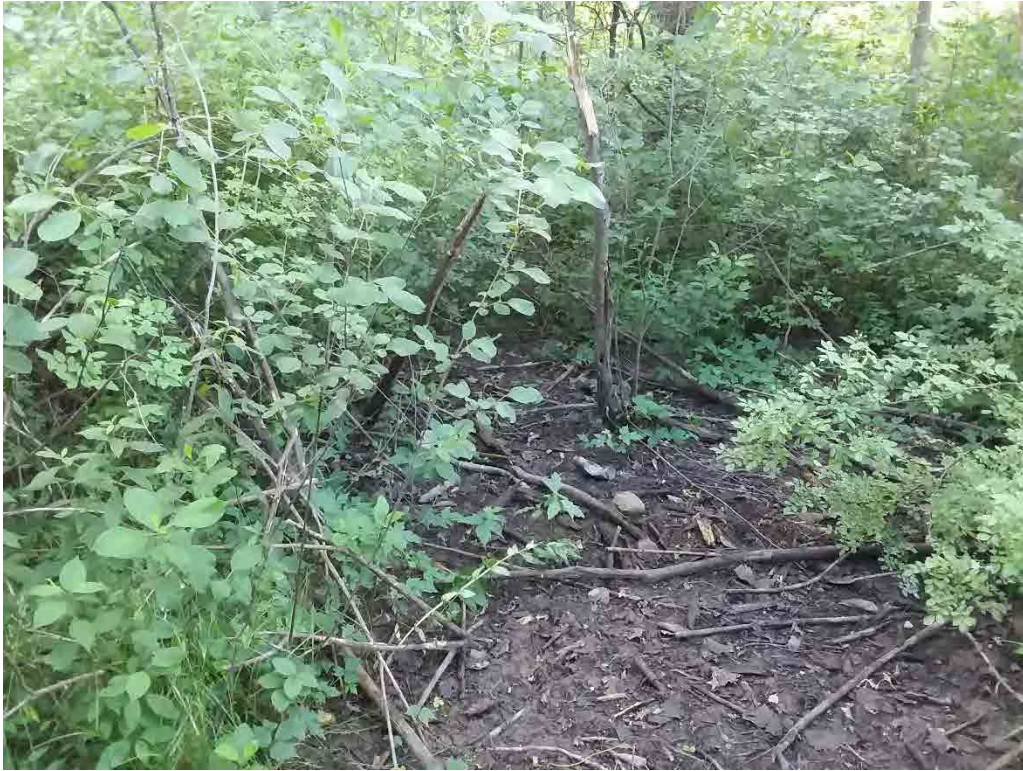
Photograph 5
View of Wetland A facing north.

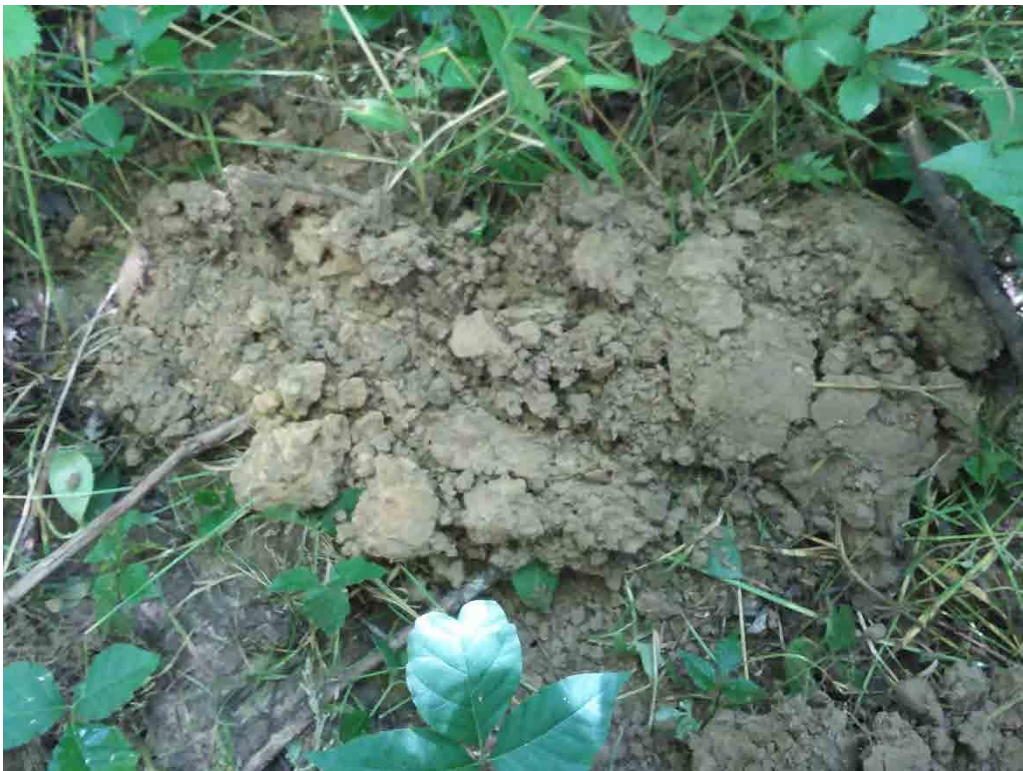
Photograph 6
View of soil profile at Data Point 2 (non-wetland).

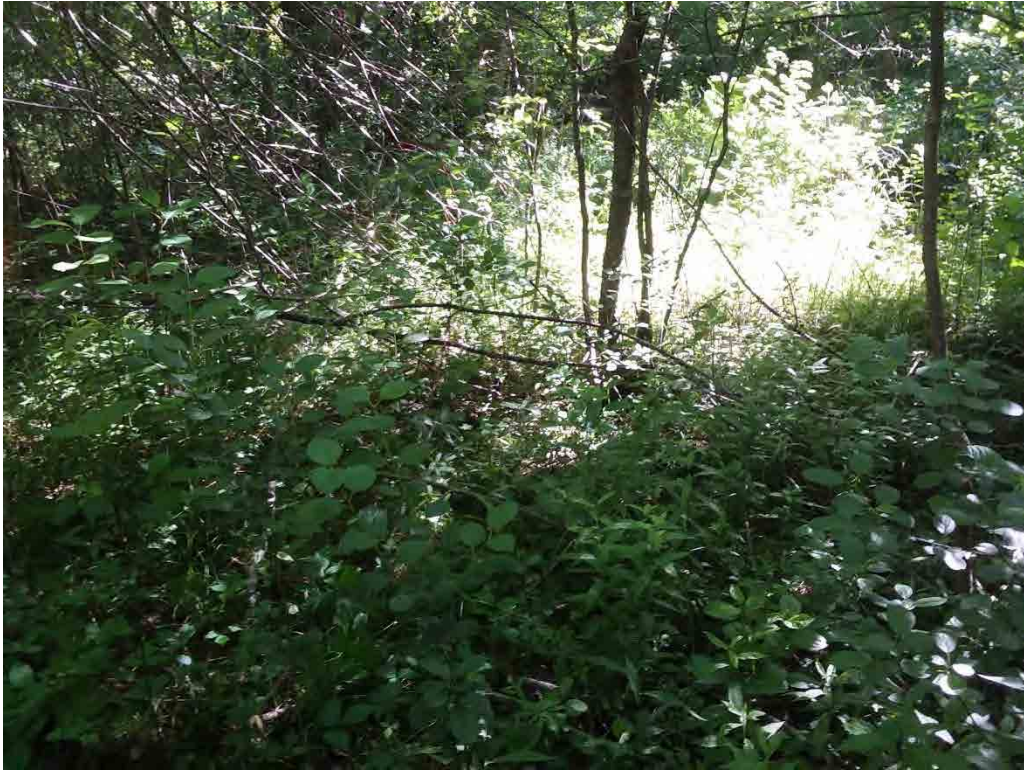
Photograph 7
View facing north depicting site conditions at Data Point 2 (non-wetland).

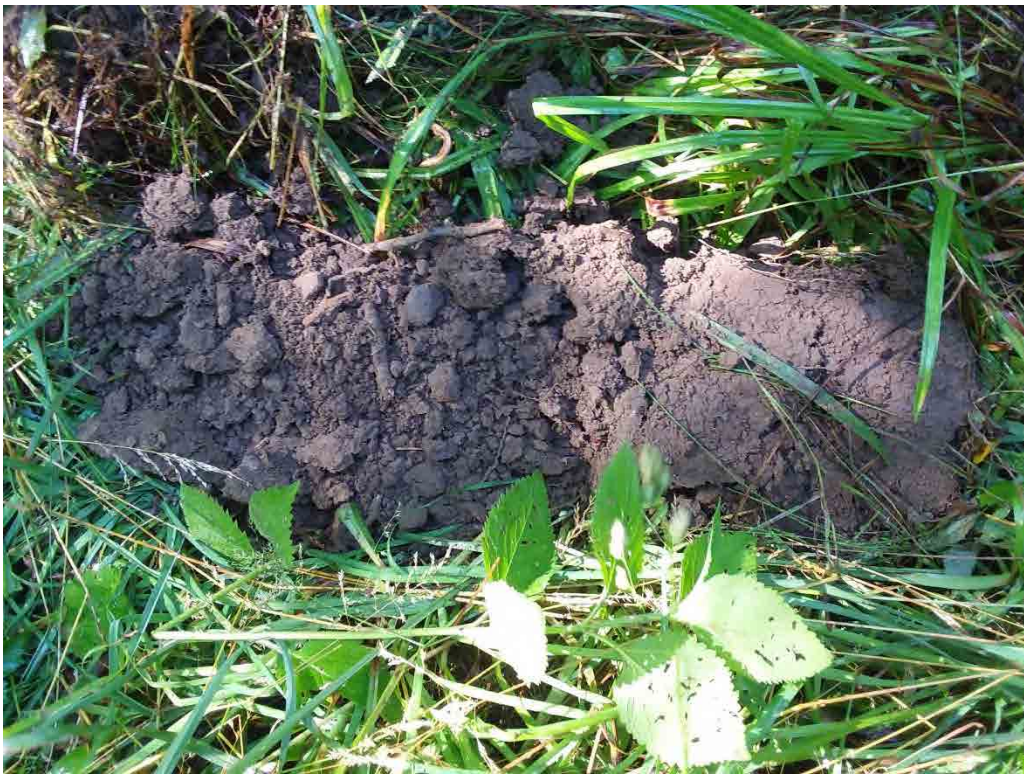
Photograph 8
View of soil profile at Data Point 3 (non-wetland).

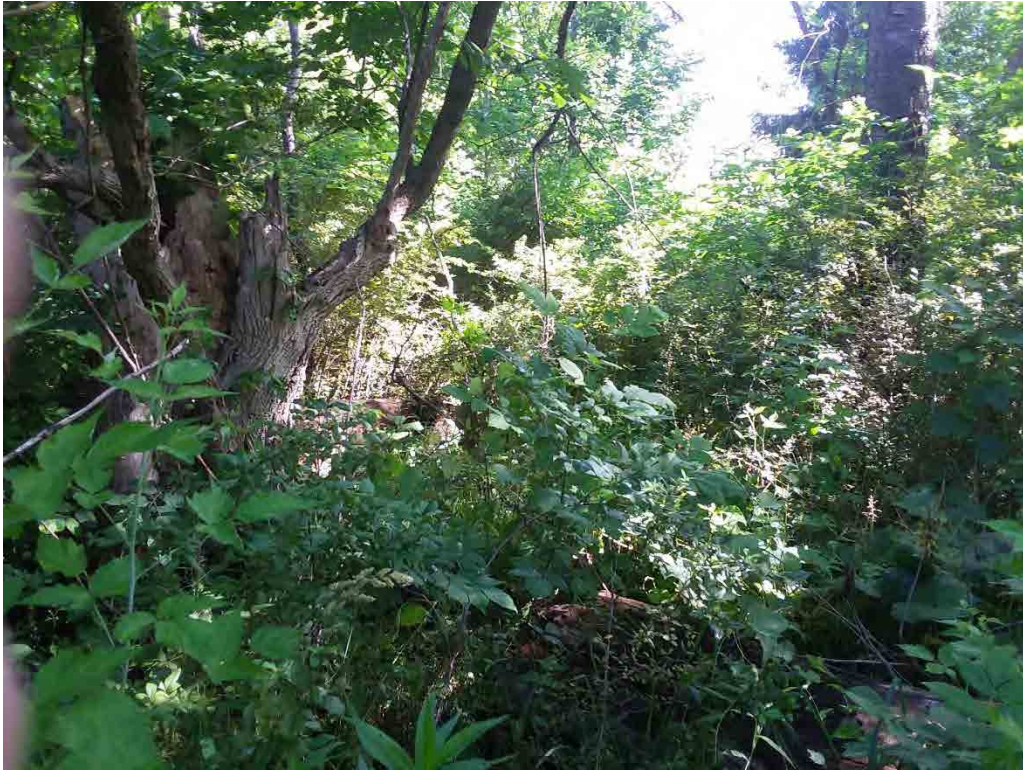
Photograph 9
View facing north depicting site conditions at Data point 3 (non-wetland).

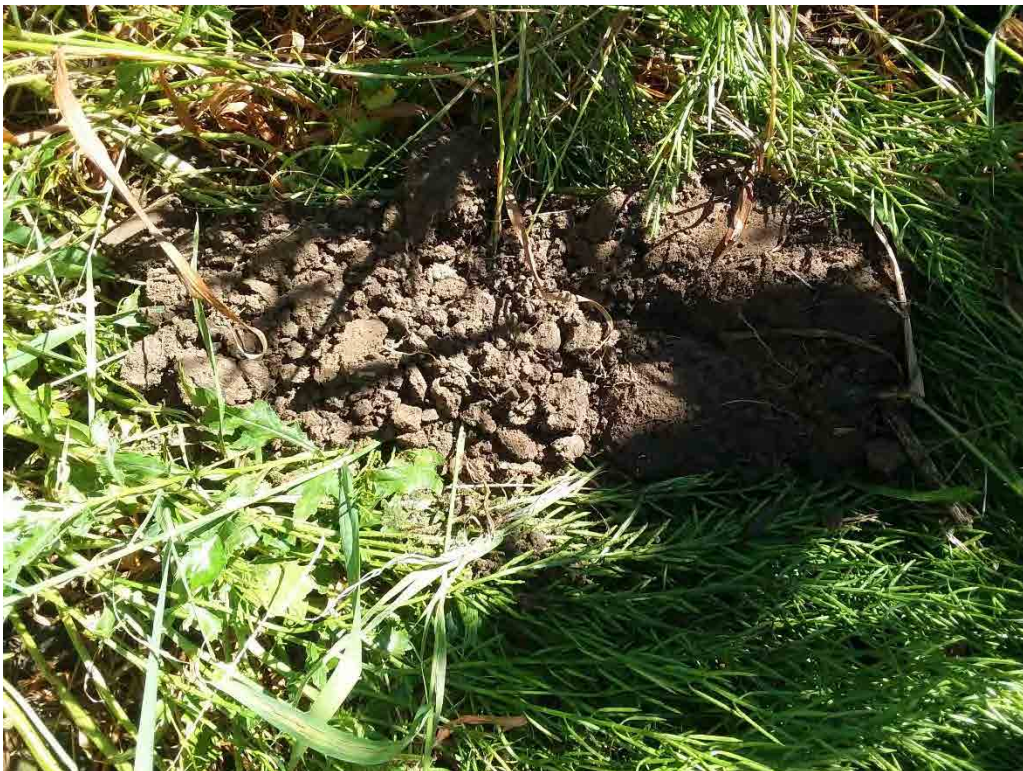
Photograph 10
View of soil profile at Data Point 4 (non-wetland).

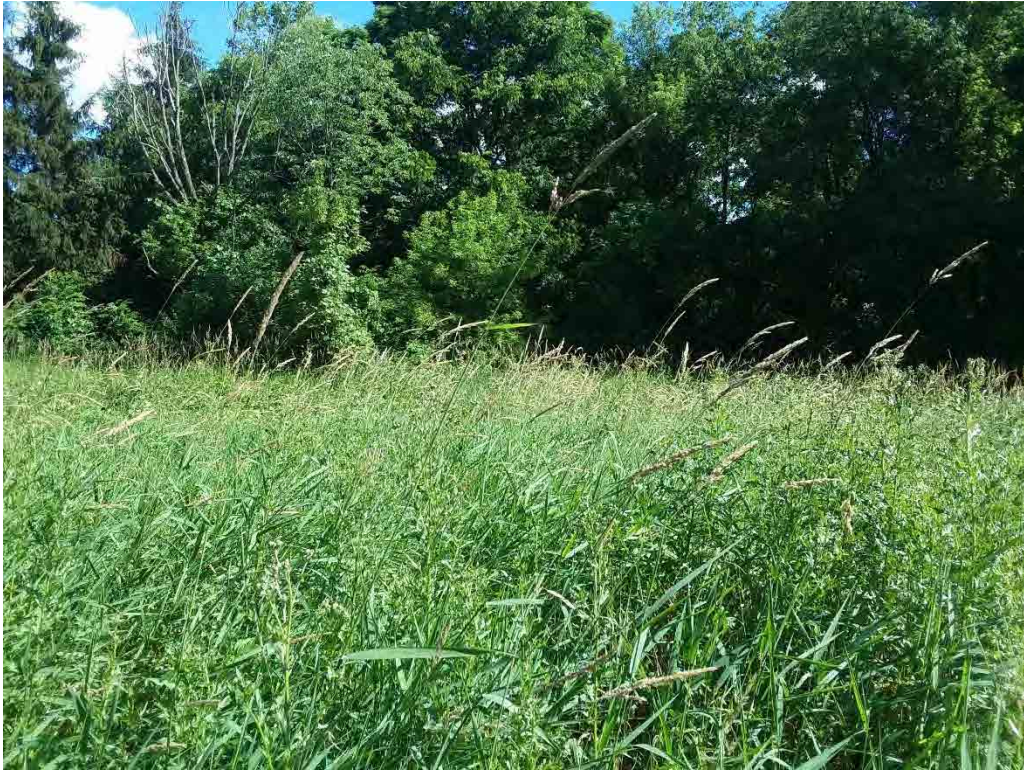
Photograph 11
View facing north depicting site conditions at Data Point 4 (non-wetland).
