Secondary Option
Site Plan

Customer: n/a n/a
Address: 21 Aurora St
Hudson, OH 44236
System size: 24.29 kW
Yr 1 Production: 29,008 kWh
Designer: Better Together Solar
Date: August 25th, 2020

Interpreting The Secretary of the Interior's Standards for Rehabilitation

Subject: Incorporating Solar Panels in a Rehabilitation Project

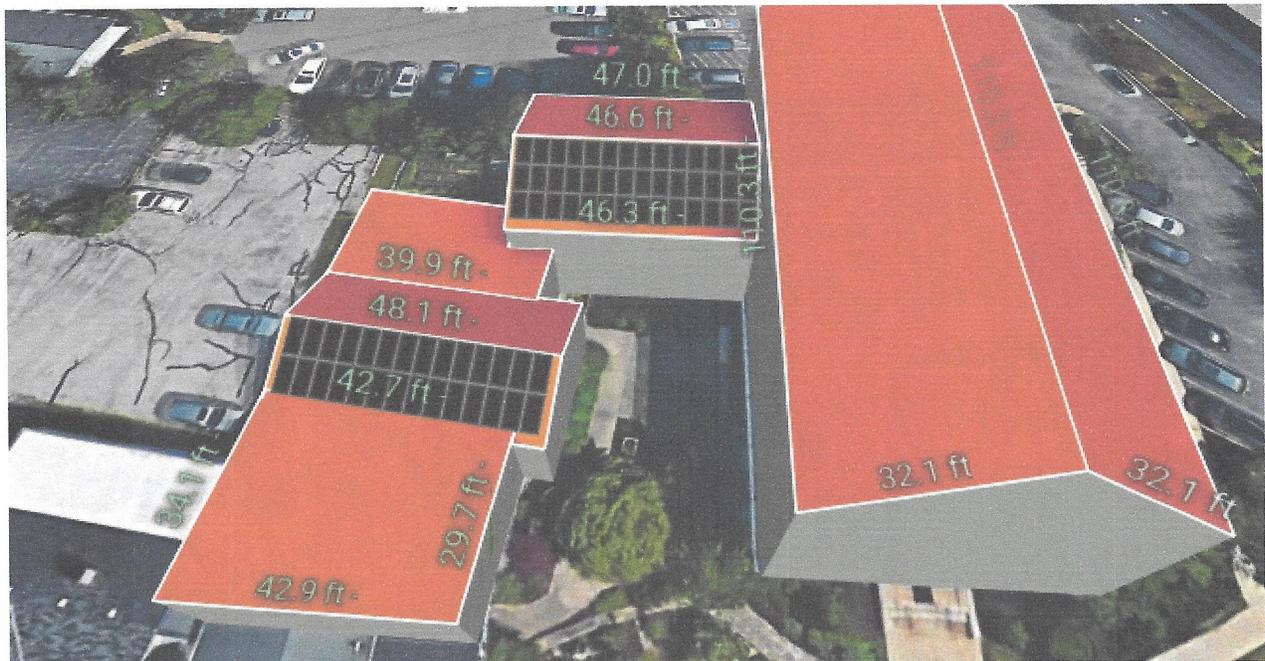
Component List

Manufacturer	Model	Quantity
Canadian Solar Inc.	CS1H-325MS (1000V)	42
SolarEdge Technologies Inc.	P370	42
Canadian Solar Inc.	CS3U-380MS (1000V)	28
SolarEdge Technologies Inc.	P405	28
SolarEdge Technologies Inc.	SE14.4KUS (208V)	2
(none)	Meter	1
null	30A Fused AC Disconnect	2

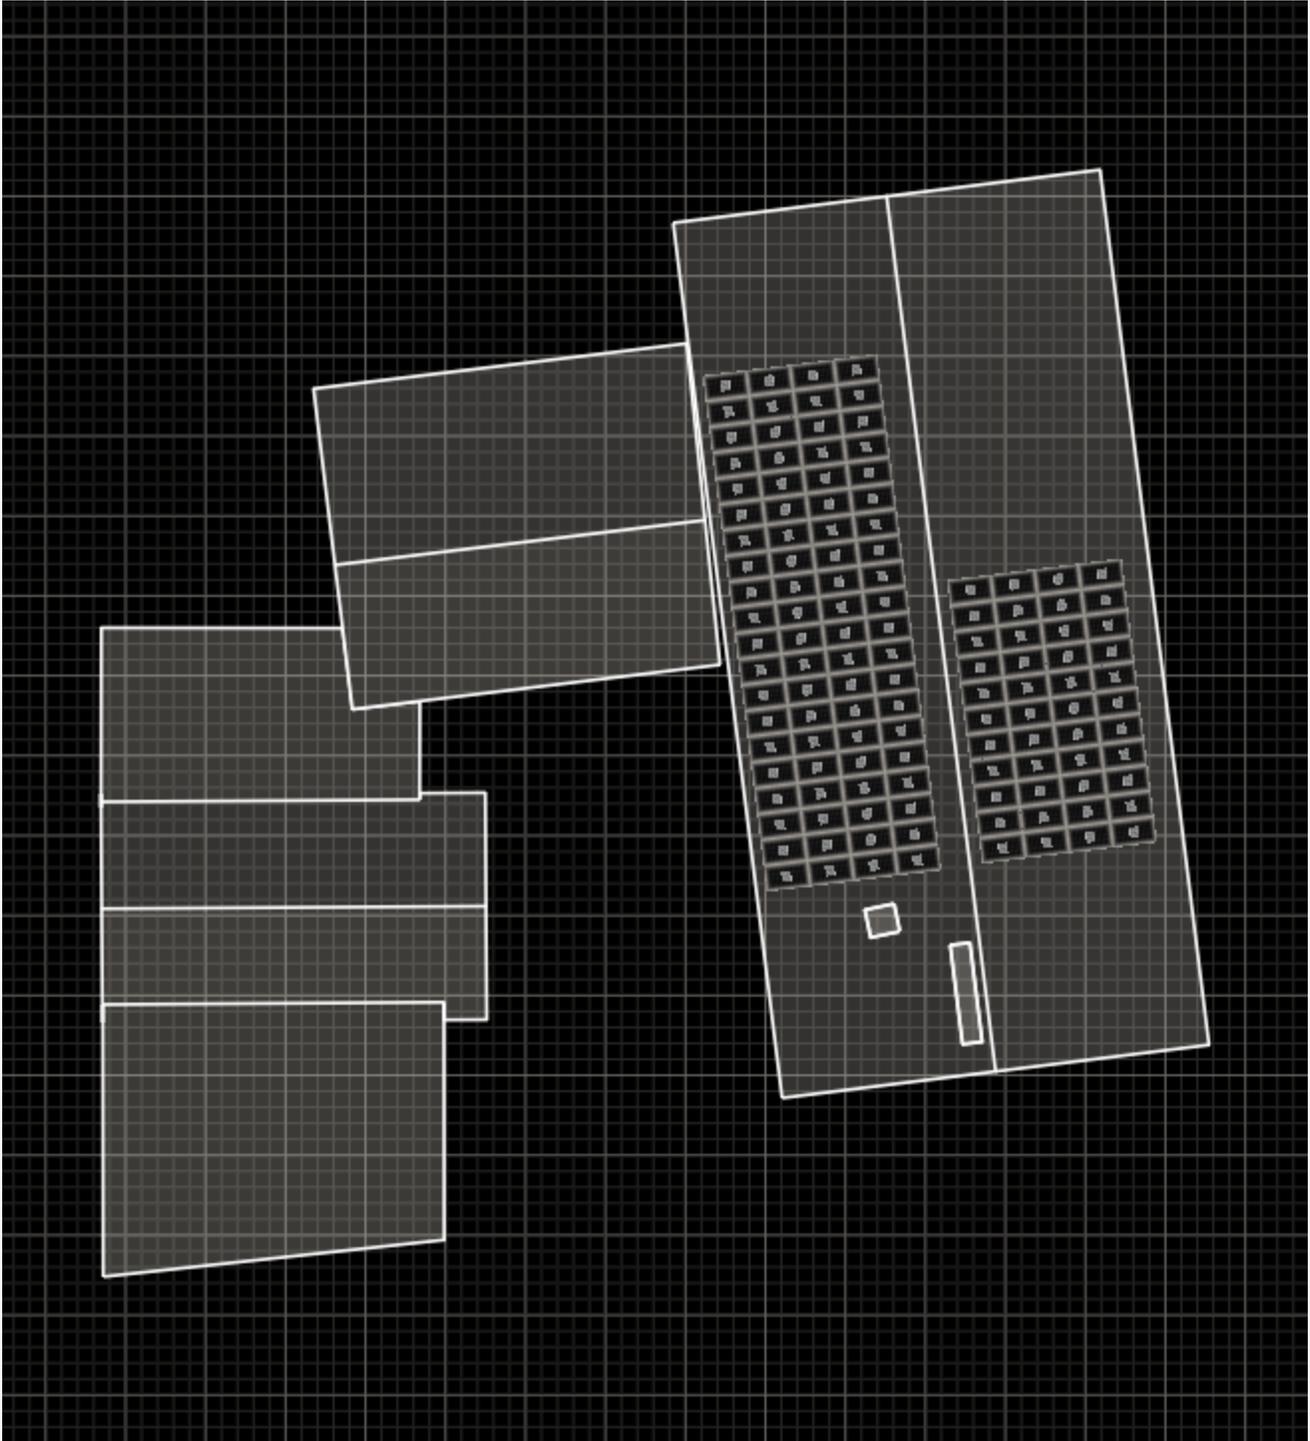
Site Assessment

System size: 47.12 kW
Yr 1 Production: 50,251 kWh
Designer: Jamie Doyle
Date: September 21st, 2020

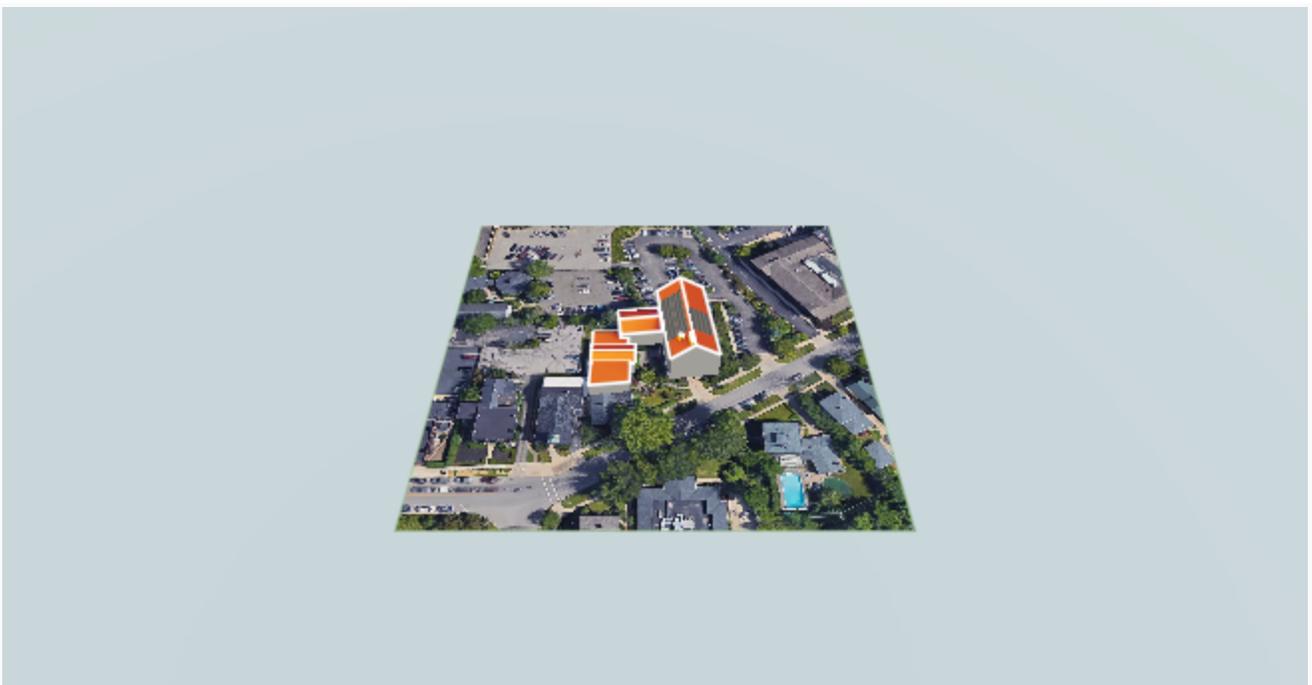
Component List

Manufacturer	Model	Quantity
Canadian Solar Inc.	CS3U-380MS (1000V)	124
SolarEdge Technologies Inc.	P405	124
SolarEdge Technologies Inc.	SE43.2k	1
(none)	Load Center	1
(none)	Meter	1
(none)	Disconnect	1

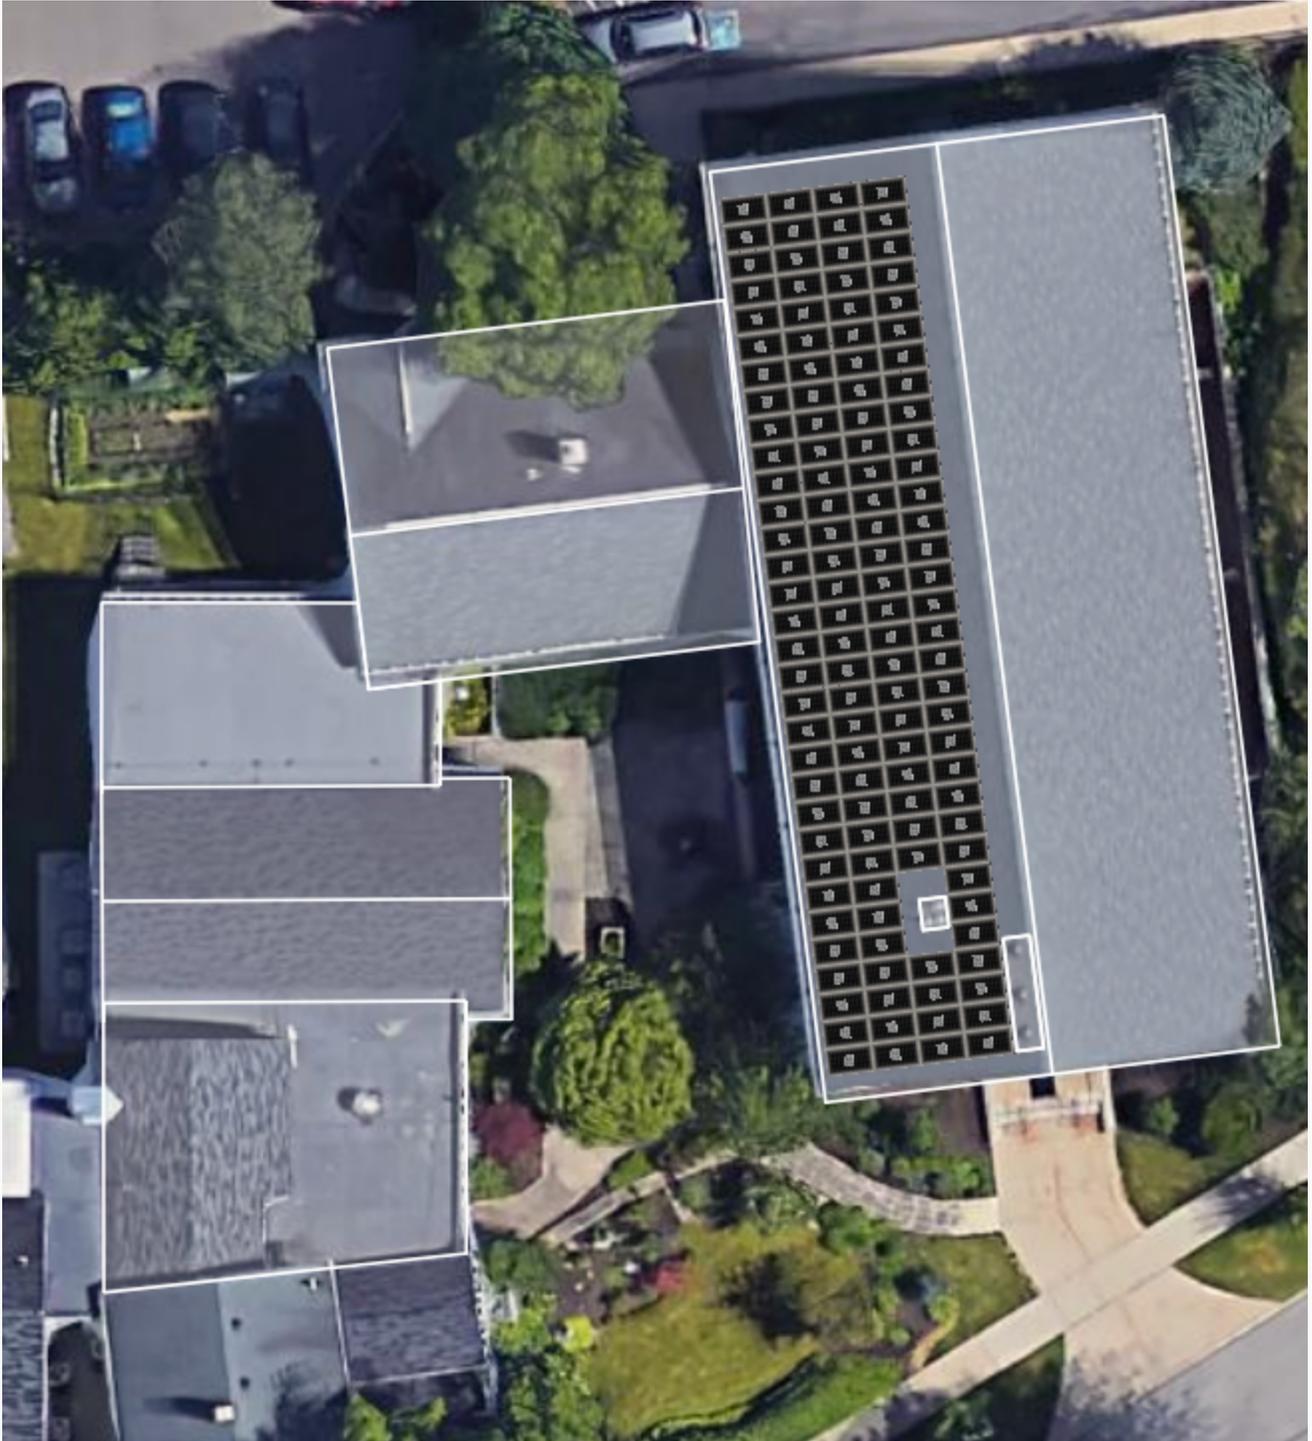
Site Assessment

Customer: n/a n/a
Address: 21 Aurora St
Hudson, OH 44236
System size: 47.50 kW
Yr 1 Production: 54,892 kWh
Designer: Jamie Doyle
Date: September 21st, 2020

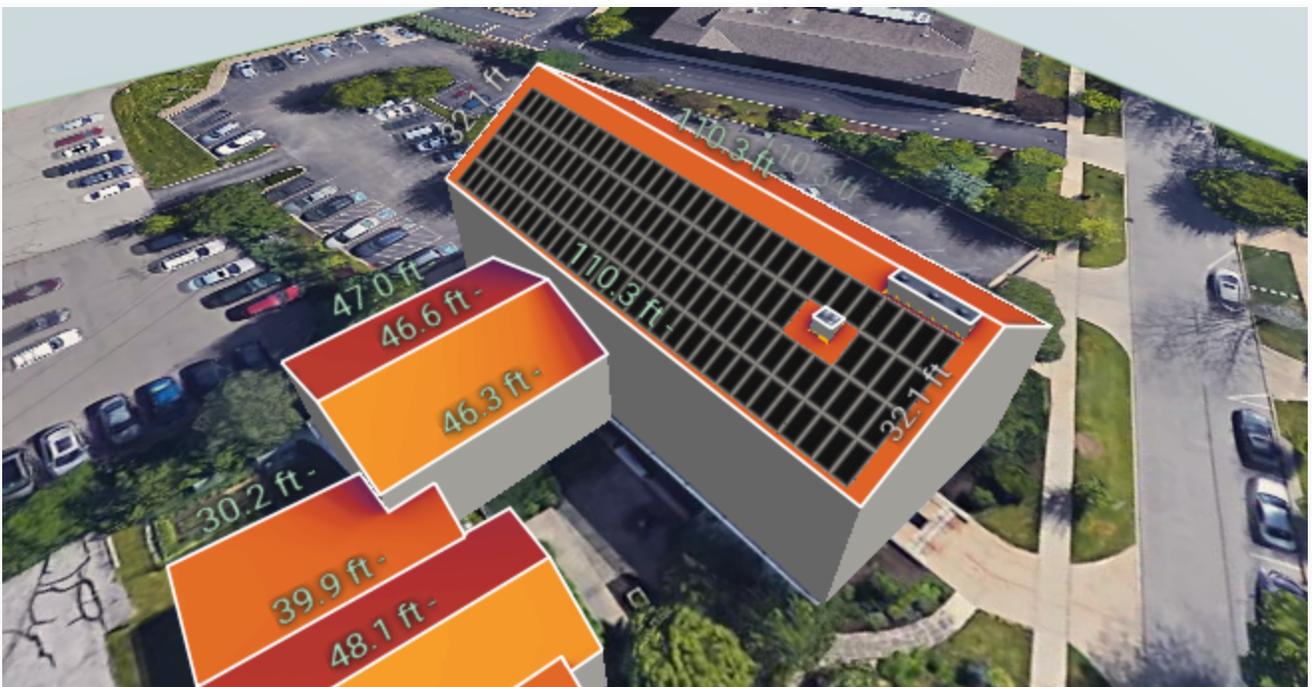
Component List

Manufacturer	Model	Quantity
Canadian Solar Inc.	CS3U-380MS (1000V)	125
SolarEdge Technologies Inc.	P405	125
SolarEdge Technologies Inc.	SE43.2k	1
(none)	Load Center	1
(none)	Meter	1
(none)	Disconnect	1

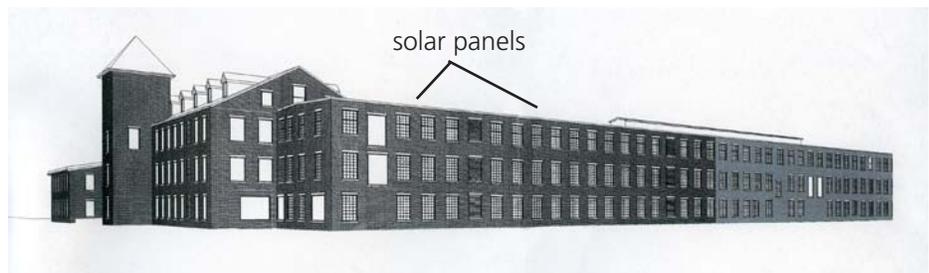
Because of the size of this historic mill, a large array of solar panels could be installed on the flat roof without being seen from the ground.

The rehabilitation of this mid-nineteenth century mill incorporated a large, roof-mounted photovoltaic installation. Although the historic building does not have a parapet wall at the roofline, the height of the building and the arrangement of the panels render the entire installation invisible from the ground. It is important to note that the panels are placed horizontally. Had the panels been installed with a vertical tilt, the angle required to maximize efficiency would have caused the panels to extend significantly higher above the roof. Simply changing the direction in which the panels are tilted can affect their visibility and reduce their impact on the character of the historic property.

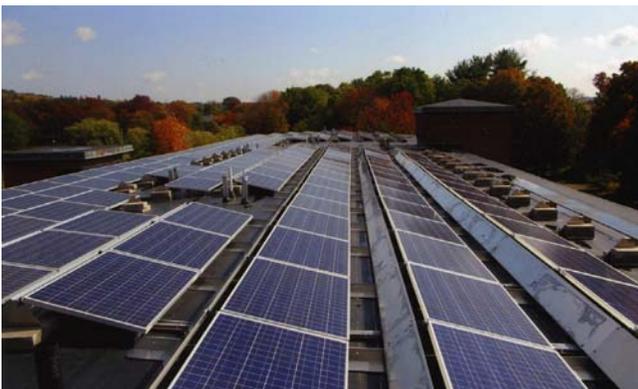
Solar panels installed on the flat roof.

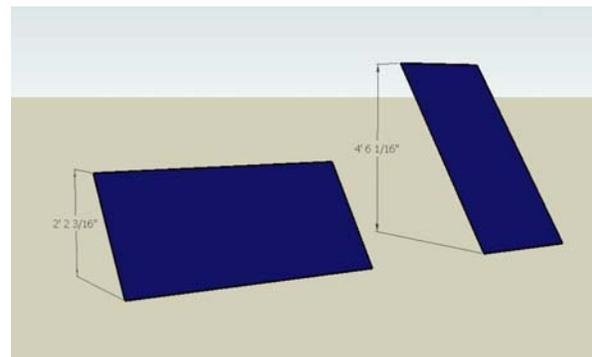
By placing the panels horizontally, the overall height of the installation and its visibility is reduced.

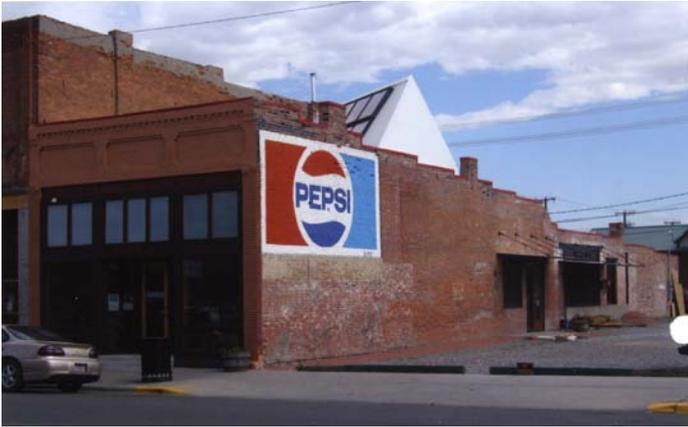
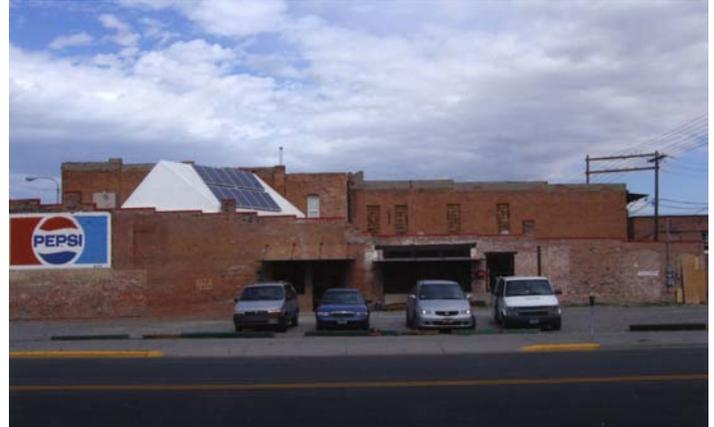
The addition of a large rooftop monitor featuring skylights on the front slope and solar panels on the rear slope is not compatible with the historic character of this small, one-story commercial building.

Application 2 (*Incompatible treatment*): During the rehabilitation of this late-nineteenth century commercial building, a conspicuous rooftop monitor with prominent solar panels and skylights was constructed on the one-story structure. The size and finish of this rooftop addition are incompatible with the historic character of the building. However, the building could have accommodated both skylights and solar panels if they had been installed differently. An alternative design that could have met the Standards would have included low-profile skylights and solar panels concealed behind the parapet wall.

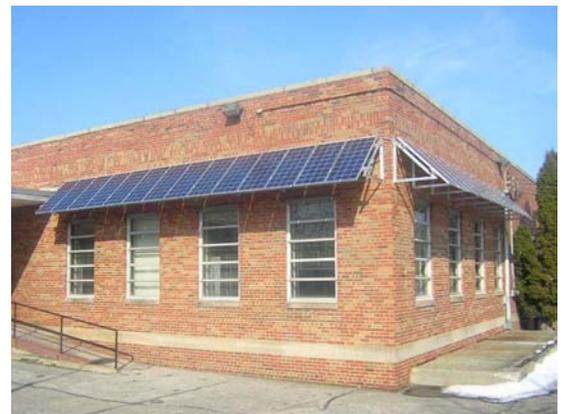
Above: Shown from the rear of the property, these solar panels serve a secondary function as awnings to shade south-facing windows. Because of their location at the back of the building immediately adjacent to a loading dock, the installation of these panels does not affect the historic character of the property.

Application 3 (*Compatible treatment*): The rehabilitation of this historic post office incorporated solar panels as dual-function features: generation of electricity and shading for south-facing windows. In this instance, the southern elevation of the building is also a secondary elevation with limited visibility from the public right of way. Additionally, because this area of the building is immediately next to the post office's loading dock, it has a more utilitarian character than the primary facades and, therefore, can better accommodate solar panels. Because the panels are in a suitable location at the rear of the property and are appropriately sized to serve as awnings, they do not affect the overall historic character of the property. Additionally, a screen of tall plantings shields the solar panels from view from the front of the building, further limiting their visibility.

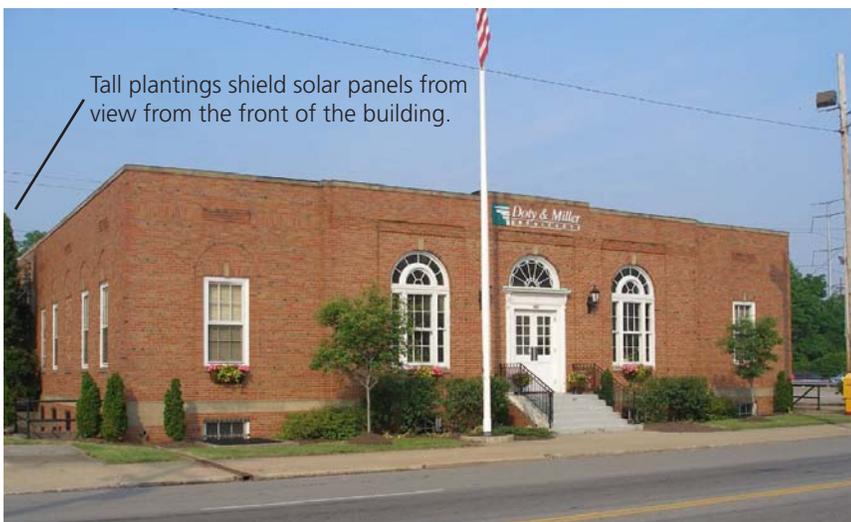
Left: The solar panels are not visible from the front of the building. Additionally, even if the vegetation were removed, the installation would only be minimally visible along an alley at the rear of a secondary side elevation.

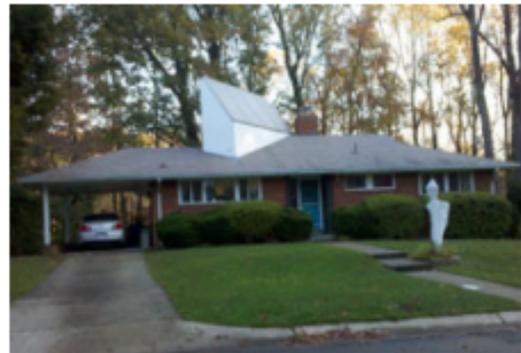
This installation negatively impacts the character of this mid-twentieth century house and does not meet the *Standards*.

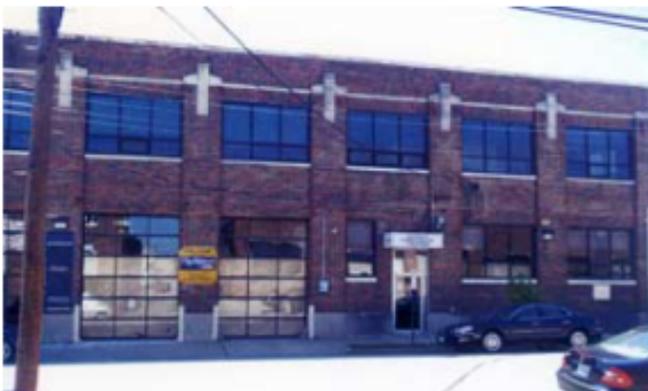
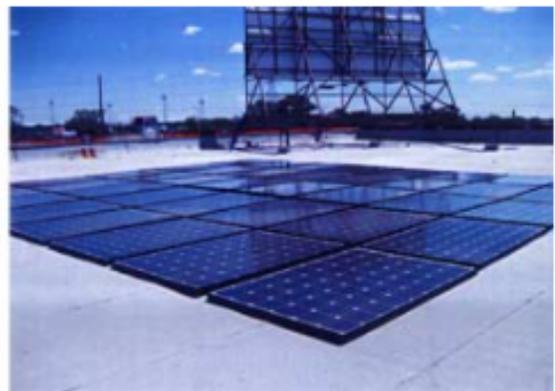
This "invisible" installation of solar panels on a historic industrial building—hidden behind a low parapet—meets the *Standards for Rehabilitation*.

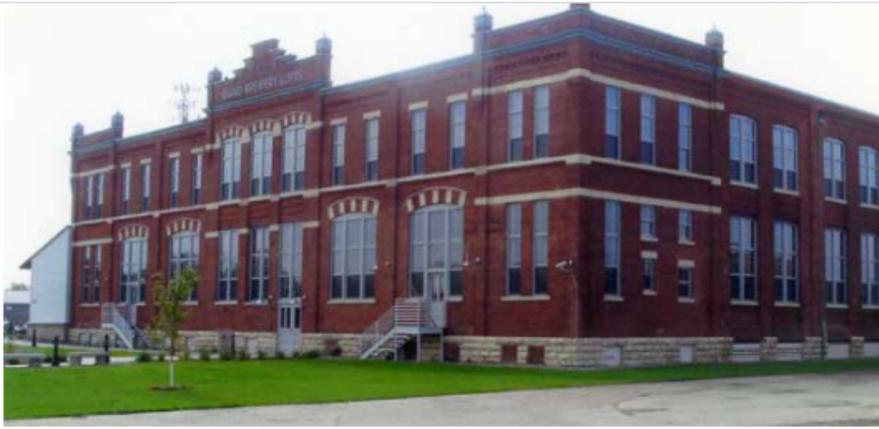
Gund Brewery, Wisconsin

Primary view of the brewery after rehabilitation.

Solar panels were installed on a new addition as part of the rehabilitation of this historic brewery. Although visible from a parking area on the site, the panels are appropriately located on top of a compatible new addition at the back of the historic property. The installation of these panels is consistent with the historic industrial character of the site, and the project meets the Standards.

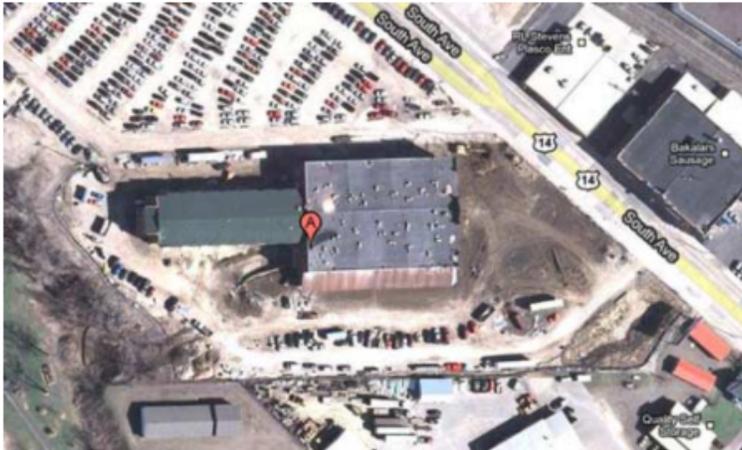
Site map showing the new addition constructed behind the historic brewery. Image from Google Maps 2010.

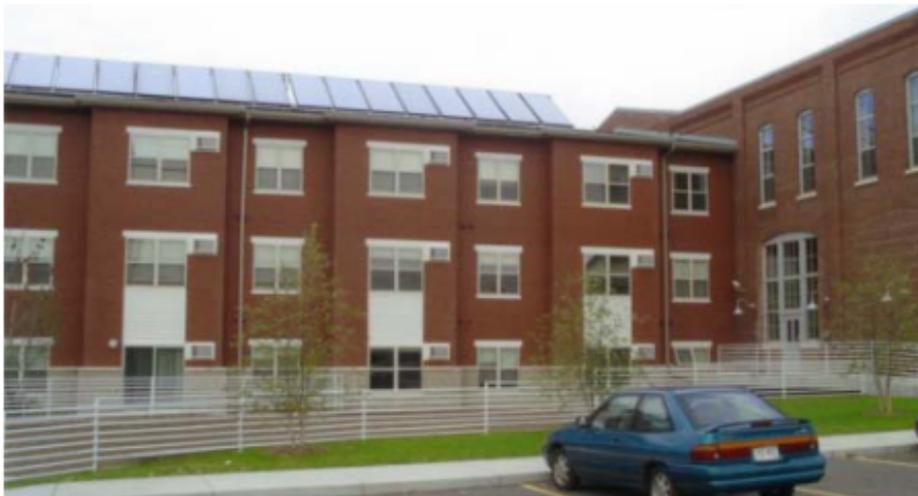
New rear addition with rooftop solar panels.

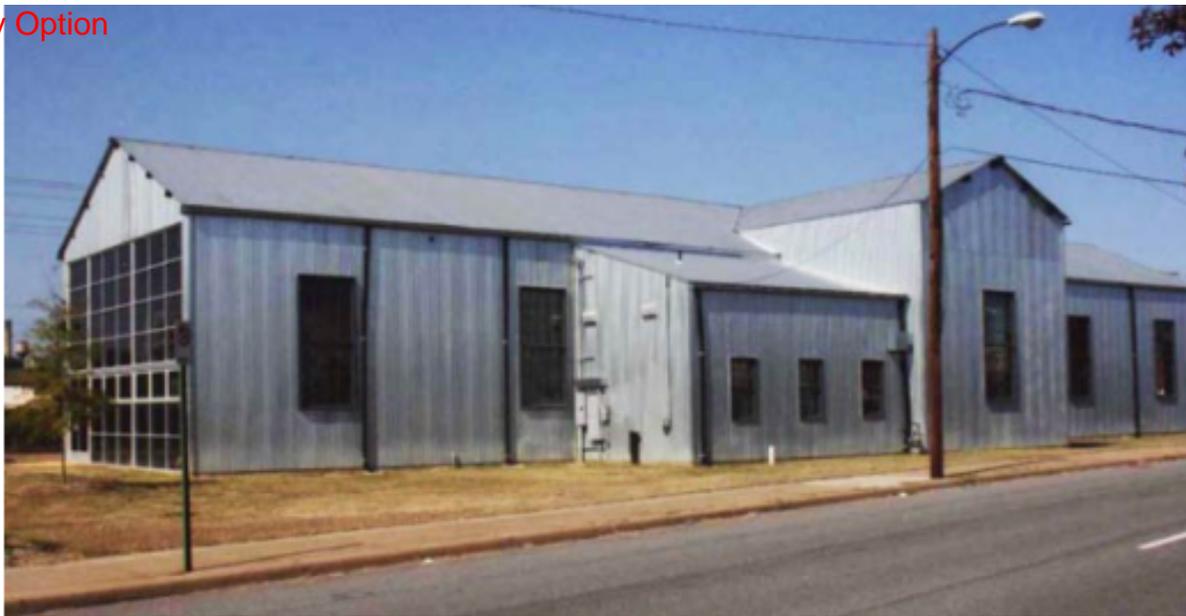
Richmond & Chesapeake Railway Barn, Virginia

Front view of the railway barn after it was rehabilitated for office use.

Two pole-mounted arrays of solar panels were installed at the rear of this historic railway barn. Because the site is industrial in character and the panels are located at the end of the barn away from primary viewpoints, this installation meets the Standards.

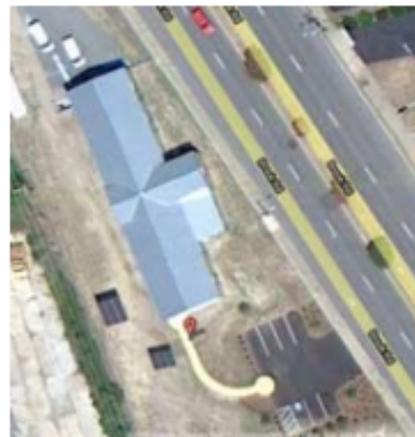
This site map shows the location of the pole-mounted solar panels. Image from Google Maps 2010.

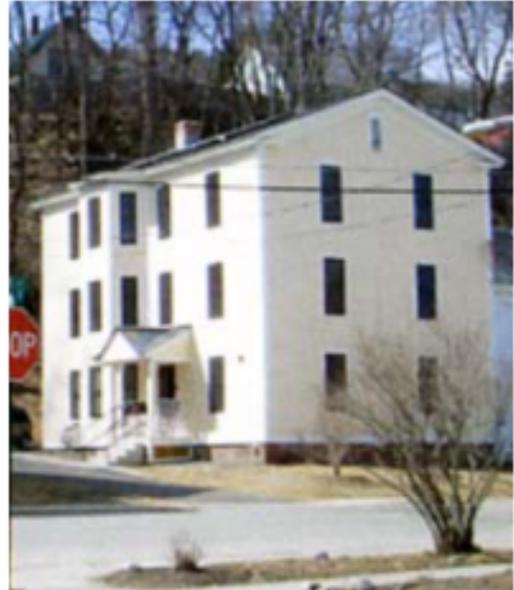
Low-profile solar collectors located on the south side of the gable roof are minimally visible.

The gable end of this historic apartment building faces the street. Low profile solar collectors for a water heating system were flush mounted on the sloped roof on the south side of the gable. Though visible, these few panels have relatively little impact on the historic character of the property. However, if the roof had been a more prominent feature of the property, this installation may not have been appropriate.

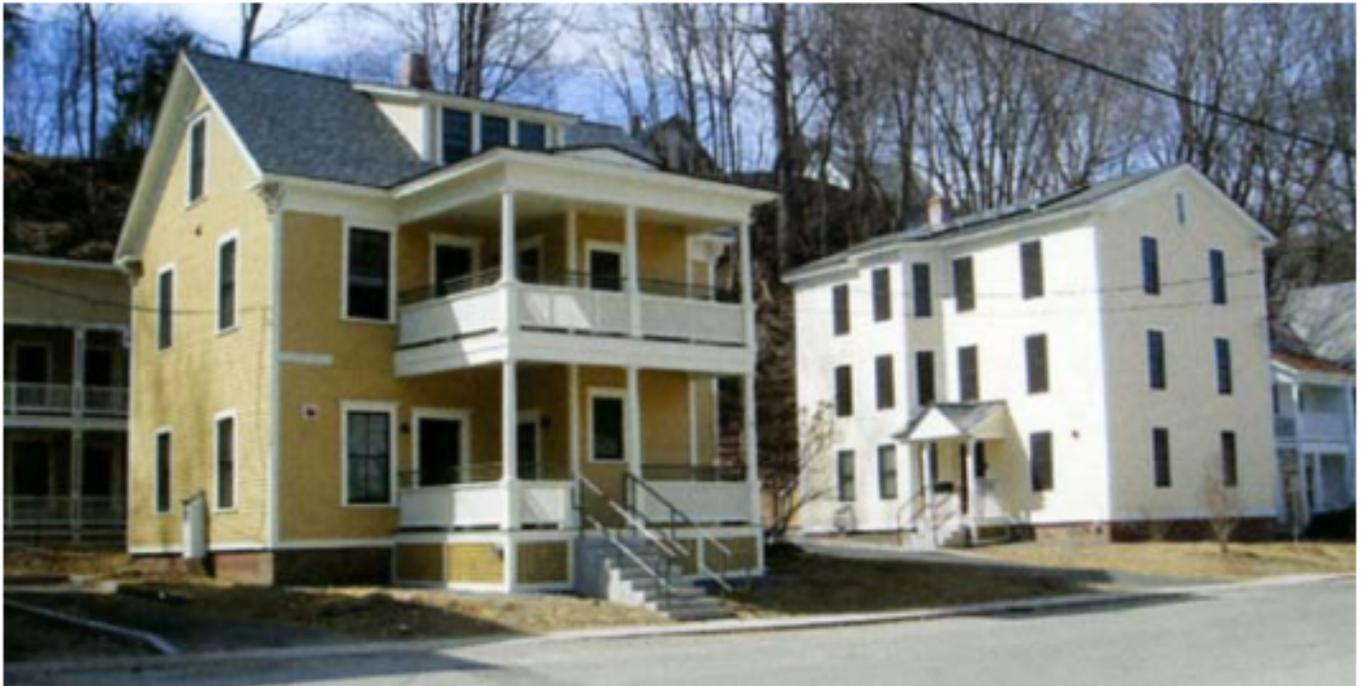
From this angle, the panels are more noticeable, yet the historic character of the building is not significantly diminished.

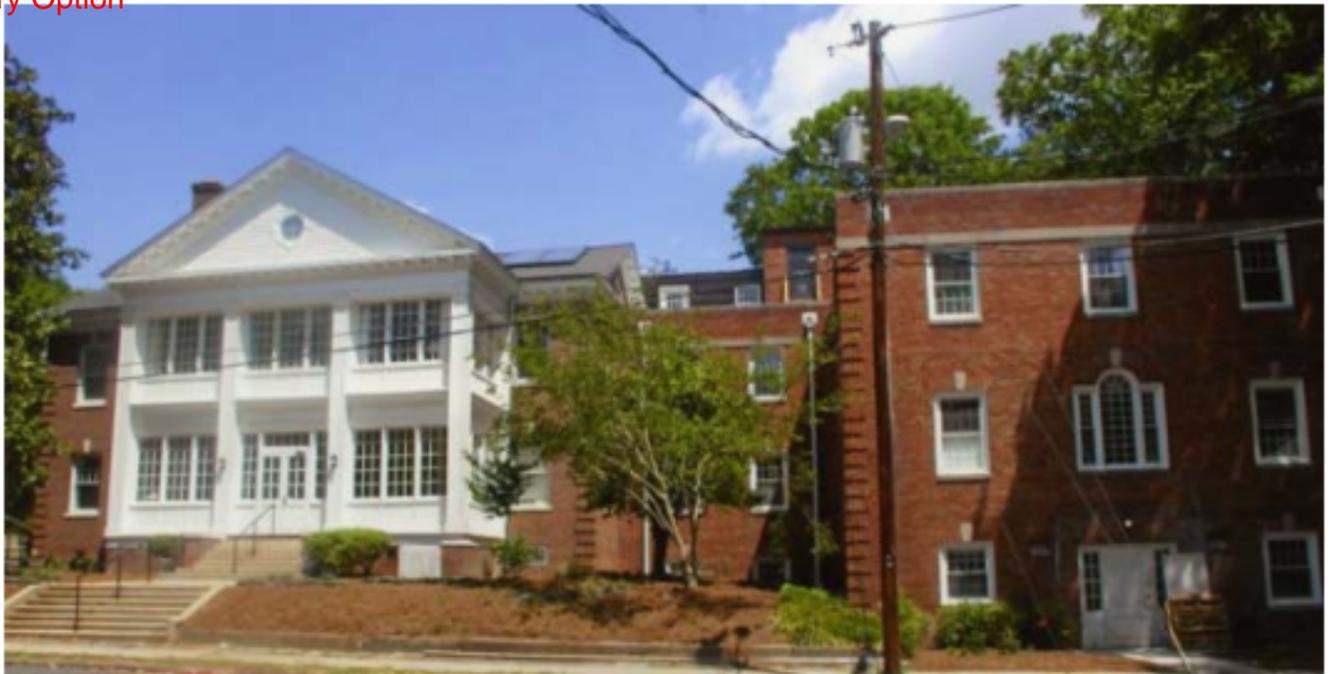
The visual prominence of the two solar collectors installed on this project is further minimized by the complexity of this side elevation.

Several specific circumstances made it possible to install solar collectors on a street-facing slope of this gable roof. The panels were flush-mounted on a low-pitch roof, and only two were required. They were installed on a portion of the roof that is set back from the face of the building behind a prominent pediment. Thus, the solar collectors are visible but not conspicuous, and this installation meets the Standards in the context of the overall project.

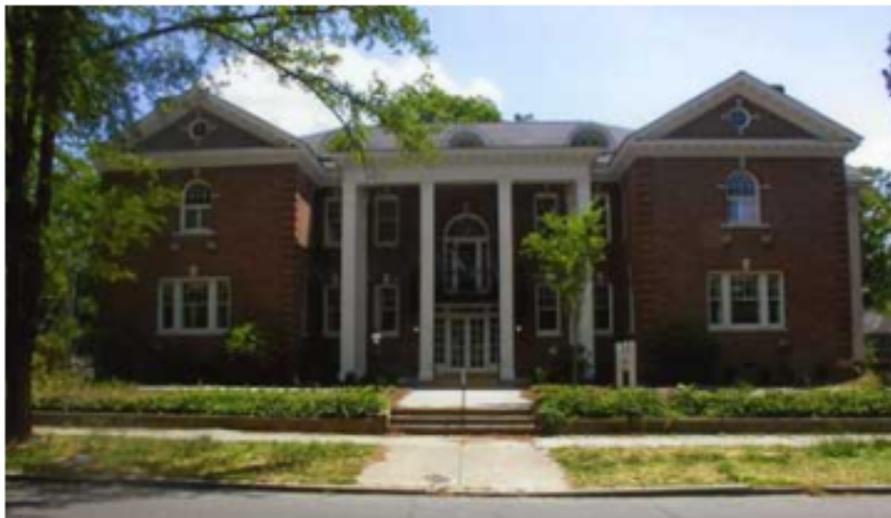
King's Daughters Home, North Carolina

The front of the King's Daughters Home. The solar panels are installed on the facade that faces the street at the right edge of this photograph.

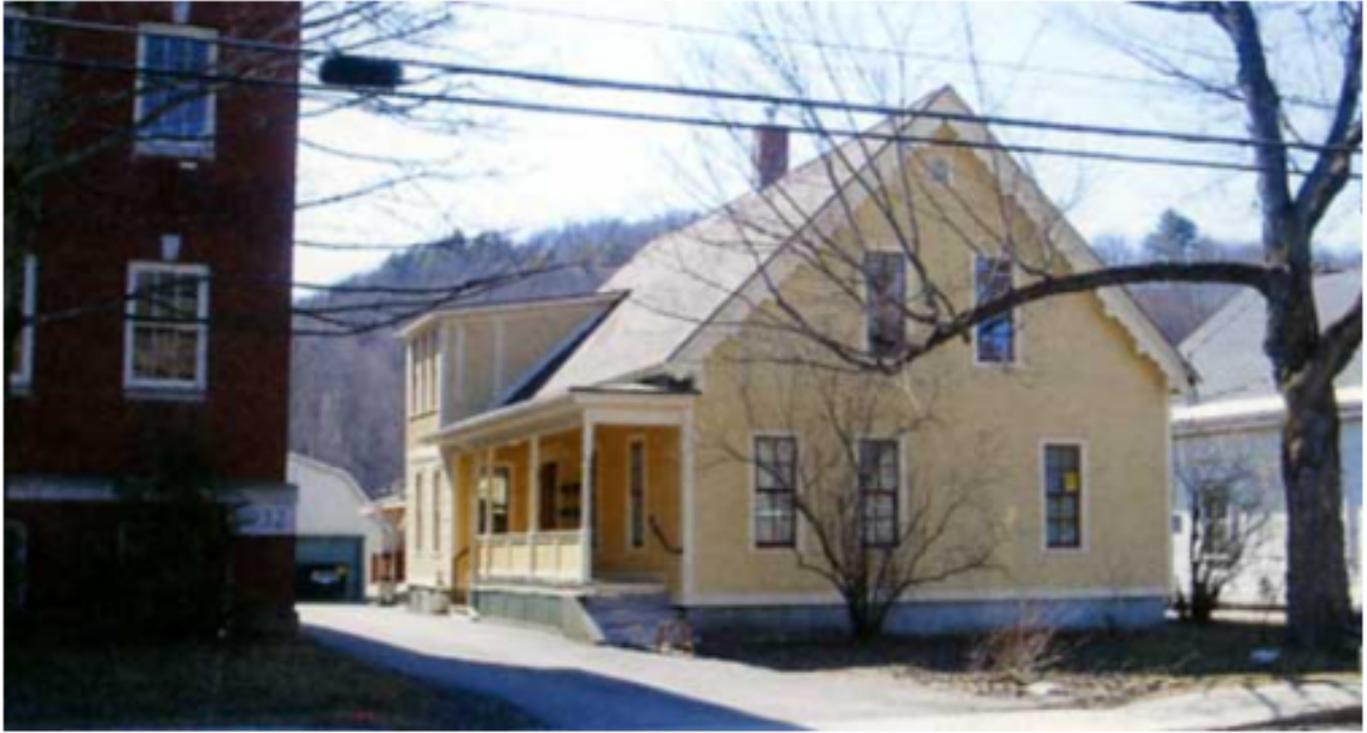
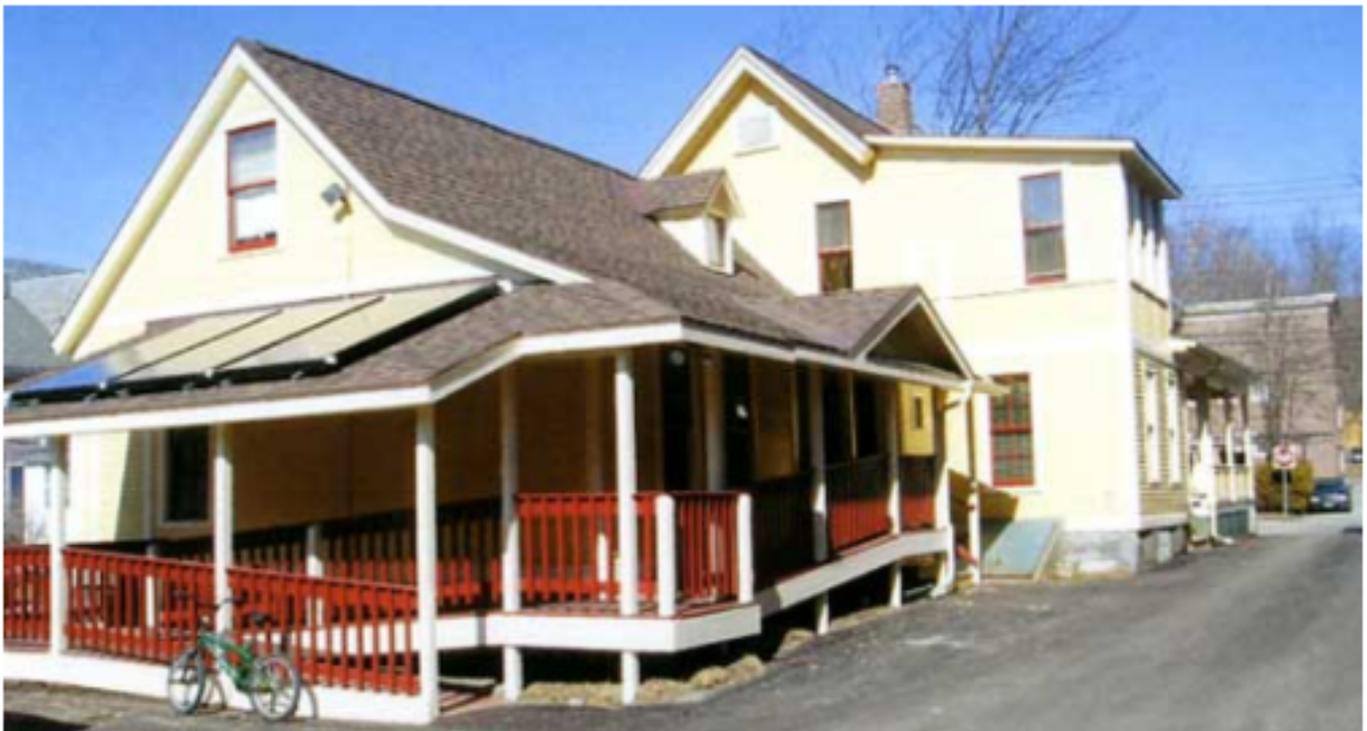
This view of the historic house from the front shows that it retains its historic character (above), because the solar collectors were installed on the sloped roof over a new access ramp at the rear of the property and are not visible from the street (below).

This is another example of a minimally intrusive installation of a solar hot water system. The solar collectors are located on a new roof sheltering an access ramp added to the rear of the residence. In some instances, new additions may provide opportunities to incorporate solar panels on a historic property in a sensitive way.

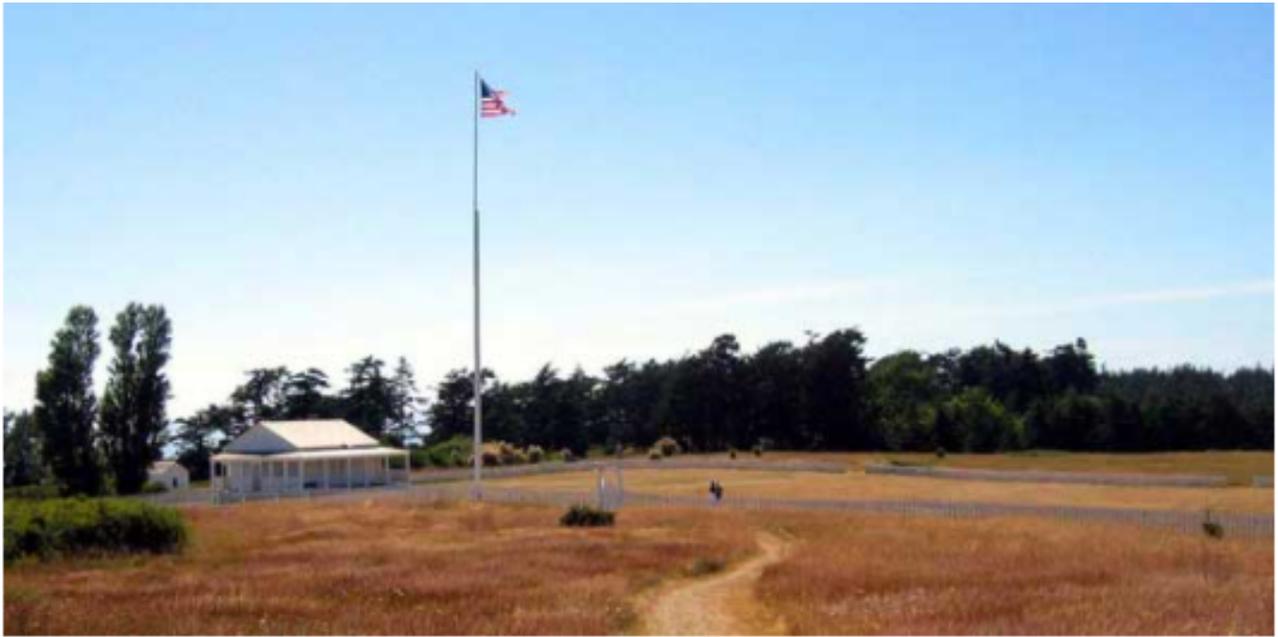
Locating solar arrays off-site allowed for the preservation of the historic character of the buildings and cultural landscape as well as the important vistas within San Juan Island National Historical Park.

It can be extremely difficult to find an appropriate location for solar panels for large historic sites where the cultural landscape is as important as the historic structures. The National Park Service found an innovative solution to such a problem at San Juan Island NHP in Washington state by partnering with a local utility company to create a renewable energy system off site. The utility company provided land at a customer service center, and the park purchased and installed a photovoltaic system. Under the agreement, the park is credited with the energy production of the solar panels, and visitors still enjoy the National Historical Park without the visual intrusion of modern-day technology.

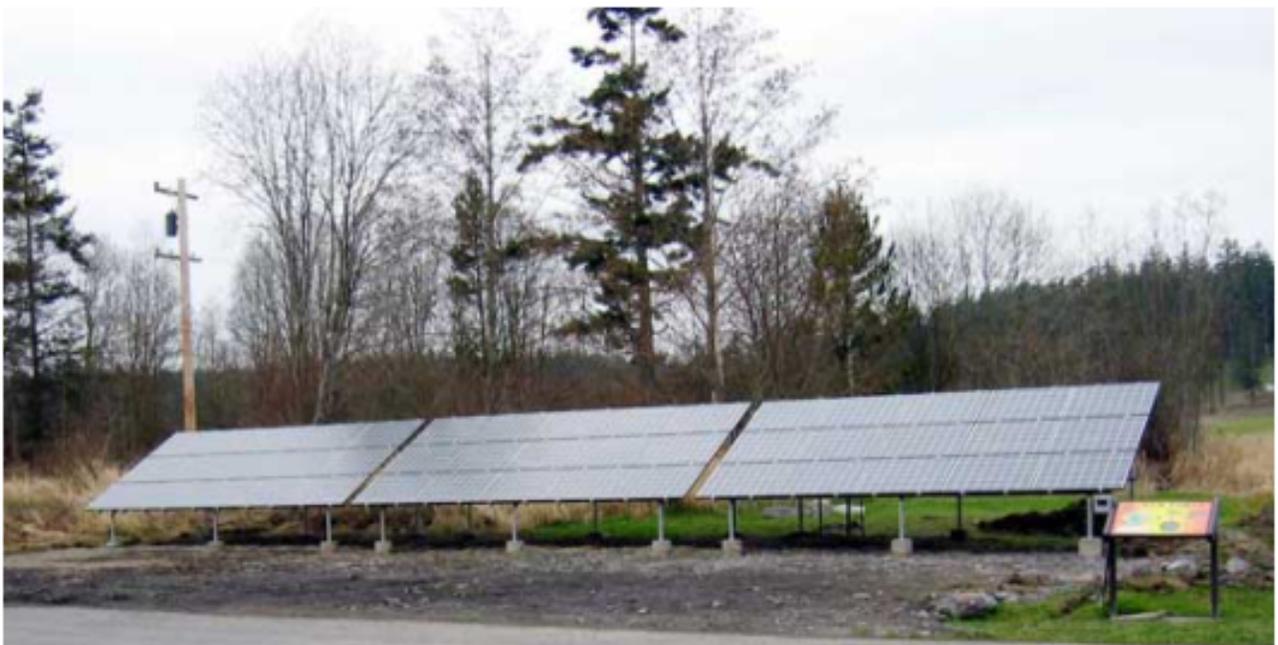
This large solar array serves the National Historical Park, but it is located outside park boundaries.
