WESTERN RESERVE ACADEMY: ELLSWORTH HALL

Hudson AHRB Submission

Schematic Design Review | April 26, 2023

14 PRESERVATION BRIEFS

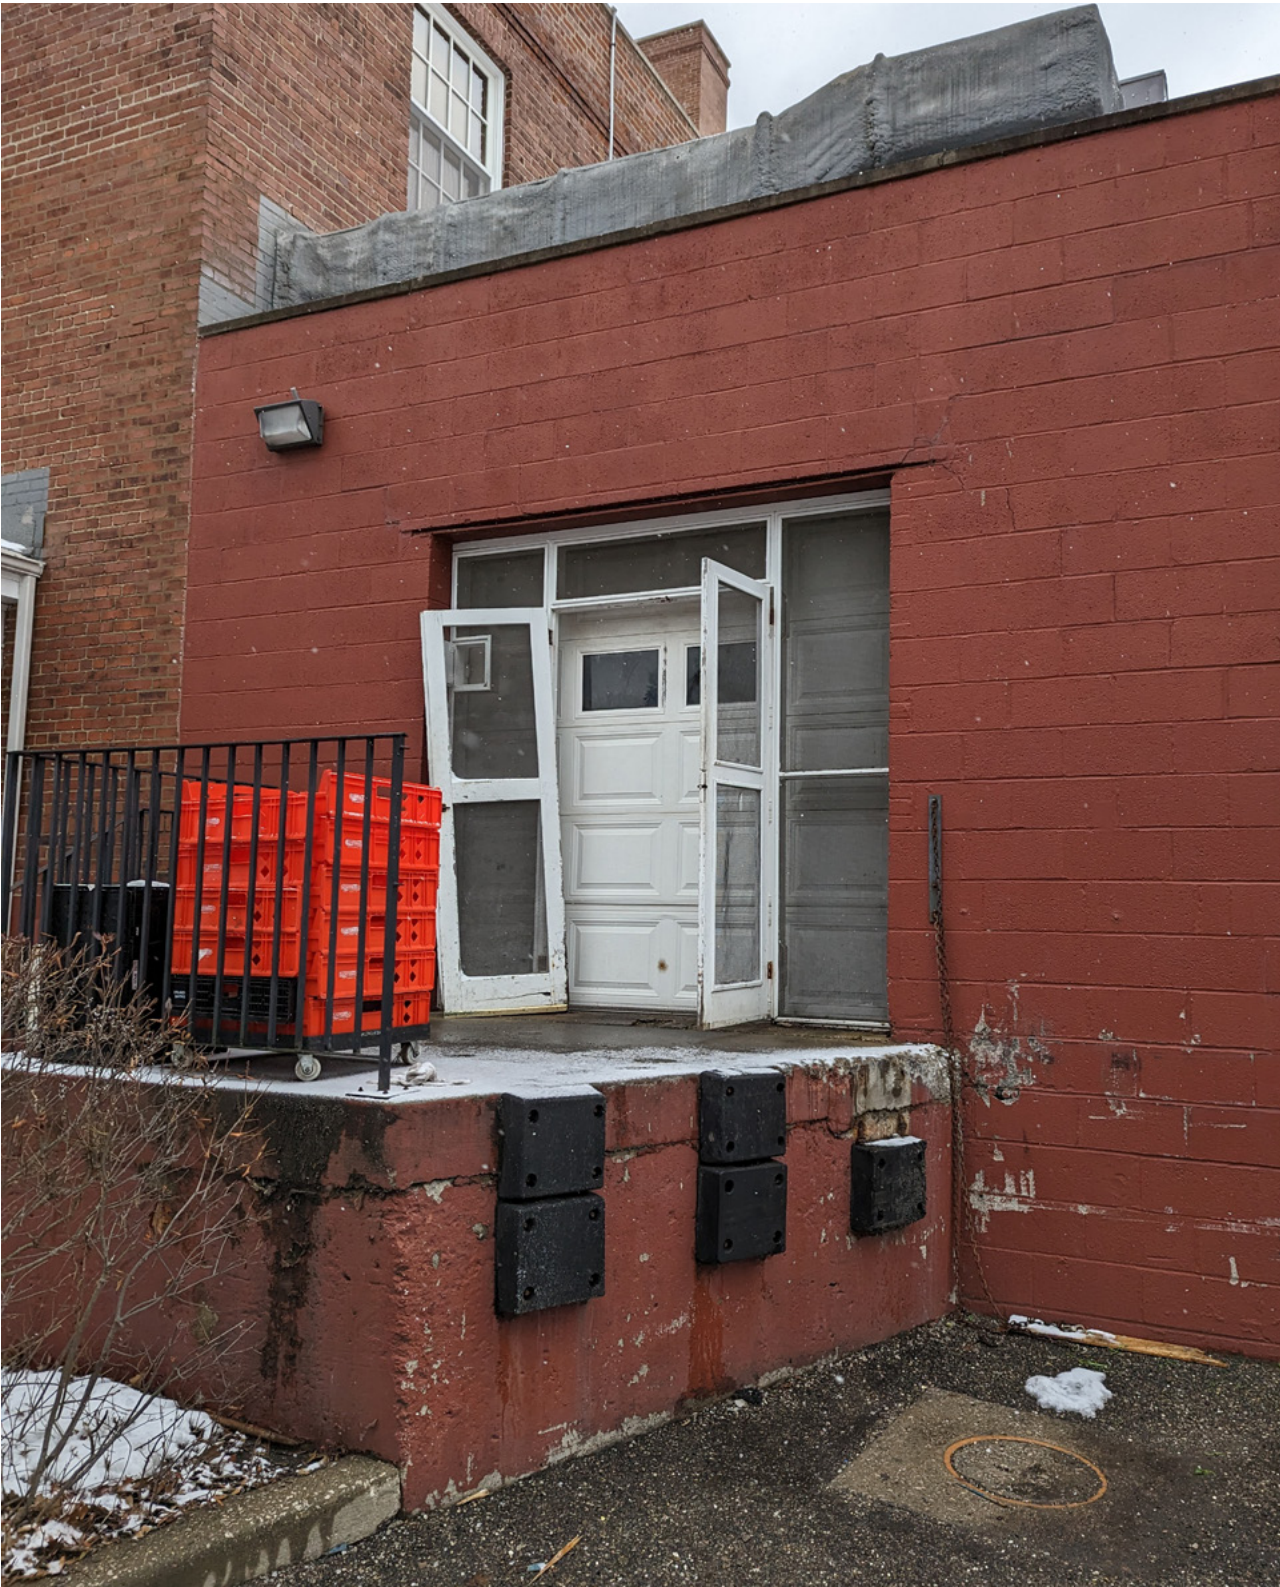
View of Ellsworth Hall truck dock and delivery drop-off access door

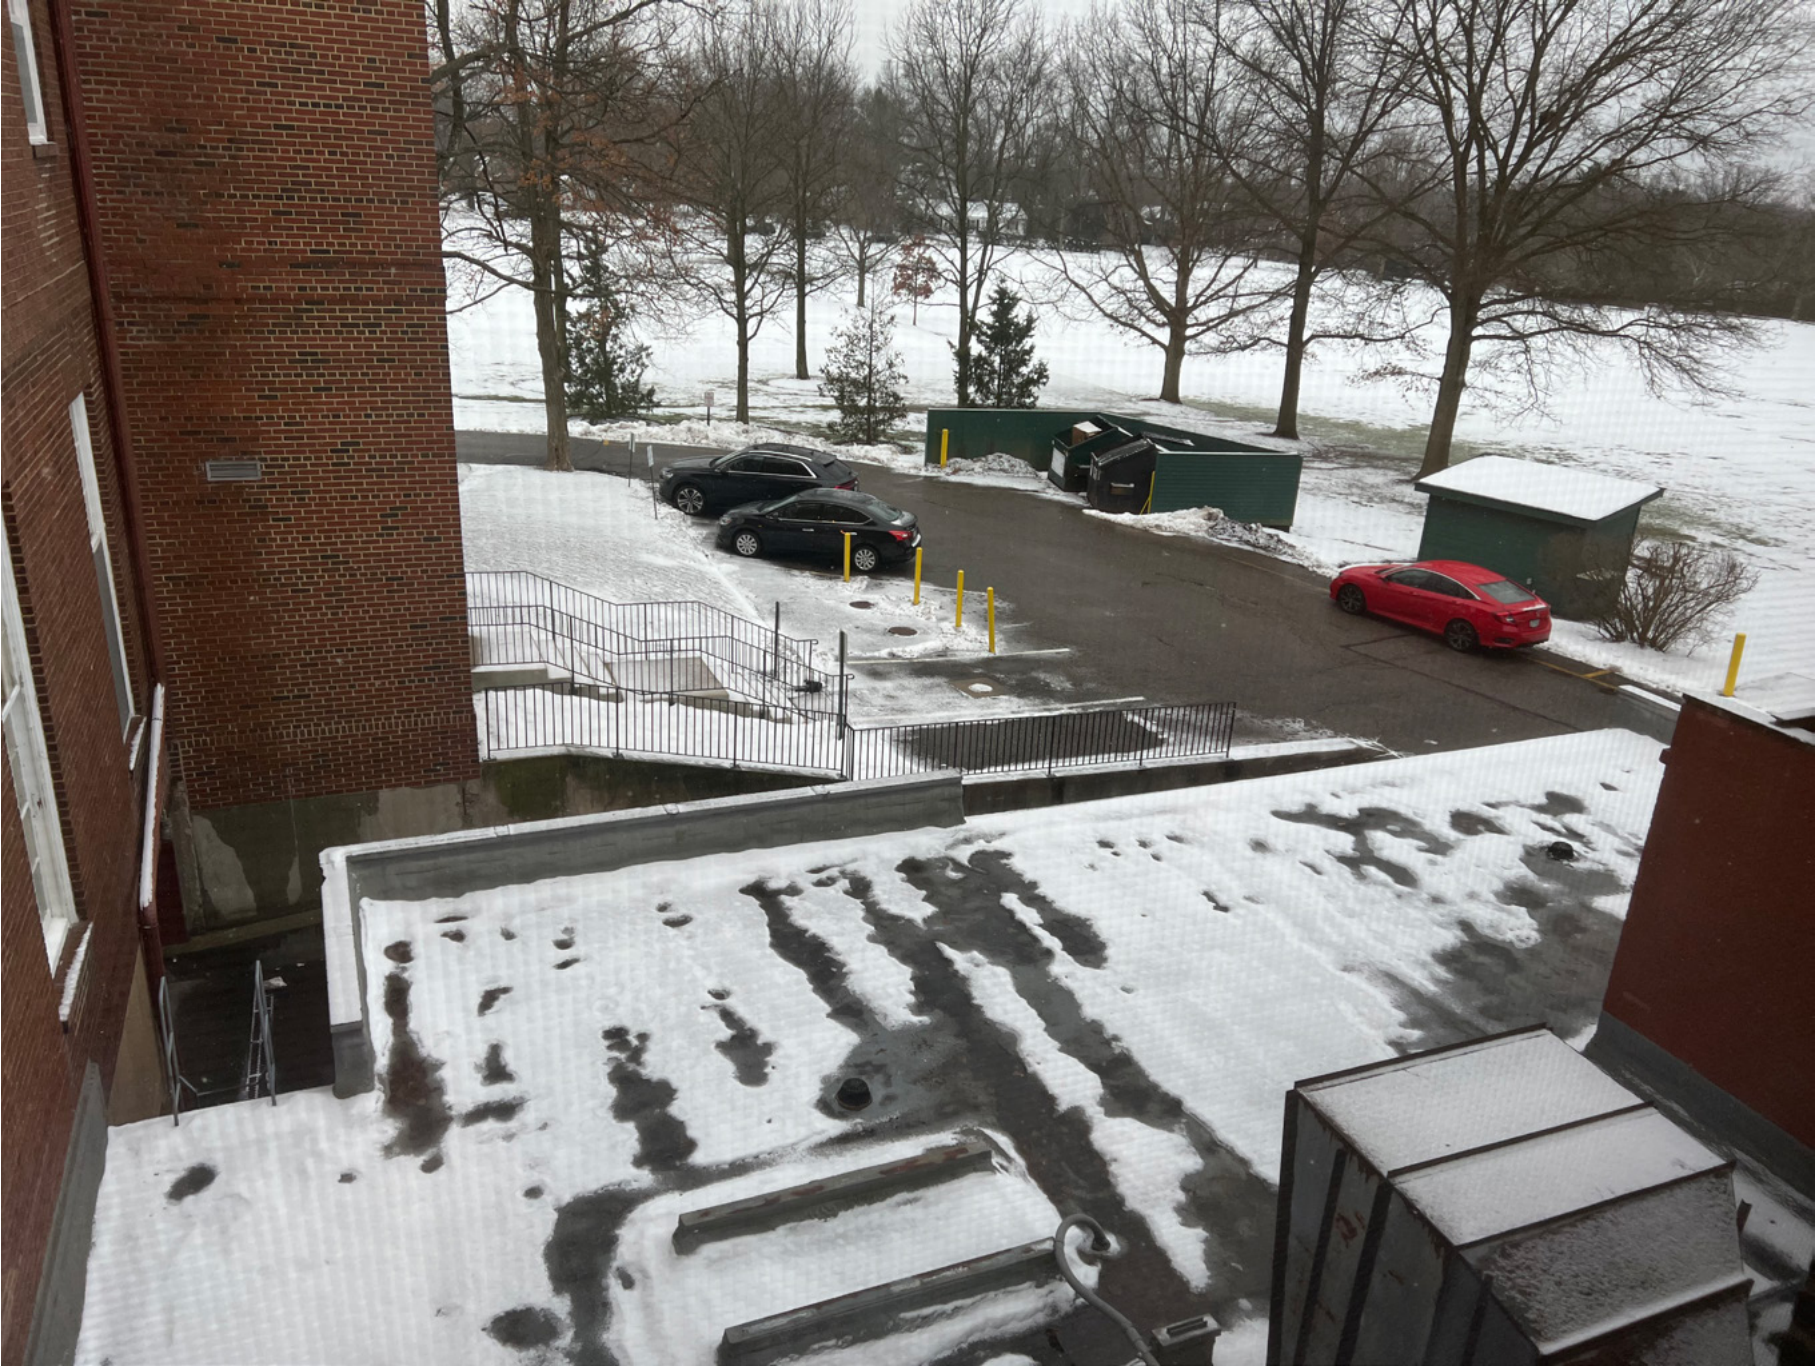
View of Ellsworth Hall service addition rooftop and equipment, looking South-West from Second Floor of residential hall west wing

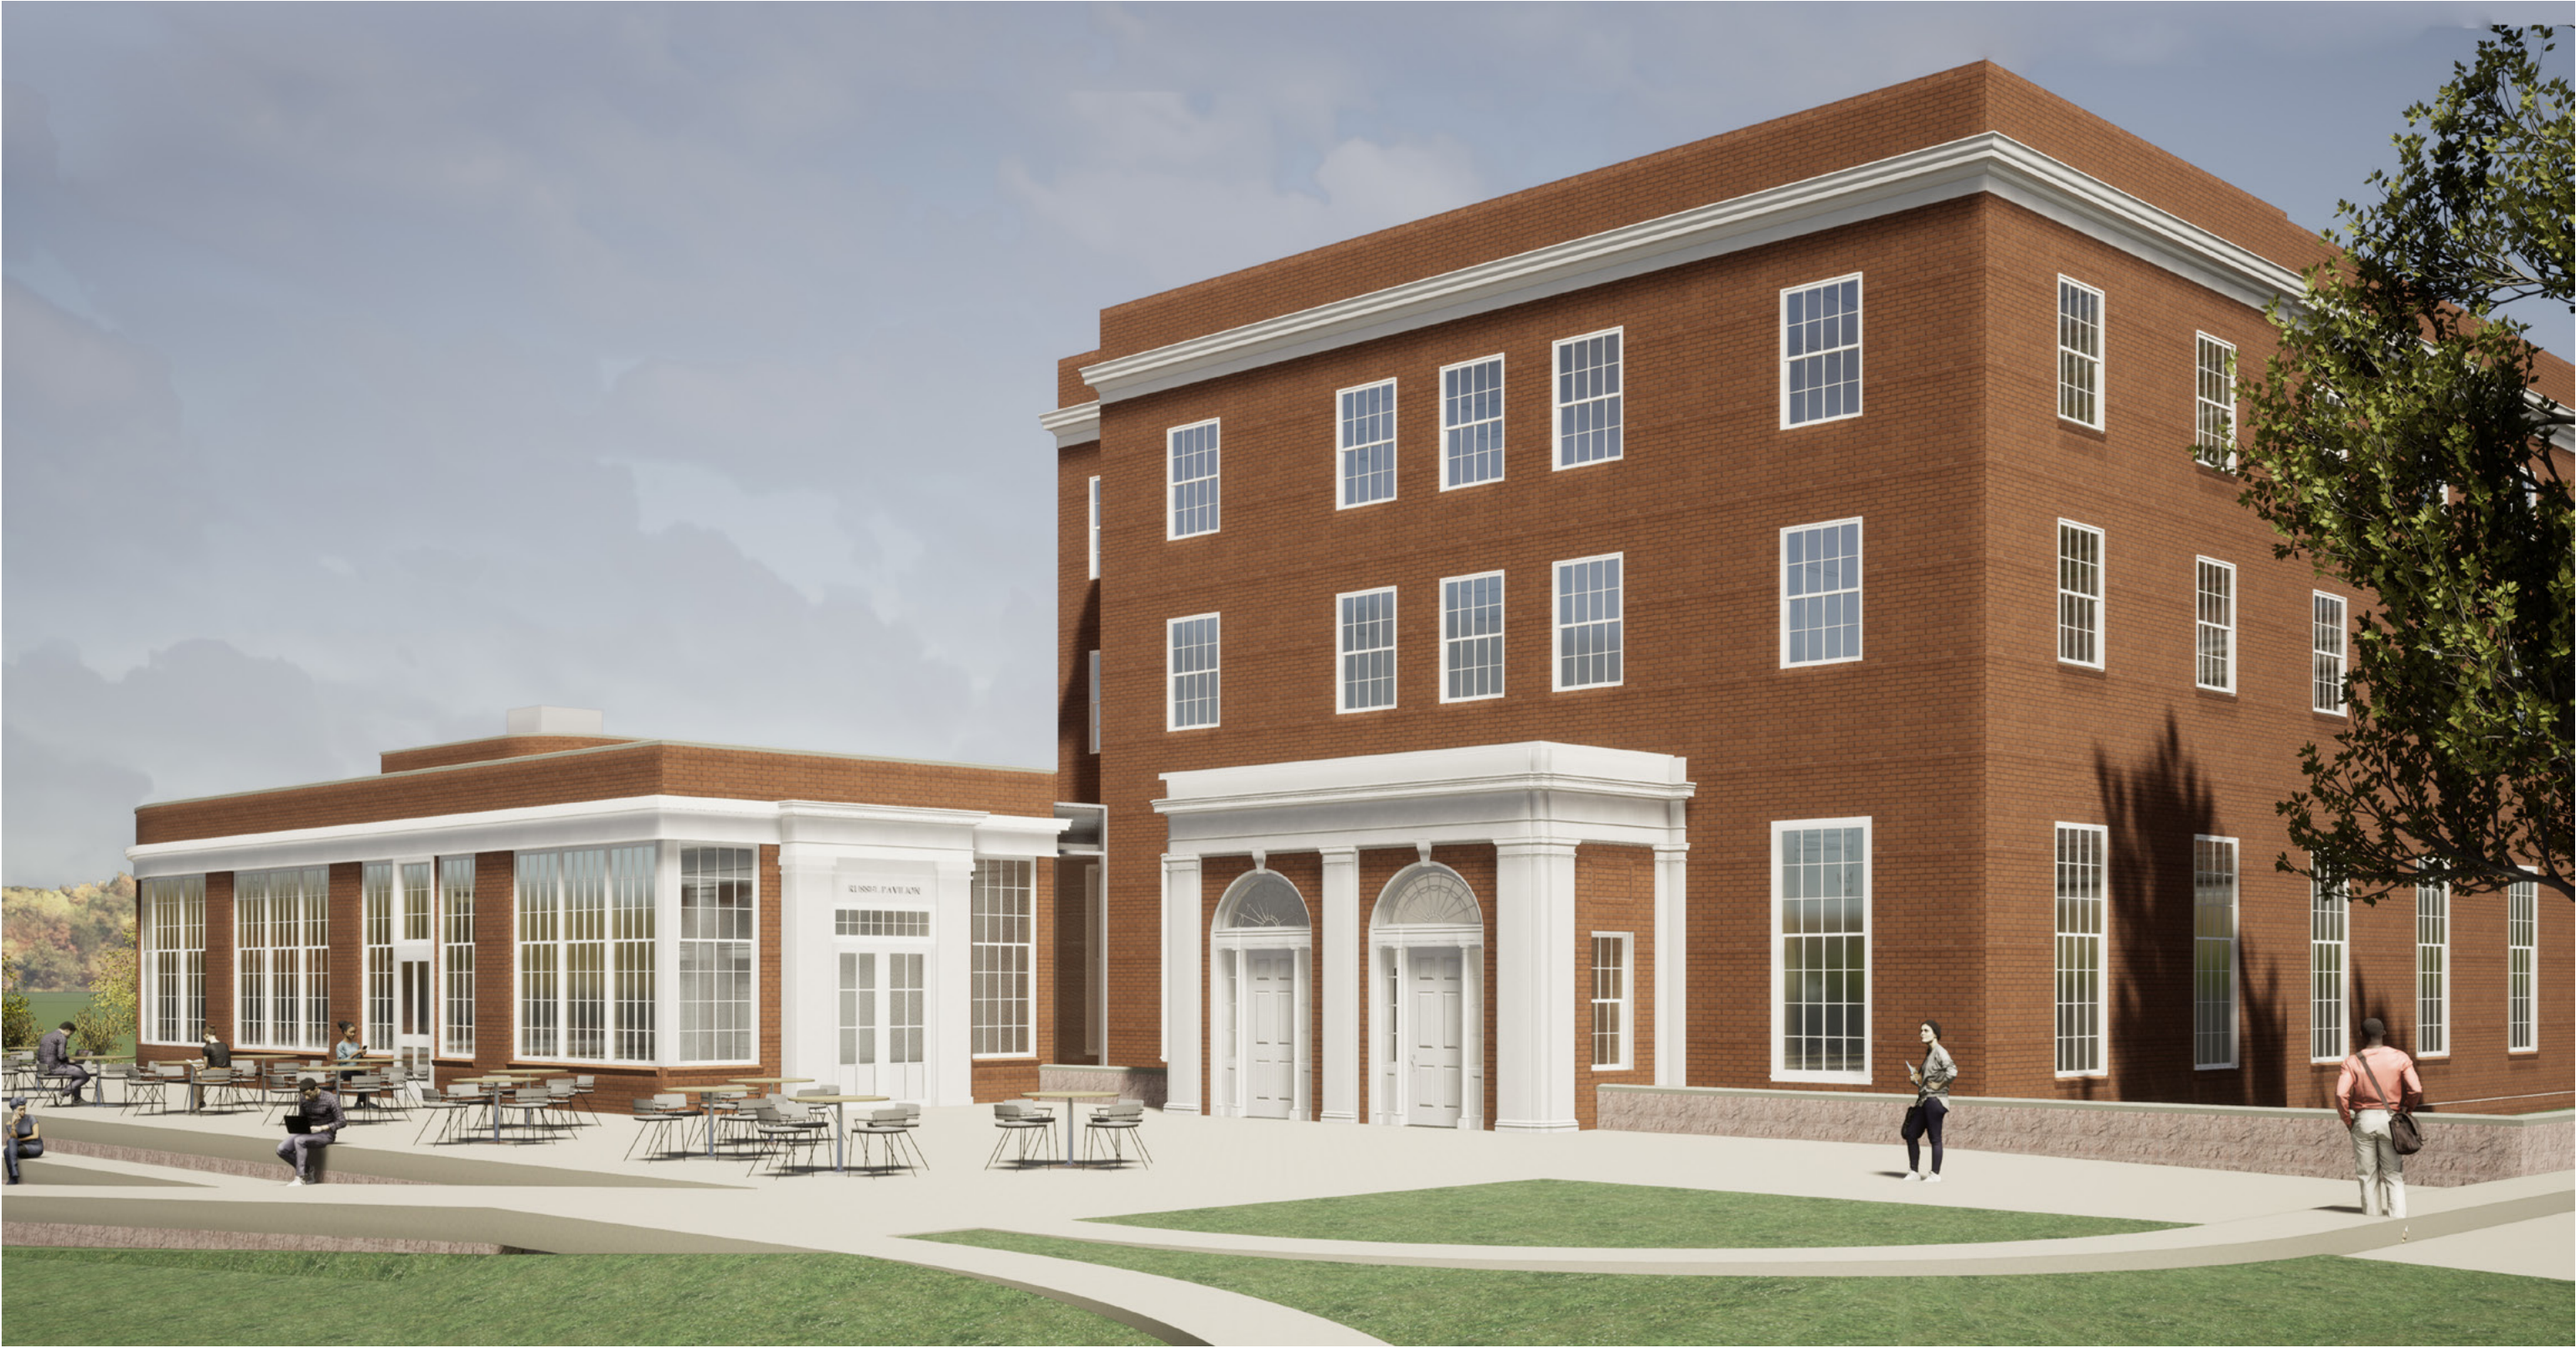
EXTERIOR PERSPECTIVE

VIEW FROM COLLEGE STREET LOOKING NORTH-WEST

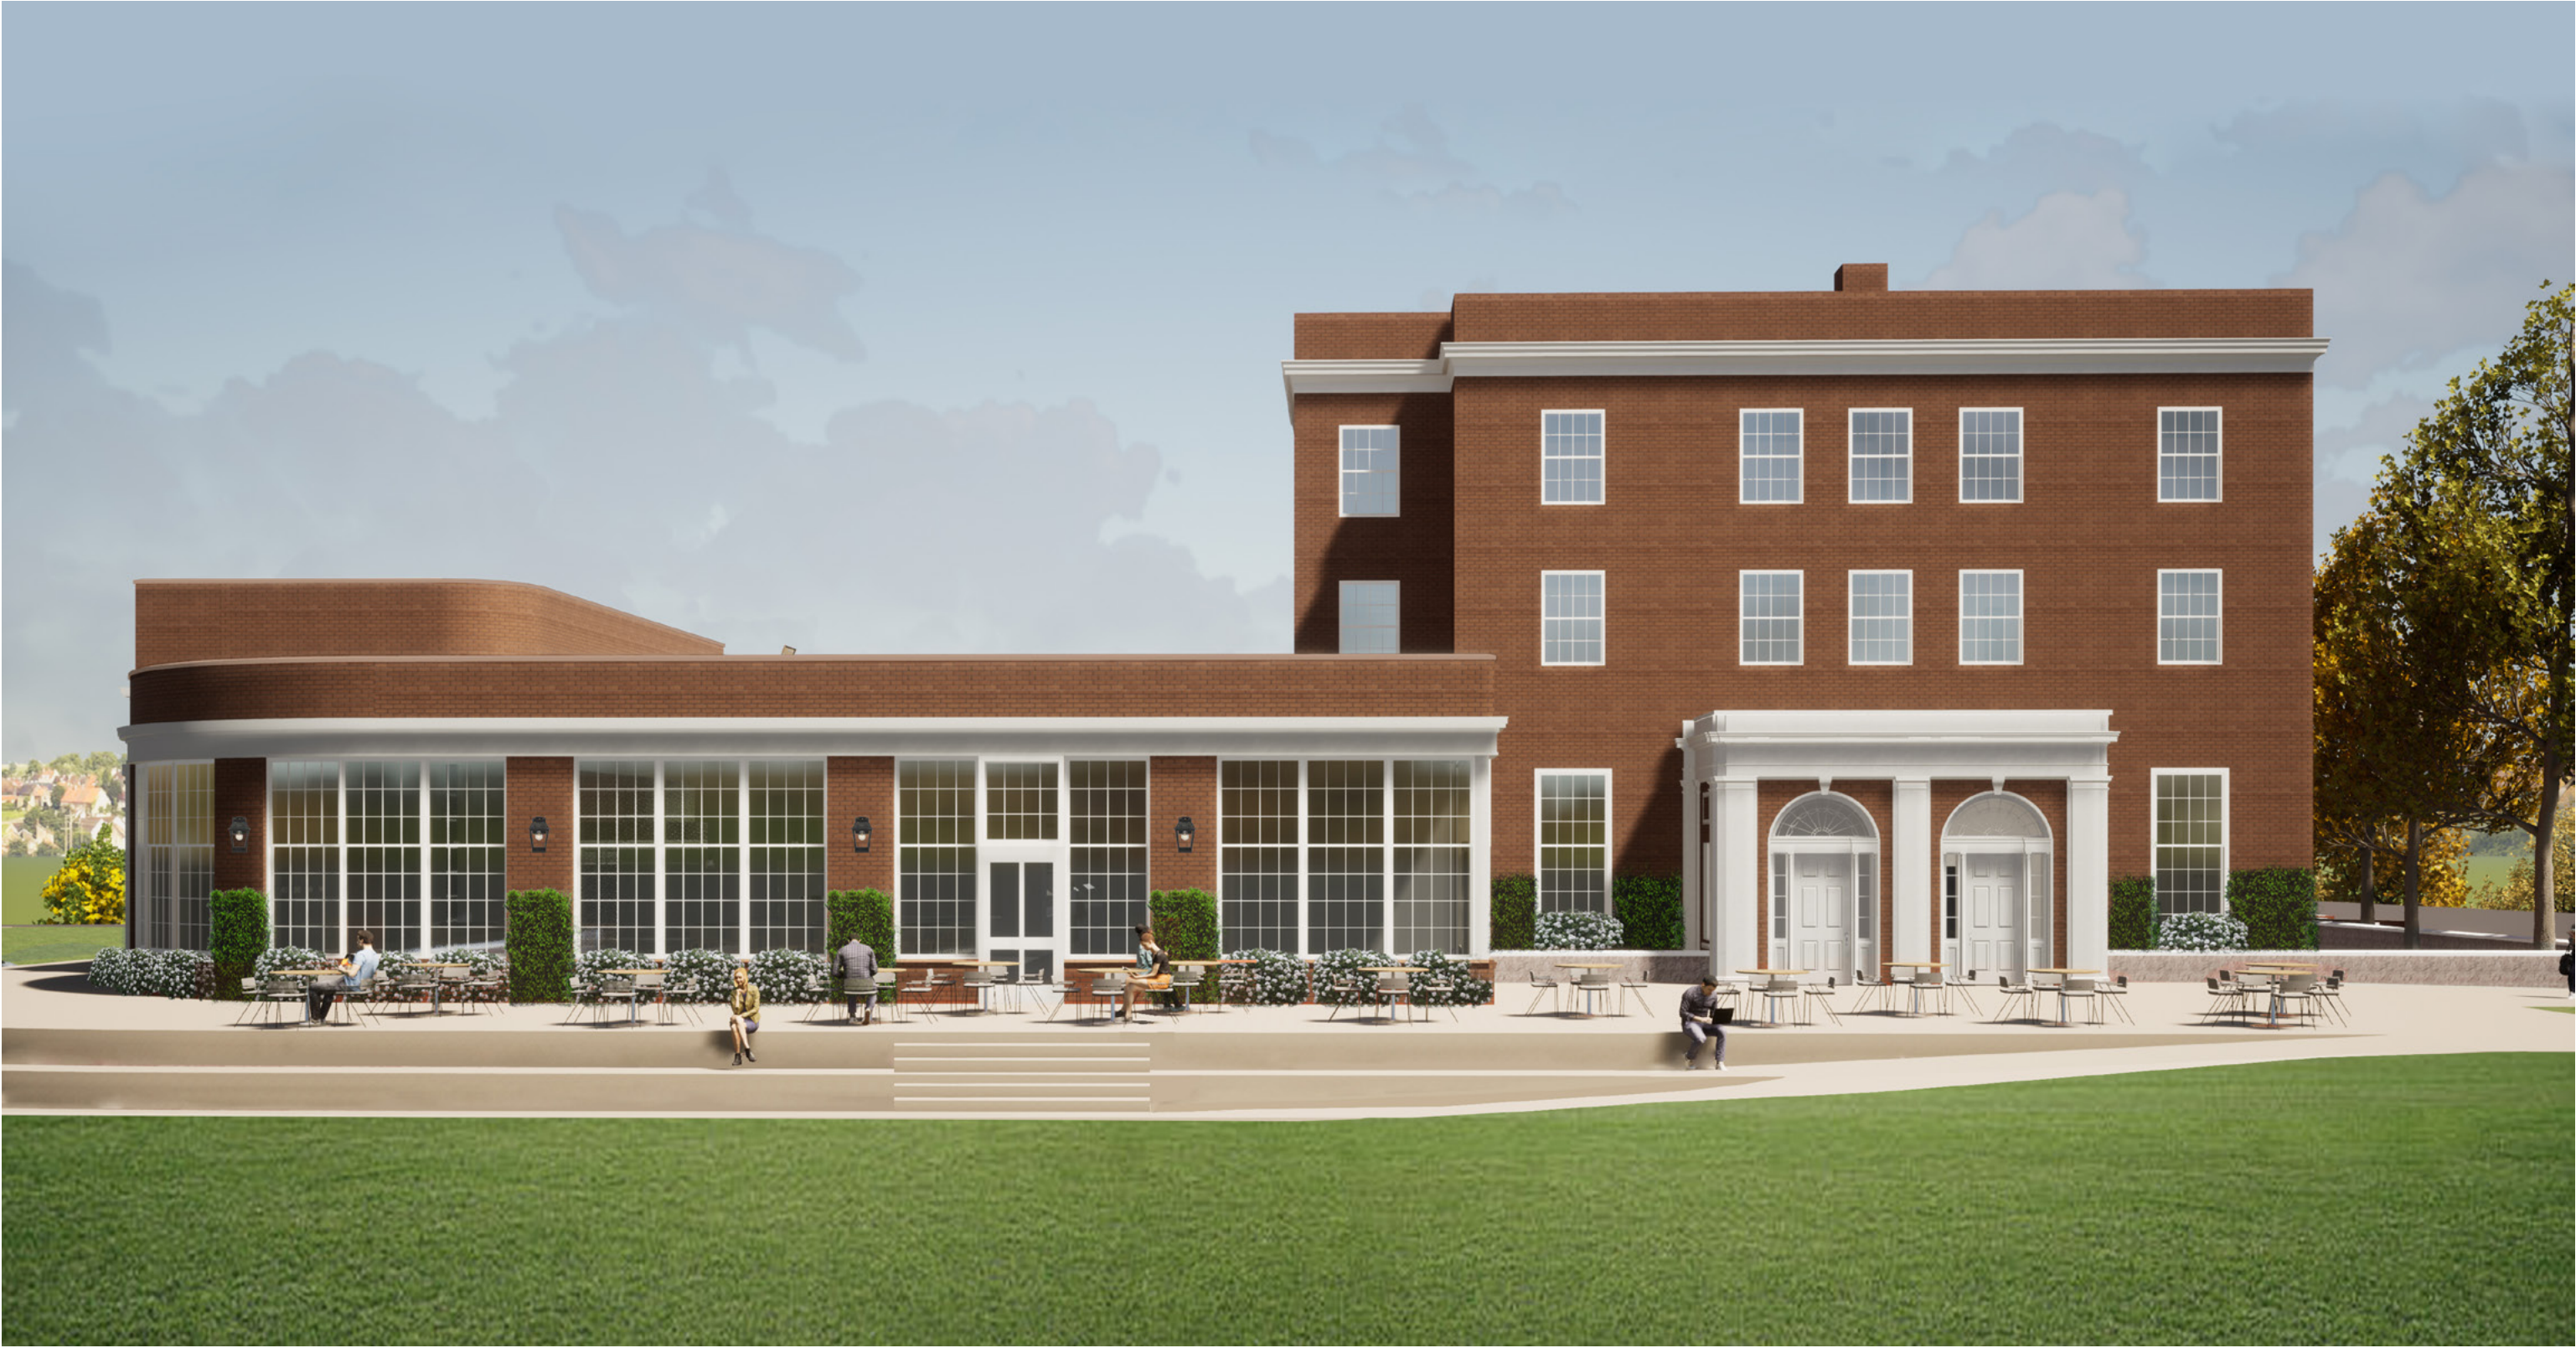
EXTERIOR ELEVATION STUDY

VIEW FROM PRACTICE FIELDS LOOKING NORTH

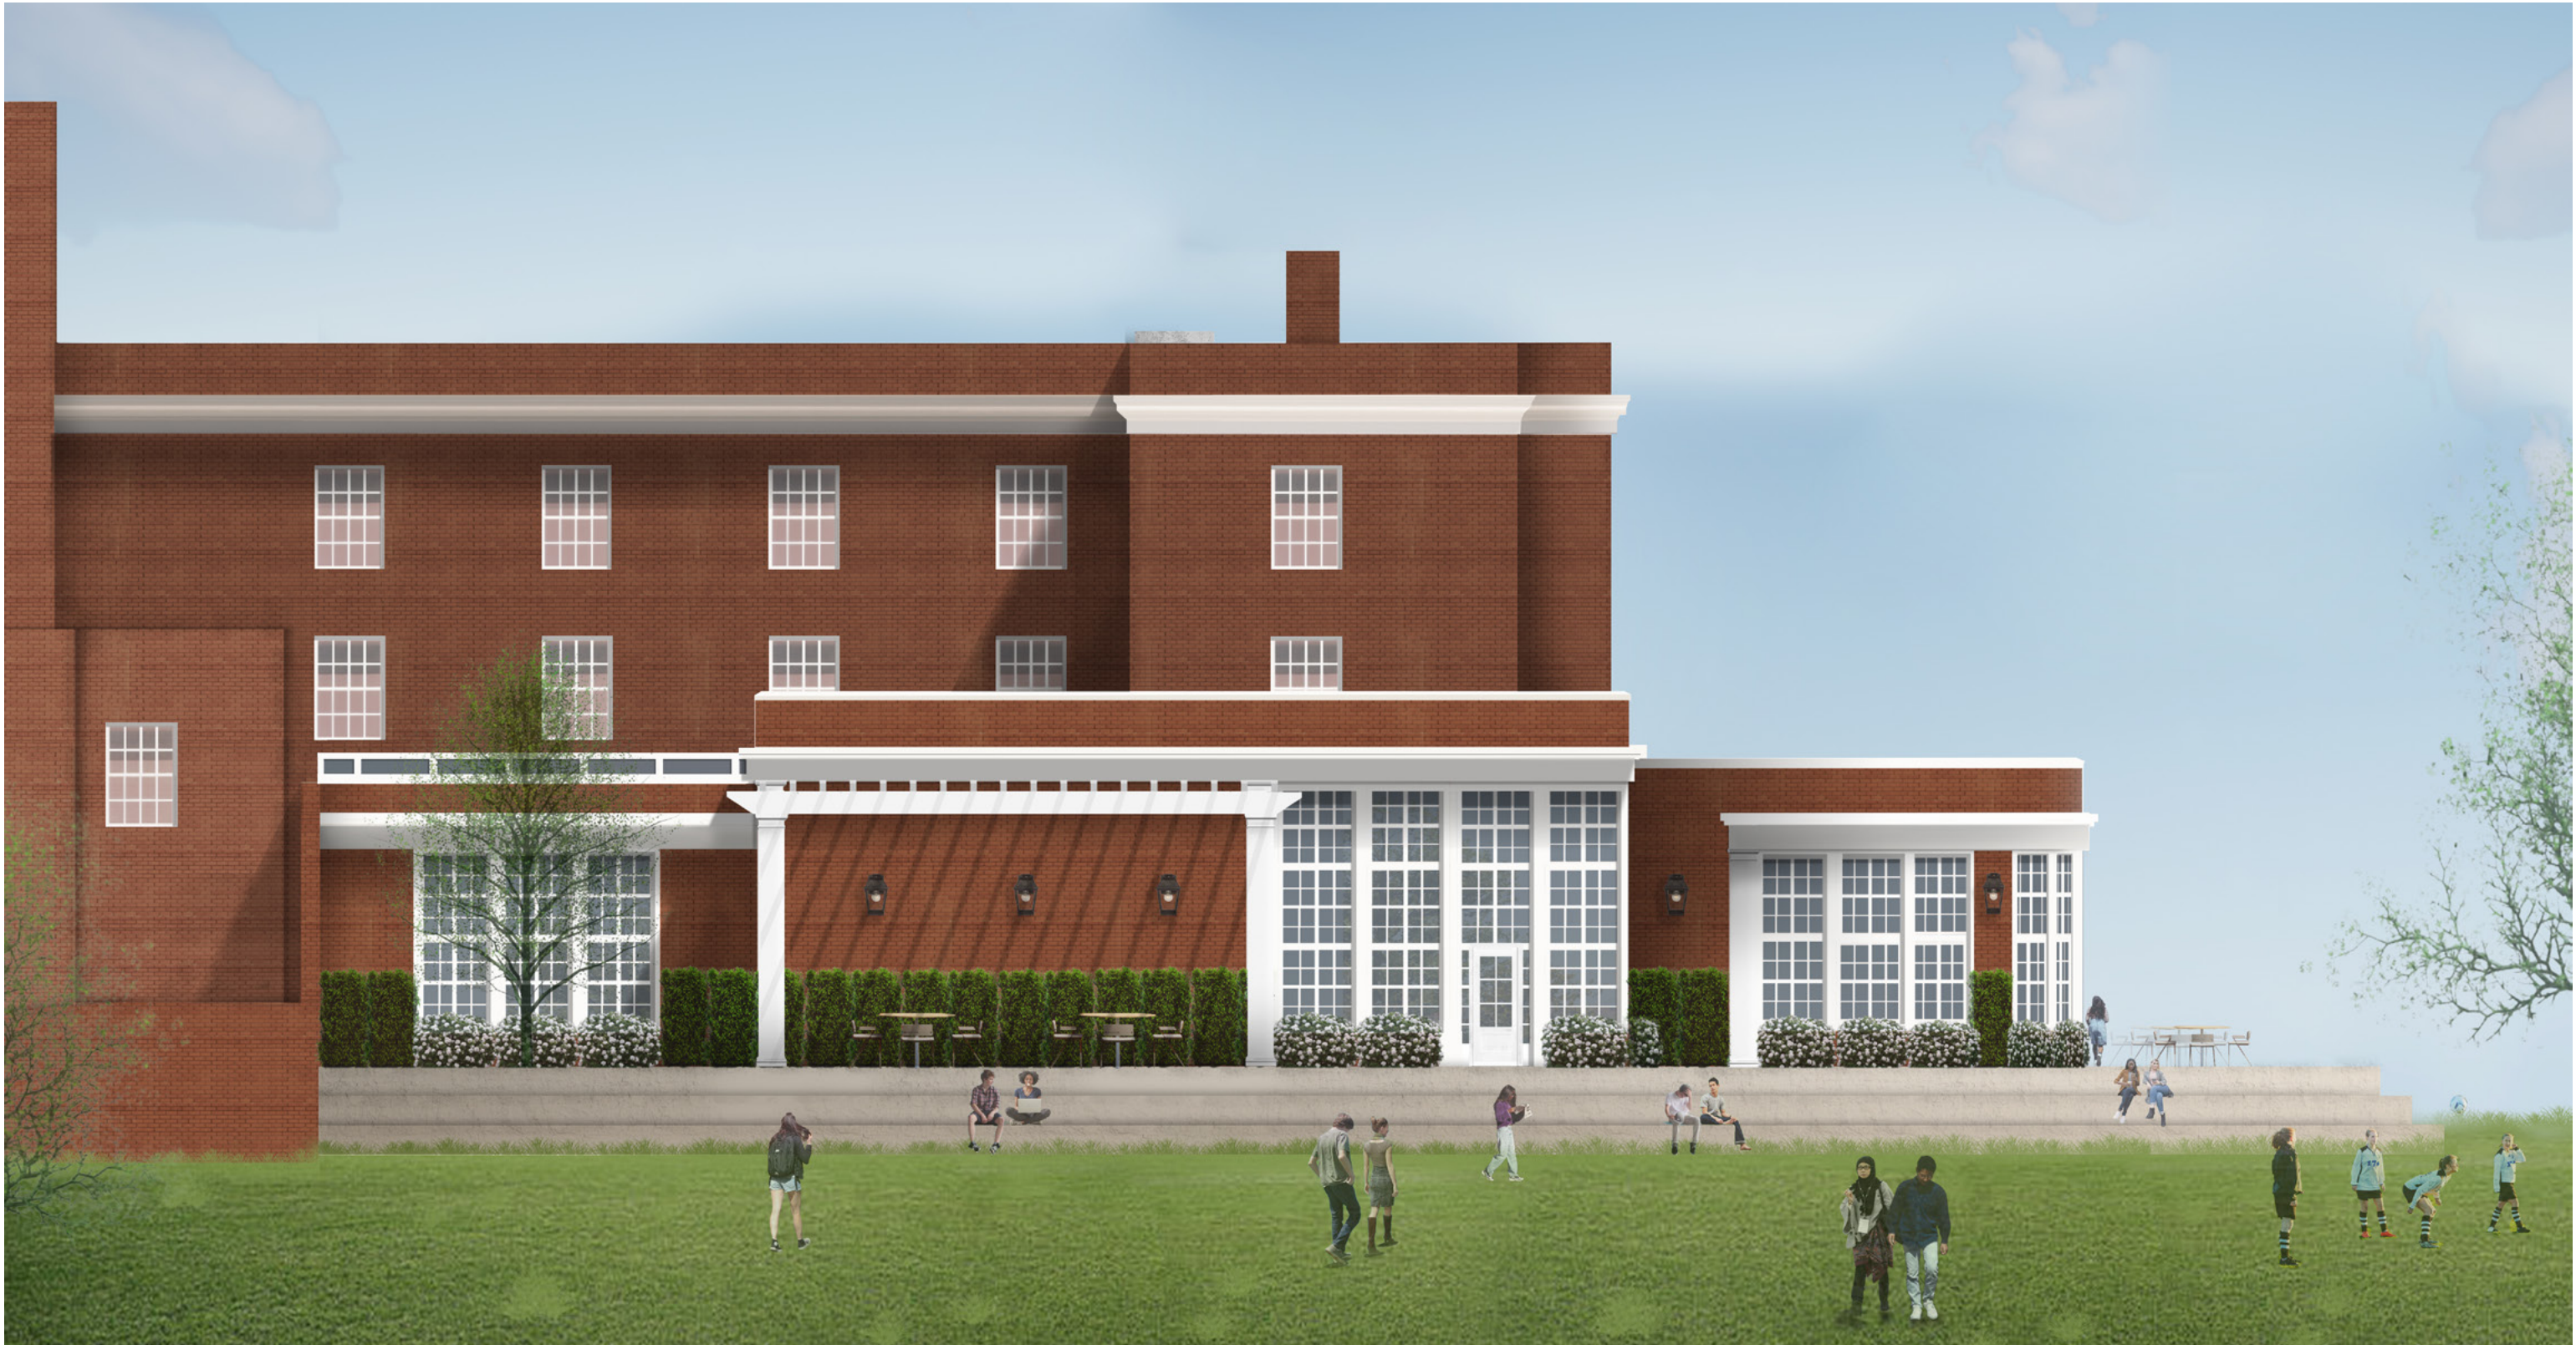
EXTERIOR ELEVATION STUDY

VIEW FROM PRACTICE FIELDS LOOKING EAST

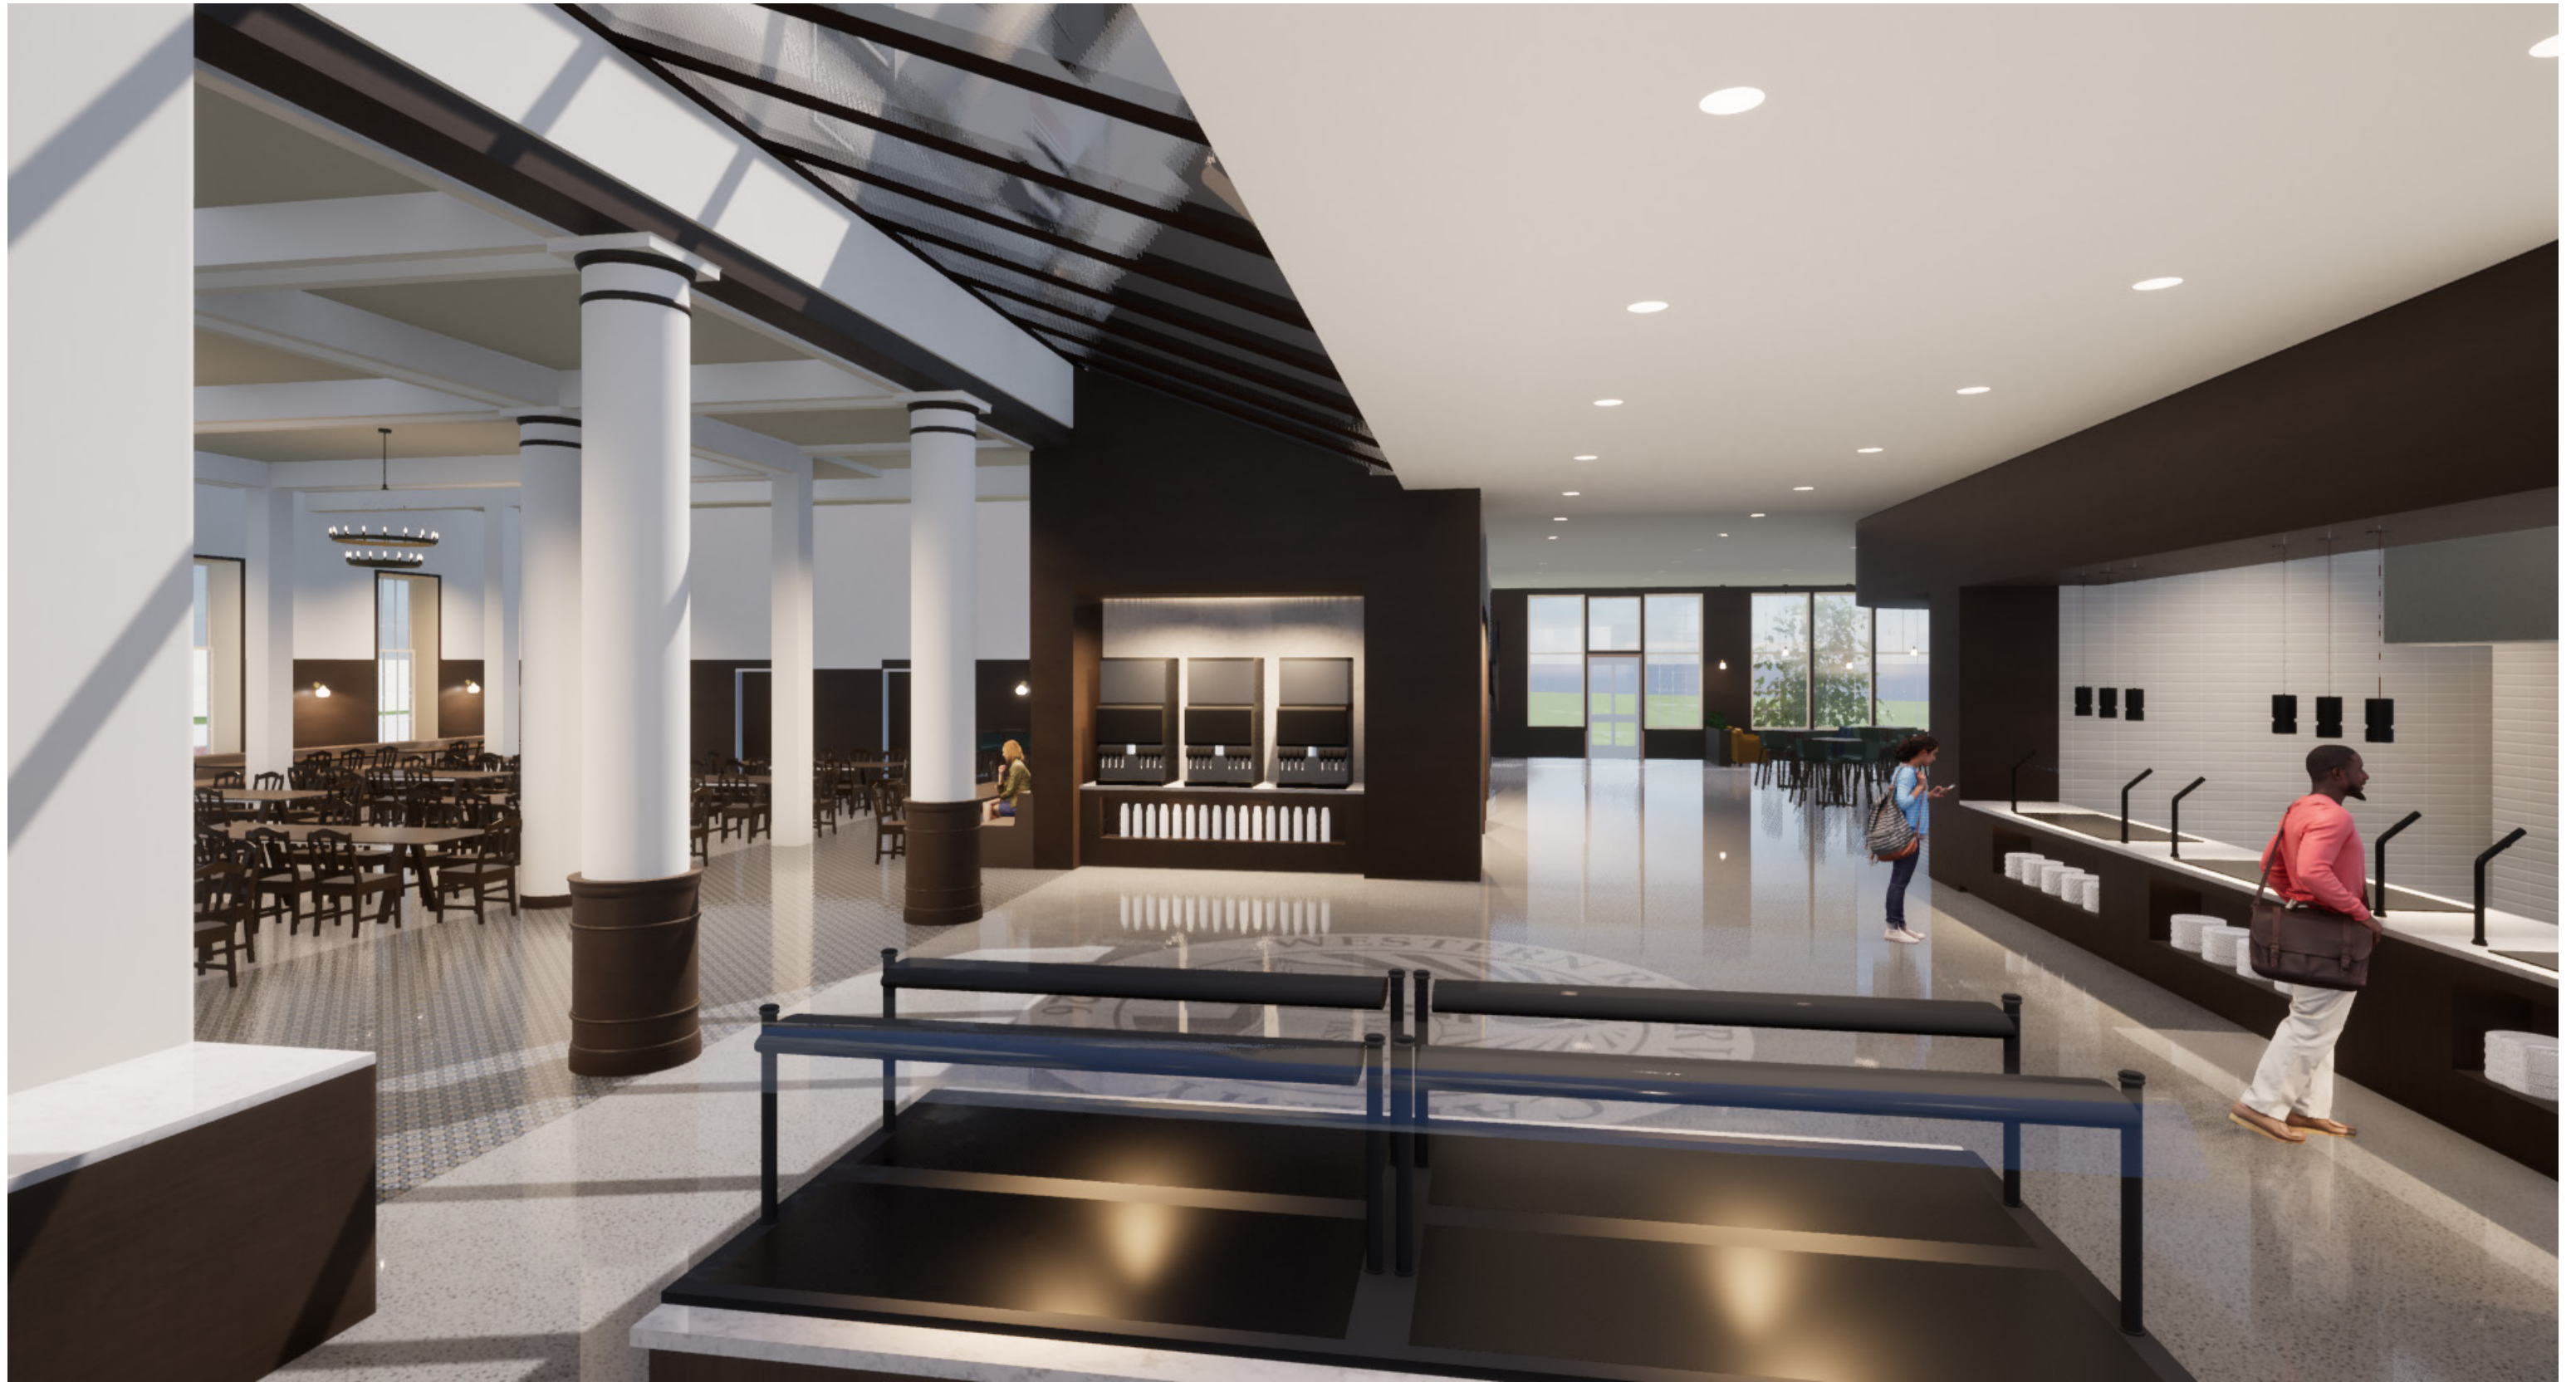
INTERIOR RENDERING STUDY

VIEW FROM SERVERY LOOKING SOUTH

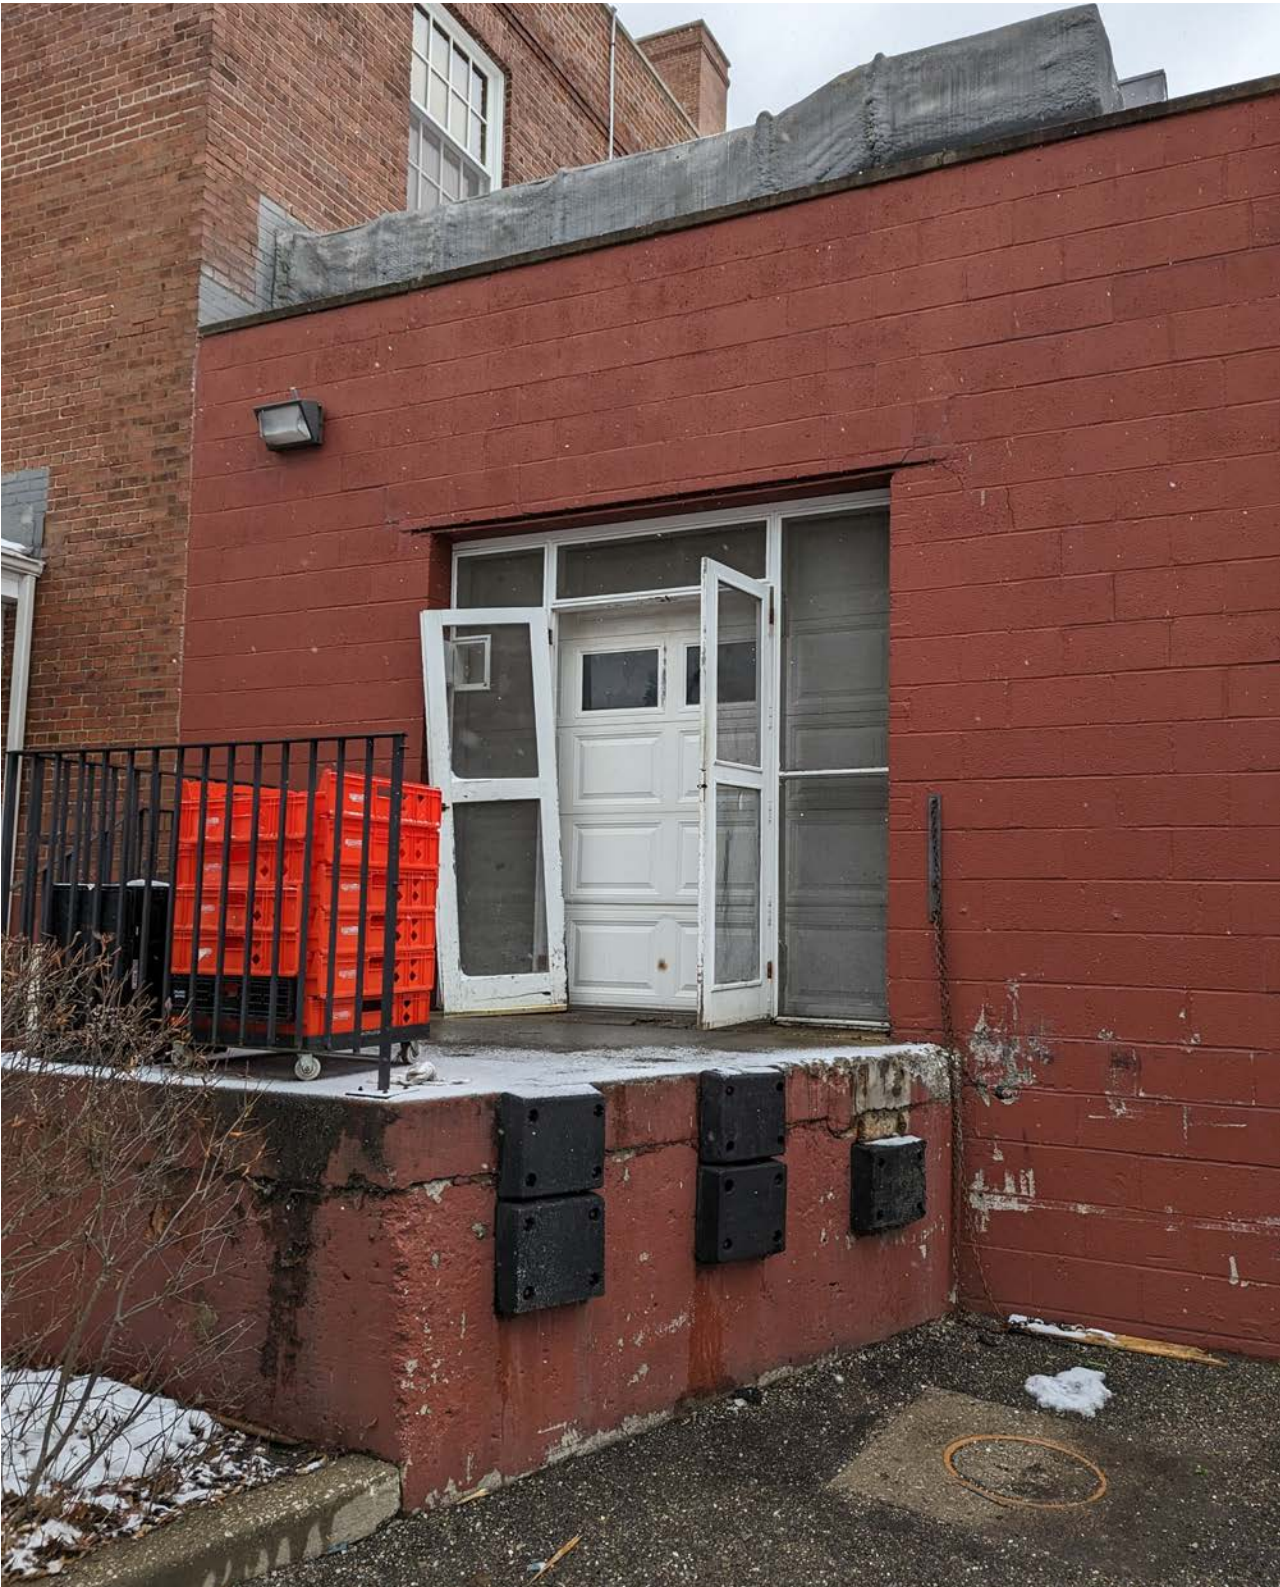
View of Ellsworth Hall truck dock and delivery drop-off access door

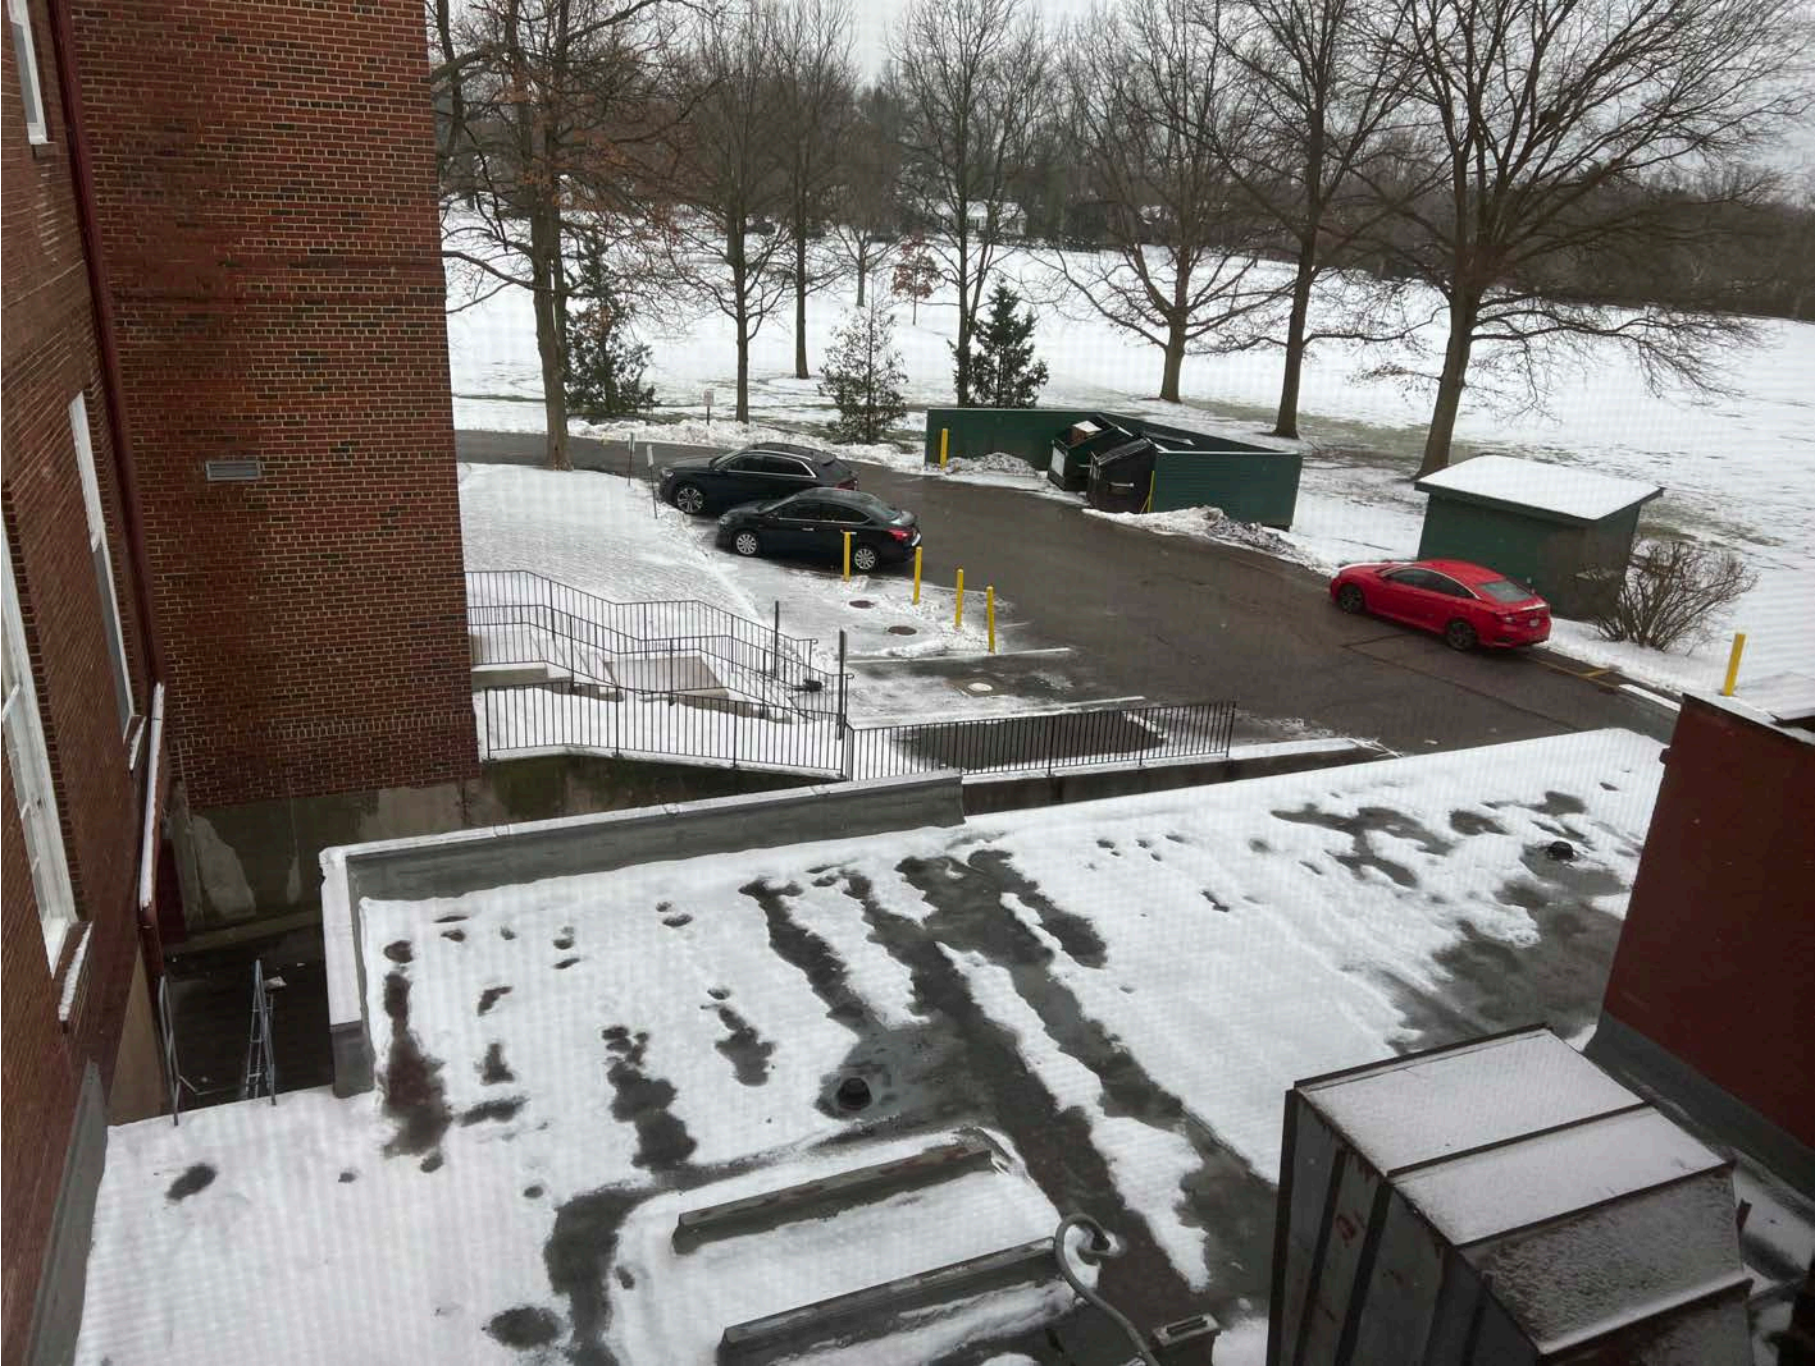
View of Ellsworth Hall service addtion rooftop and equipment, looking South-West from Second Floor of residential hall west wing
