WESTERN RESERVE ACADEMY: ELLSWORTH HALL

Hudson AHRB Submission

Schematic Design Review | April 26, 2023

14 PRESERVATION BRIEFS

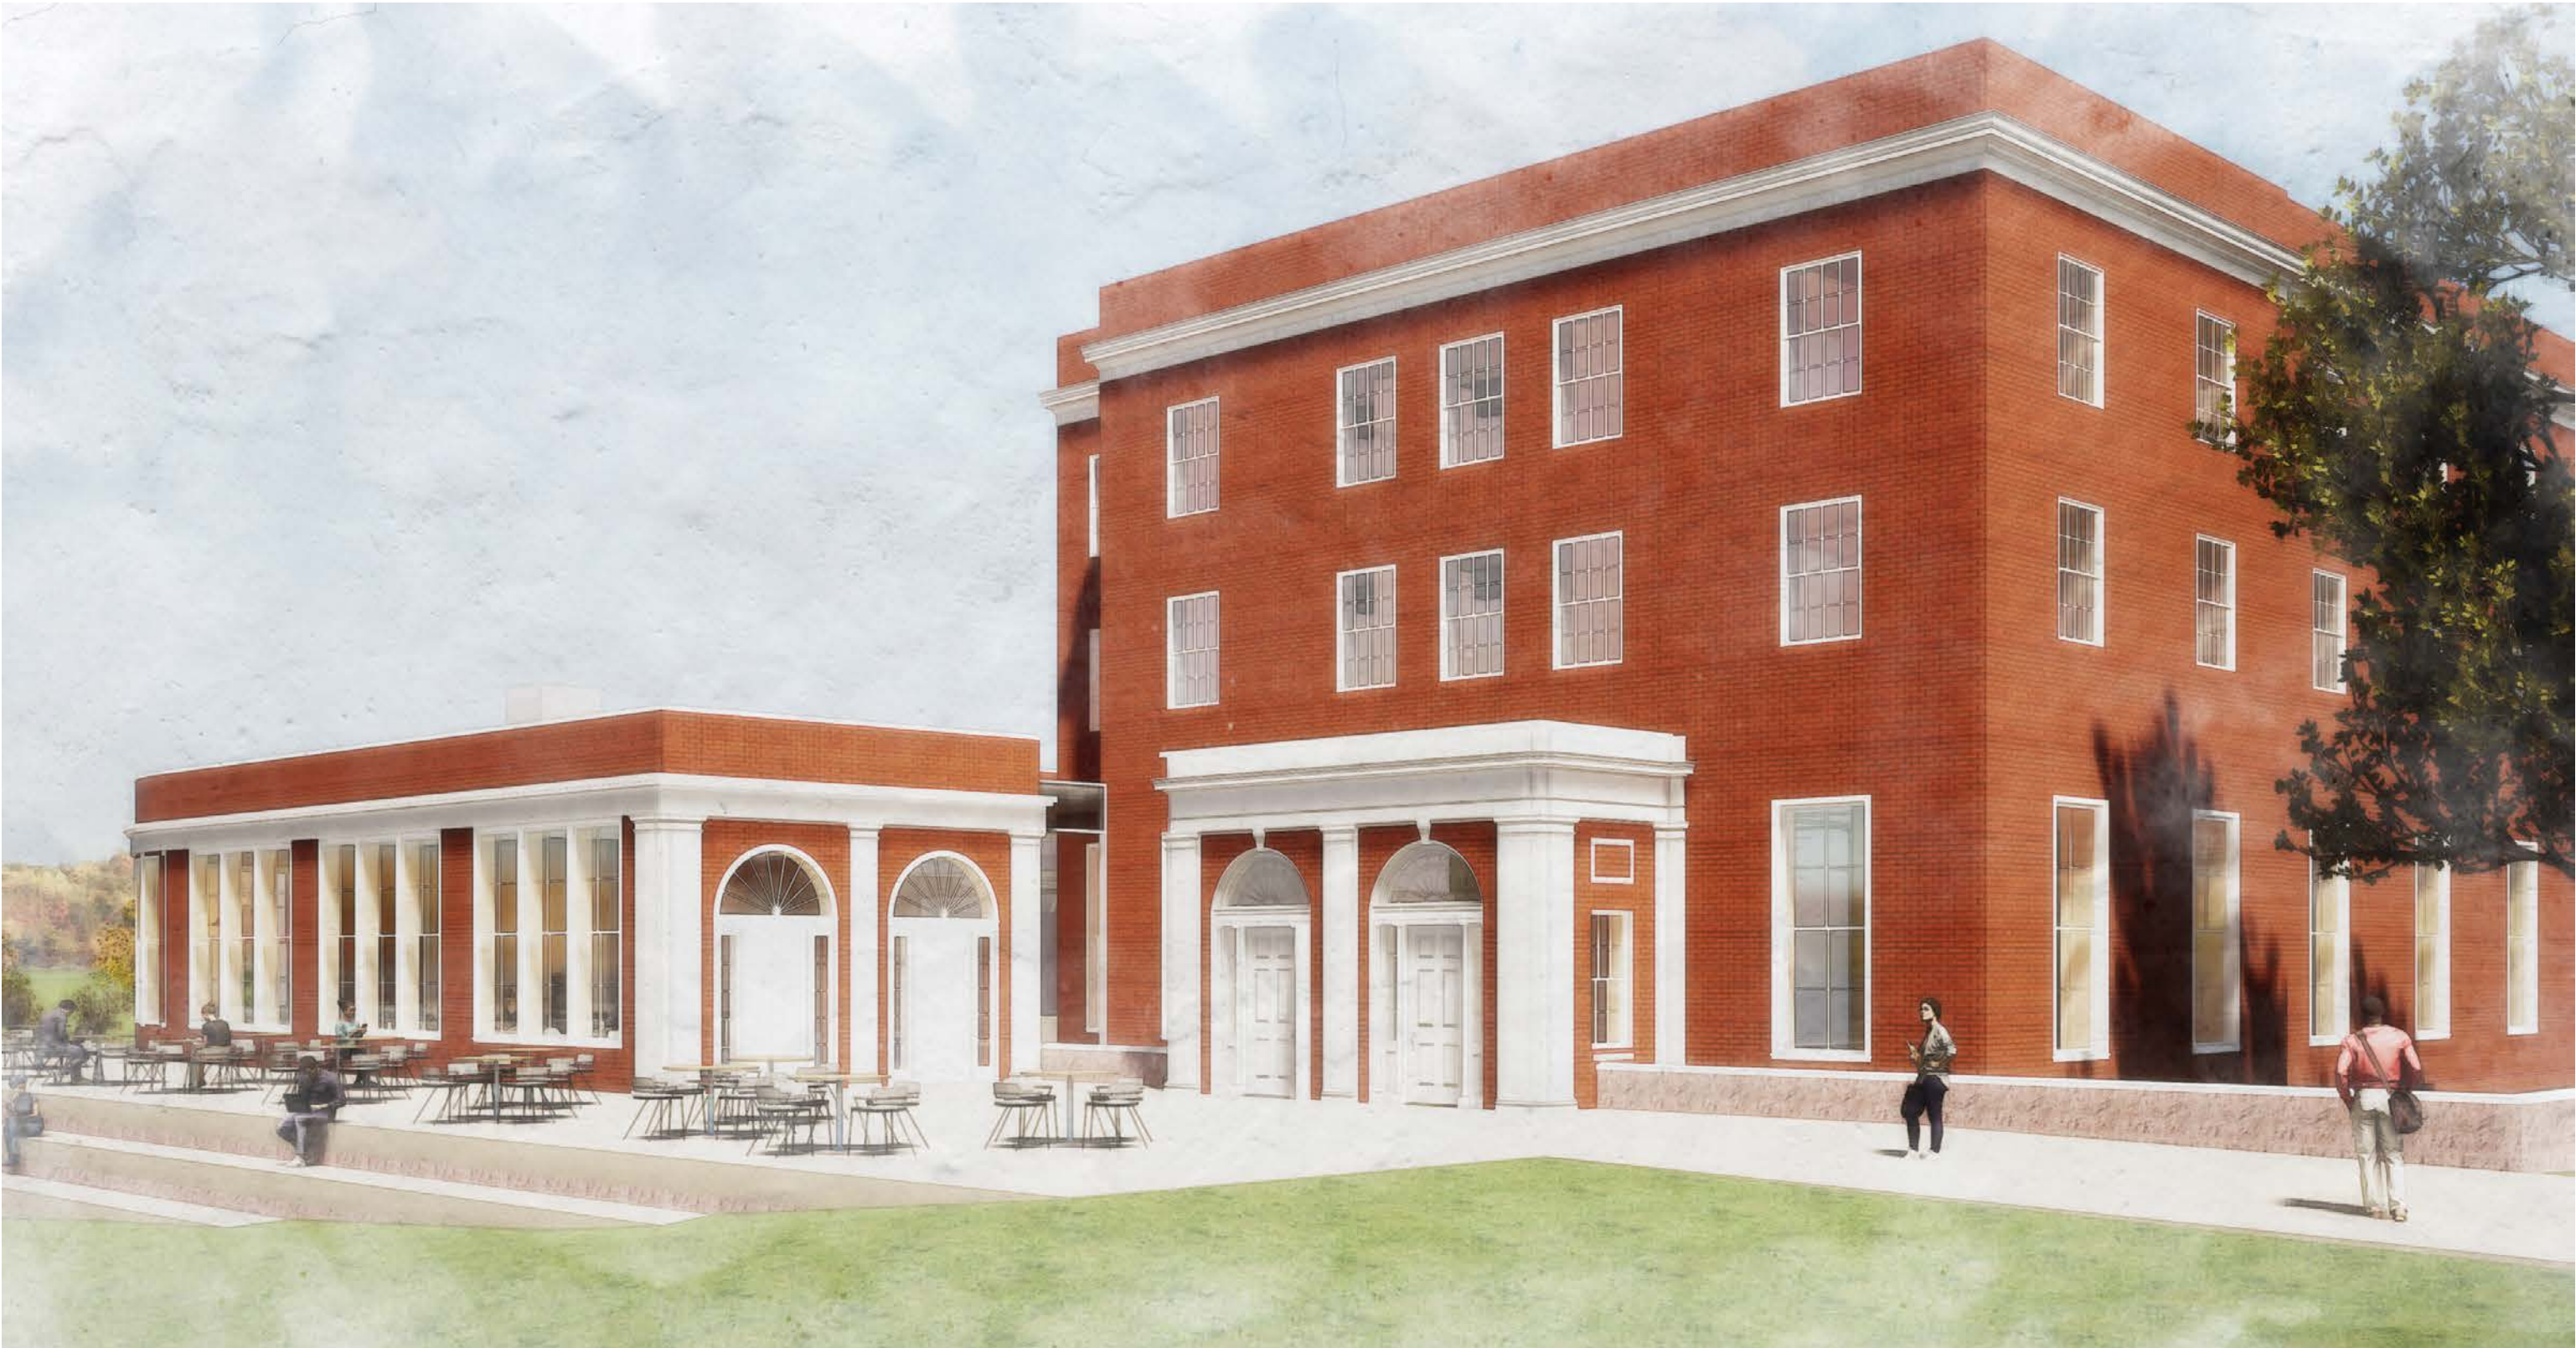
EXTERIOR PERSEPECTIVE

VIEW FROM COLLEGE STREET LOOKING NORTH-WEST

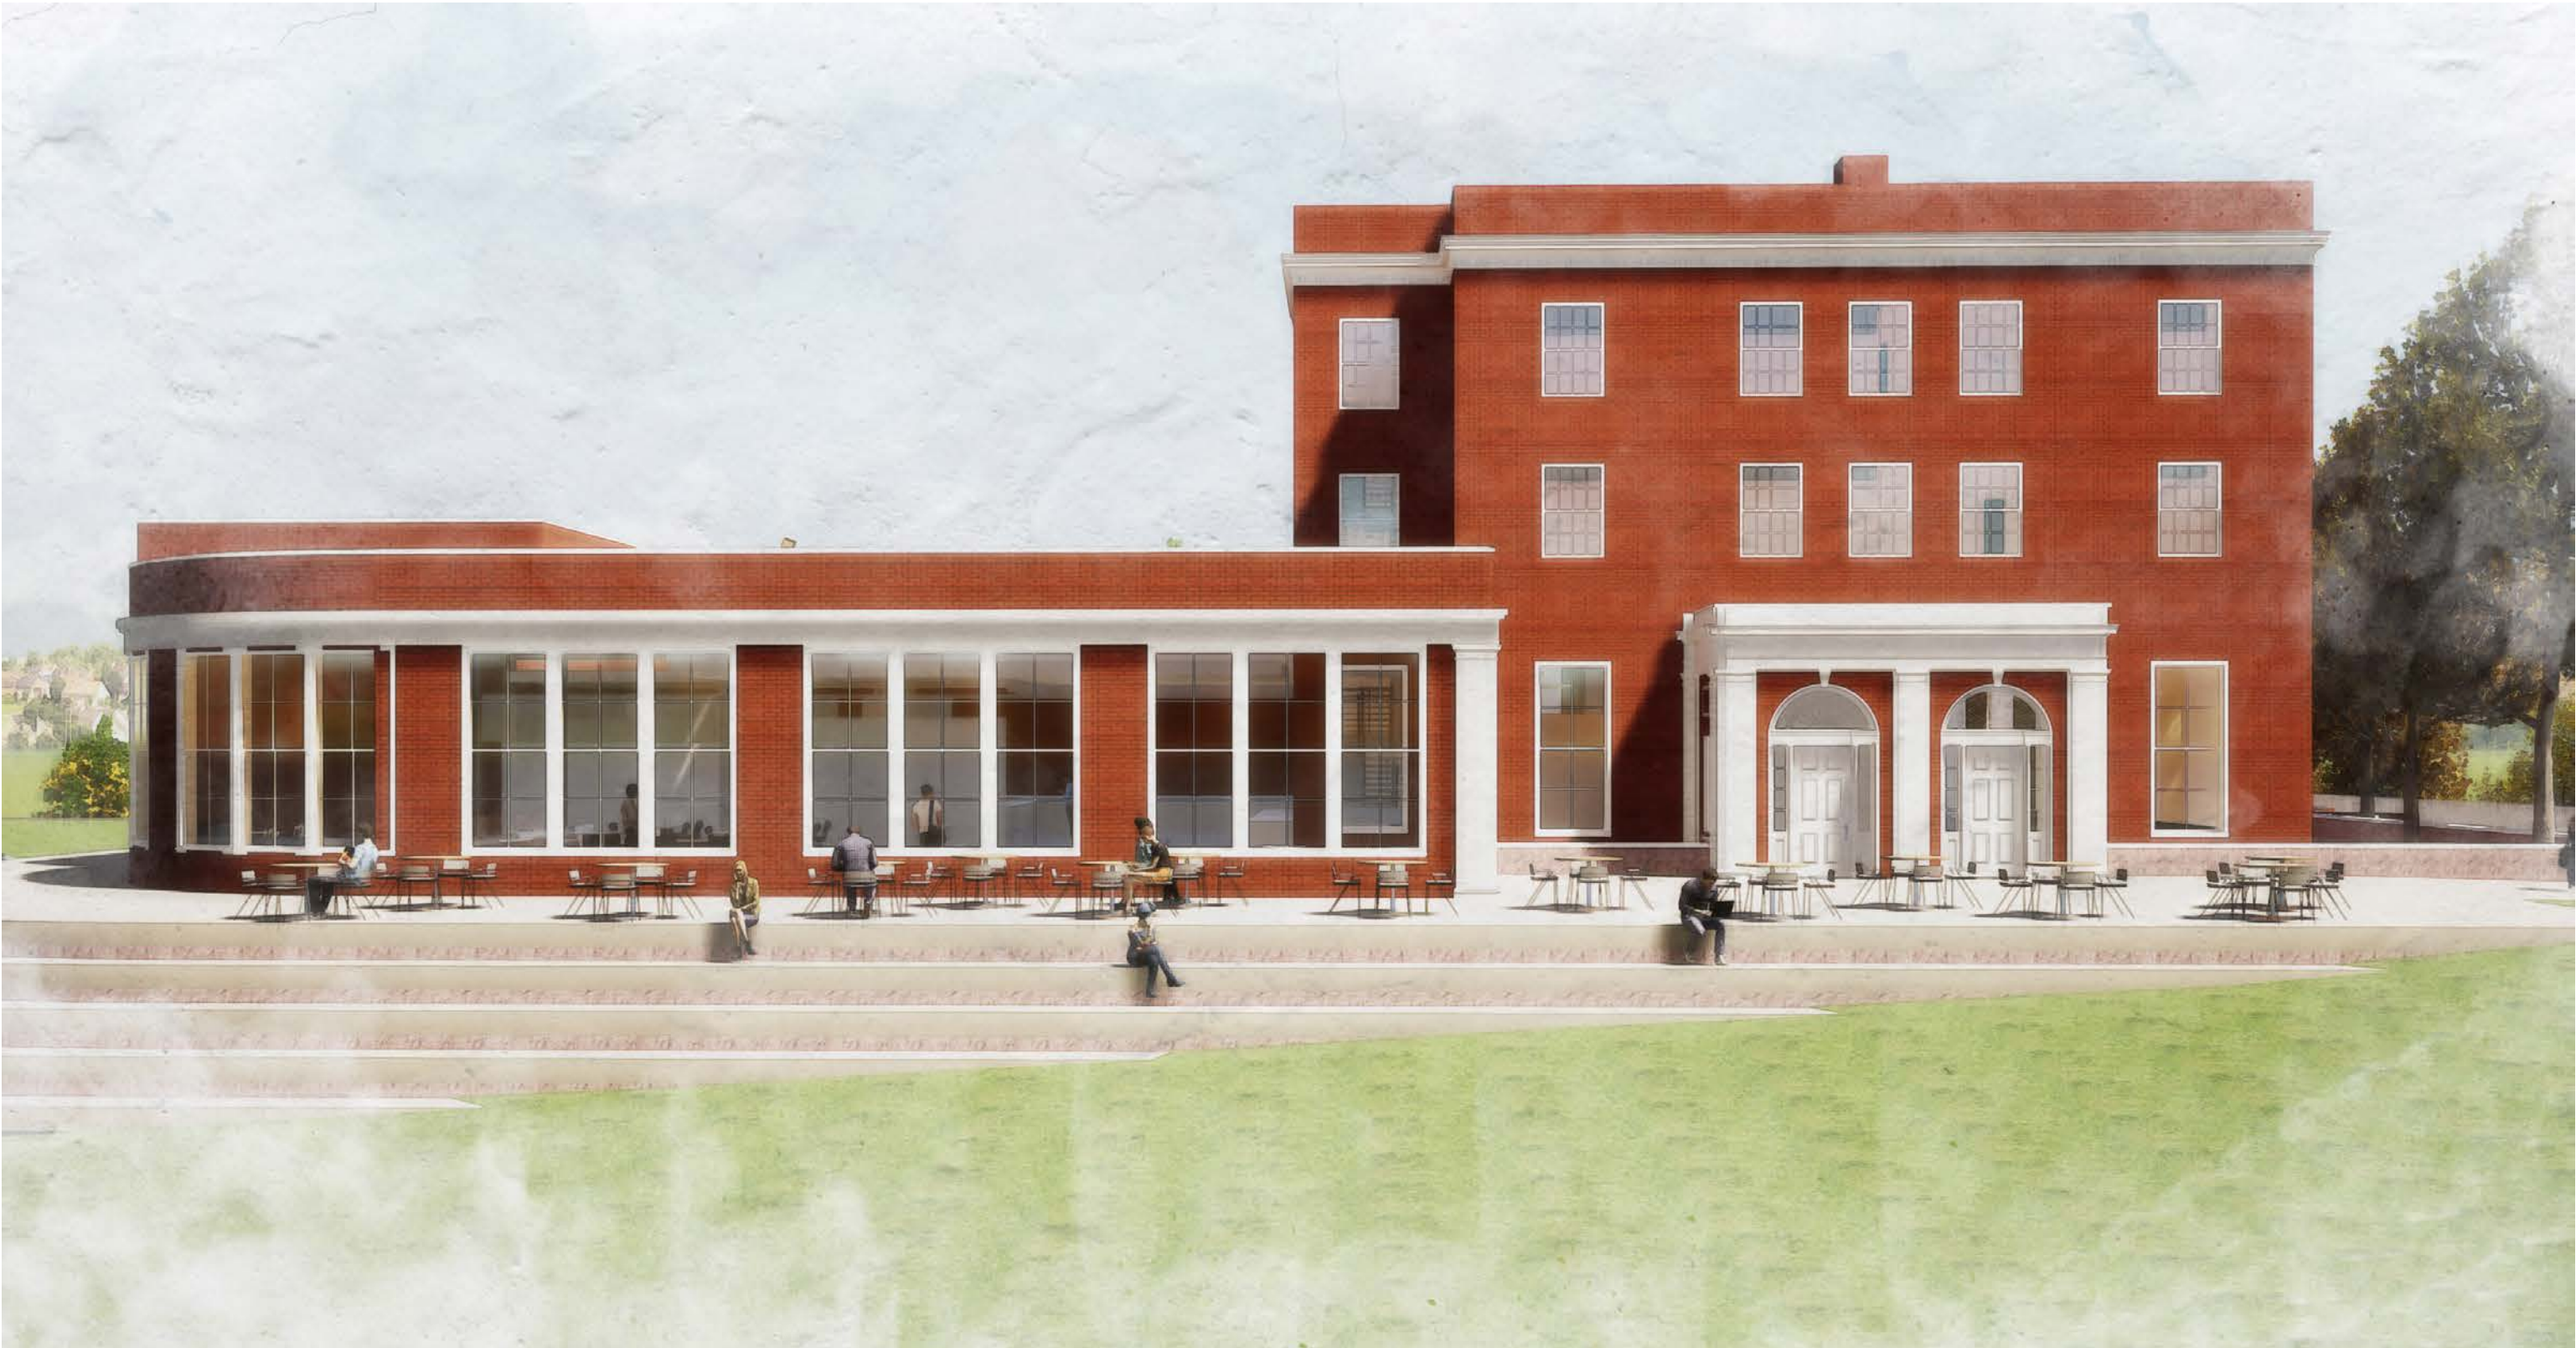
EXTERIOR ELEVATION STUDY

VIEW FROM PRACTICE FIELDS LOOKING NORTH

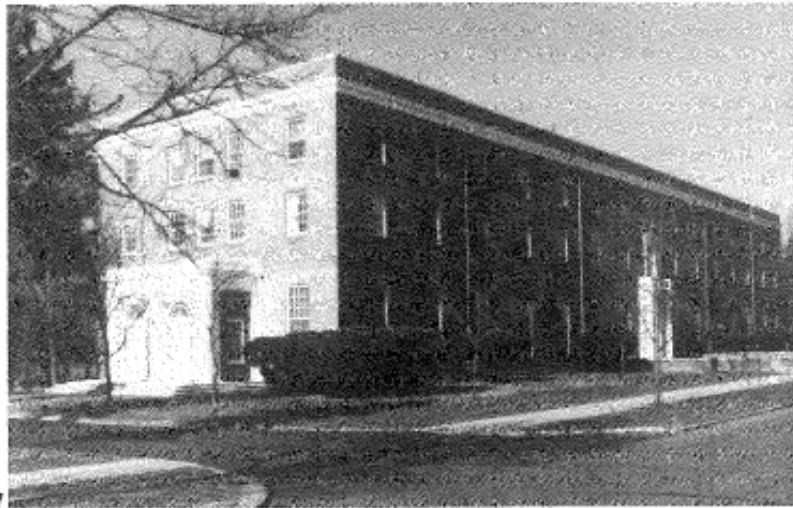
178 COLLEGE STREET

Ellsworth Hall, Western Reserve Academy, serves as dining hall, dormitory and common room. Built in 1922 to the specifications of James W. Ellsworth and the design of J.W.C. Corbusier, it is Neo-Classical Revival in every sense—the portico with a heavy entablature, decorative trim, Doric columns and rectangular tracery transom over the double doors; the pedimented window and balustrade over the portico; the second portico on the north side, with three pillars,

an elliptical tracery transom and sidelights. There is a belt course on the first story and a stone course at the roofline.

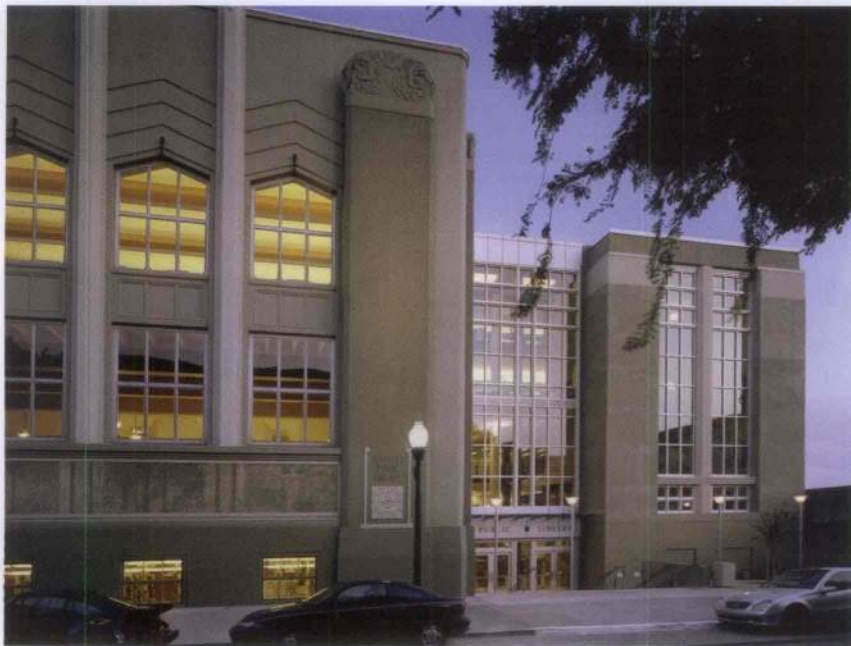
Figure 1. The addition to the right with its connecting hyphen is compatible with the Collegiate Gothic-style library. The addition is set back from the front of the library and uses the same materials and a simplified design that references, but does not copy, the historic building. Photo: David Wakely Photography.

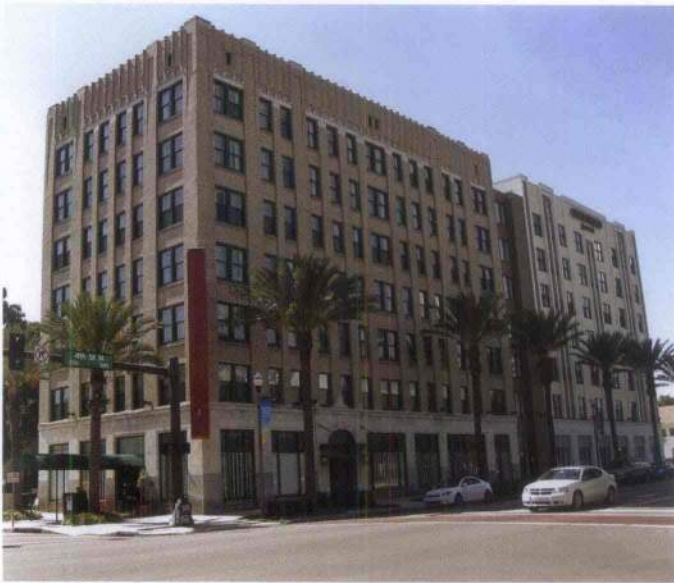
Figure 2. The new section on the right is appropriately scaled and reflects the design of the historic Art Deco-style hotel. The apparent separation created by the recessed connector also enables the addition to be viewed as an individual building.

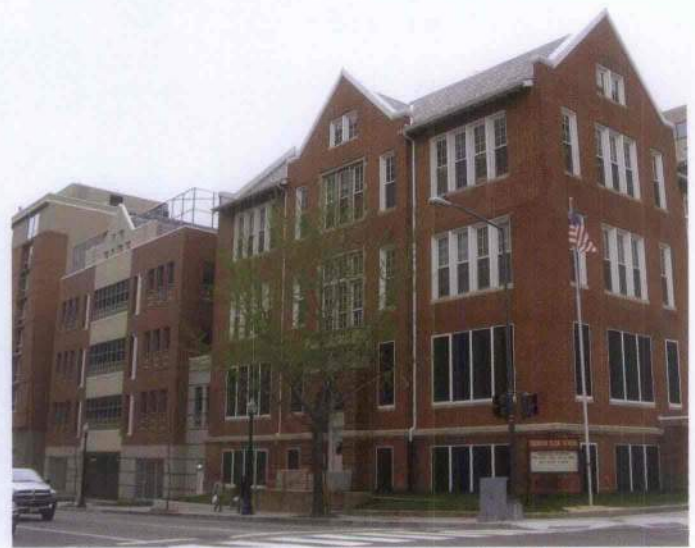
Figure 3. The red and buff-colored parking addition with a rooftop playground is compatible with the early-20th century school as well as with the neighborhood in which it also serves as infill in the urban setting.

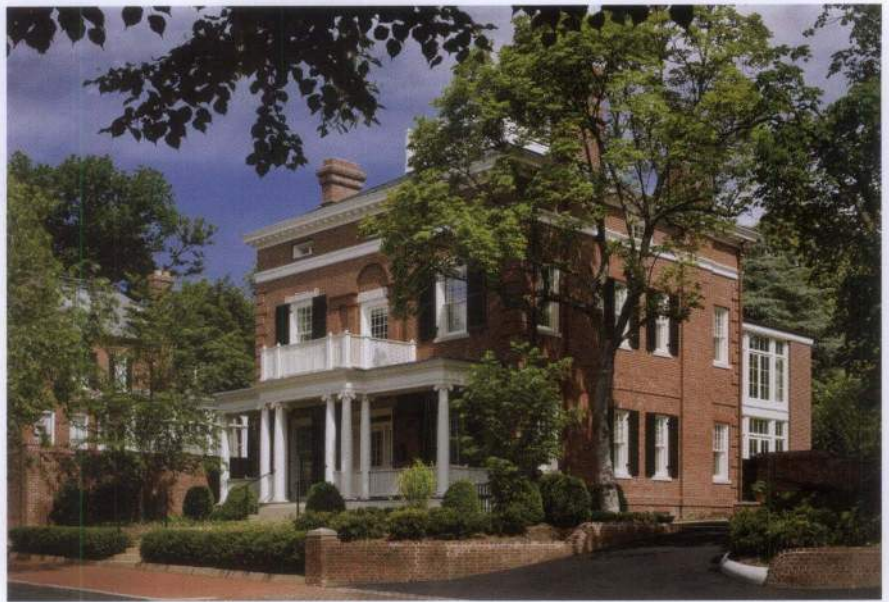
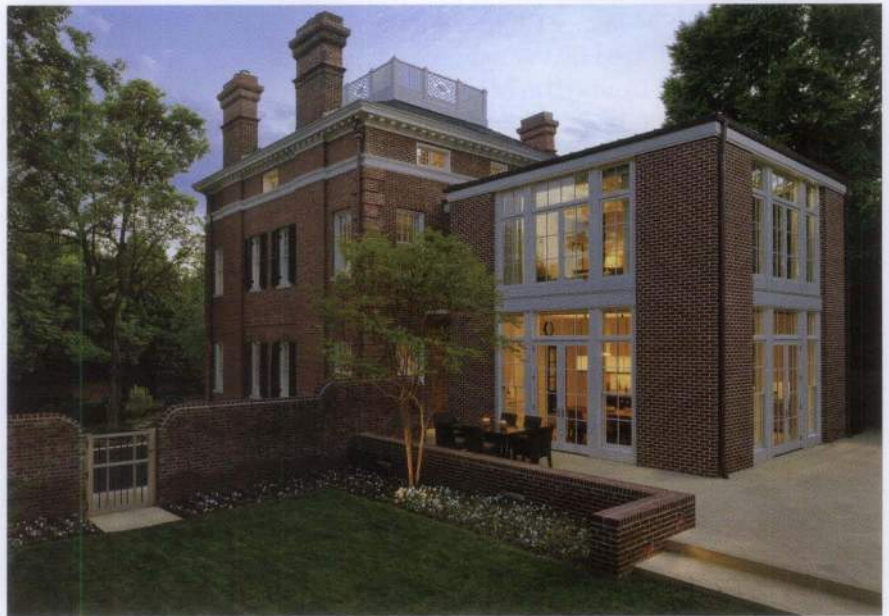
Figure 4. This glass and brick structure is a harmonious addition set back and connected to the rear of the Colonial Revival-style brick house. Cunningham/Quill Architects. Photos: © Maxwell MacKenzie.

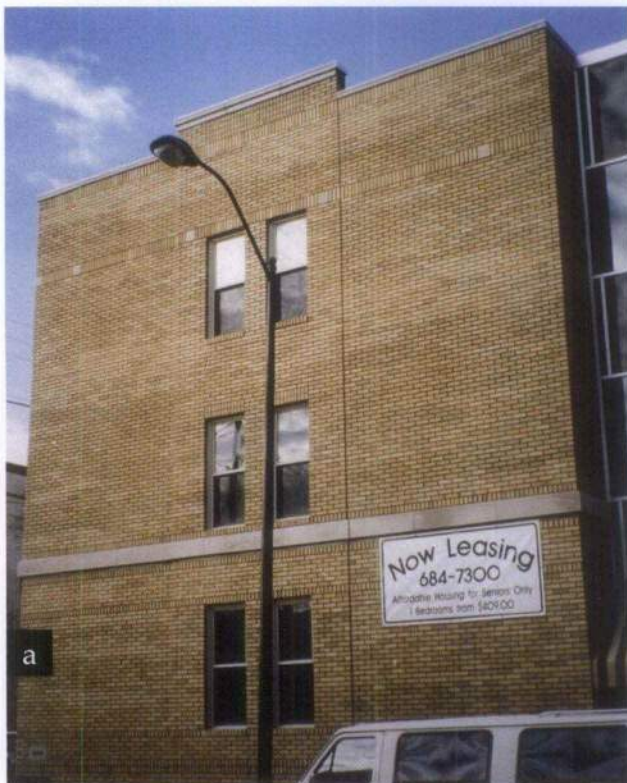
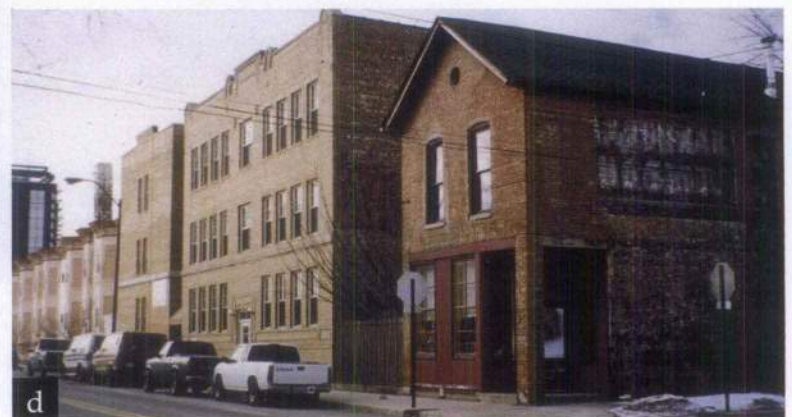
Figure 5. This addition (a) is constructed of matching brick and attached by a recessed connector (b) to the 1914 apartment building (c). The design is compatible and the addition is smaller and subordinate to the historic building (d).

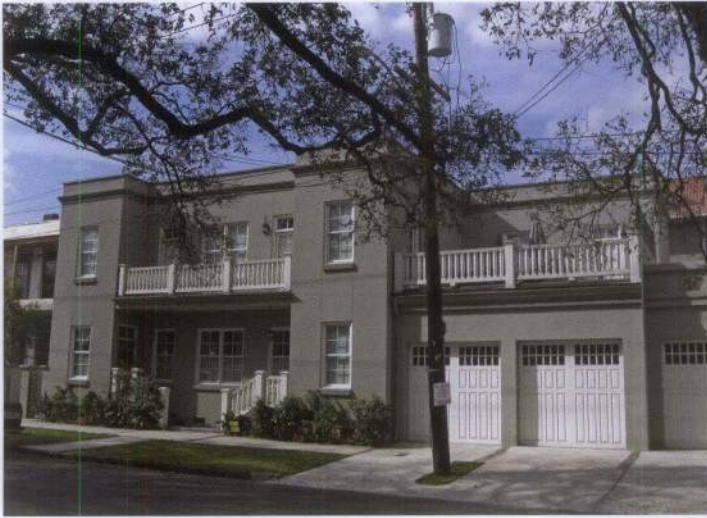
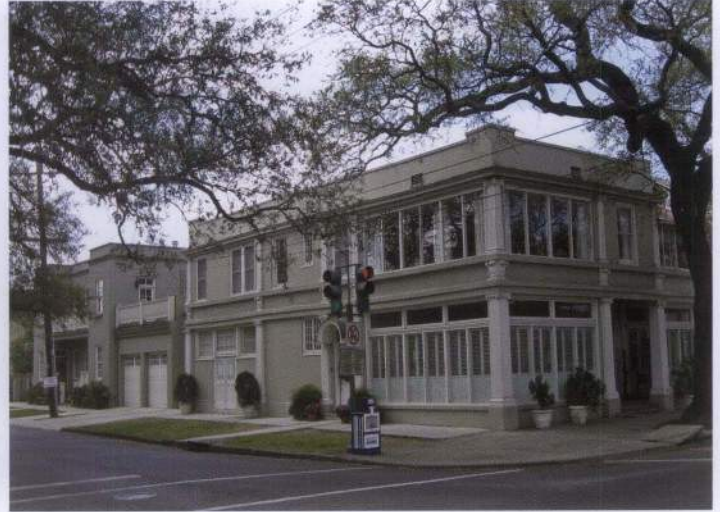
Figure 6. A new addition (left) is connected to the garage which separates it from the main block of the c. 1910 former florist shop (right). The addition is traditional in style, yet sufficiently restrained in design to distinguish it from the historic building.

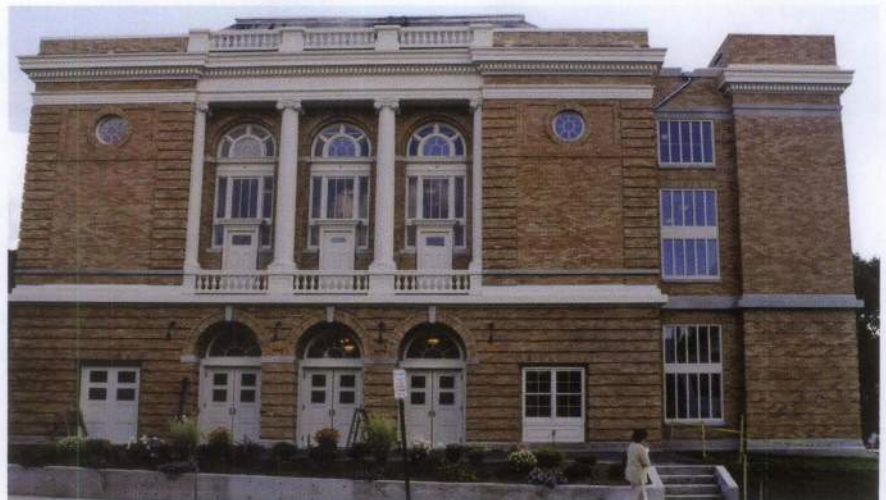
Figure 7. A vacant side lot was the only place a new stair tower could be built when this 1903 theater was rehabilitated as a performing arts center. Constructed with matching materials, the stair tower is set back with a recessed connector and, despite its prominent location, it is clearly subordinate and differentiated from the historic theater.

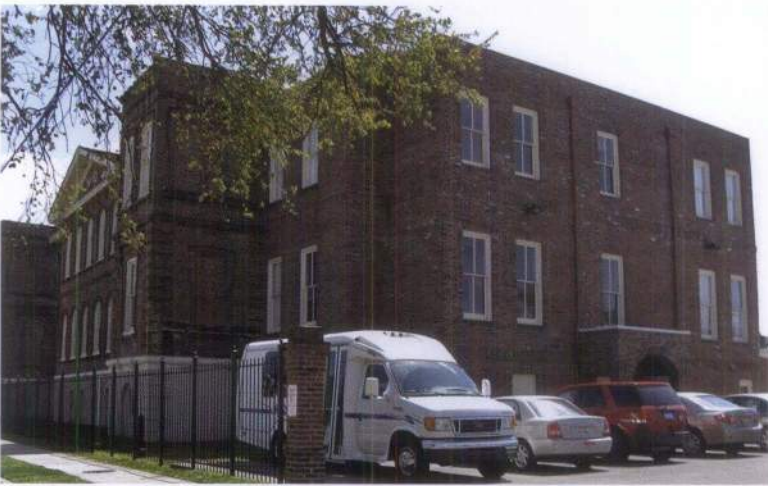
Figure 9. A simple, brick stair tower replaced two non-historic additions at the rear of this 1879 school building when it was rehabilitated as a women's and children's shelter. The addition is set back and it is not visible from the front of the school.

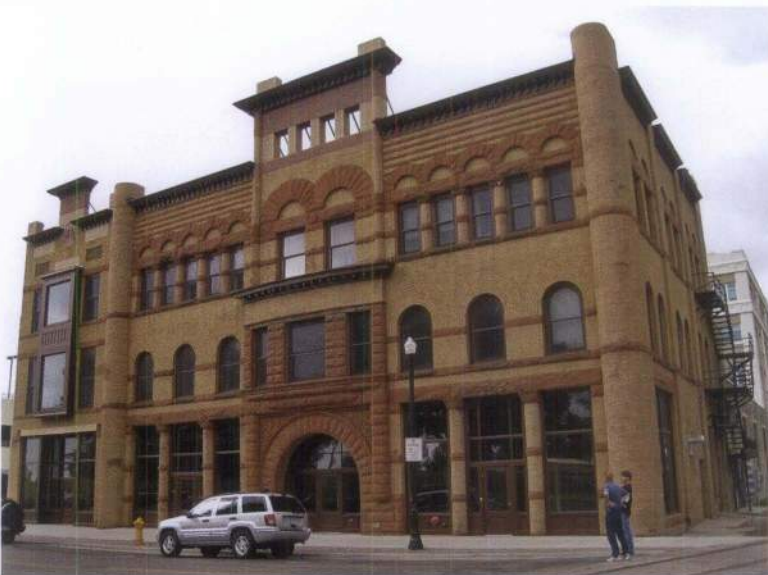
Figure 10. The small size and the use of matching materials ensures that the new addition on the left is compatible with the historic Romanesque Revival-style building.

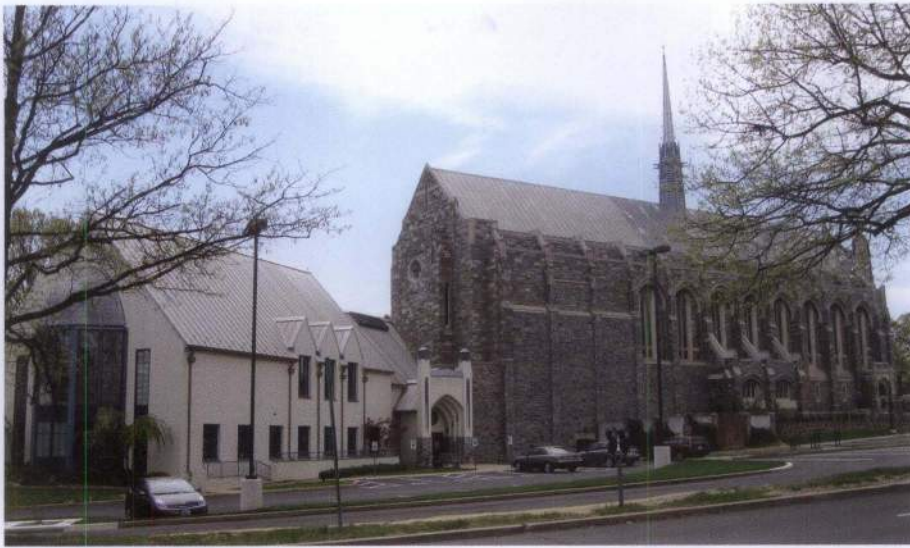
Figure 11. The addition to this early-20th century Gothic Revival-style church provides space for offices, a great hall for gatherings and an accessible entrance (left). The stucco finish, metal roof, narrow gables and the Gothic-arched entrance complement the architecture of the historic church. Placing the addition in back where the ground slopes away ensures that it is subordinate and minimizes its impact on the church (below).

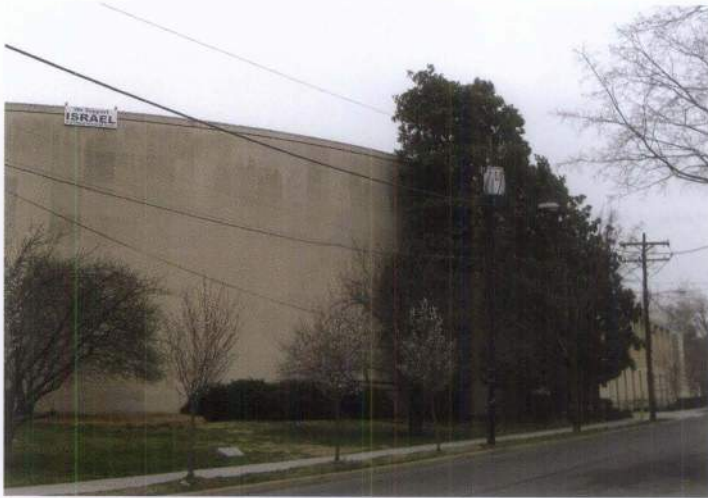
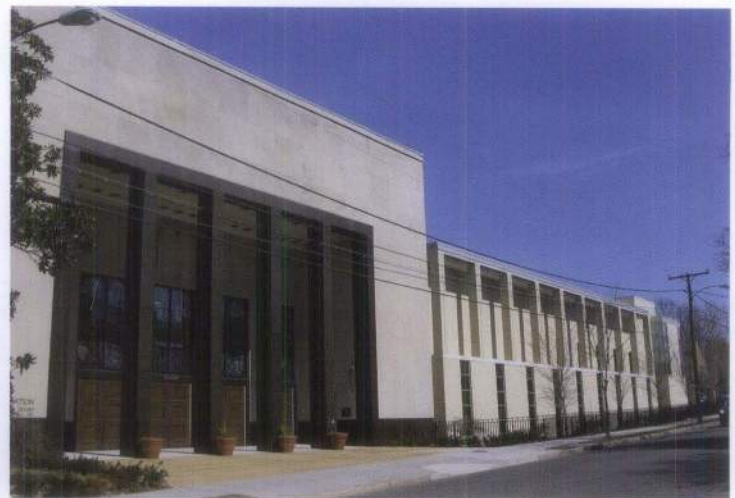
Figure 12. This 1954 synagogue (left) is accessed through a monumental entrance to the right. The new education wing (far right) added to it features the same vertical elements and color and, even though it is quite large, its smaller scale and height ensure that it is secondary to the historic resource.

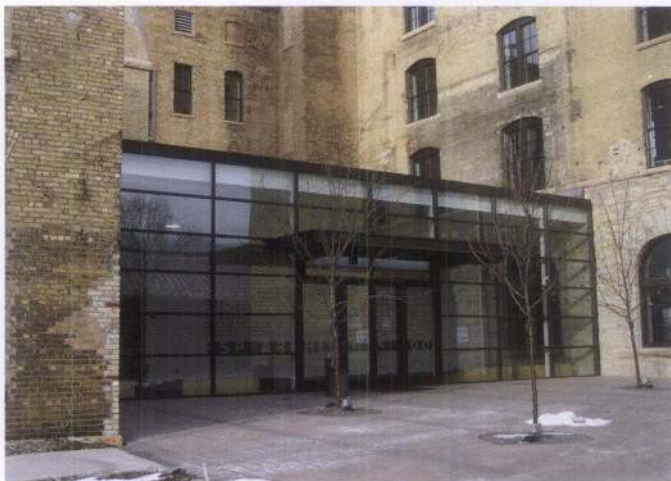
Figure 14. This glass addition was erected at the back of an 1895 former brewery during rehabilitation to provide another entrance. The addition is compatible with the plain character of this secondary elevation.

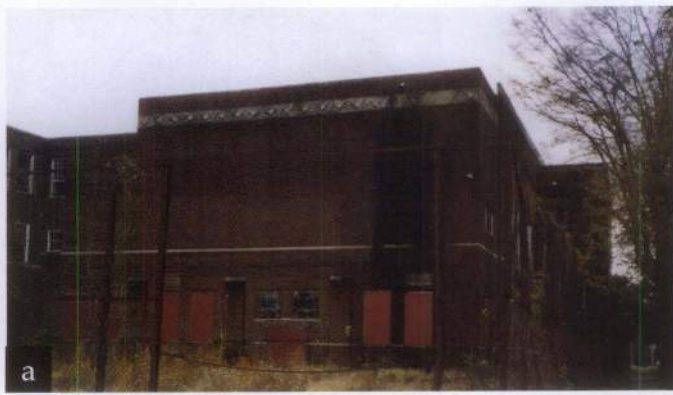
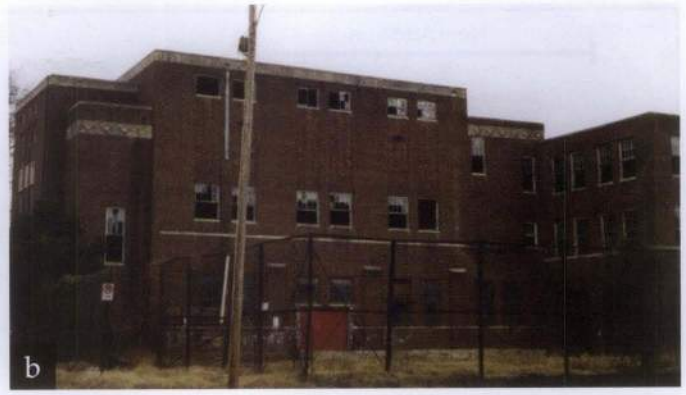
Figure 15. The rehabilitation of a c. 1930 high school auditorium for a clinic and offices proposed two additions: a one-story entrance and reception area on this elevation (a); and a four-story elevator and stair tower on another side (b). The gabled entrance (c) first proposed was not compatible with the flat-roofed auditorium and the design of the proposed stair tower (d) was also incompatible and overwhelmed the historic building. The designs were revised (e-f) resulting in new additions that meet the Standards (g-h).

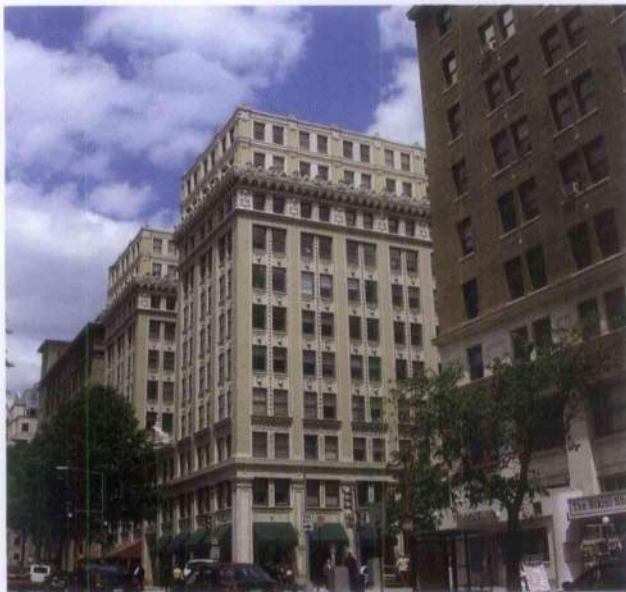
Figure 19. The upper two floors of this early-20th century office building were part of the original design, but were not built. During rehabilitation, the two stories were finally constructed. This treatment does not meet the Standards because the addition has given the building an appearance it never had historically.

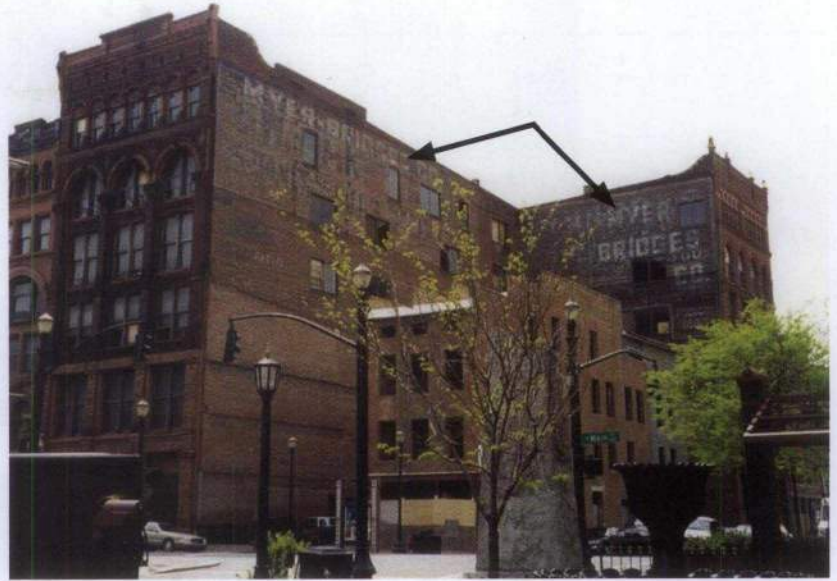
Figure 21. Both wings of this historic L-shaped building (top), which fronts on two city streets, adjoined vacant lots. A two-story addition was constructed on one lot (above, left) and a six-story addition was built on the other (above, right). Like the historic building, which has two different facades, the compatible new additions are also different and appear to be separate structures rather than part of the historic building.

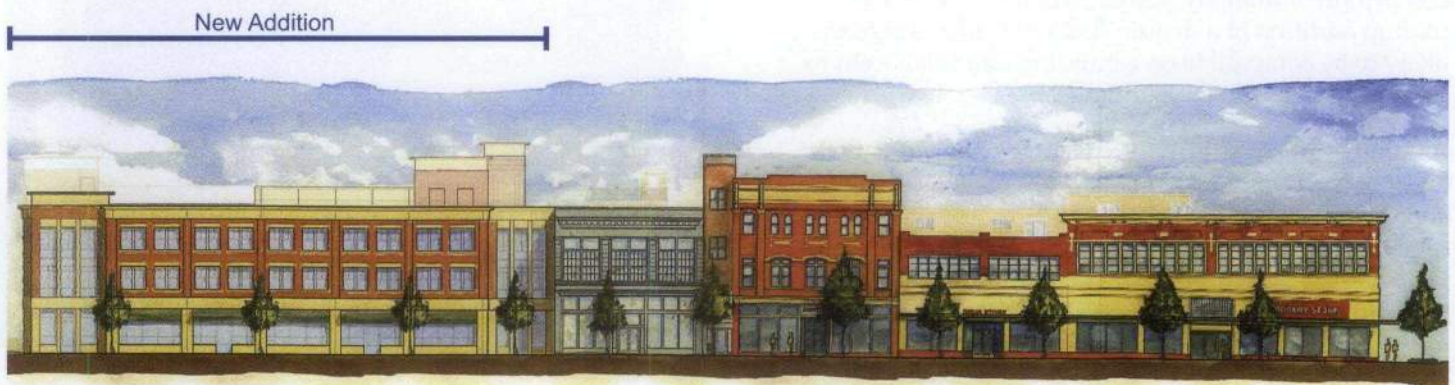
Figure 22. The proposed new addition is compatible with the historic buildings that remain on the block. Its design with multiple storefronts helps break up the mass.

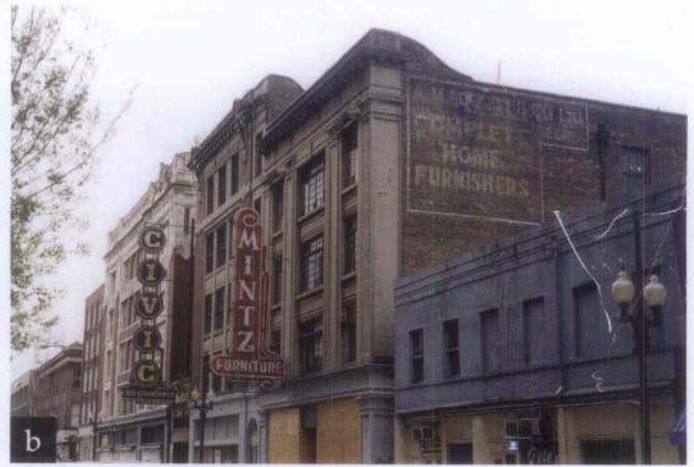
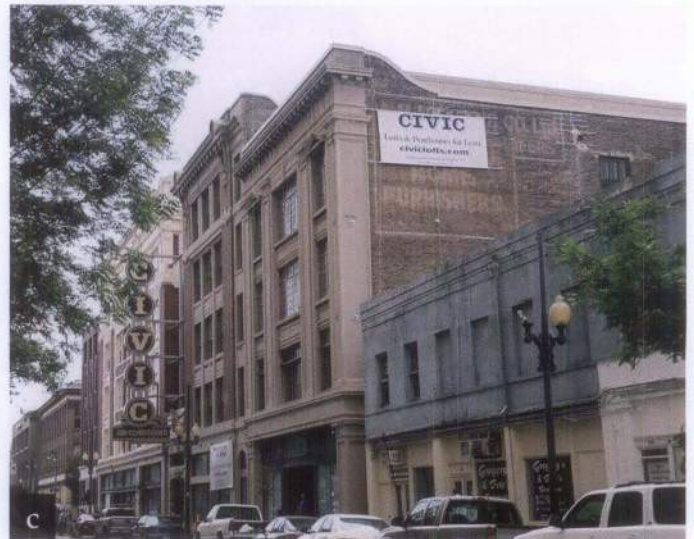
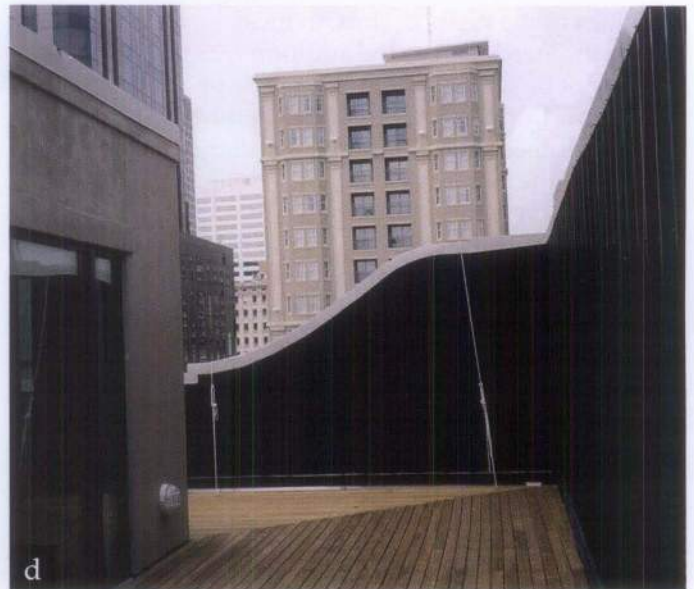
Figure 23. Colored flags marking the location of a proposed penthouse addition (a) were placed on the roof to help evaluate the impact and visibility of an addition planned for this historic furniture store (b). Based on this evaluation, the addition was constructed as proposed. It is minimally visible and compatible with the 1912 structure (c). The tall parapet wall conceals the addition from the street below (d).

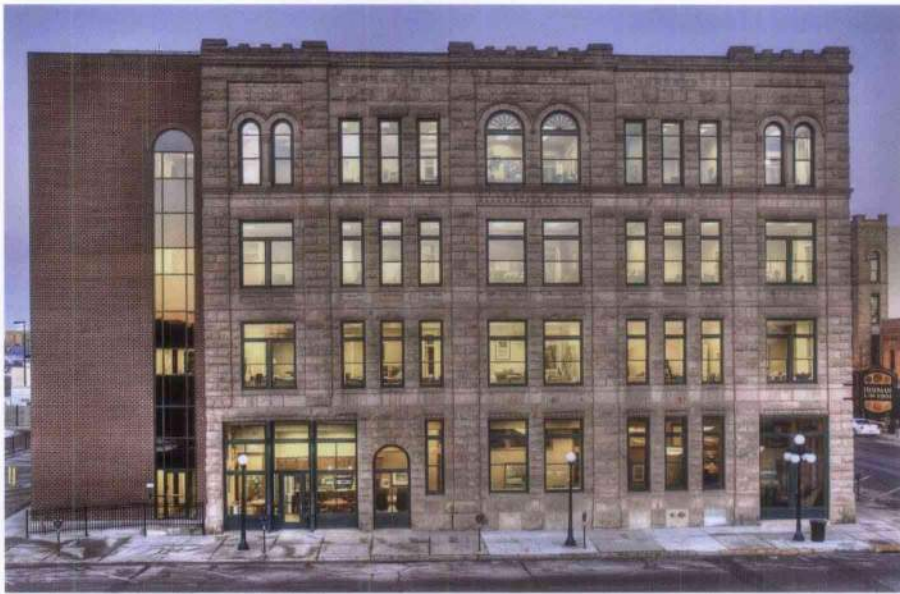
Figure 27. Although the new brick stair/elevator tower (left) is not visible from the front (right), it is on a prominent side elevation of this 1890 stone bank. The compatible addition is set back and does not compete with the historic building. Photos: Chadd Gossmann, Aurora Photography, LLC.

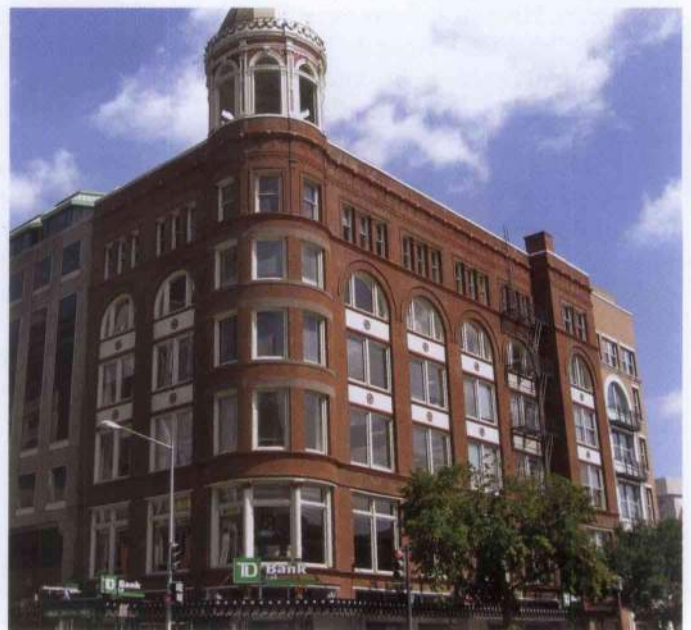
Figure 30. The small addition on the right of this late-19th century commercial structure is clearly secondary and compatible in size, materials and design with the historic building.

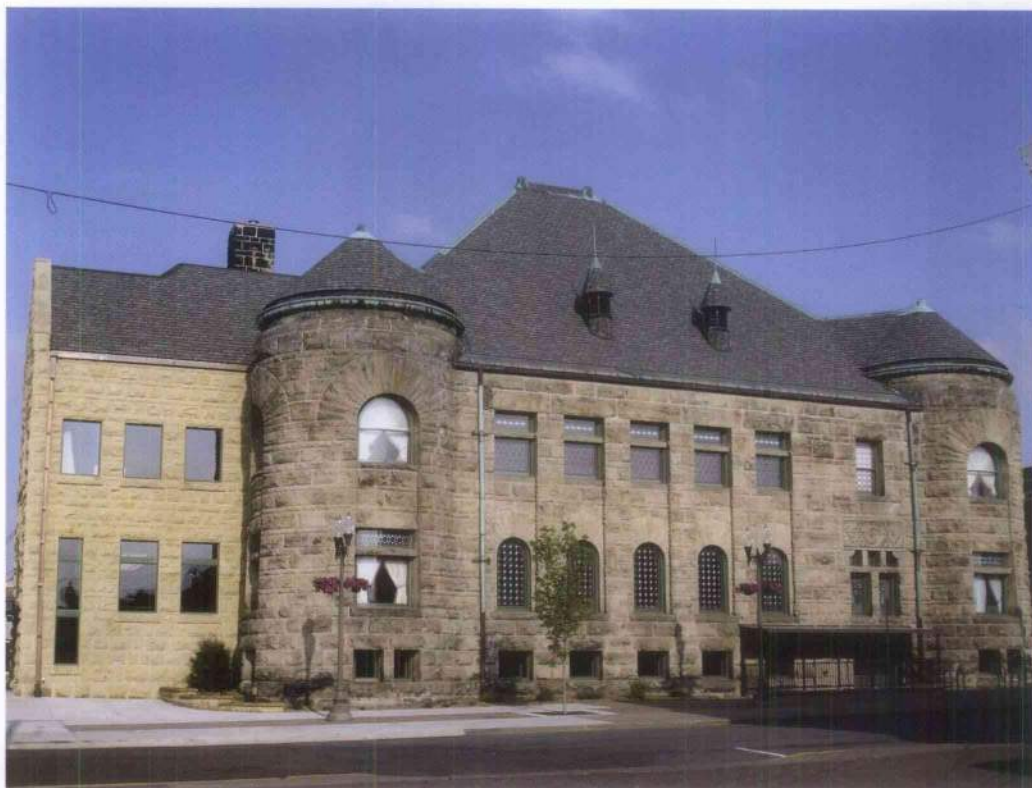
Figure 31. An elevator/stair tower was added at the back of this Richardsonian Romanesque-style theater when it was rehabilitated. Rough-cut stone and simple cut-out openings ensure that the addition is compatible and subordinate to the historic building. Photo: Chuck Liddy, AIA.
