Natural Resources Report

Christ Community Chapel

Hudson, Ohio

Date Prepared: March 14, 2025

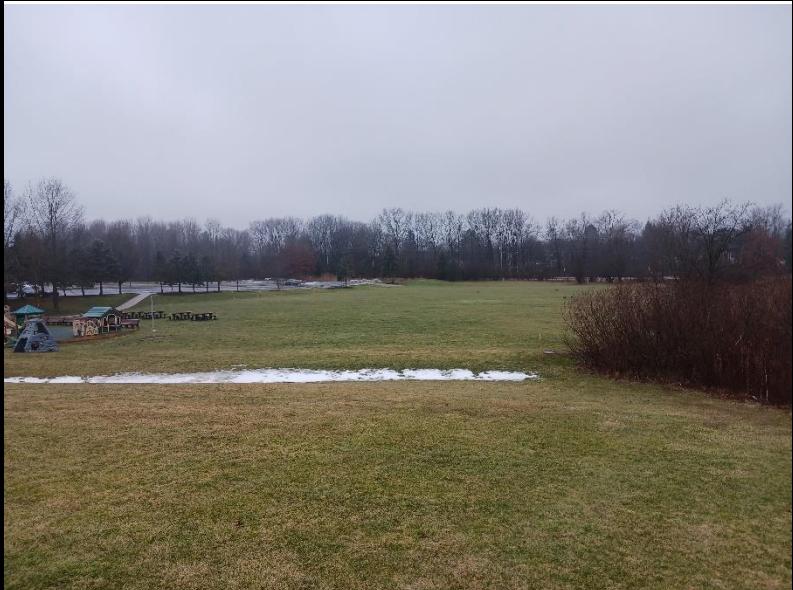
Photograph #	6	
Date:	2-27-2025	
Description:

View of AOI with drainage into existing stormwater basin facing west.

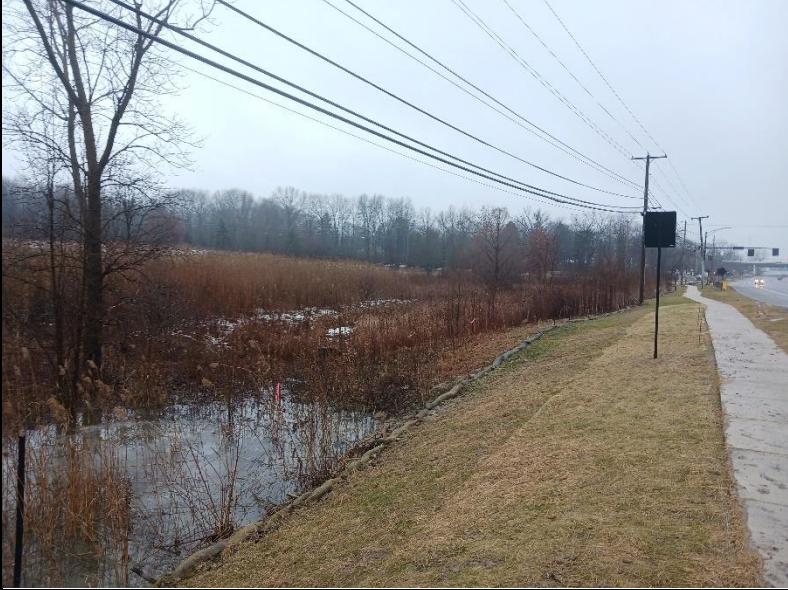
Photograph #	7	
Date:	2-27-2025	
Description:		
View of AOI with existing stormwater basin facing south.

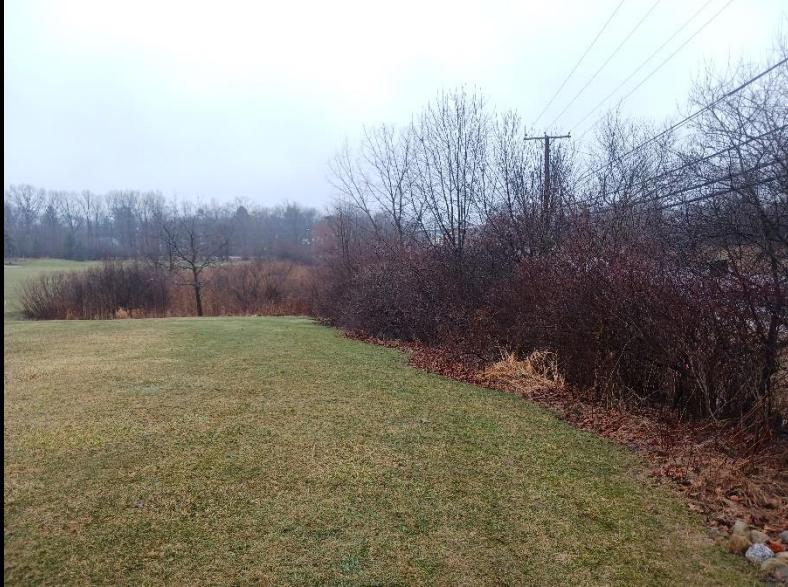
Photograph #	8	
Date:	2-27-2025	
Description:		
View of AOI with existing stormwater basin facing west.

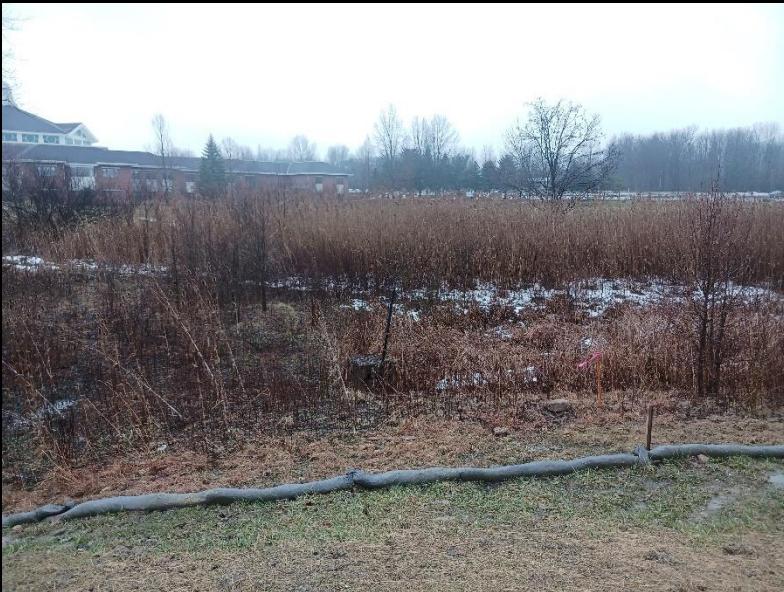
Photograph #	9	
Date:	2-27-2025	
Description:		
View of AOI with existing stormwater basin facing south.

A photograph showing a stormwater basin in a residential area. The basin is filled with water and surrounded by tall, dry grass and reeds. A grey flexible hose lies on the ground in the foreground. In the background, there are houses and trees under a cloudy sky.

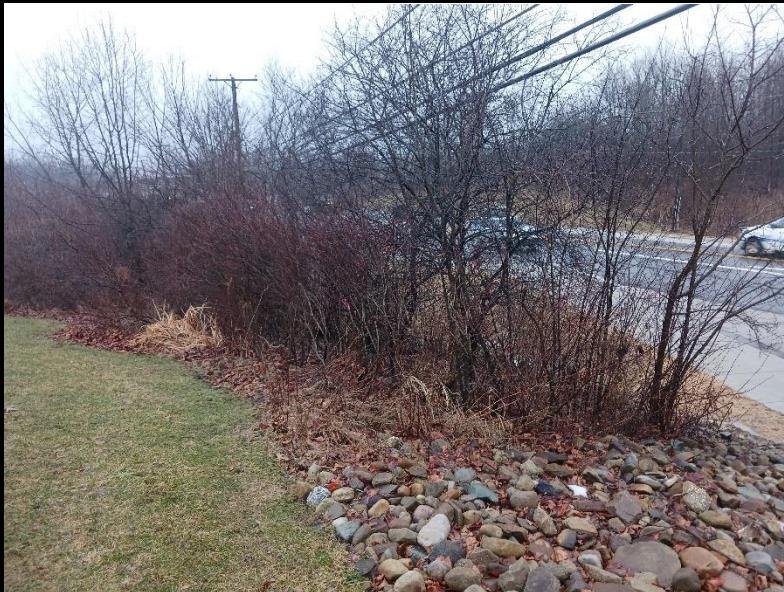
Photograph #	10	
Date:	2-27-2025	
Description:		
View of AOI with existing stormwater basin facing west.

A photograph showing a stormwater basin in a residential area. The basin is filled with water and surrounded by tall, dry grass and reeds. A grey flexible hose lies on the ground in the foreground. In the background, there are houses and trees under a cloudy sky.

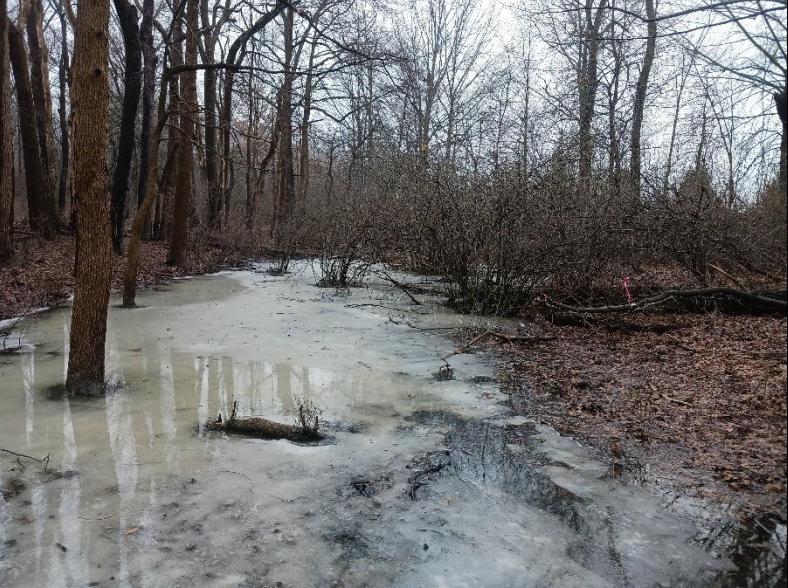
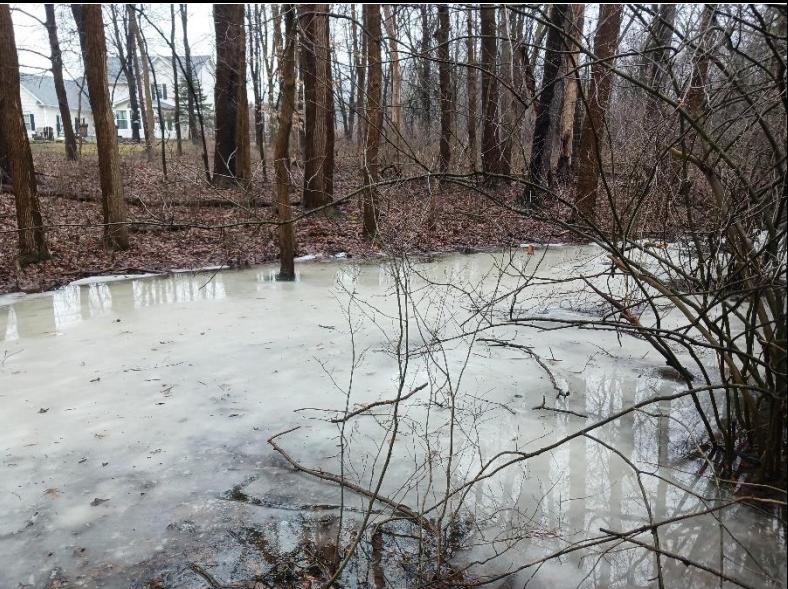
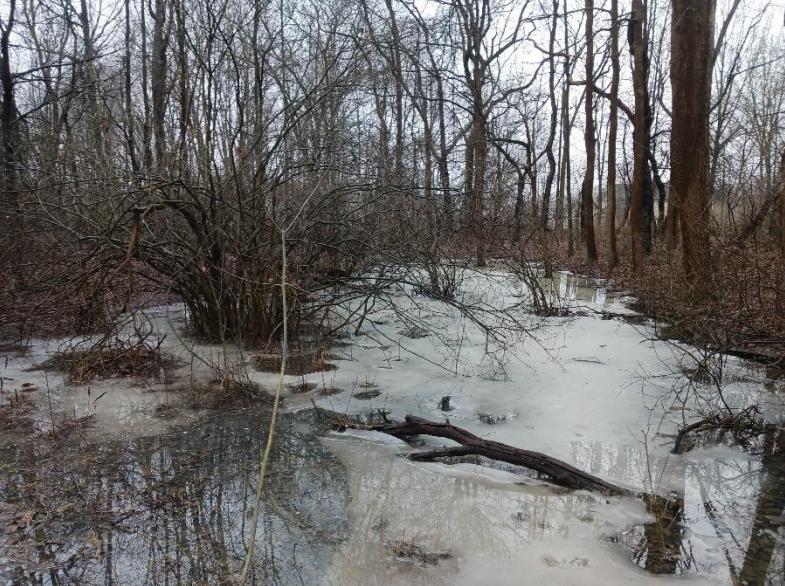
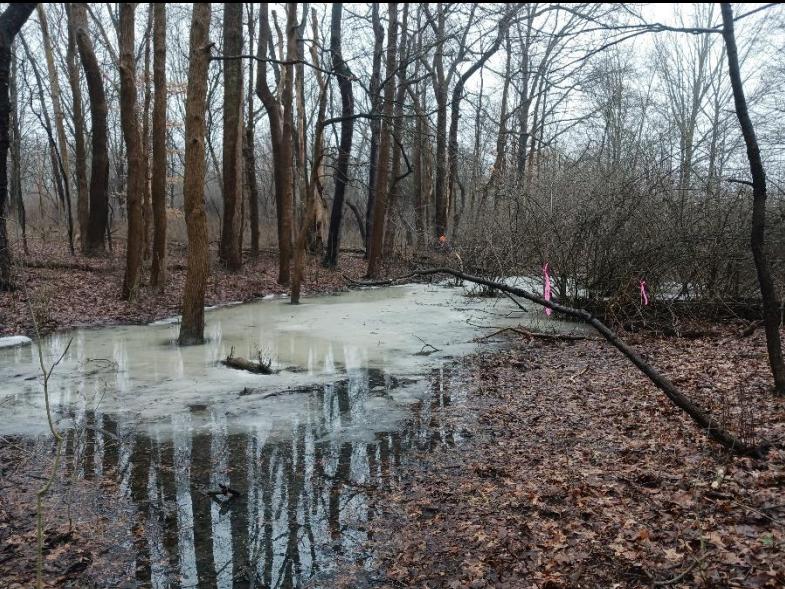
Photograph #	11
Date:	2-27-2025
Description:	
View of wetland W-1 facing north.

Photograph #	12
Date:	2-27-2025
Description:	
View of wetland W-1 facing south.

Photograph #	13
Date:	2-27-2025
Description:	<p>View of wetland W-1 facing east.</p>

Photograph #	14
Date:	2-27-2025
Description:	<p>View of wetland W-1 facing west.</p>

Wetland ID	Cowardin Classification	Acreage within AOI (ac)
W-1	PEM/PSS	0.10
W-2	PEM	0.04
W-3	PEM/PSS	0.15

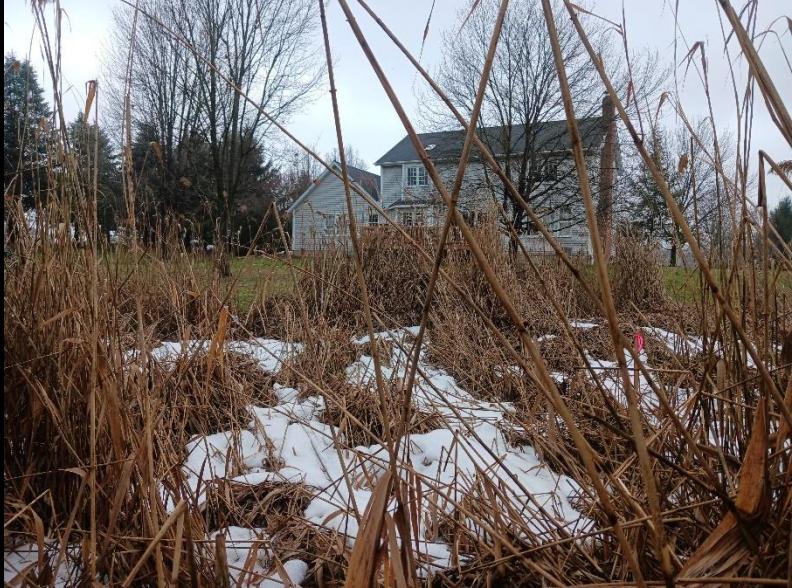
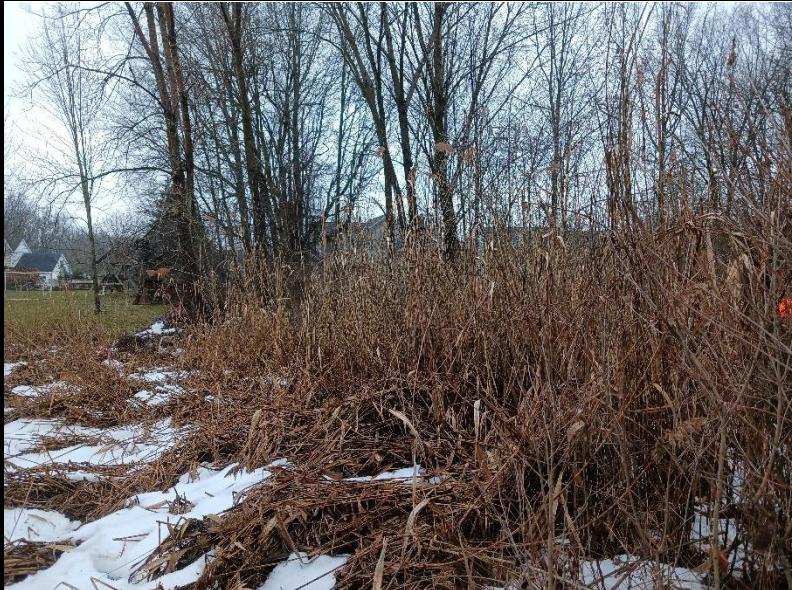
Date:	2-27-2025	
Description:	View of wetland W-2 facing north.

Date:	2-27-2025	
Description:	View of wetland W-2 facing south.

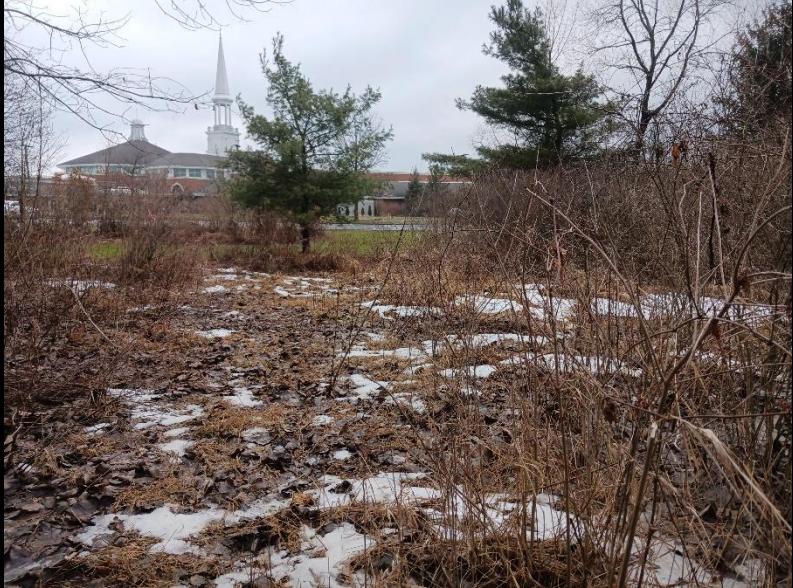
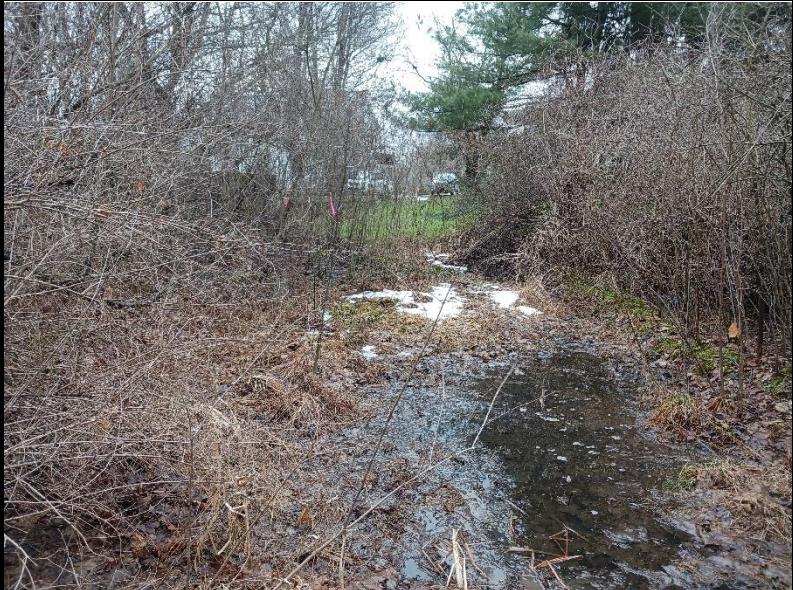
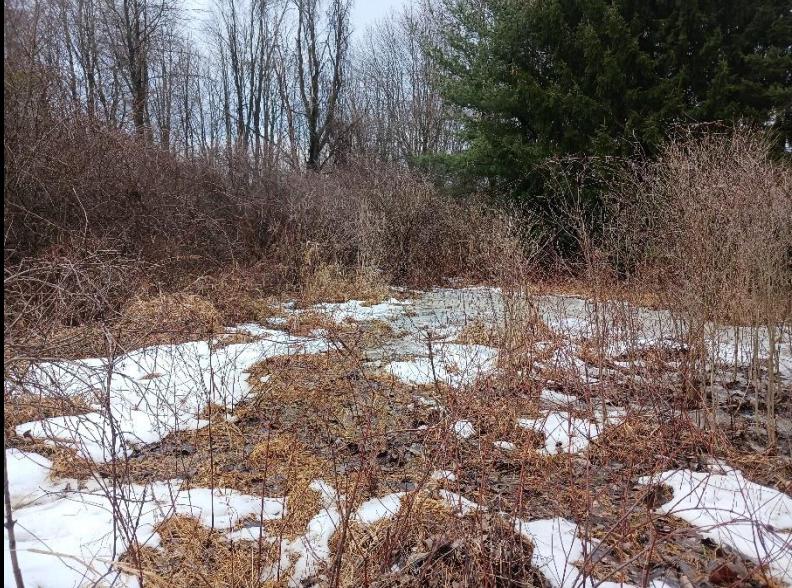
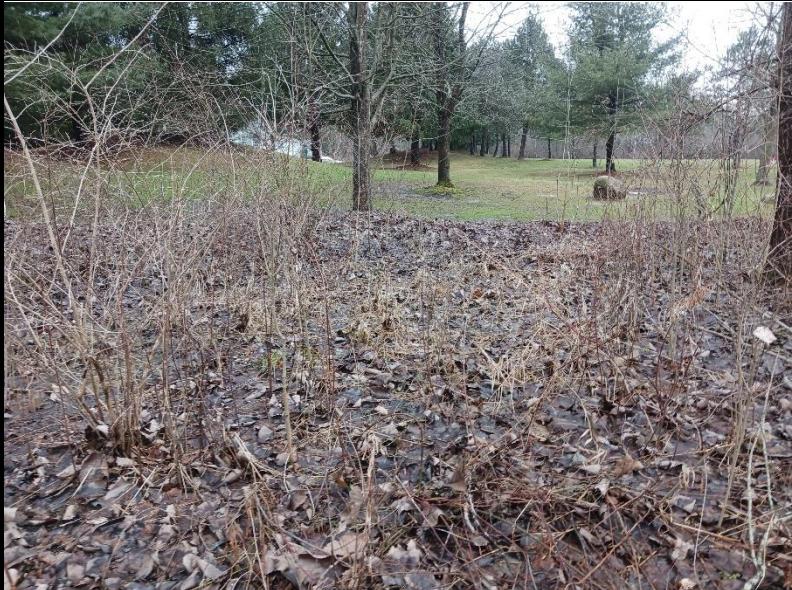
Photograph #	19	
Date:	2-27-2025	
Description:		
View of wetland W-3 facing north.

Photograph #	20	
Date:	2-27-2025	
Description:		
View of wetland W-3 facing south.

Photograph #	21	
Date:	2-27-2025	
Description:		
View of wetland W-3 facing east.

Photograph #	22	
Date:	2-27-2025	
Description:		
View of wetland W-3 facing west.

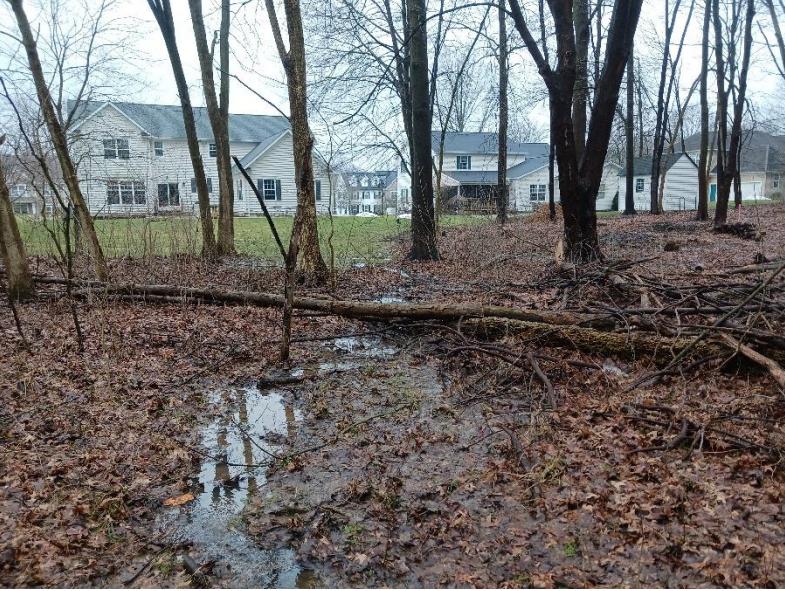
Photograph #	28
Date:	2-27-2025
Description:	<p>View of seep 1.</p>

Three (3) wetlands, two (2) seeps, and no streams were identified within the AOI. Wetland data forms are provided in Appendix A of this report. Color photographs of each aquatic feature are included in Appendix B. The features are depicted on Figure 3 Delineated Aquatic Features. Two (2) functioning constructed stormwater retention basins were also located within the AOI.

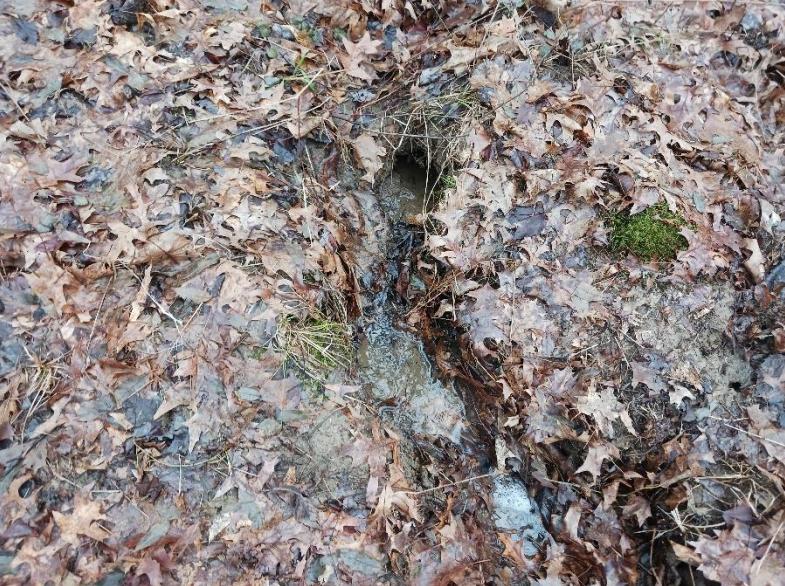
Photograph #	29
Date:	2-27-2025
Description:	View of seep 2.

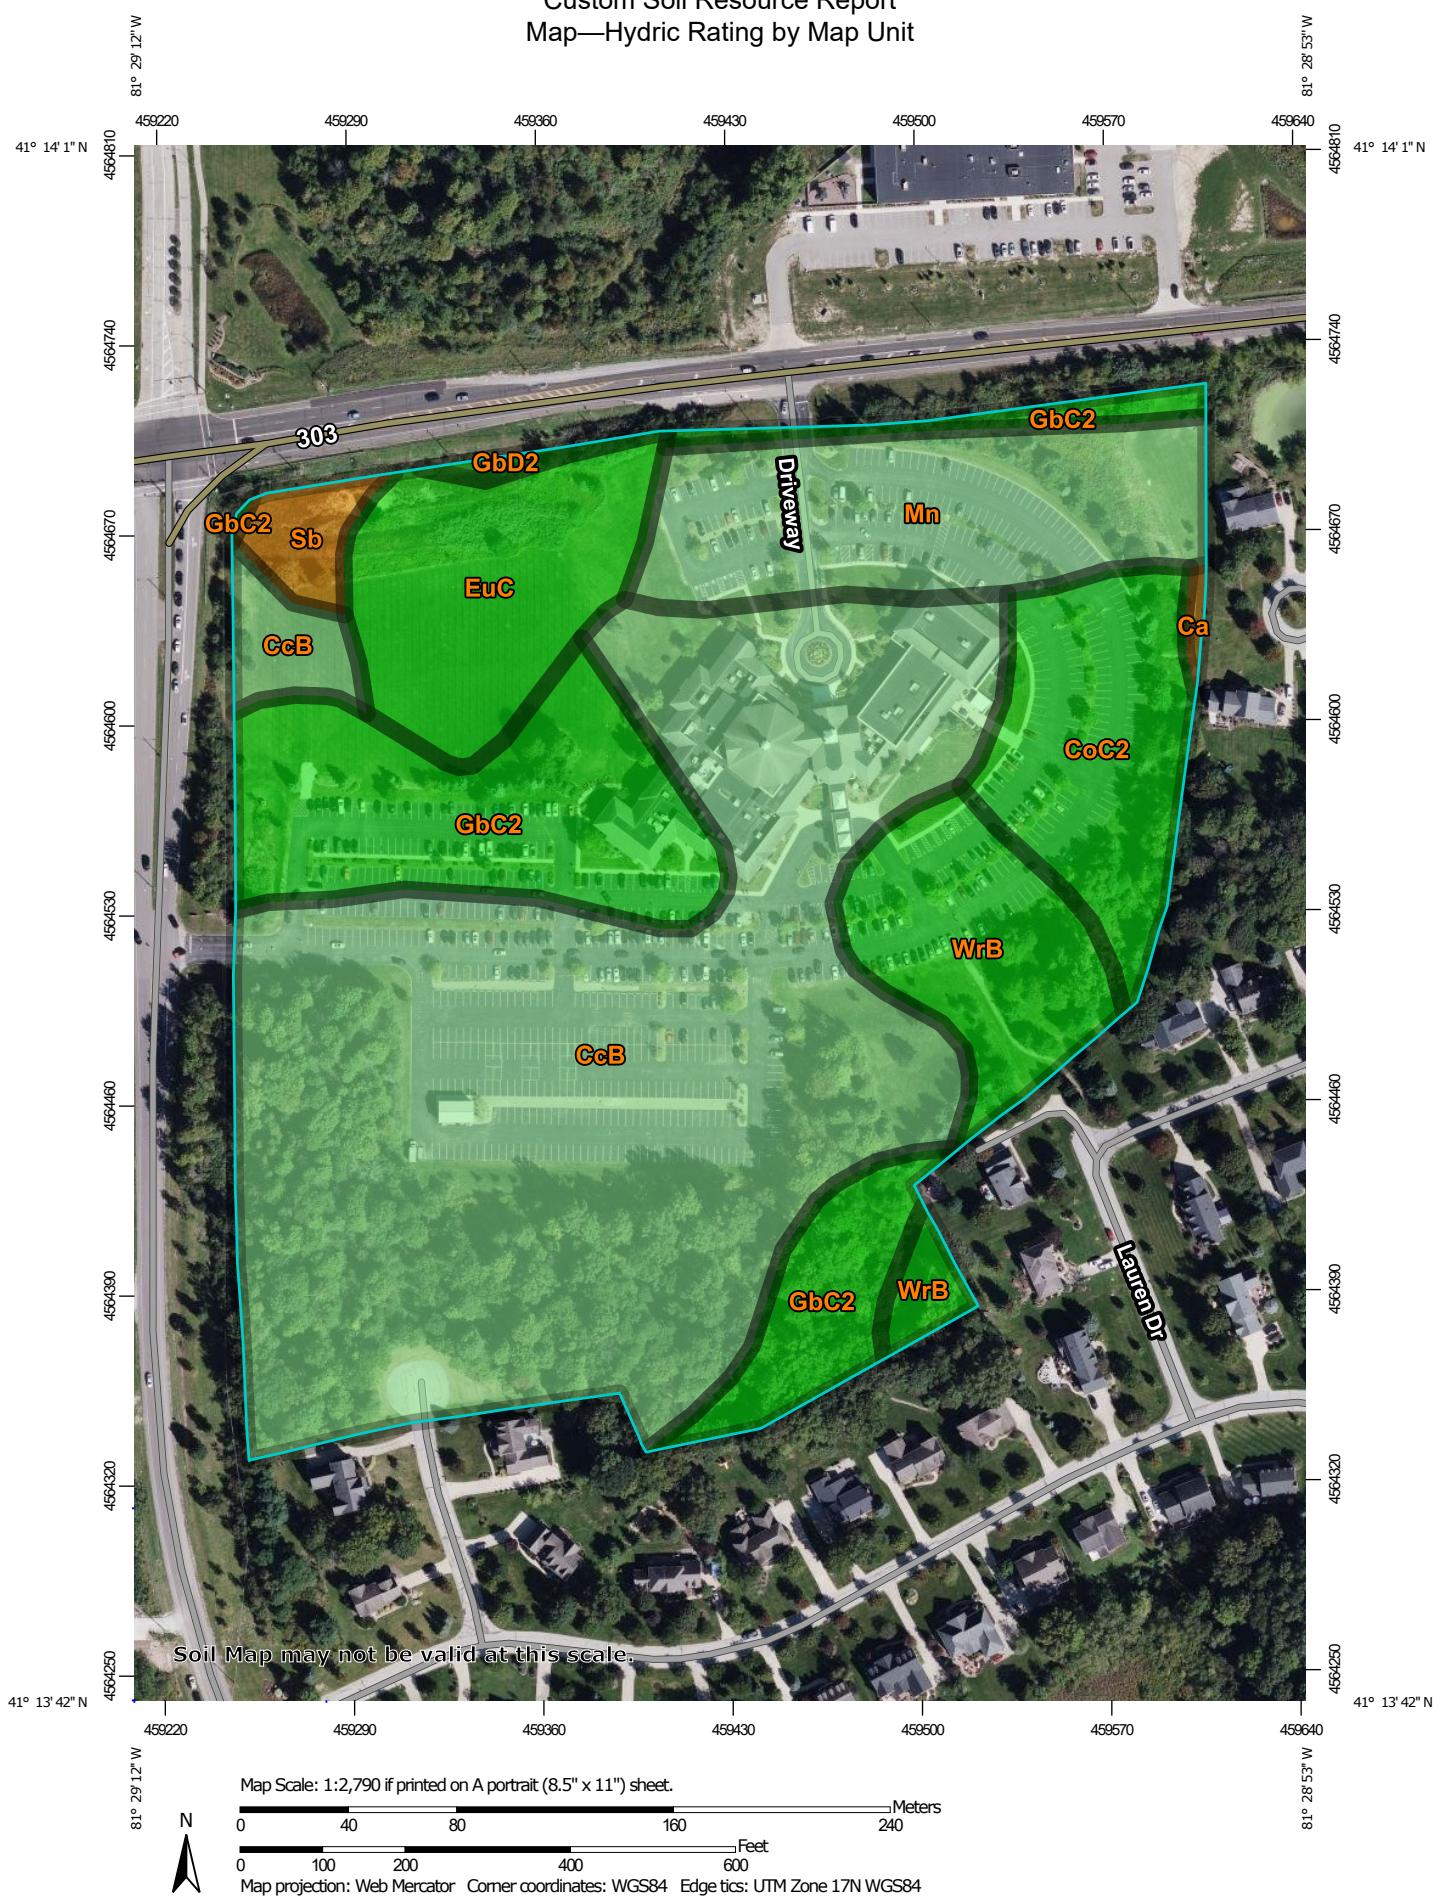
Custom Soil Resource Report Map—Hydric Rating by Map Unit

The aggregation method "Percent Present" returns the cumulative percent composition of all components of a map unit for which a certain condition is true. For example, attribute "Hydric Rating by Map Unit" returns the cumulative percent composition of all components of a map unit where the corresponding hydric rating is "Yes". Conditions may be simple or complex. At runtime, the user may be able to specify all, some or none of the conditions in question.

NRCS Soil Map Unit Name	Map Unit Symbol	Hydric Status	Hydric Rating
Canadice silty clay loam	Ca	Predominately hydric	95
Caneadea silt loam, 2 to 6 percent slopes	CcB	Predominately non-hydric	3
Chili gravelly loam, 6 to 12 percent slopes, moderately eroded	CoC2	Non-hydric	0
Ellsworth–Urban land complex, 6 to 18 percent slopes	EuC	Non-hydric	0
Geeburg silt loam, 6 to 12 percent slopes moderately eroded	GbC2	Non-hydric	0
Geeburg silt loam, 12 to 18 percent slopes, moderately eroded	GbD2	Non-hydric	0

Mahoning – Urban land complex, 0 to 2 percent slopes	Mn	Predominately non-hydric	5
Sebring silt loam, 0 to 2 percent slopes	Sb	Predominately hydric	92
Wheeling silt loam, 2 to 6 percent slopes	WrB	Non-hydric	0
