# 45 PRESERVATION BRIEFS

## Preserving Historic Wood Porches

Aleca Sullivan and John Leeke

National Park Service  
U.S. Department of the Interior  
Heritage Preservation Services

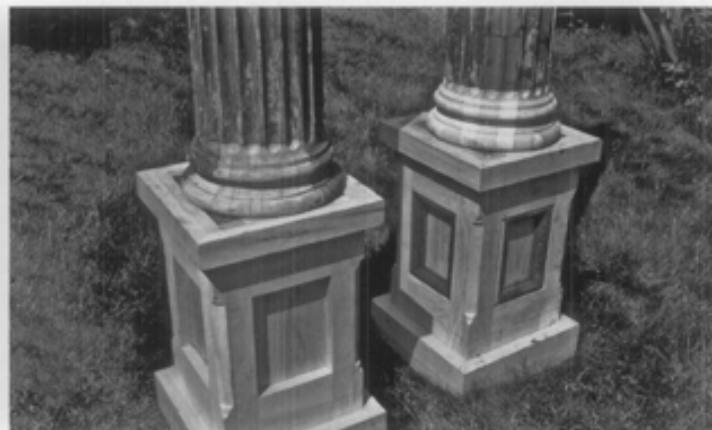
Figure 10. This nineteenth century porch column is made of wood staves, similar to the way a wood barrel is put together. After replacing the torus and making dutchman repairs to the apophyge along the base, the column and pedestal are ready to be reinstalled on the porch. Photos: NPS files.
