**From:** Preview View <jdfield23@aol.com>  
**Sent:** Wednesday, January 31, 2024 11:09 AM  
**To:** Amanda Krickovich  
**Cc:** Eric Chupack; Laurie Frankino; Wendy Hess; Mark Schildhouse; Jean Rhodes; Amy McCormick; Michael Ross  
**Subject:** Temple Beth Shalom Security Door Application Follow-up  
**Attachments:** Metal Door Photo.jpg; Temple Beth Shalom, Hudson Security Assessment 2023 - FINAL 3.30.2023.docx

## SECURITY ASSESSMENT FOR TEMPLE BETH SHALOM

On March 7, 2023, a security assessment was conducted by writer at Temple Beth Shalom at 50 Division Street, Hudson, OH, 44236.

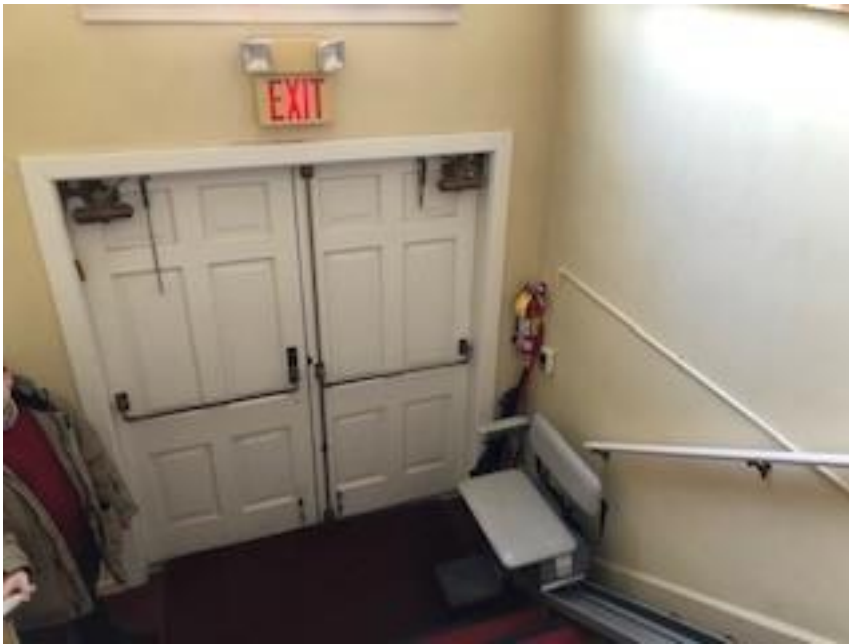
The windows and doors are very old and could be easily forced open/broken into. They do not have bullet proof windows or protective safety film on their exterior/interior windows. All windows should be replaced. They do not have an alerting system or audible door alarms if the doors are not properly secured or propped open. In an emergency, there are two defined areas to exit - the main door to the rear of the worship area or the side door to the east of the worship area.

*Figure 3 interior front door entrance*

Replacement of the front entrance door and side door is recommended and should include a changeable lock code system and should include a window. Create standoff from potential vehicle attacks by placing aesthetic concrete bollards/planters or landscape boulders/shrubbery at the front drive entrance as well as around the perimeter and side entrance of the facility. This will prevent potential assailants from driving/attacking with a vehicle at the main entrance door.

It is recommended that the windows be replaced with a more secure option. In particular the windows adjacent to the side entrance need to be replaced with a system that allows easy visibility to vet individuals prior to being allowed into the building. A plan should be implemented to allow occupants of the facility to retreat to specifically designed "safe room" in the event of an intrusion/attack. These rooms should be equipped with additional panic buttons, pepper spray containers and a turn-key lock (specifically marked) indicating both the lock position as well as the unlock position. A system to enhance interior door security should be implemented. The "Bearcade" Lockdown Response System should be considered to enhance security in the event of an active shooter situation. First aid bags should also be readily available in these room. All exterior windows should be "numbered" which would assist First Responders in quickly locating the exact room/area/classroom needing assistance. The "number should be visible from both the interior and exterior of the window.

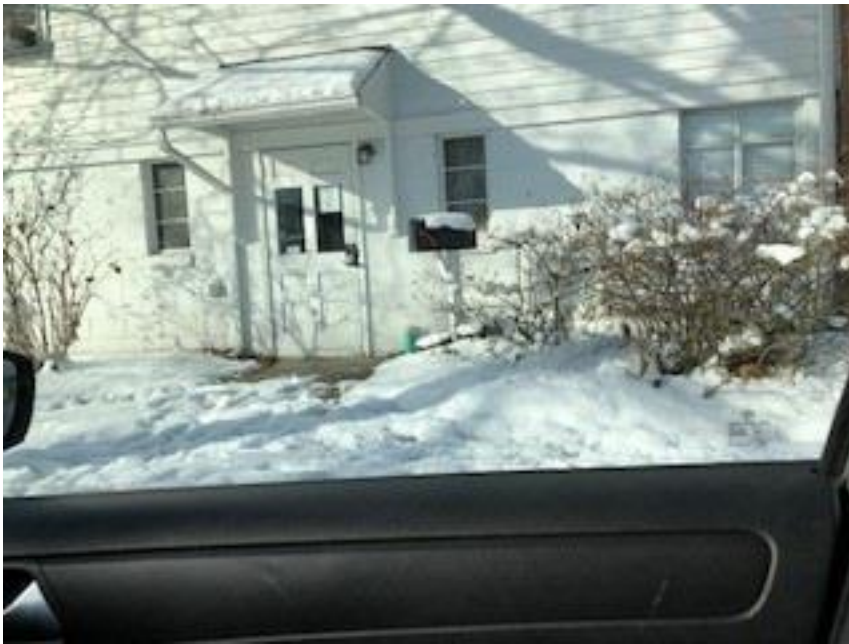
*Figure 5 exterior entrance on College Street - side door*

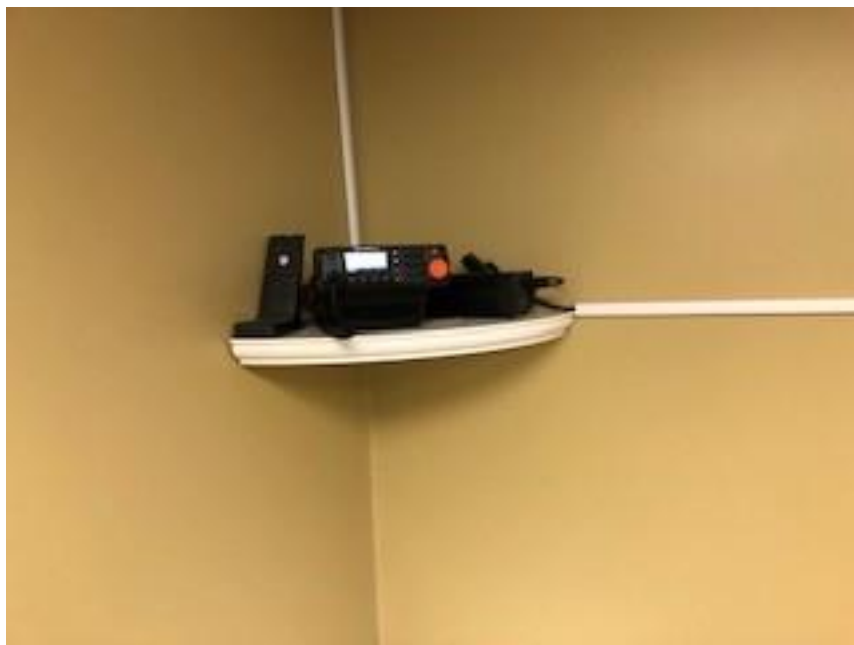
The Temple does not have an alarm system. There is one (1) panic alarm in the building. There are no audible door alarms to alert if propped open or not shut properly. Contact with the area police department is only by landline or cell phone.

*Figure 8 panic alarm*

All exits should have an alarm to prevent doors from being propped open and unattended. Install an alarm system with monitoring capabilities as well as a direct method of communication to the area police department in the event of an emergency. Additionally, install a series of panic alarms in the office assigned to the Rabbi, in classrooms, in the sanctuary and at both the rear entrance as well as the main entrance. Ensure that all the buildings panic alarms when activated trigger a text/email notification to police, staff and congregants to alert them to the threat in the building.

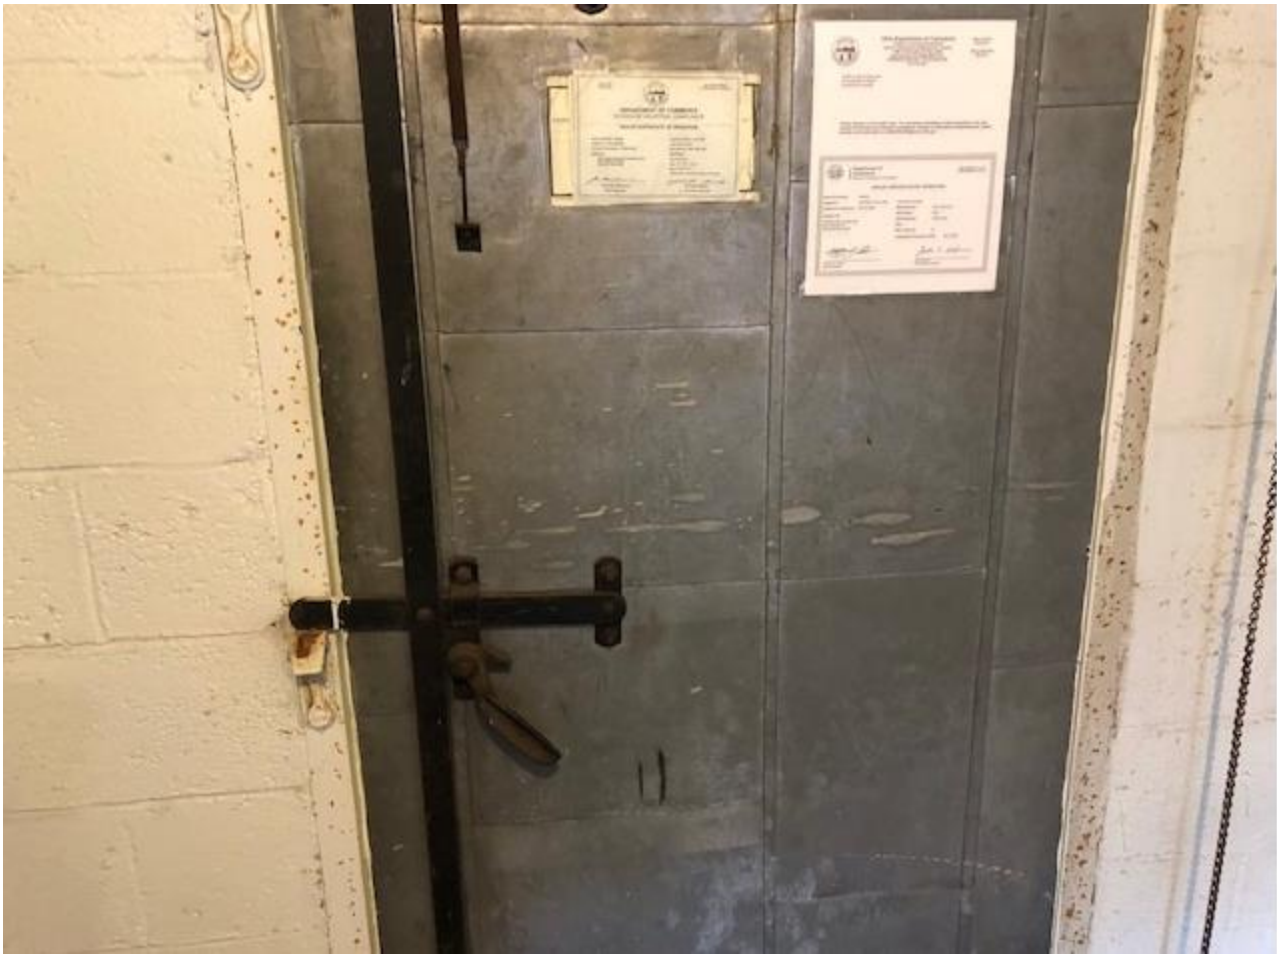
*Figure 9 - possible SAFE ROOM - Boiler room*
