## **WETLAND AND WATER RESOURCE DELINEATION REPORT**

**~2.13-Acre Property  
1465 Norton Road  
Hudson, Summit County, Ohio  
(Parcel ID: 30-10362)**

**BCI Dental & Medical Specialists  
2950 Westway Drive, Suite 109  
Brunswick, Ohio 44212  
CC: Mr. Bill Savel**

May 26, 2026

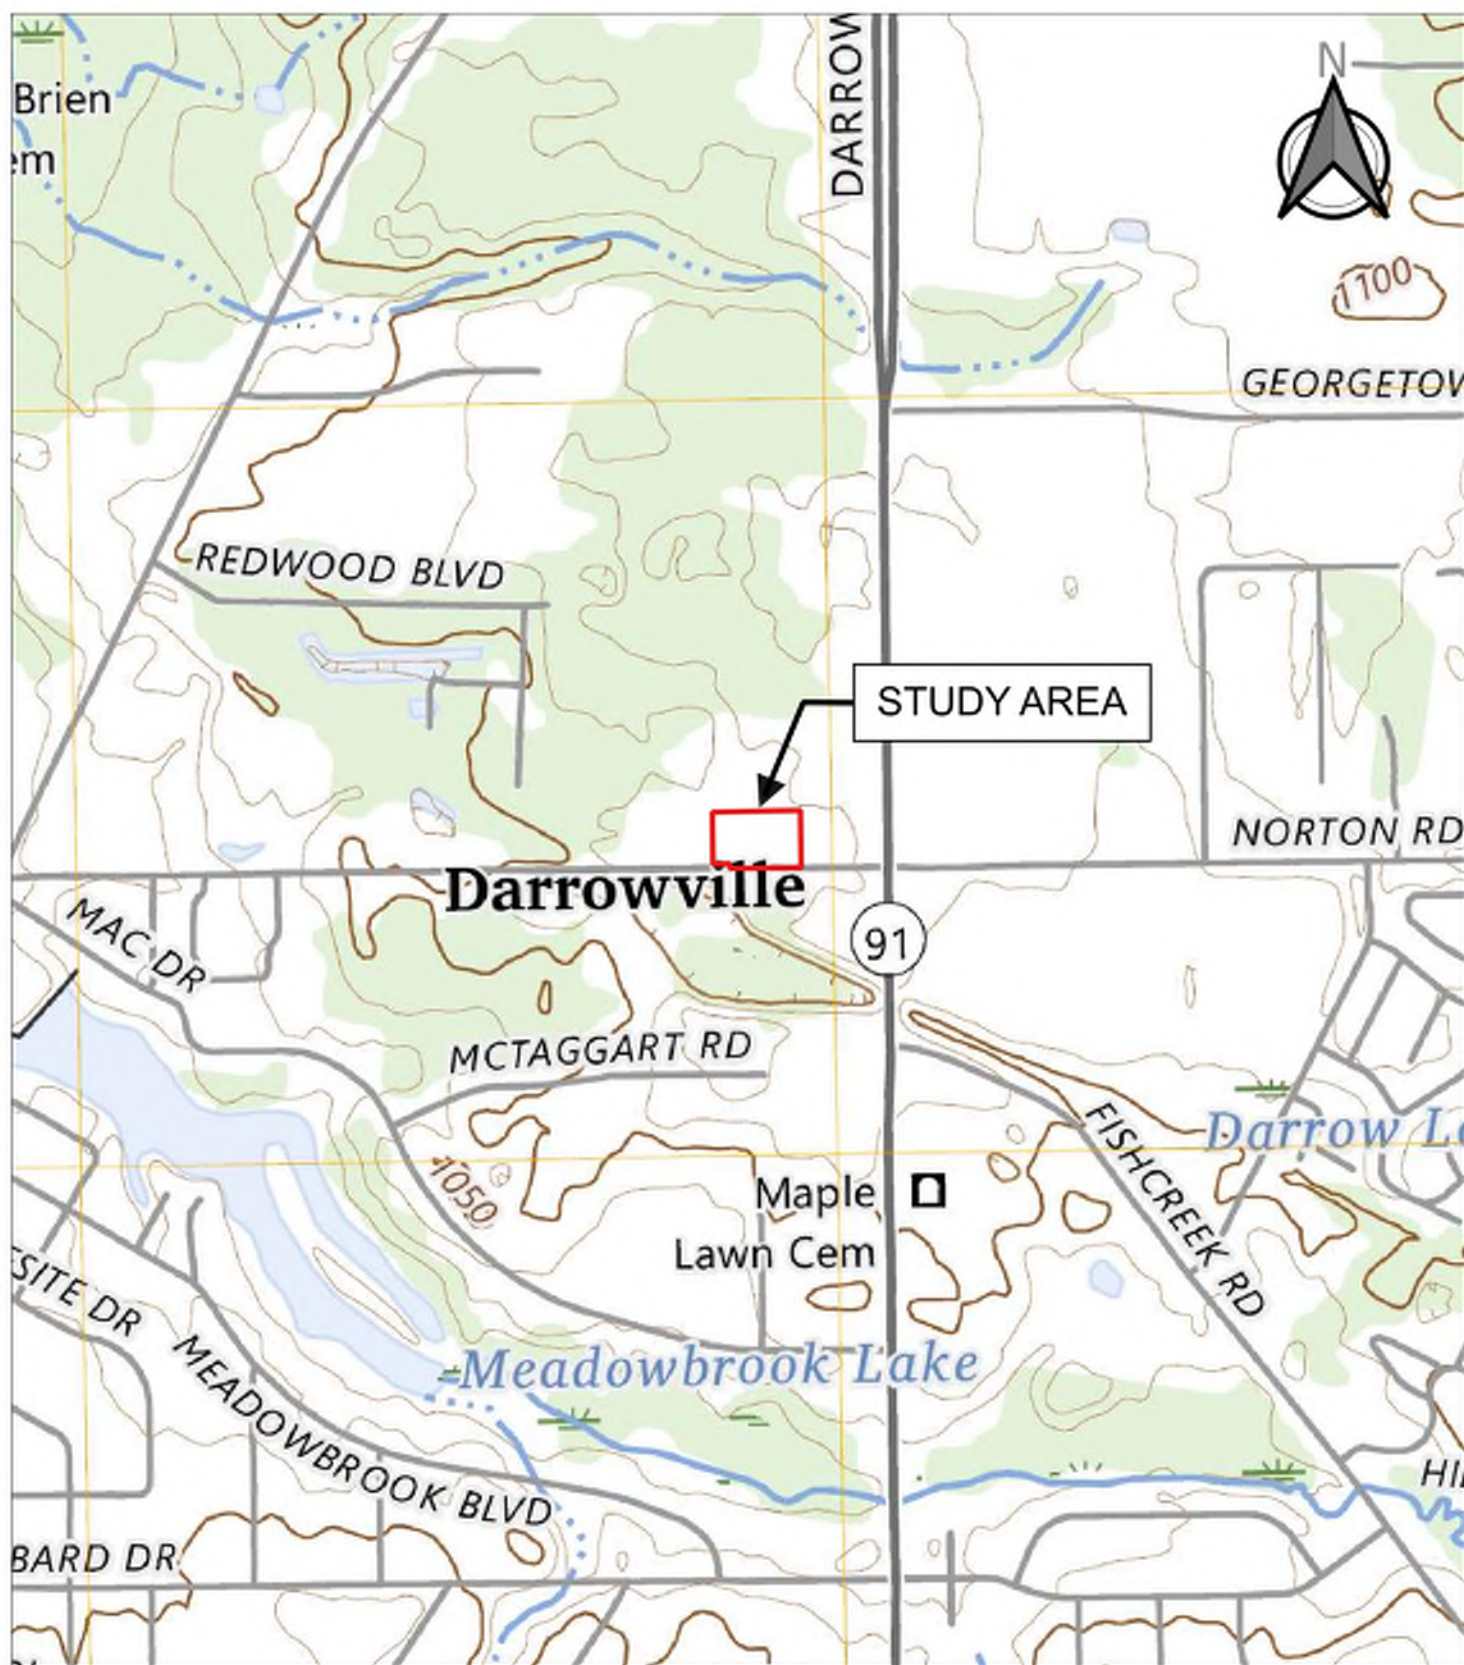
**FIGURE 3**  
 USGS TOPOGRAPHIC MAP  
**BCI DENTAL & MEDICAL SPECIALISTS**  
 1465 NORTON AVENUE, HUDSON,  
 SUMMIT COUNTY, OHIO

The topography on the site is relatively flat and gently slopes to the northwest. Review of the Hudson, Ohio USGS 7.5-minute Topographic Quadrangle map (2023) and the Summit County Geographic Information System (GIS) mapping indicates that the existing topography on the site ranges between 1062 to 1070 feet in elevation above the National Geodetic Vertical Datum (NGVD). Contours from the Summit County GIS do not indicate any potential drainage features within the Project Area. The portion of the USGS Topographic map showing the Project Area is included in **Appendix A as Figure 3**.

The majority of the surficial flow is generally conveyed in a northwestern direction towards an unnamed tributary of Powers Brook. This unnamed tributary drains 0.15 square miles of Summit County. The Project Area is located within the Cuyahoga River watershed, designated with the 8-digit Hydrologic Unit Code (HUC-8) 04110002.

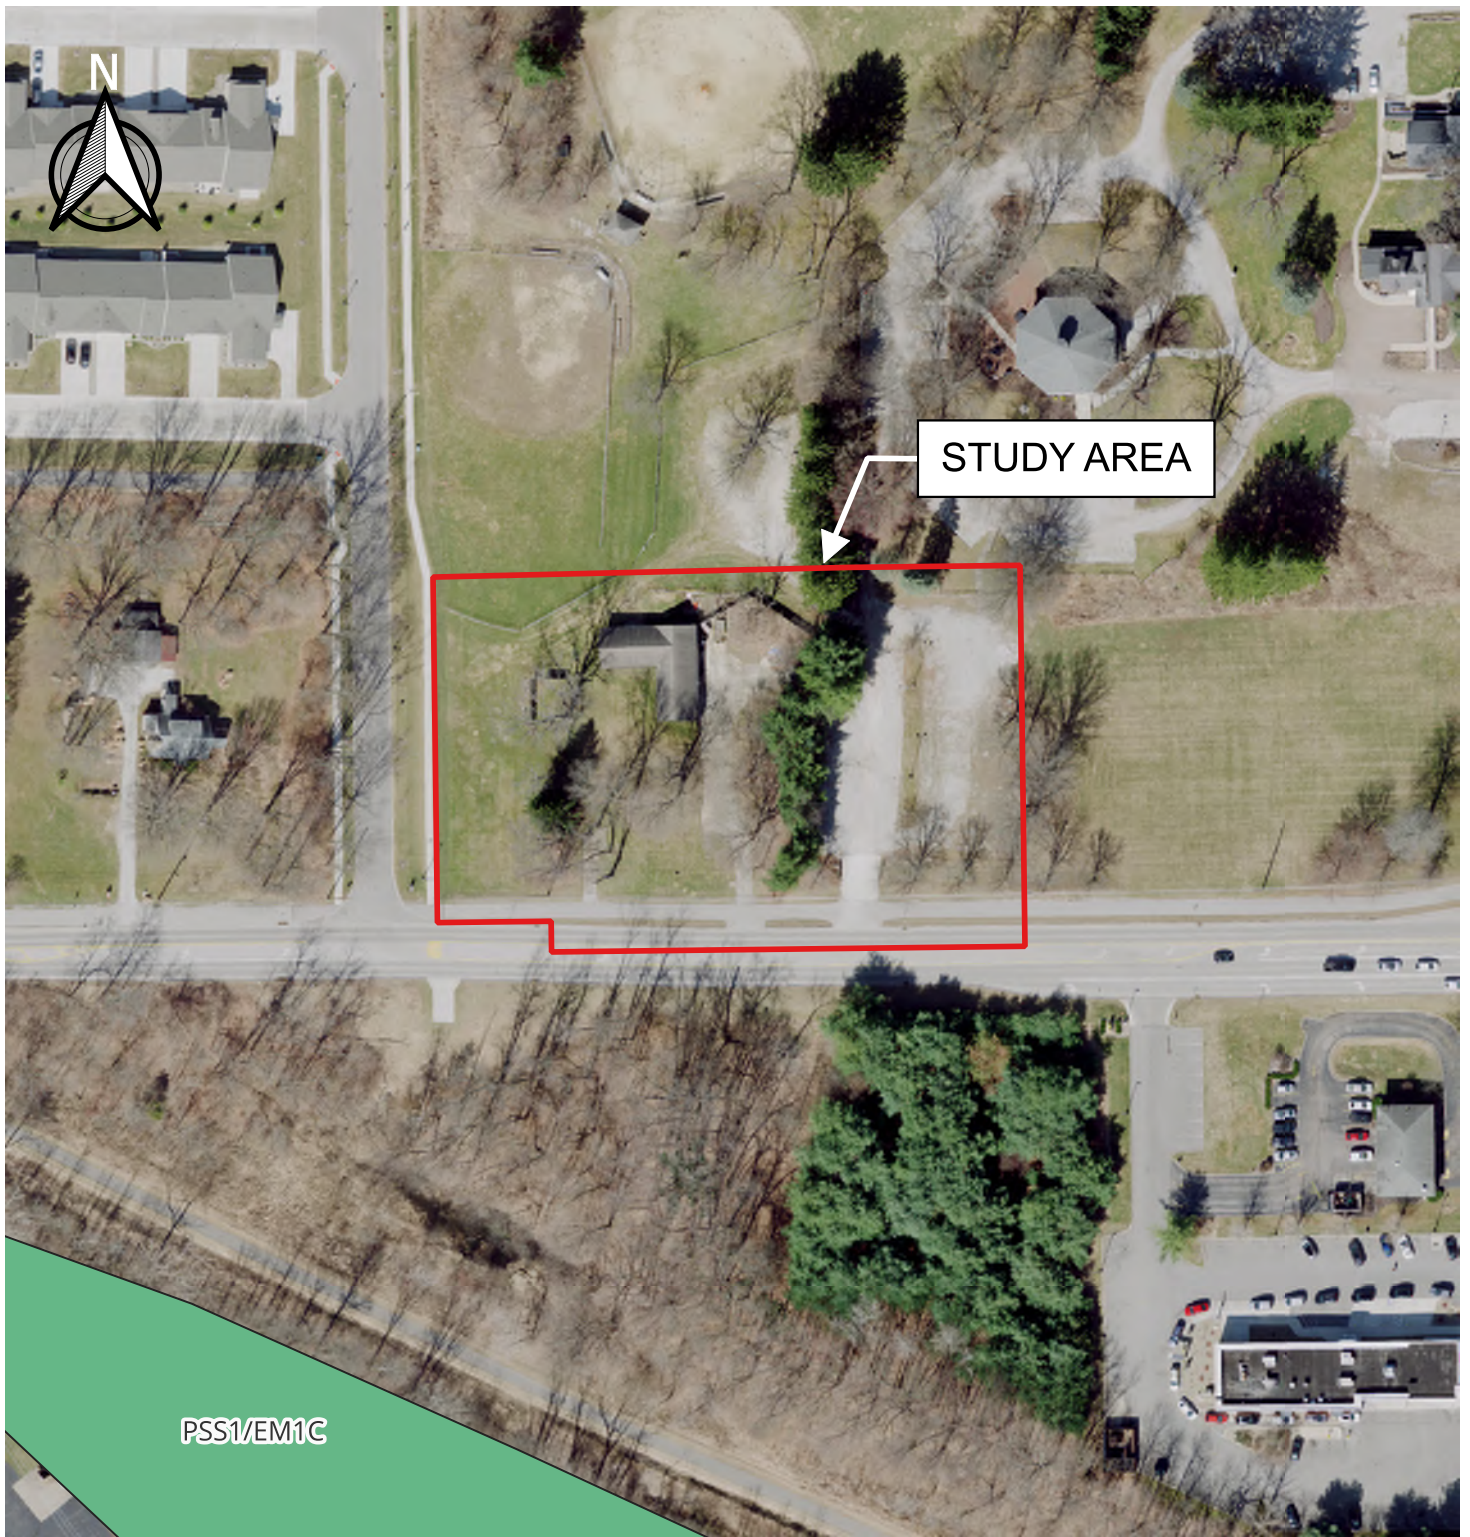
**FIGURE 2**  
**NATIONAL WETLANDS INVENTORY MAP**  
**BCI DENTAL & MEDICAL SPECIALISTS**  
1465 NORTON AVENUE, HUDSON,  
SUMMIT COUNTY, OHIO

A review of the USFWS National Wetlands Inventory (NWI) map of Hudson, Ohio did not indicate any wetlands, streams, or open-water habitats (ponds) within the Project Area (**Appendix A, Figure 2**). Note that NWI maps were derived from aerial photo interpretation and are designed for general planning purposes only.

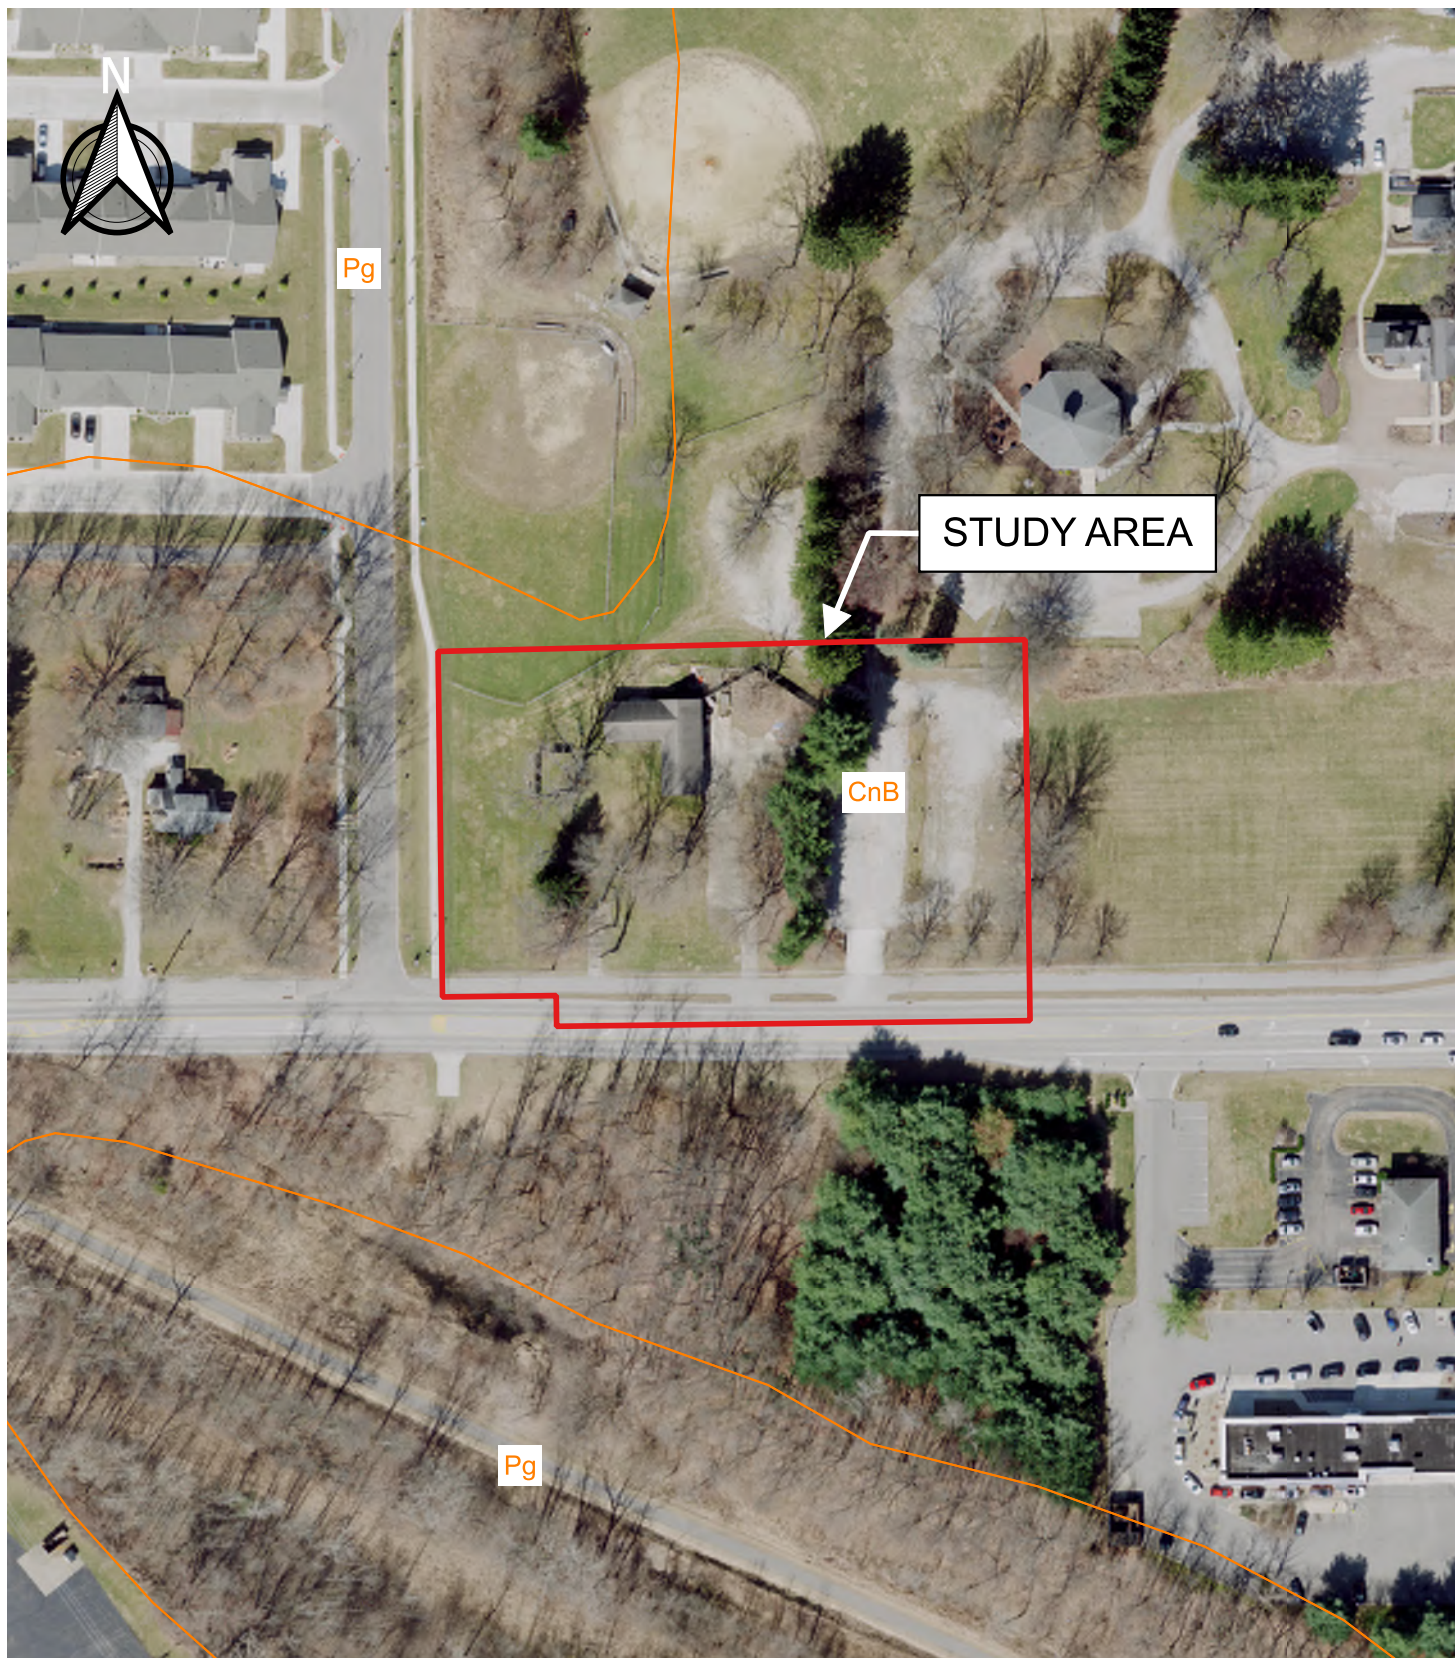
**FIGURE 4**  
 NRCS SOIL SURVEY MAP  
**BCI DENTAL & MEDICAL SPECIALISTS**  
 1465 NORTON AVENUE, HUDSON,  
 SUMMIT COUNTY, OHIO

The Soil Survey of Summit County, Ohio (<http://websoilsurvey.nrcs.usda.gov/app/WebSoilSurvey.aspx>) indicates that one (1) soil is mapped within the Project Area: Chili loam, 2-6% slopes (CnB). CnB is considered a well-drained soil. The Summit County Natural Resource Conservation Service (NRCS) designates CnB as non-hydric. The portion of the soil survey showing the Project Area is included in **Appendix A as Figure 4**.

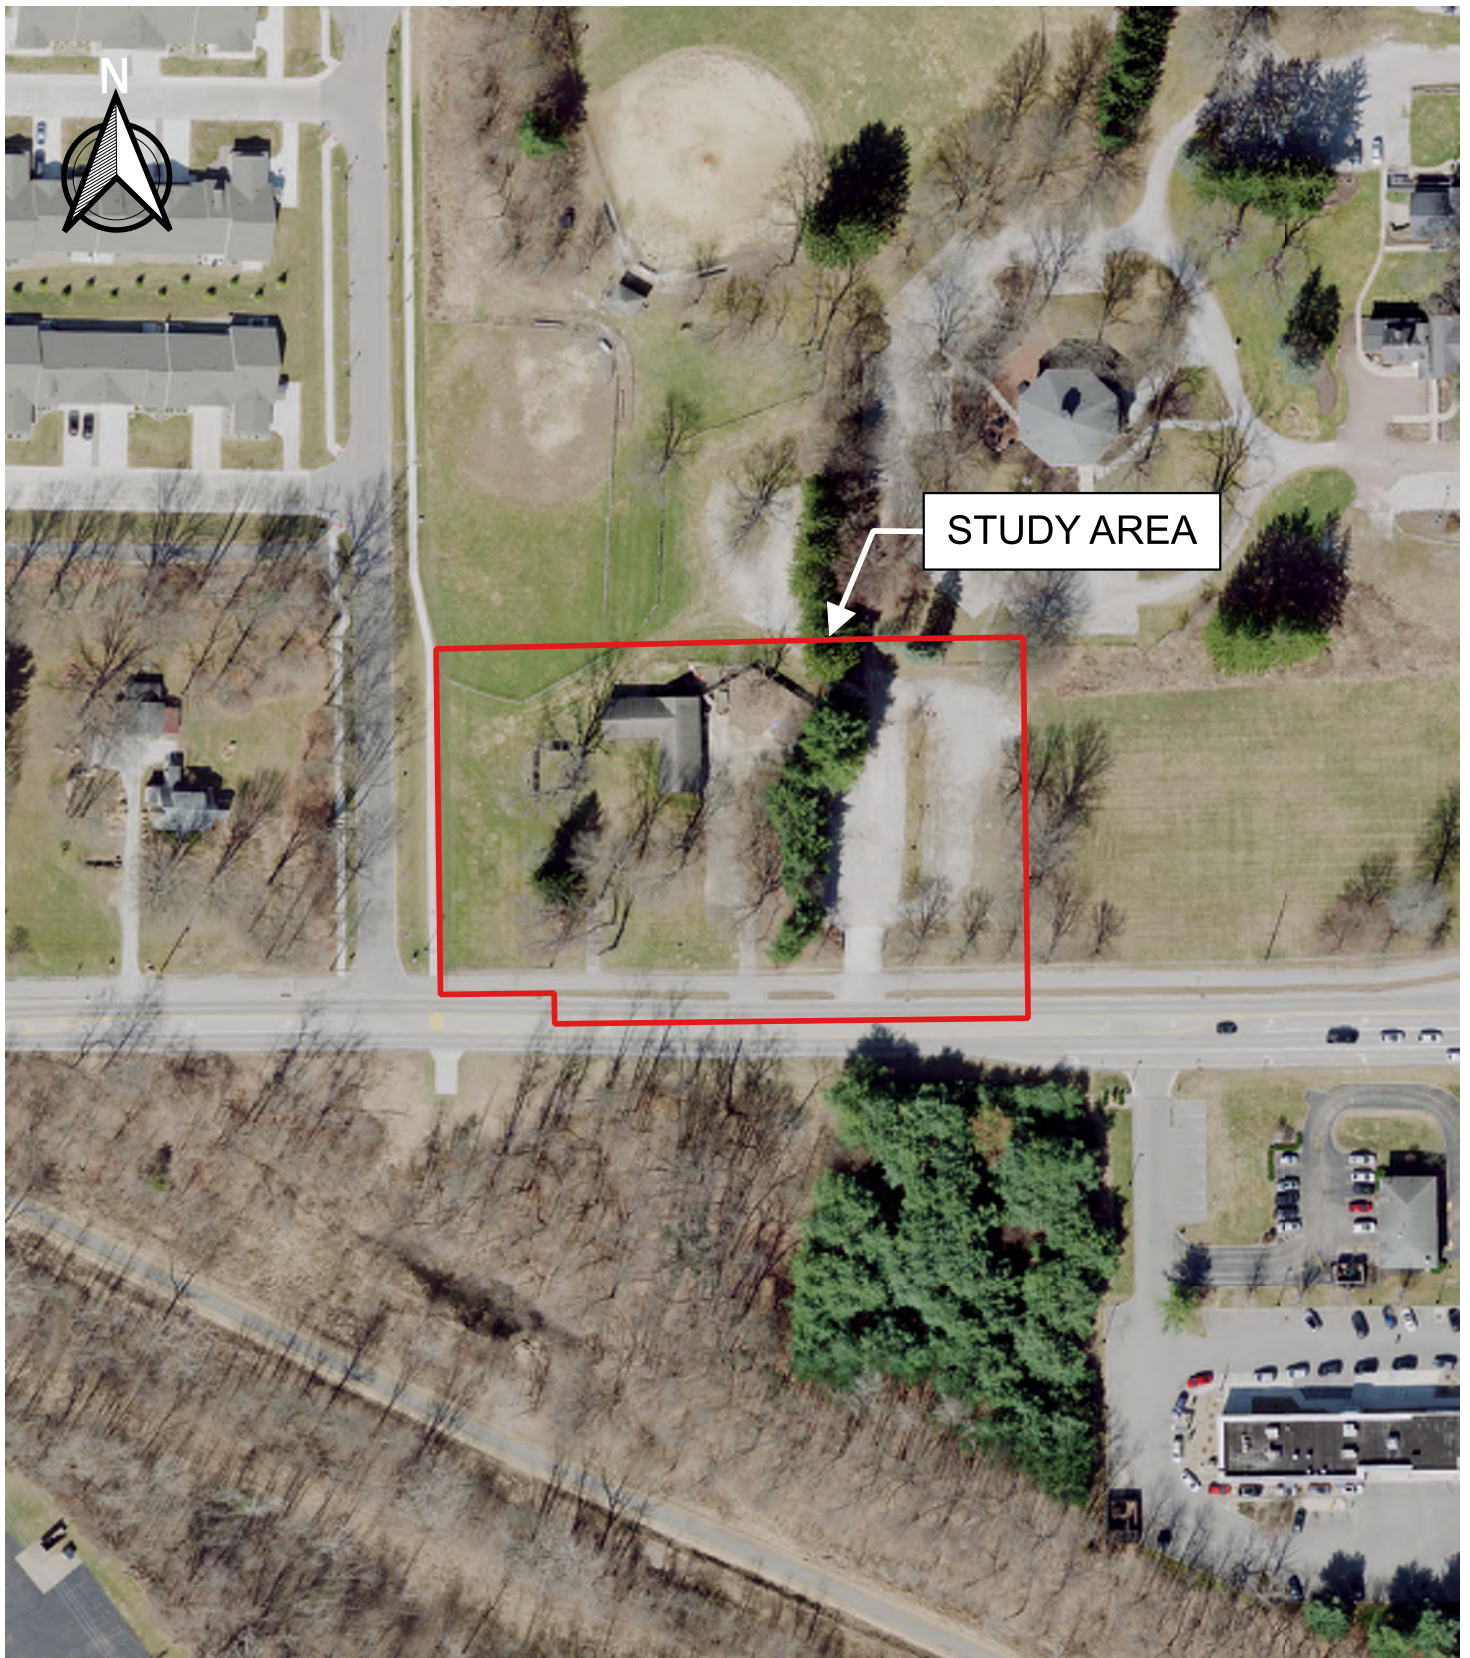
**FIGURE 5**  
AERIAL PHOTOGRAPH MAP  
**BCI DENTAL & MEDICAL SPECIALISTS**  
1465 NORTON AVENUE, HUDSON,  
SUMMIT COUNTY, OHIO

A review of aerial imagery from the Summit County GIS and Google Earth shows that the Project Area is comprised of primarily managed herbaceous habitat with a minority of forested habitats. A larger portion of the Project Area was comprised of active agricultural fields with a residential structure in the southwestern portion of the Project Area from the earliest available aerial imagery (1952) to 1982. The gravel access road and parking area in the eastern portion of the site were constructed between 1982 and 1994. The existing storage structure in the northwestern portion of the site was constructed between 2004 and 2006. The residential structure was removed between 2011 and 2013, and the site has since succeeded to its current state. No drainage patterns or dark spots (indicators of potential streams or wetlands) are apparent within the Project Area throughout the historical aerial imagery reviewed. Aerial imagery from OGRIP OSIP Imagery Program (2025) is provided in **Appendix A as Figure 5**.

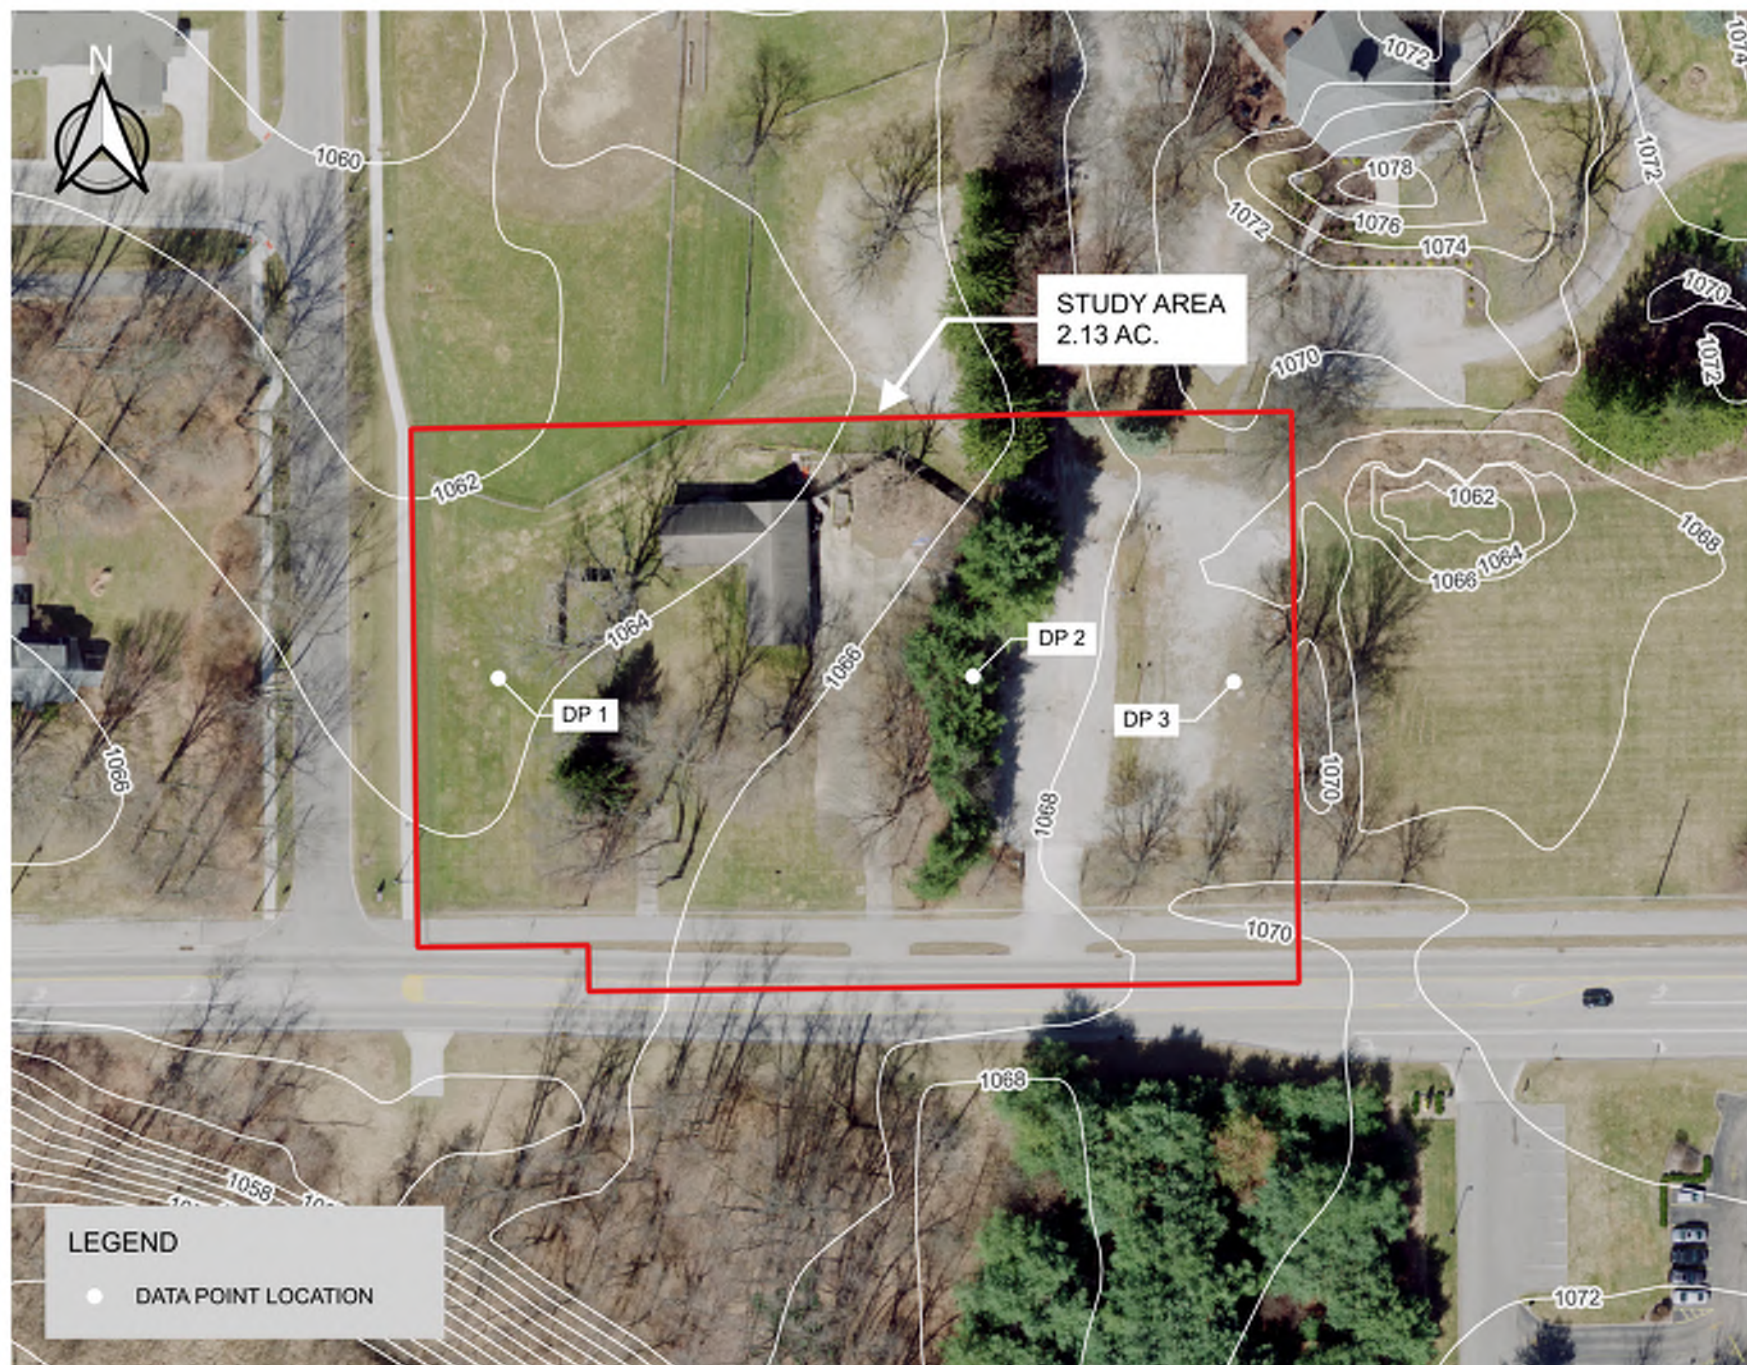
**FIGURE 6**  
FIELD DATA LOCATION MAP  
**BCI DENTAL & MEDICAL SPECIALISTS**  
1465 NORTON AVENUE, HUDSON,  
SUMMIT COUNTY, OHIO

Three (3) data points (designated as “DP1” to “DP3”) were collected within the Project Area. The Field Data Location Map depicting the surveyed data point locations and photograph locations with directions is provided in **Appendix A, Figure 6**. The data points collected within the Project Area were each recorded on a Wetland Determination Data Form provided in **Appendix B**. Site photographs are located in **Appendix C**. The following descriptions provide a summary of each data point, including the location and characteristics.

No wetlands were identified within the Project Area. The data point locations are shown on the Field Data Location Map (**Appendix A, Figure 6**). No drainage features, aquatic features, or open water (pond) habitats were observed within the Project Area.

- 1) At the Client's preference, submit a copy of this report to the USACE, Buffalo District to have the absence of wetlands and water resources verified.
- 2) Since there are no wetlands or water resources, a federal or state permit is not required because there are no impacts to "waters of the United States" or "waters of the State of Ohio".

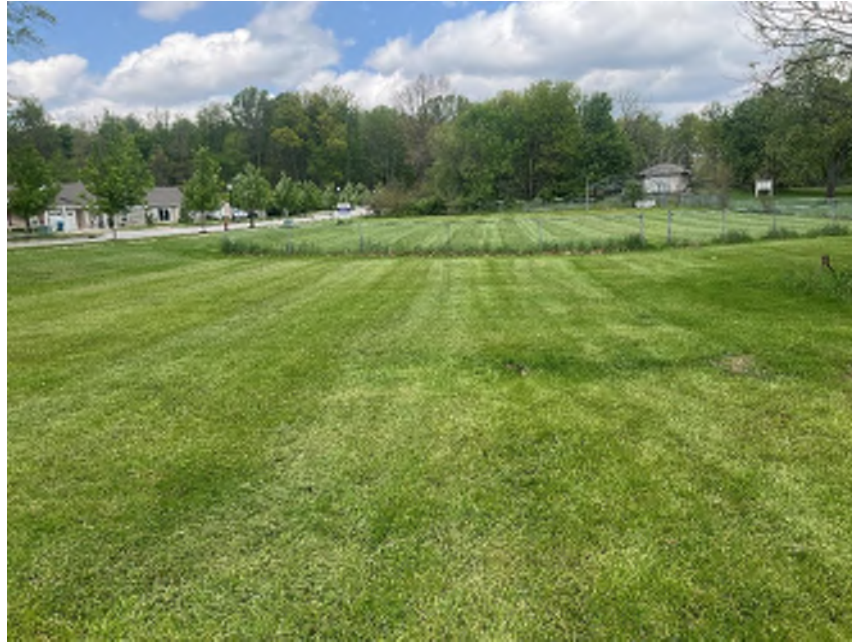
Photograph 1

**A non-wetland point, located in an herbaceous habitat and near the western portion of the Project Area.**

View facing north, depicting the herbaceous habitat at non-wetland data point DP1, located in the western portion of the Project Area.

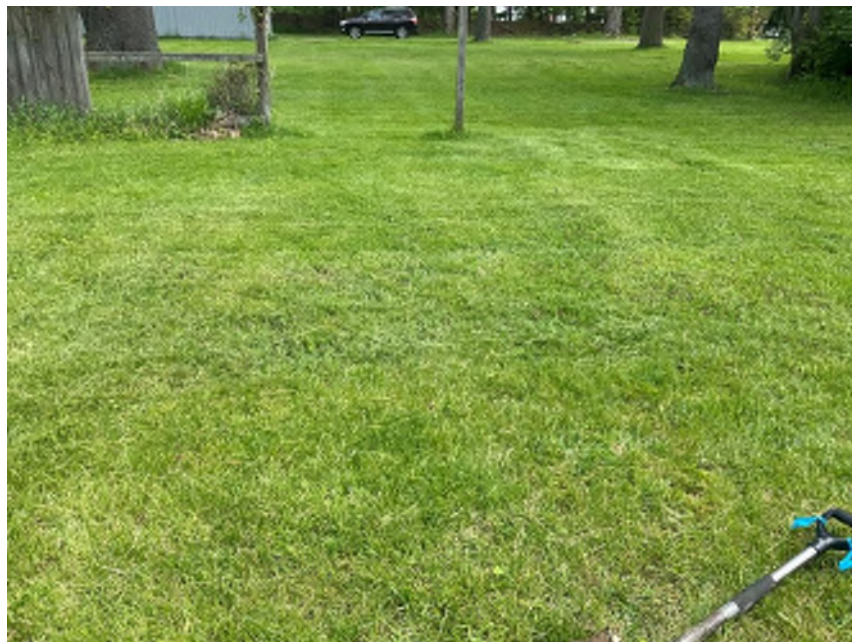
Photograph 2

View facing east, depicting the herbaceous habitat at non-wetland data point DP1, located in the western portion of the Project Area.

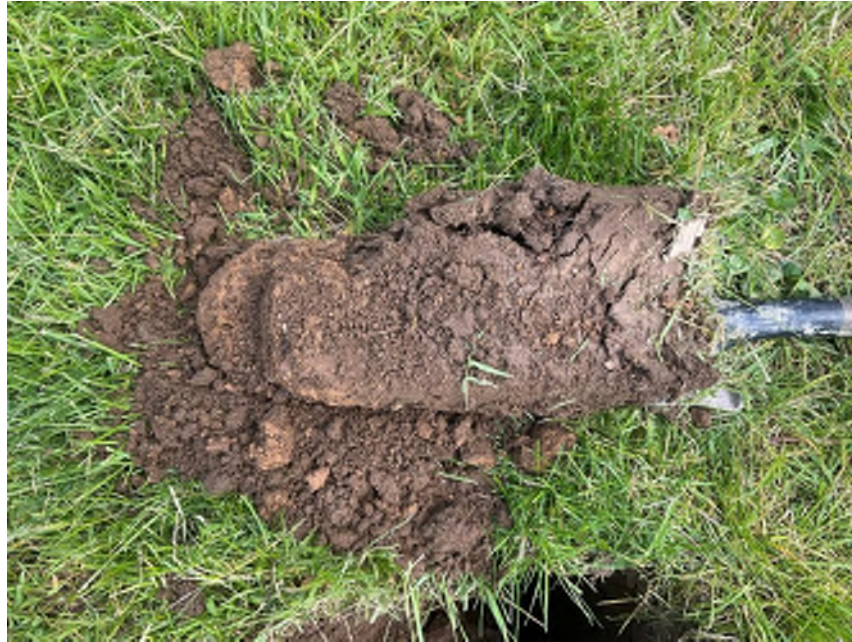
Photograph 3

No positive indication of hydric soil was observed.

Typical view of the non-hydric soil profile at data point DP1.

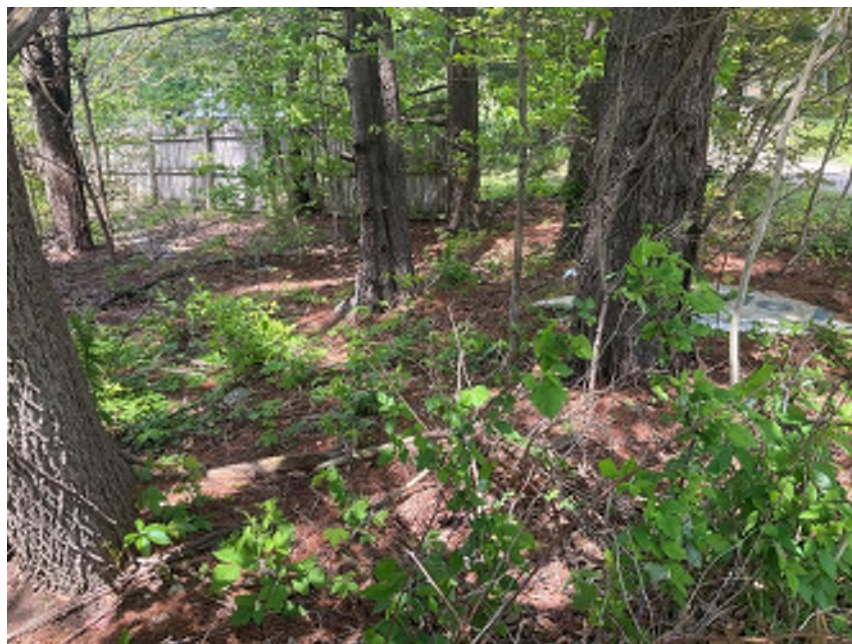
Photograph 4

The soil sample was unable to be extended past 4 inches due to the presence of gravel and a dense root mat, preventing the shovel penetration.  
No positive indication of hydric soil was observed.

View facing north, depicting the forested habitat at non-wetland data point DP2, located in the eastern-central portion of the Project Area.

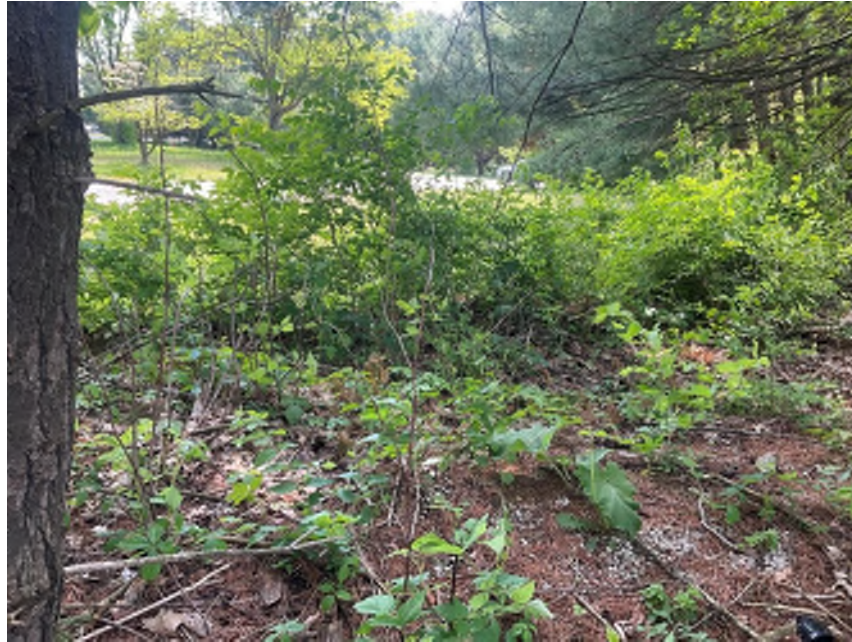
Photograph 5

View facing east, depicting the forested habitat at non-wetland data point DP2, located in the eastern-central portion of the Project Area.

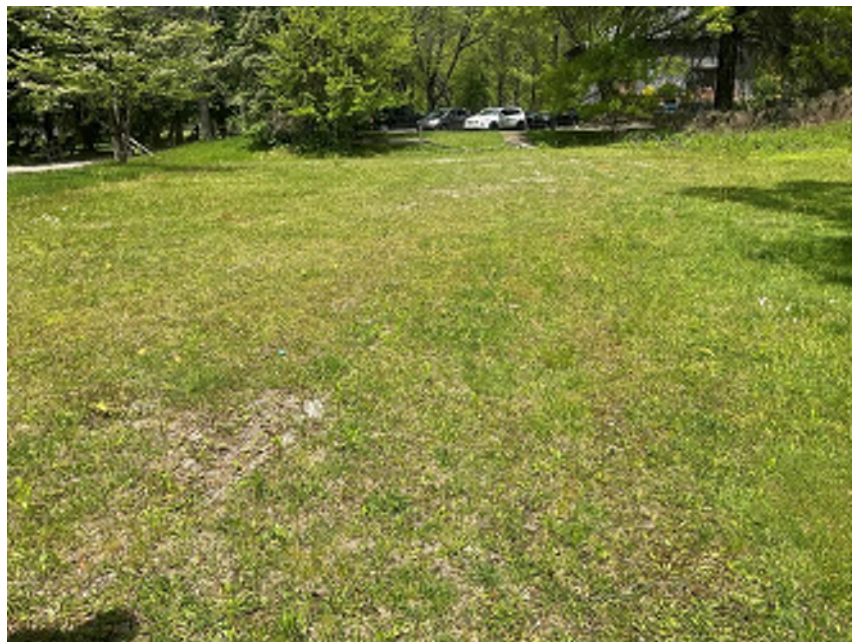
Photograph 6

No positive indication of hydric soil was observed.

View facing north, depicting the herbaceous habitat at non-wetland data point DP3, located in the eastern portion of the Project Area.

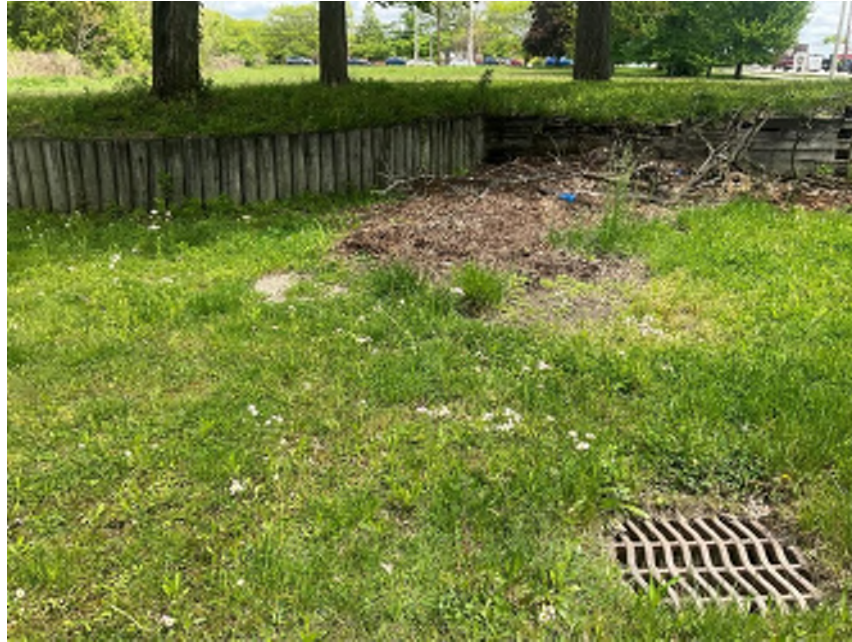
Photograph 7

View facing east, depicting the herbaceous habitat at non-wetland data point DP3, located in the eastern portion of the Project Area.

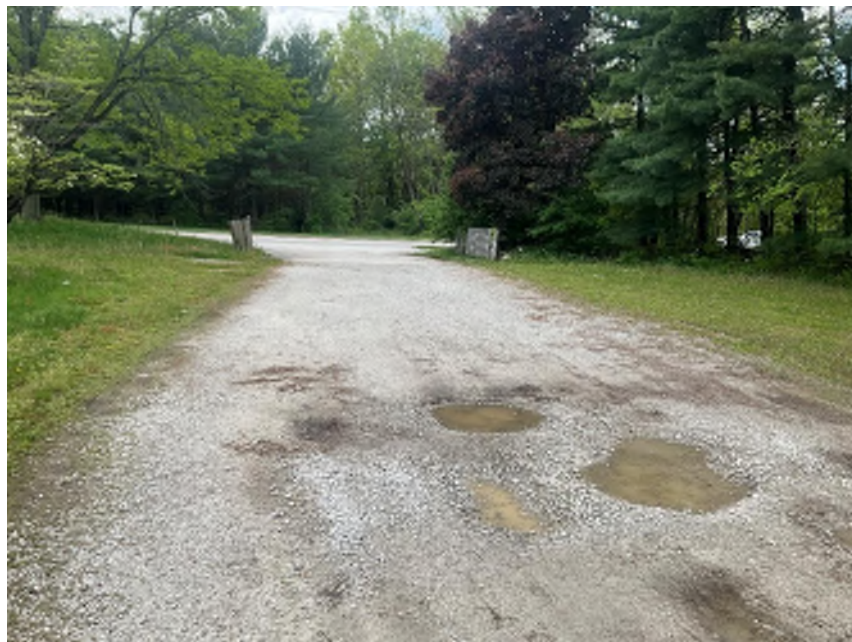
Photograph 8

Typical view facing south, depicting a gravel access road in the eastern portion of the Project Area.

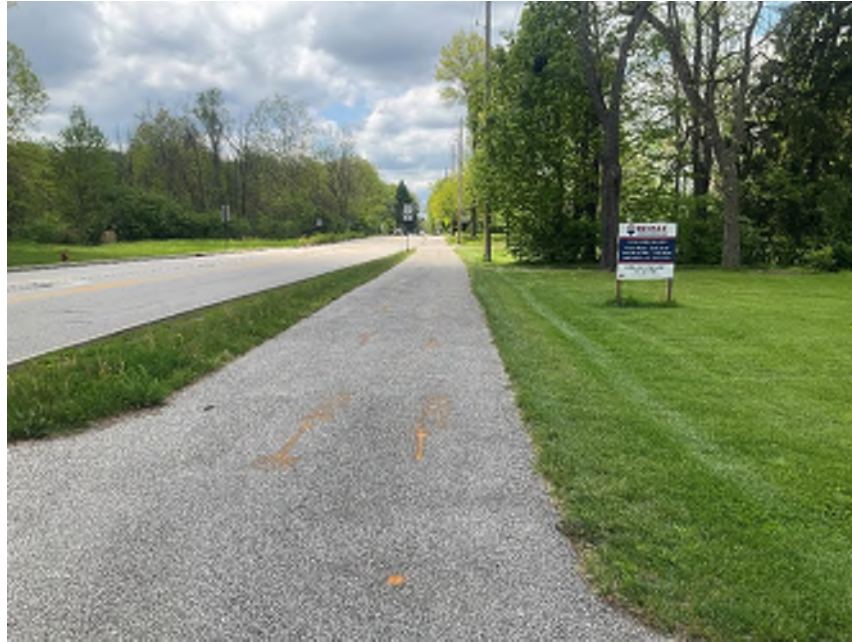
Photograph 9

Typical view facing west, depicting a paved sidewalk in the southwestern portion of the Project Area.

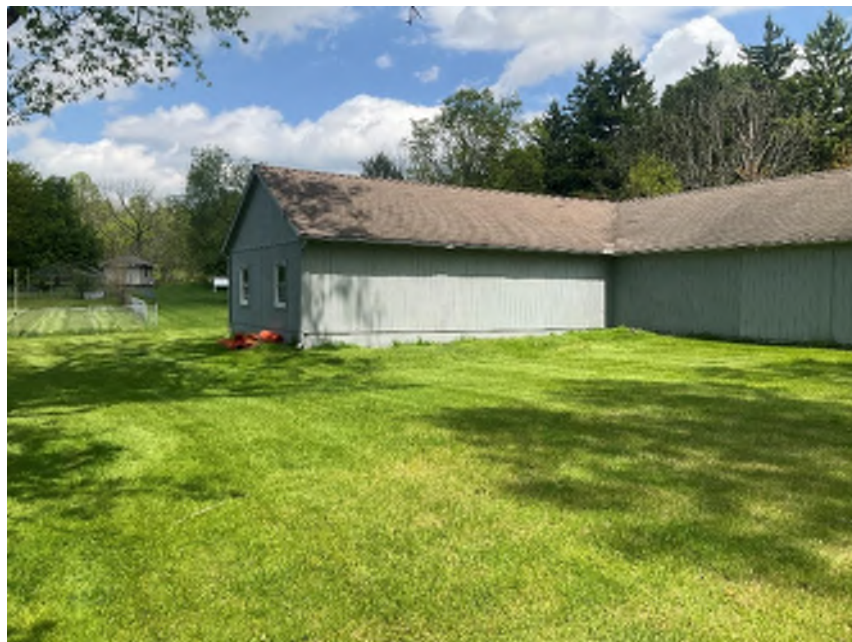
Photograph 10

Typical view facing east, depicting an existing storage structure in the northwestern portion of the Project Area.
