Pedestrian Hybrid Beacon Justification Study

SR 91 and Aurora Street Crosswalks Hudson, Ohio

PEDESTRIAN HYBRID BEACON JUSTIFICATION STUDY

SR 91 & Aurora Street Crosswalks

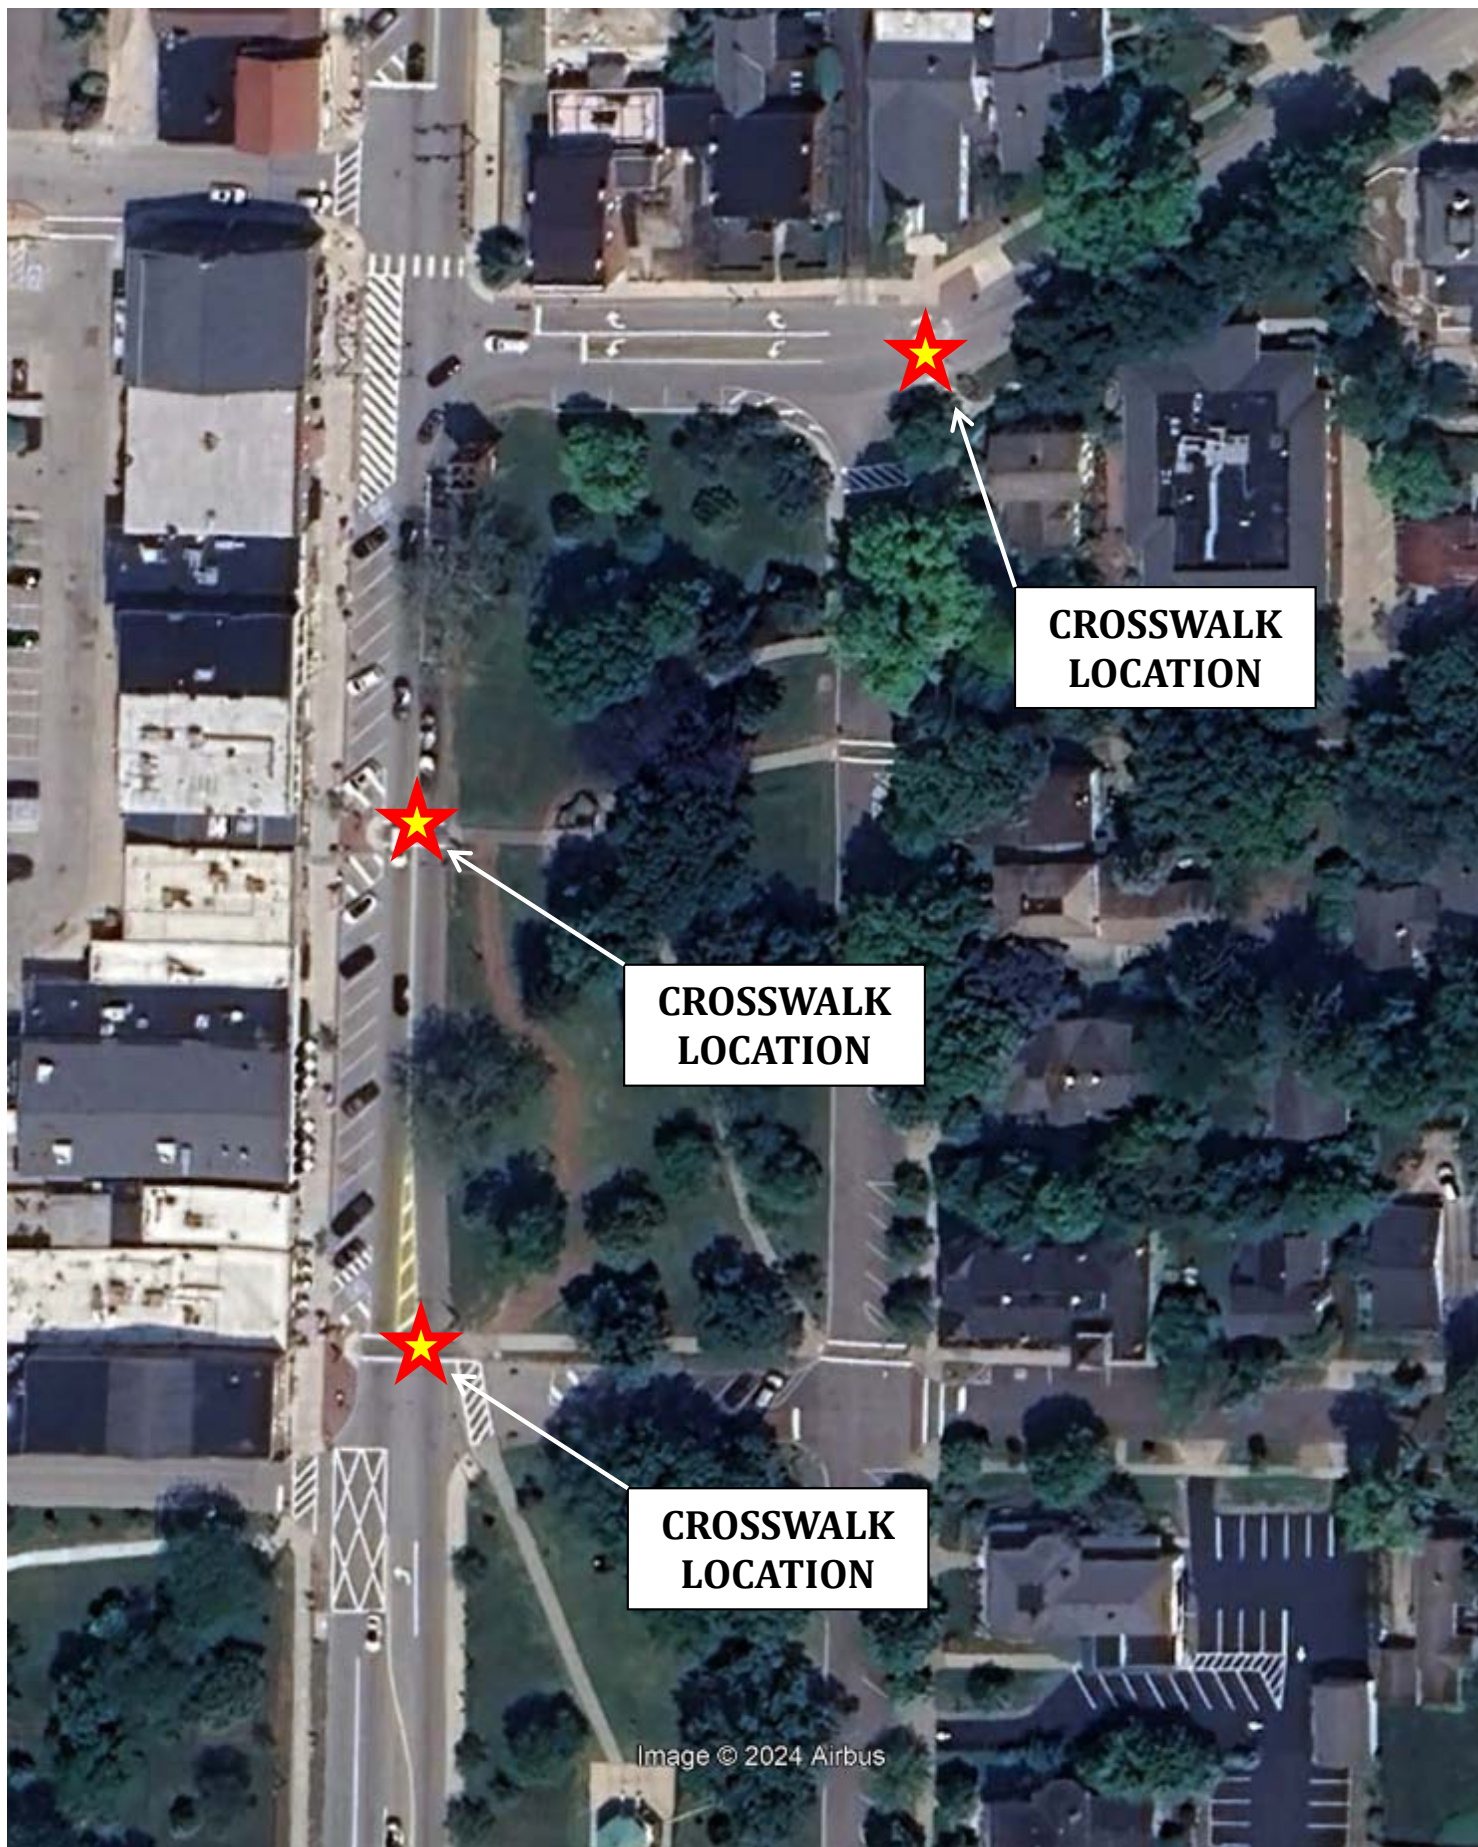
Figure 1.1, Page 2 shows the location of the study crosswalks.

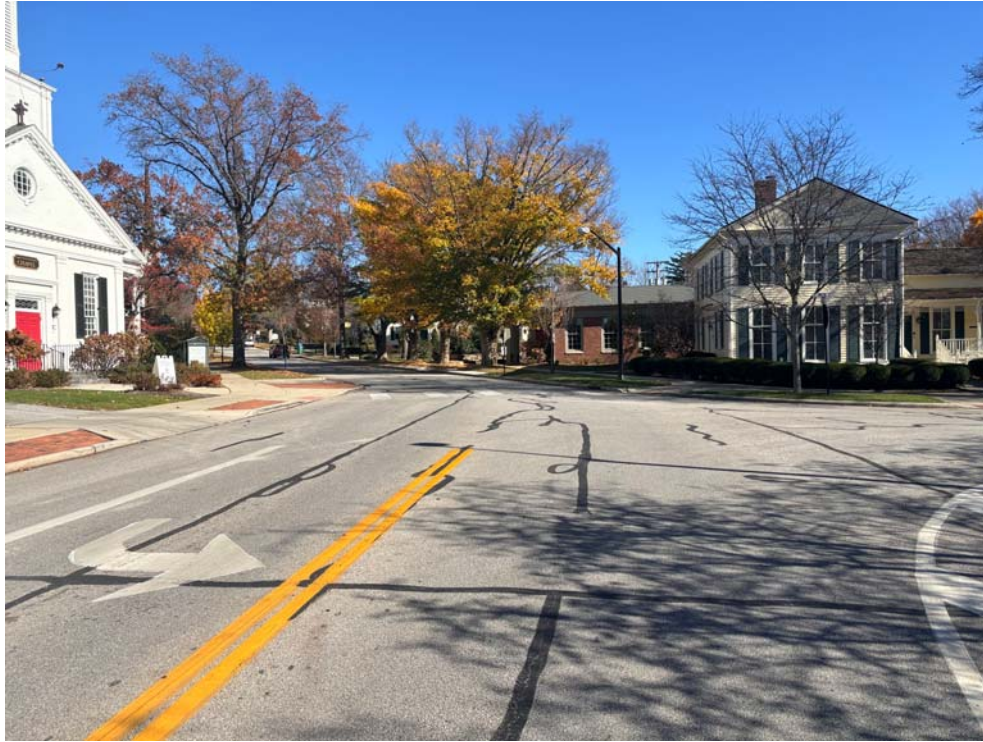
Looking Eastbound on Aurora Street at East Main Street

The stopping sight distances are not constrained by severe vertical or horizontal curves on SR 91 and Aurora Street. Photographs of the stopping sight distance along the study area roadways can be seen in **Appendix B**. The study area roadways provide adequate visibility of the existing crosswalks for approaching motorists since the recommended stopping sight distance requirements are met. Restricted stopping sight distance is not present therefor a PHB would not be recommended at the three crosswalks.

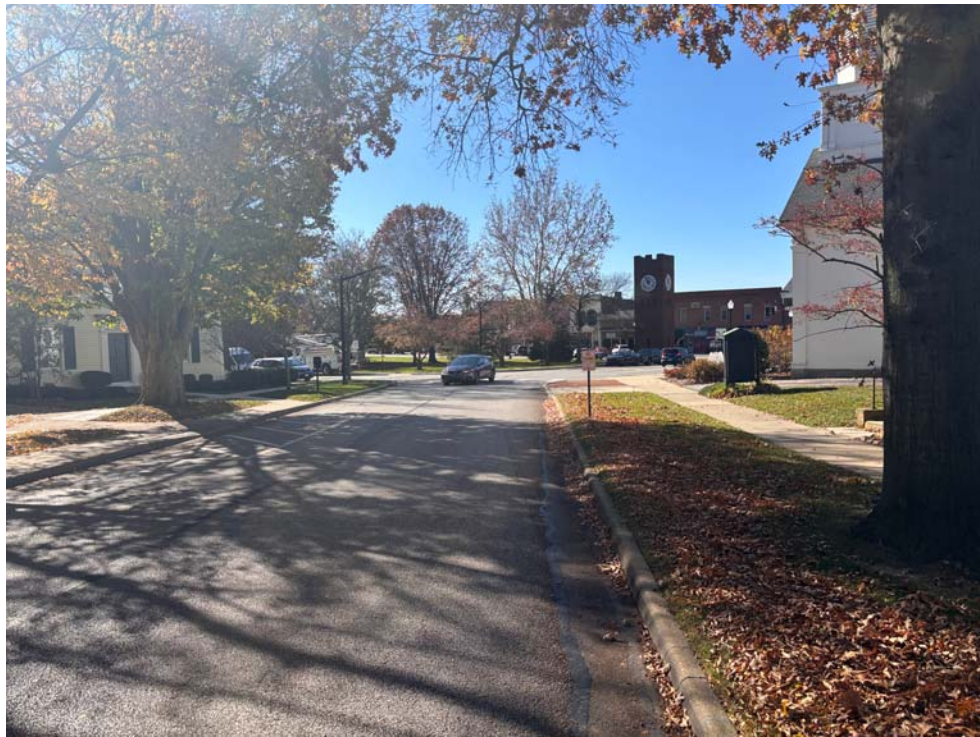
Looking Westbound on Aurora Street at East Main Street

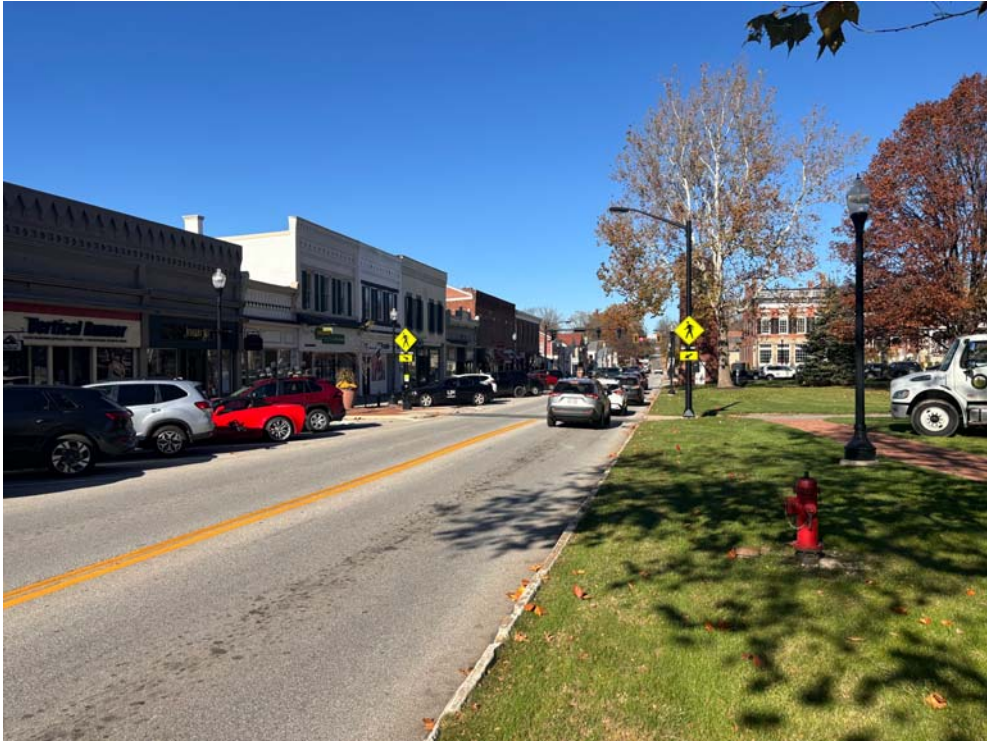
Looking Northbound on SR 91 at Mid-Block Crosswalk

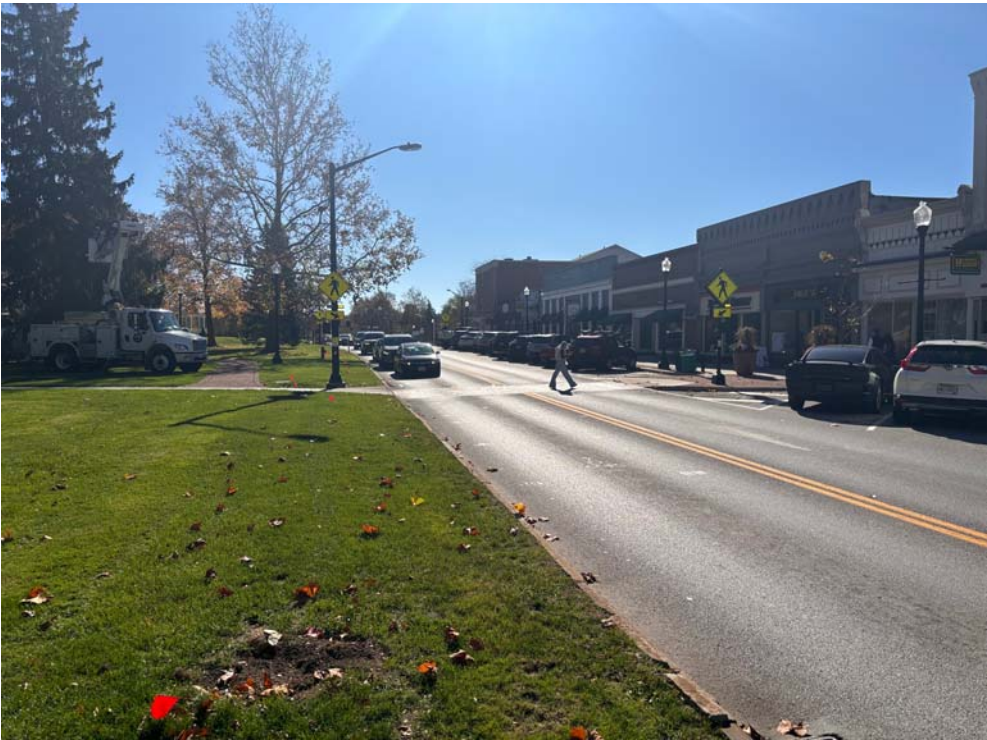
Looking Southbound on SR 91 at Mid-Block Crosswalk

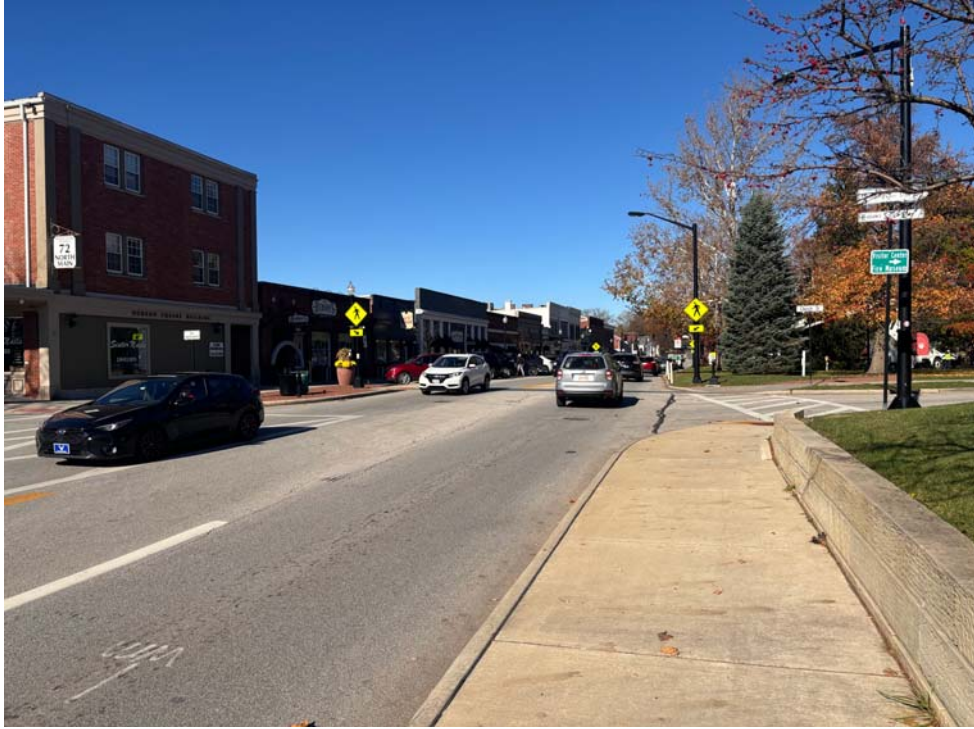
Looking Northbound on SR 91 at Church Street Crosswalk

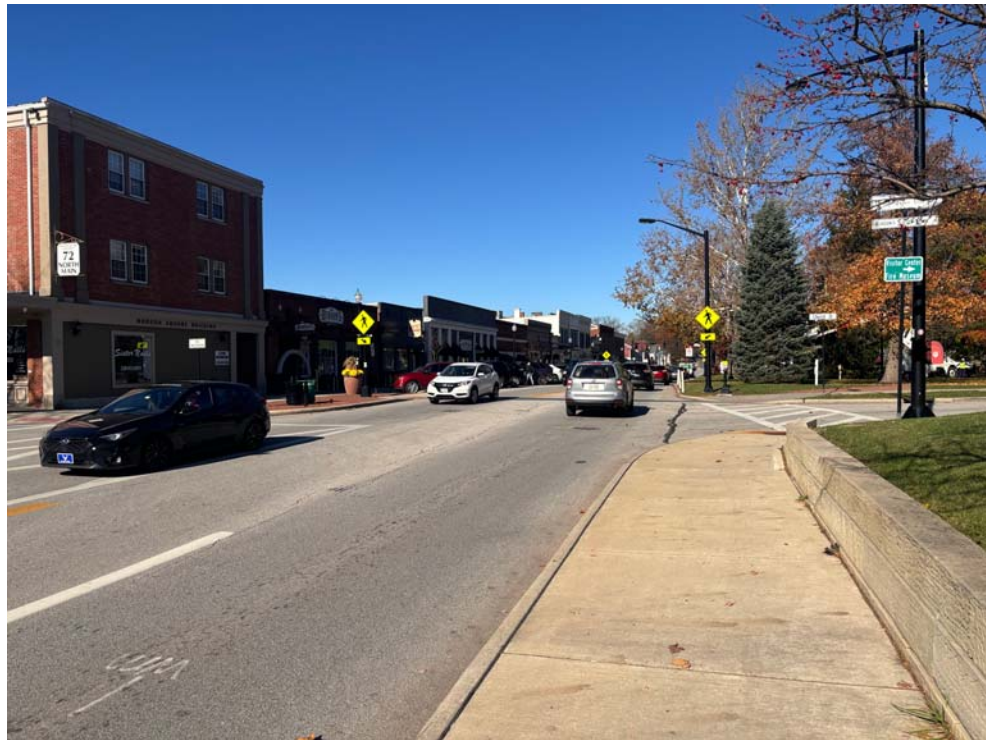
Looking Southbound on SR 91 at Church Street Crosswalk

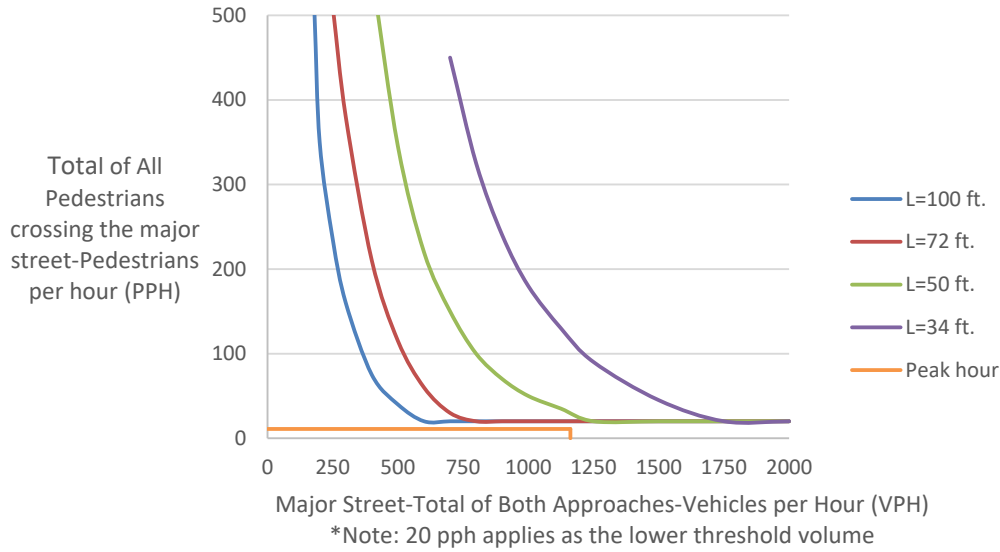
Figure 4F-1		Figure 4F-2	
Plot Points	Plot Points	Plot Points	Plot Points
0	11	1161	0
1161	11	1161	11

Figure 4F-1. Guidelines for the installation of Pedestrian Hybrid Beacons on Low-Speed Roadways (Speeds 35 mph or Less)

An analyses of the three existing pedestrian crosswalks across Aurora Street and SR 91 were performed. A copy of the Pedestrian Hybrid Evaluation Matrixes is shown in **Appendix D**. The results of the evaluation indicates that the crosswalks do not currently meet the criteria for the installation of a pedestrian hybrid beacon. A significant increase in pedestrians (approximately double) at each of the crosswalks would be necessary to have the criteria be met which is not anticipated in the future.

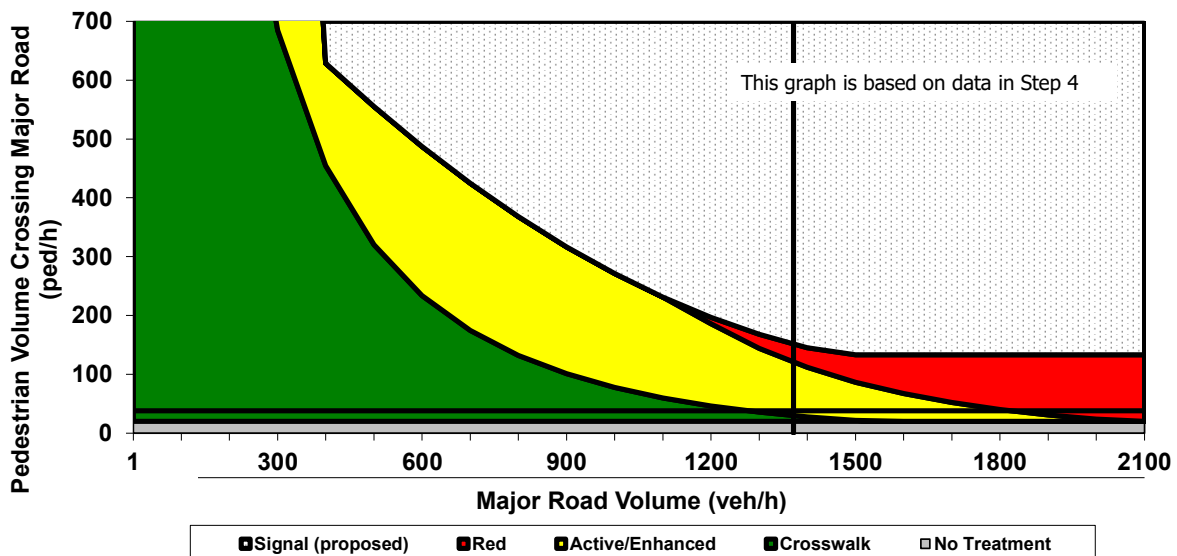
Is 15th percentile crossing speed of pedestrians less than 3.5 ft/s (1.1 m/s)? (enter YES or NO)	3d	NO
If 15th percentile crossing speed of pedestrians is less than 3.5 ft/s (1.1 m/s), then reduce 3c by up to 50%.	% rate of reduction for 3c (up to 50%)	3e 10%
	Reduced value or 3c	3f 151
Result: The signal warrant is not met. Go to step 4.		
Step 4: Estimate pedestrian delay.		
Pedestrian crossing distance, curb to curb (ft), L	4a	28
Pedestrian walking speed (ft/s), S_p (suggested speed = 3.5 ft/s)	4b	3.5
Pedestrian start-up time and end clearance time (s), t_c (suggested start-up time = 3 sec)	4c	3
[Calculated automatically] Critical gap required for crossing pedestrian (s), t_c	4d	11
Major road volume, total both approaches OR approach being crossed if raised median island is present, during peak hour (veh/h), V_{maj-d}	4e	1371
Major road flow rate (veh/s), v	4f	0.38
Average pedestrian delay (s/person), d_p	4g	158

4h	1.7
Total pedestrian delay (h), D_p The value in 4h is the calculated estimated delay for all pedestrians crossing the major roadway without a crossing treatment (assumes 0% compliance). If the actual total pedestrian delay has been measured at the site, that value can be entered in 4i to replace the calculated value in 4h.	4i	
Step 5: Select treatment based up on total pedestrian delay and expected motorist compliance.		
Expected motorist compliance at pedestrian crossings in region: enter HIGH for High Compliance or LOW for Low Compliance	5a	low
Treatment Category:	ACTIVE OR ENHANCED

The pedestrian treatment analysis worksheet determined that the “**Active or Enhanced**” level category is met for the existing crosswalk across SR 91 at the mid-block crosswalk. The amount of vehicular and pedestrian traffic was found to be sufficient to install enhanced pavement markings and signage such as rectangular rapid flashing beacons. The enhancements have already be installed at this crosswalk and no additional crosswalk improvements are necessary. The amount of vehicular and pedestrian traffic was found to be insufficient to require a PHB or any other additional enhancements like traffic signalization.
