PHYSICAL CONDITION REPORT

**OTIC DESIGN PROJECT NO. 71-22-12
PROSPECT ROAD BRIDGE (CR 34) OVER THE OHIO TURNPIKE
MILEPOST 182.1
SUMMIT COUNTY, OHIO**

CIG Project No.: 10043

August 2023

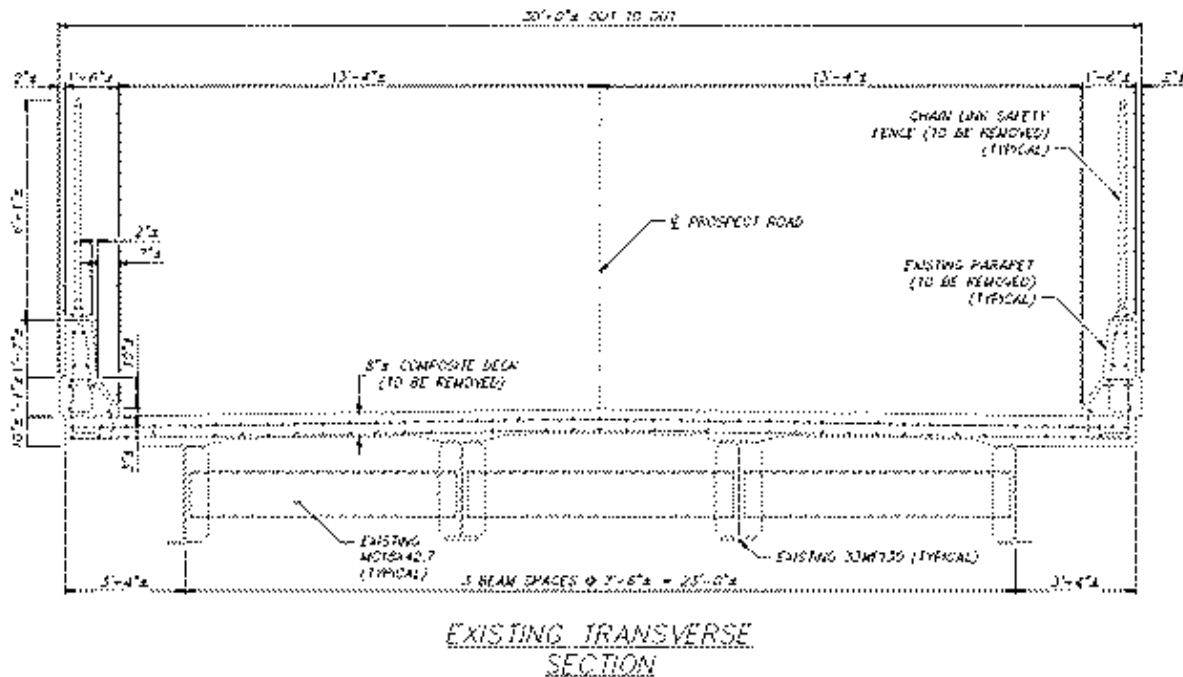
Figure 19 - Existing Transverse Section MP 182.1

The existing bridge is a four-span structure with four 33WF130 non-composite beams with cover plates at Pier 1, Pier 2 and Pier 3 which support a reinforced concrete deck on reinforced concrete abutments and piers supported by piles and spread footings. The existing beams are spaced at 7'-8"± with a 3'-4"± overhang. The toe to toe of parapet width is 26'-8"± and out to out of bridge is 30'-0"±. See Figure 19 for Existing Transverse Section.

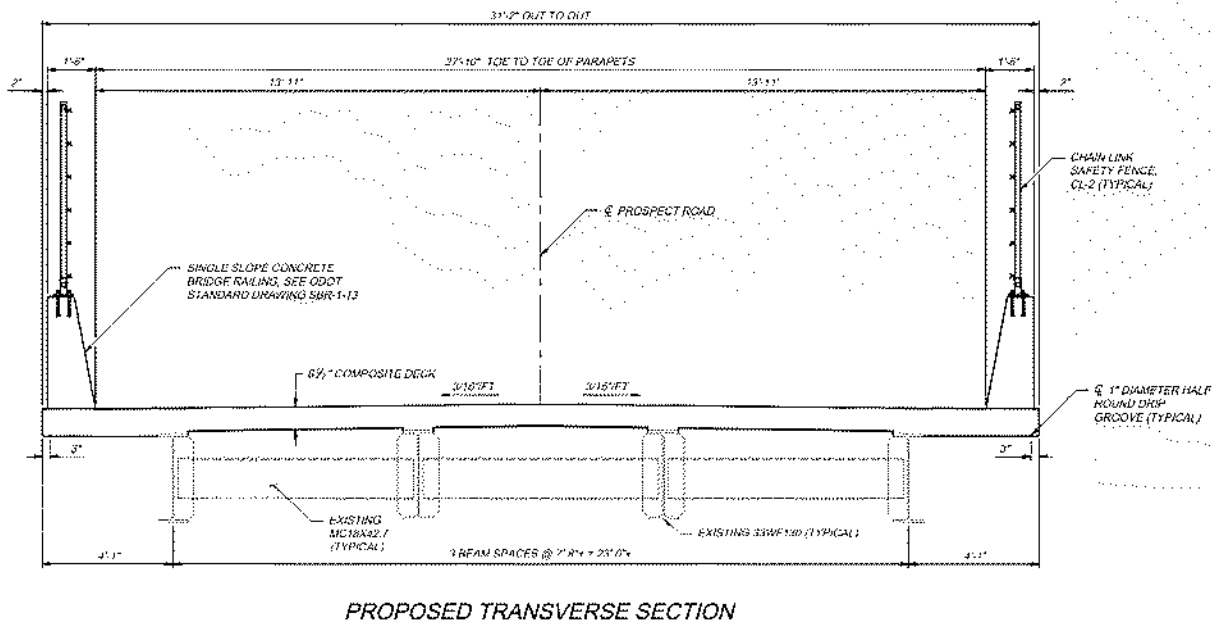
Figure 20 - Proposed Transverse Section MP 182.1

Alternative 1 and 2 - Proposed Deck Replacement: The existing deck, parapets and chain link safety fence will be removed and replaced with an 8 1/2" composite concrete deck with SBR-1-13 railing and chain link safety fence. The overhang will be increased to 4'-1" from 3'-4" to accommodate the change in barrier transitions from the Jersey style existing to the SBR-1-13 straight faced transition. These large overhangs will need to be taken into consideration during design and construction to prevent global superstructure distortion as the deck is poured, as the tributary deck load carried by the fascia beams exceeds 120% of the average tributary deck load carried by the interior beams. These loadings can be accommodated by temporary blocking and tie rods as necessary if the existing diaphragms do not have sufficient capacity. This will provide 27'-10" toe to toe of parapet and 31'-2" out to out bridge width. The proposed transverse section for the deck replacement alternative is shown as Figure 20.

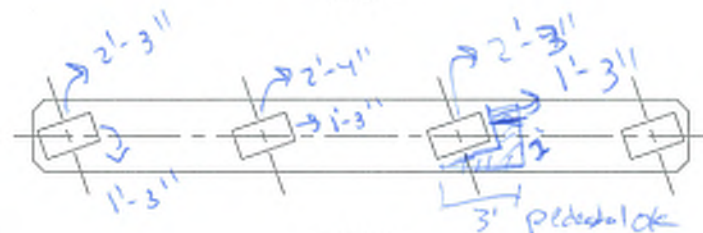
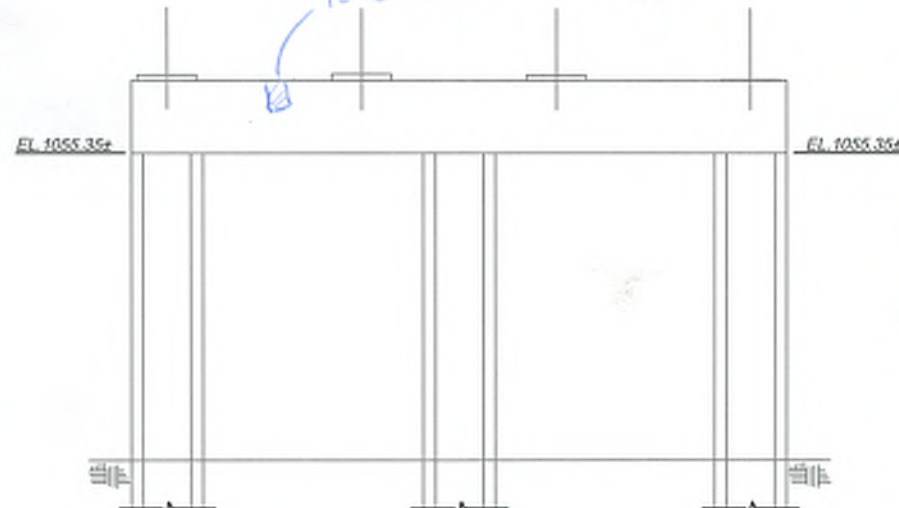
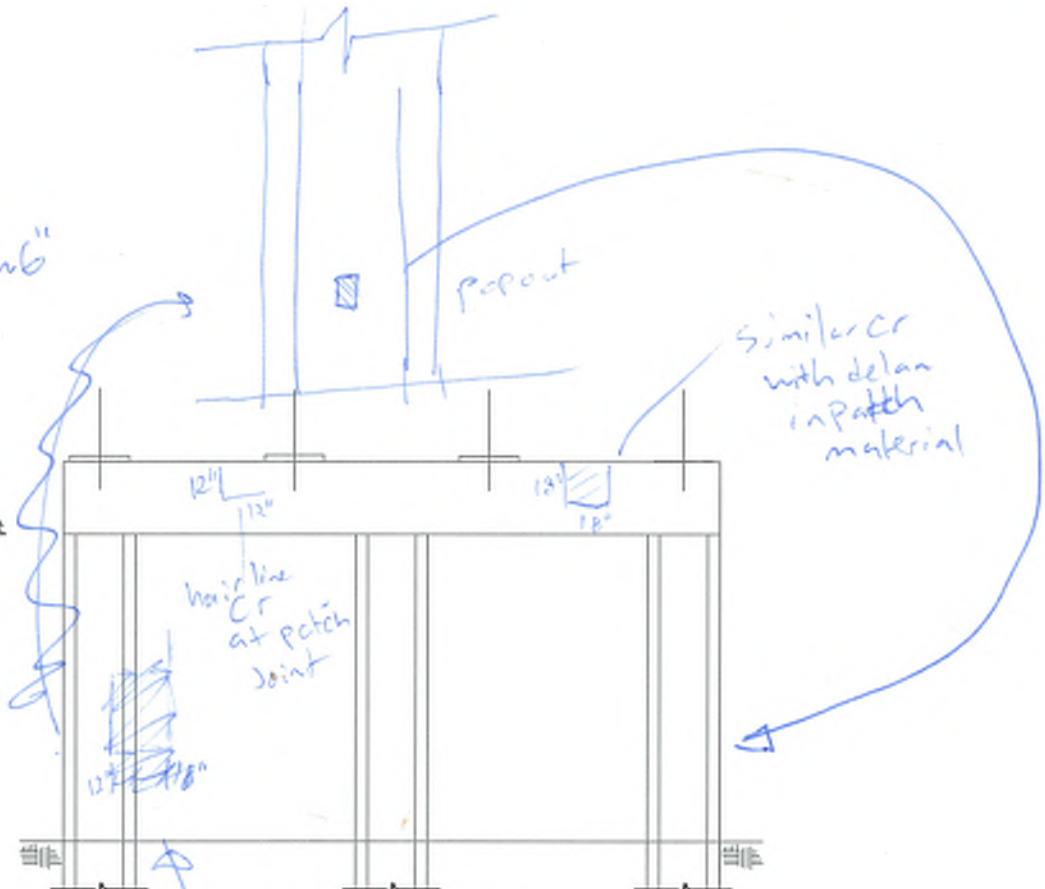
In all three pier caps, a few minor cracks were observed and measured 0.013" to 0.025" wide. Additional minor cracks exist at old patch material cold joints on both faces of Piers 1 and 3. Hammer sounding indicated localized delaminated areas on all three pier caps. The northwest corner on the cap of Pier 3 has a deep spall with reinforcing steel stirrups exposed with moderate section loss and delamination extending to the side face. This spall extends to the bearing seat pedestal, which is missing a corner of concrete extending to the bearing masonry plate with the plate overhanging 1/8".

Pier 1 Column 1 has minor delamination present on the traffic face (north face) that extends onto the west face. No deterioration was observed to Pier 2 columns. Pier 3 Column 2 has minor delamination on the traffic face (south face) that leads to the east face. Pier 3 Column 3 has a spall in the patch on the south east corner, exposing three stirrups with minor section loss. The entire patch on the west, south, and east faces and a halo around the patch are delaminated with wire mesh rust showing through on the face.

S. Pier
width 12" on N Face
18" on west face
36" tall on N
72" tall on W

- DENOTES AREAS TO BE REPAIRED AS PER ITEM SP 519
- REMOVAL PER SP 202, SEE SHEET X OF X.

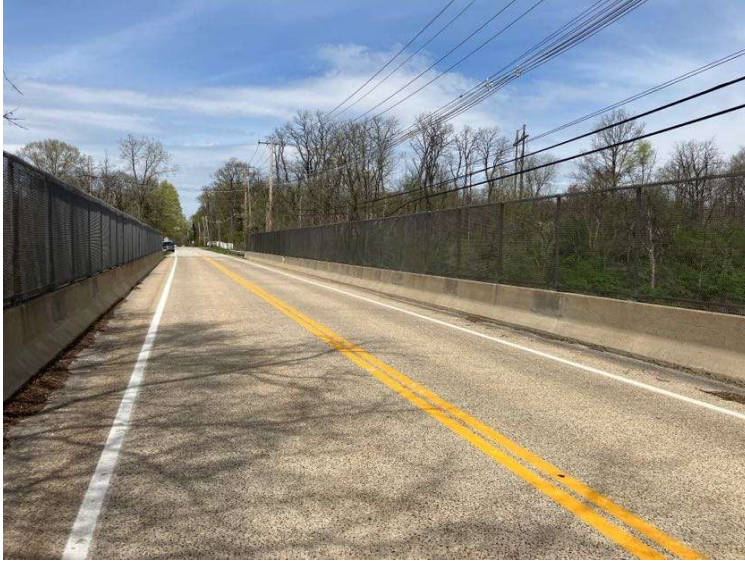
PHOTO 1
View of Prospect Road (MP
182.10).

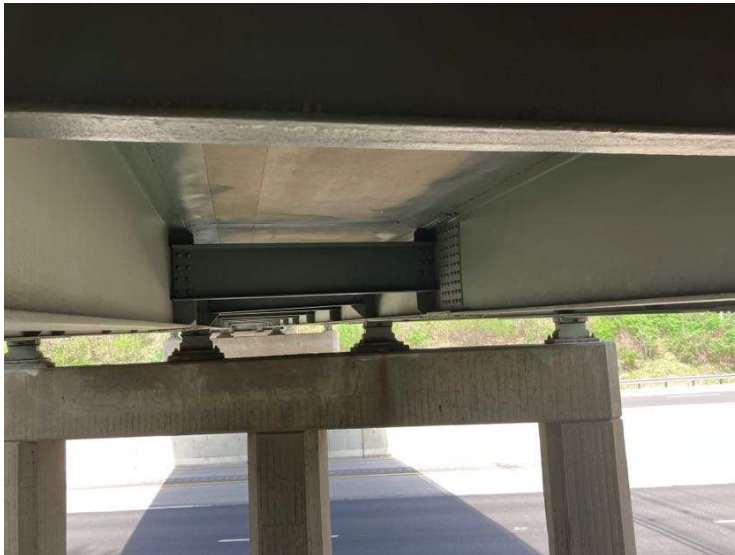
PHOTO 2
View of structure underside. No
utilities were affixed.

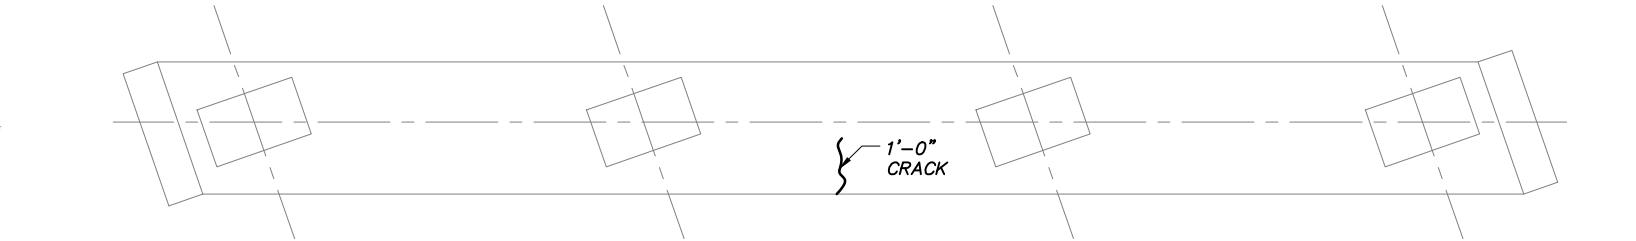
PLAN
REAR ABUTMENT

SP 519 REPAIR AREAS		
MEASURED QUANTITY (SQ. FT.)	CONTINGENT QUANTITY (SQ. FT.)	TOTAL (SQ. FT.)
0	10	10
SP 516A AREAS		
MEASURED QUANTITY (FT.)	CONTINGENT QUANTITY (FT.)	TOTAL (FT.)
3.5	10	13.5

- DENOTES AREAS TO BE REPAIRED AS PER ITEM SP 519

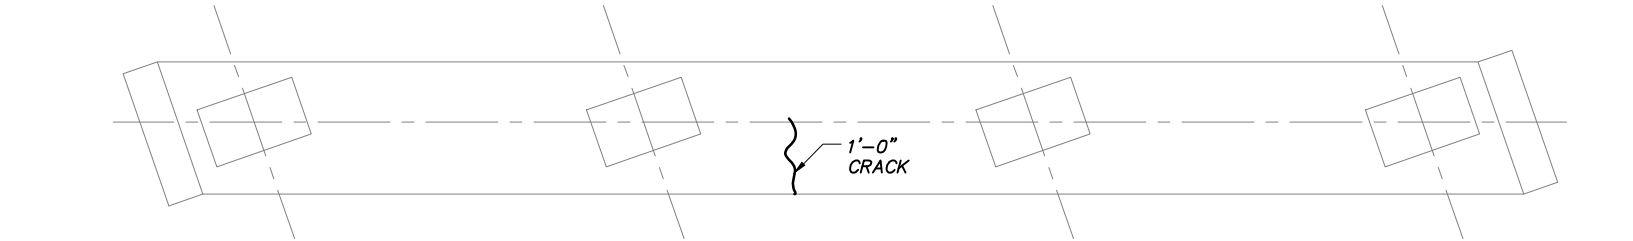
PLAN
FORWARD ABUTMENT

SP 519 REPAIR AREAS		
MEASURED QUANTITY (SQ. FT.)	CONTINGENT QUANTITY (SQ. FT.)	TOTAL (SQ. FT.)
0	10	10
SP 516A AREAS		
MEASURED QUANTITY (FT.)	CONTINGENT QUANTITY (FT.)	TOTAL (FT.)
8	10	18

- DENOTES AREAS TO BE REPAIRED AS PER ITEM SP 519
-

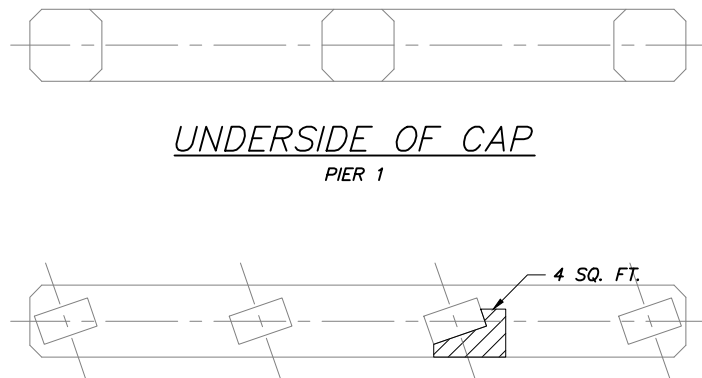
UNDERSIDE OF CAP
PIER 1

SP 519 REPAIR AREAS		
MEASURED QUANTITY (SQ. FT.)	CONTINGENT QUANTITY (SQ. FT.)	TOTAL (SQ. FT.)
20	3	23
SP 516A AREAS		
MEASURED QUANTITY (FT.)	CONTINGENT QUANTITY (FT.)	TOTAL (FT.)
6	0	6

- DENOTES AREAS TO BE REPAIRED AS PER ITEM SP 519

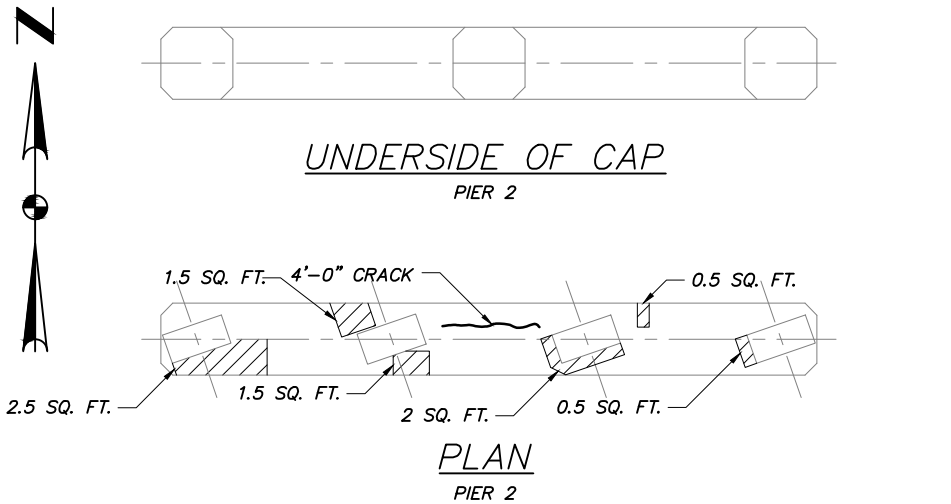
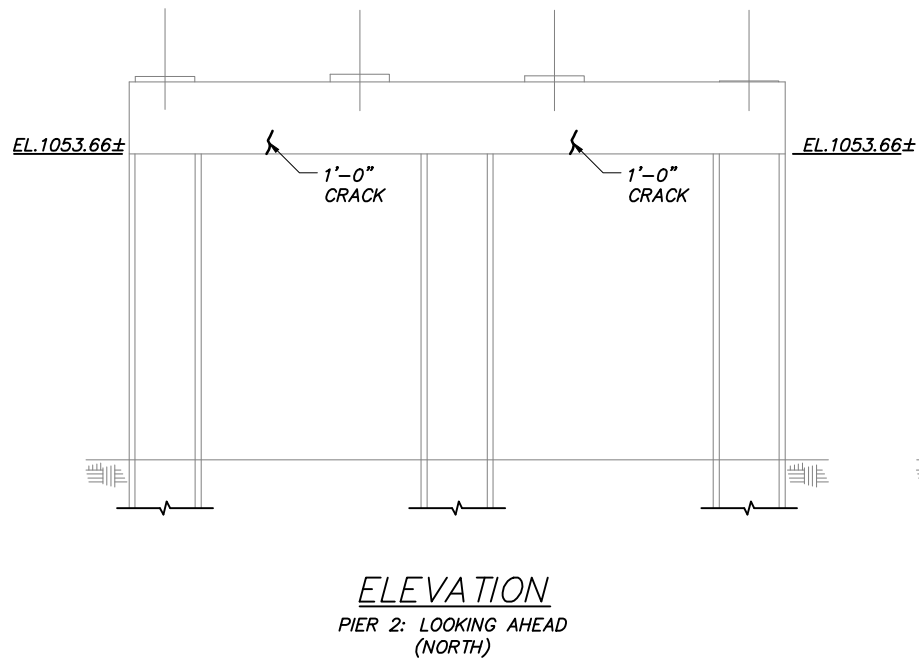
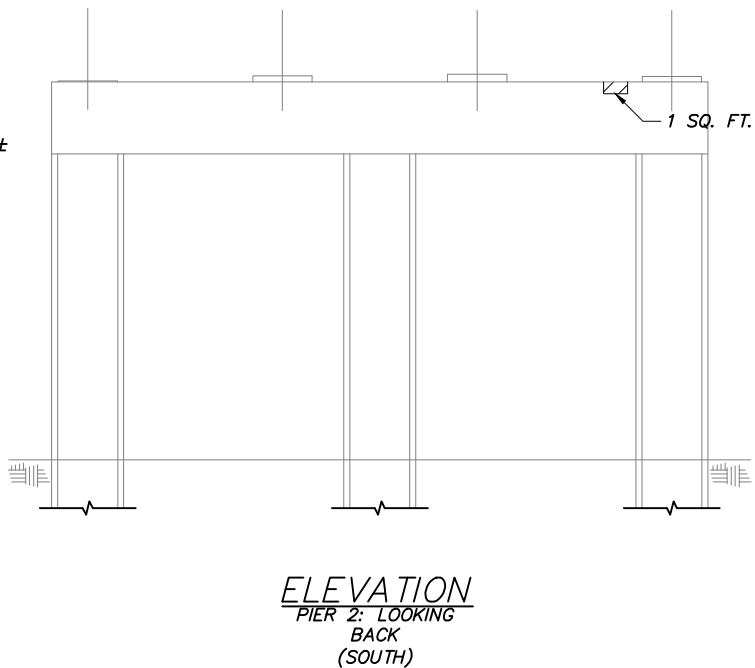
SP 519 REPAIR AREAS		
MEASURED QUANTITY (SQ. FT.)	CONTINGENT QUANTITY (SQ. FT.)	TOTAL (SQ. FT.)
9.5	0	9.5
SP 516A AREAS		
MEASURED QUANTITY (FT.)	CONTINGENT QUANTITY (FT.)	TOTAL (FT.)
6	0	6

- DENOTES AREAS TO BE REPAIRED AS PER ITEM SP 519
 -

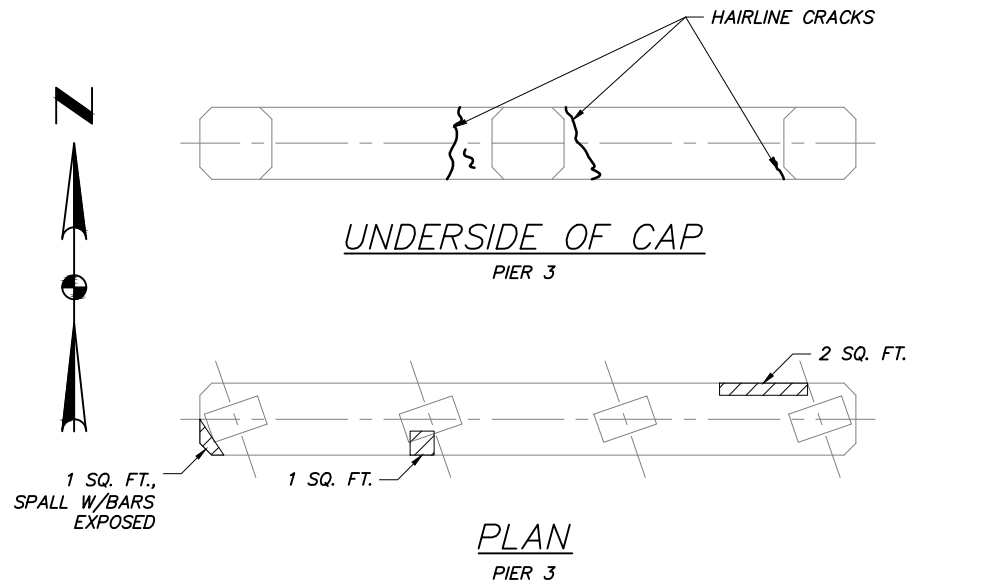
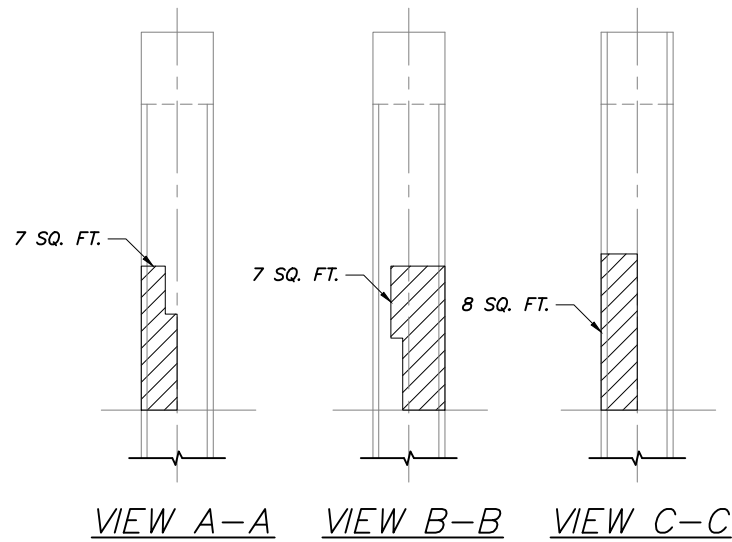
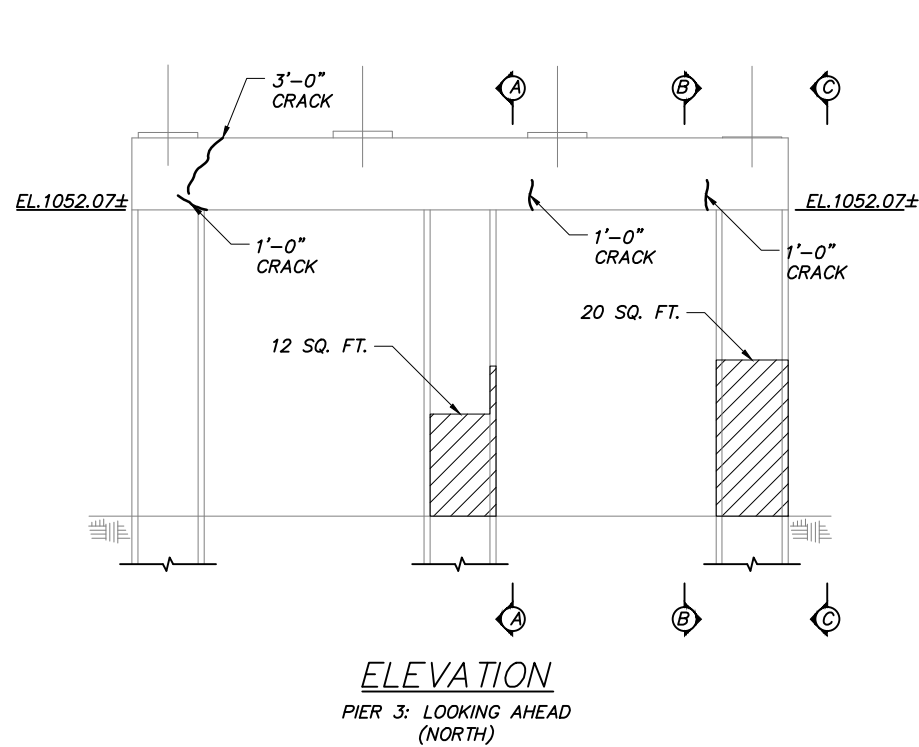
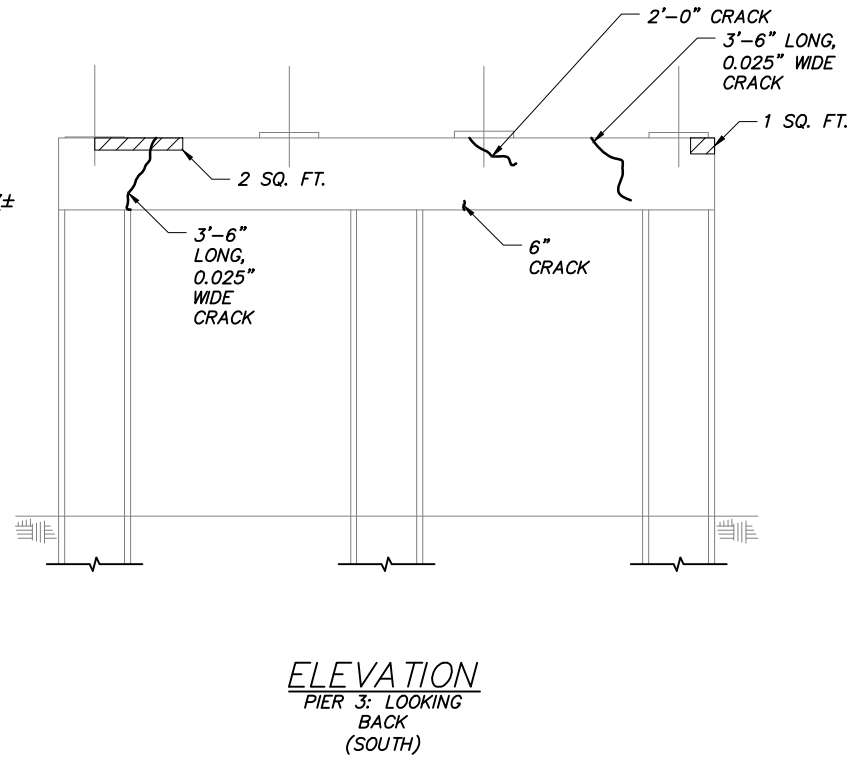
SP 519 REPAIR AREAS		
MEASURED QUANTITY (SQ. FT.)	CONTINGENT QUANTITY (SQ. FT.)	TOTAL (SQ. FT.)
61	0	61
SP 516A AREAS		
MEASURED QUANTITY (FT.)	CONTINGENT QUANTITY (FT.)	TOTAL (FT.)
23	0	23

- DENOTES AREAS TO BE REPAIRED AS PER ITEM SP 519
-
