# PHYSICAL CONDITION REPORT

**OTIC DESIGN PROJECT NO. 71-22-12  
PROSPECT ROAD BRIDGE (CR 34) OVER THE OHIO TURNPIKE  
MILEPOST 182.1  
SUMMIT COUNTY, OHIO**

**CIG Project No.: 10043**

*August 2023*

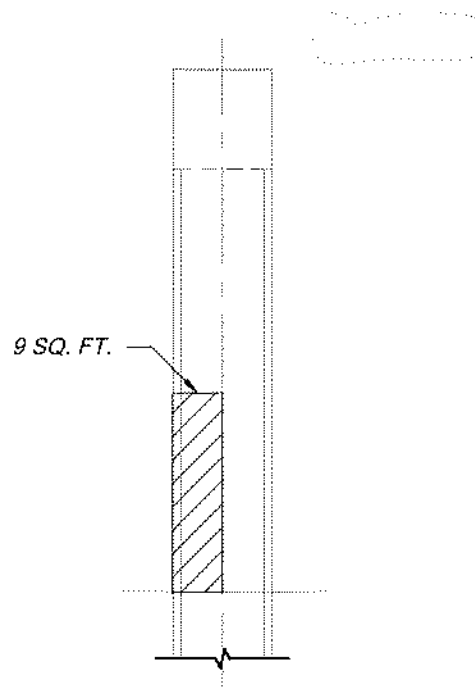
**Figure 8 - Location of Proposed Concrete Repairs - Pier 1 View A-A MP 182.1**

Pier 1 Column 1 has minor delamination present on the traffic face (north face) that extends onto the west face. No deterioration was observed to Pier 2 columns. Pier 3 Column 2 has minor delamination on the traffic face (south face) that leads to the east face. Pier 3 Column 3 has a spall in the patch on the south east corner, exposing three stirrups with minor section loss. The entire patch on the west, south, and east faces and a halo around the patch are delaminated with wire mesh rust showing through on the face.

Details showing the extents of these deteriorations and recommend areas to be repaired are detailed in the Figures below.

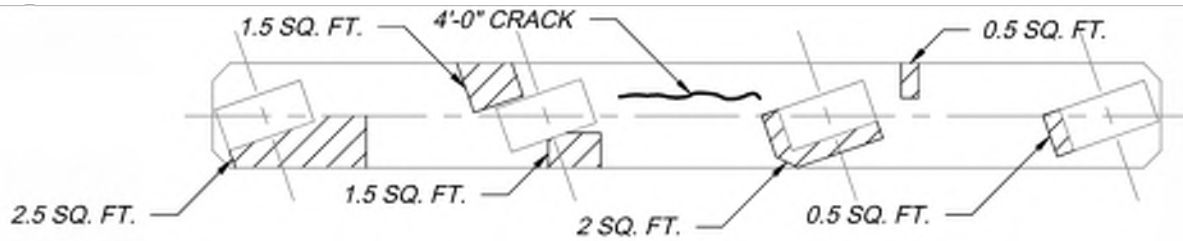
**Figure 11 - Location of Proposed Concrete Repairs - Pier 2 Plan View MP 182.1**

In all three pier caps, a few minor cracks were observed and measured 0.013" to 0.025" wide. Additional minor cracks exist at old patch material cold joints on both faces of Piers 1 and 3. Hammer sounding indicated localized delaminated areas on all three pier caps. The northwest corner on the cap of Pier 3 has a deep spall with reinforcing steel stirrups exposed with moderate section loss and delamination extending to the side face. This spall extends to the bearing seat pedestal, which is missing a corner of concrete extending to the bearing masonry plate with the plate overhanging 1/8".

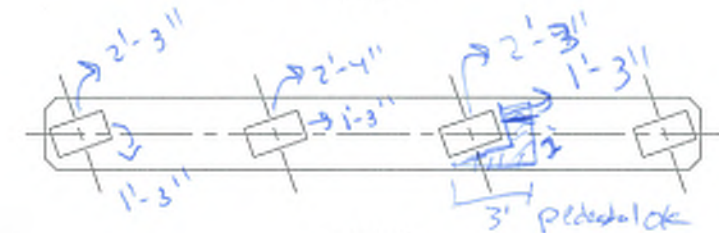
PLAN  
PIER 1

IMF / JFK 4/27/23  
Photos  
1 - Pier 1 beam 4 brg  
w/minor rust (typ)  
2 - rest of P1 brgs tilted  
Back twd abut  
3/4 crack at patch  
s. face (look N)  
5 - minor pack on Brg  
rust plates

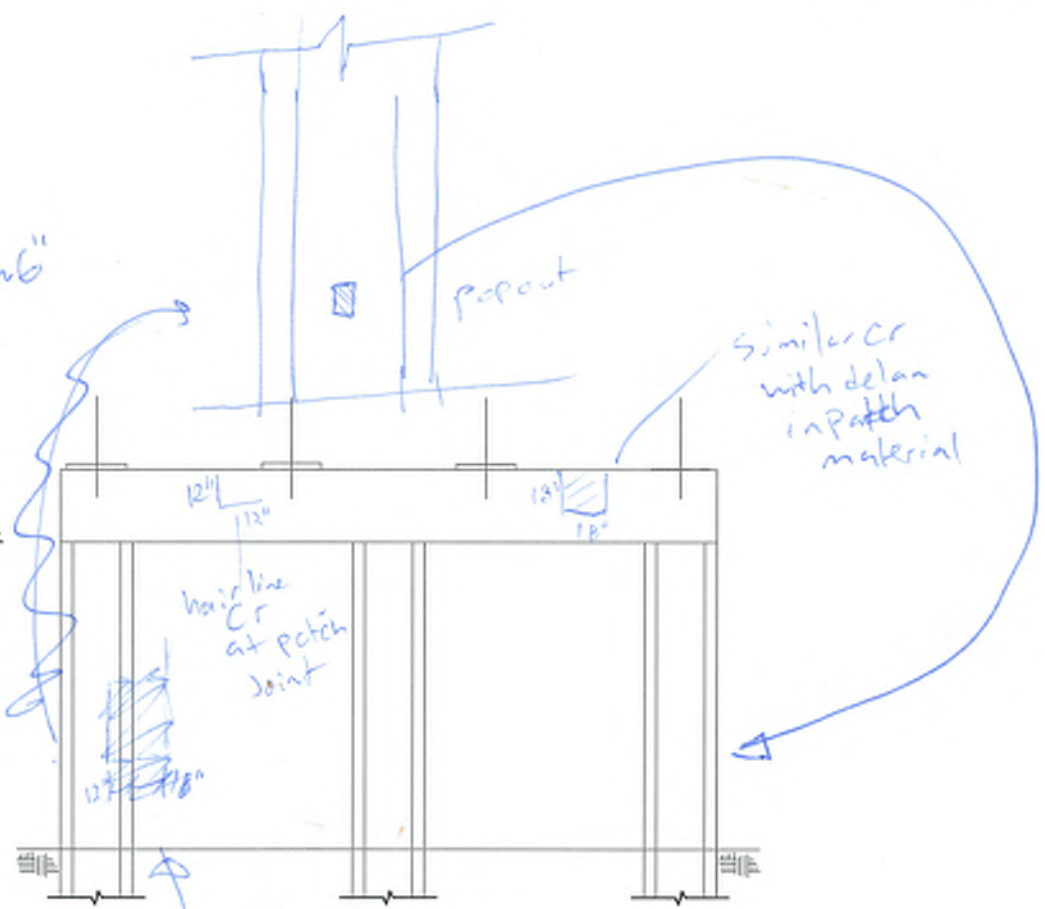
ELEVATION  
PIER 1: LOOKING BACK

S. Pier  
width 12" on N Face  
18" on west face  
36" tall on N  
72" tall on W

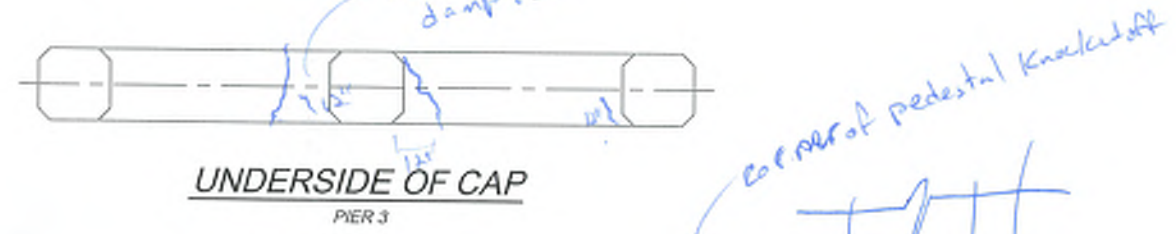
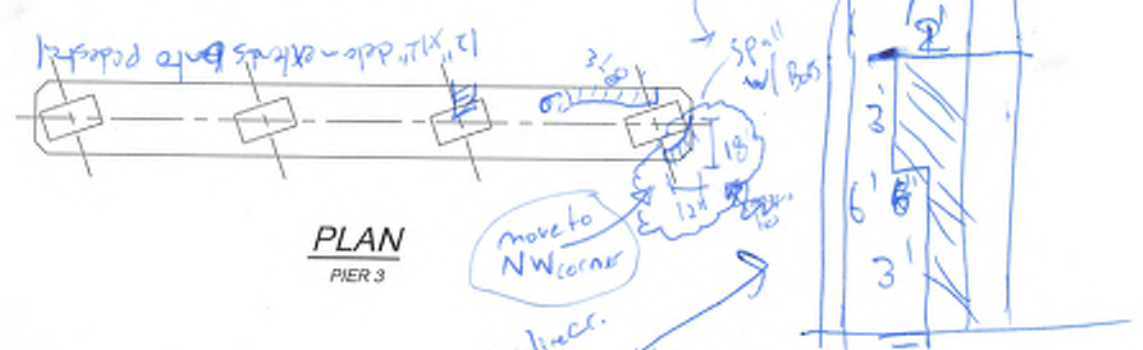
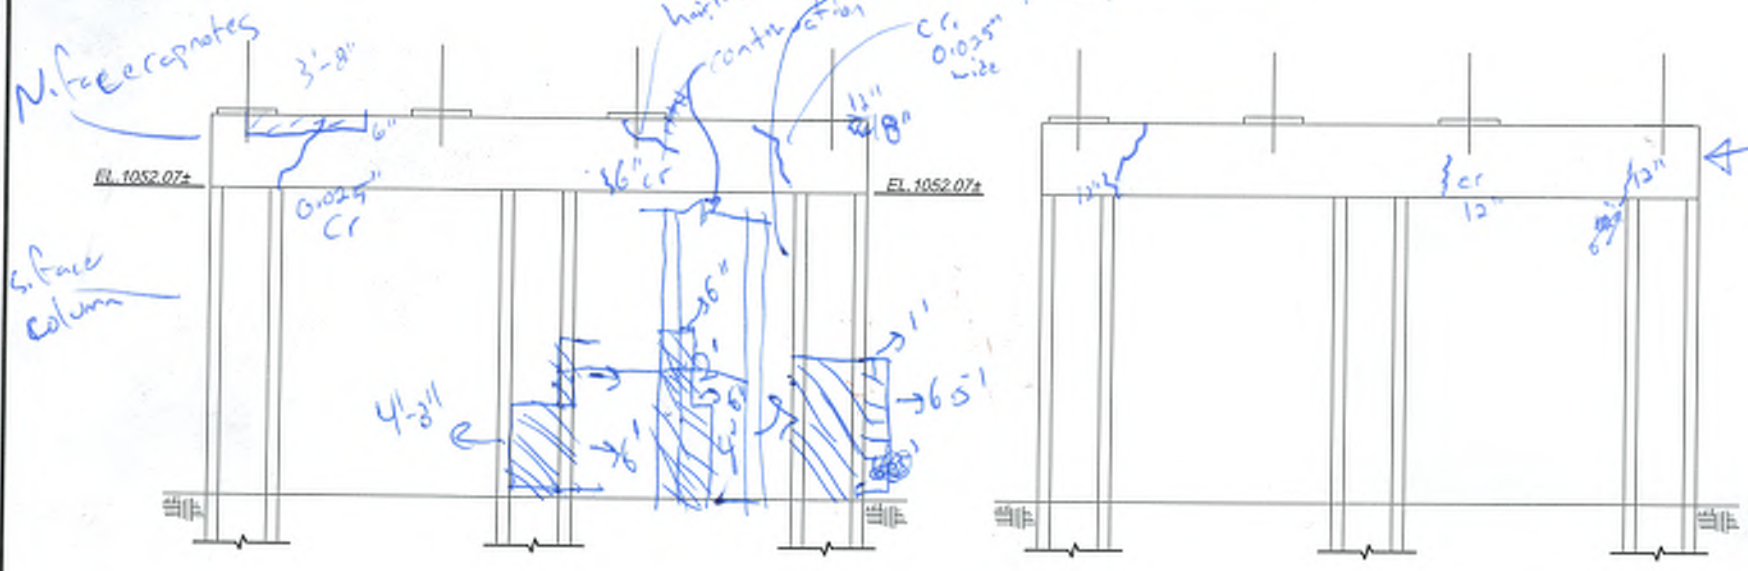
- Mpics
- 9 - ELEV. VIEW
  - 10 - CR under bn 4
  - 11 - CR under bn 3
  - 12 - CR top width ~0.013"
  - 13 - Pier 3, column 3 spall/delan
  - 14 - " column 2
  - 15/16 - corners spall
  - 17 - West side of N face cap showing marked cracks - hairline except noted
  - 18 - Bn 3 pedestal N side top delam onto pedestal
  - 19 - EAST END top cap cr/cr/rep

could not reach with ladder contractor to confirm

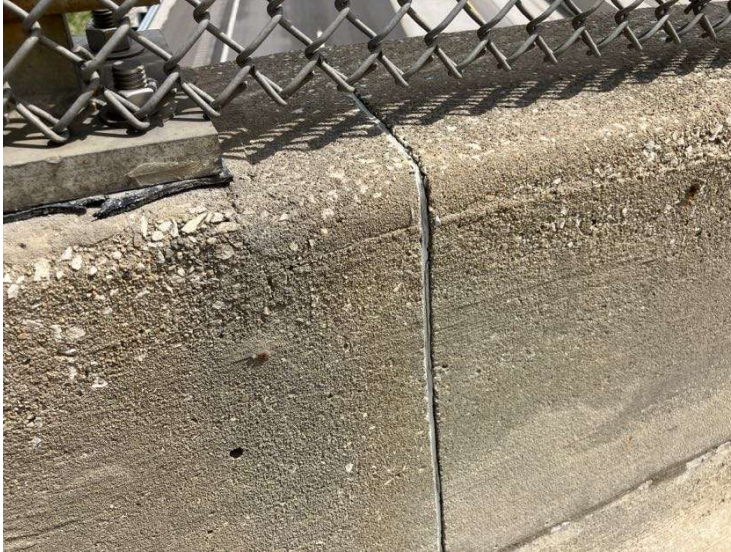
PHOTO 4  
View of typical joint on parapet wall. Samples taken of caulk material.

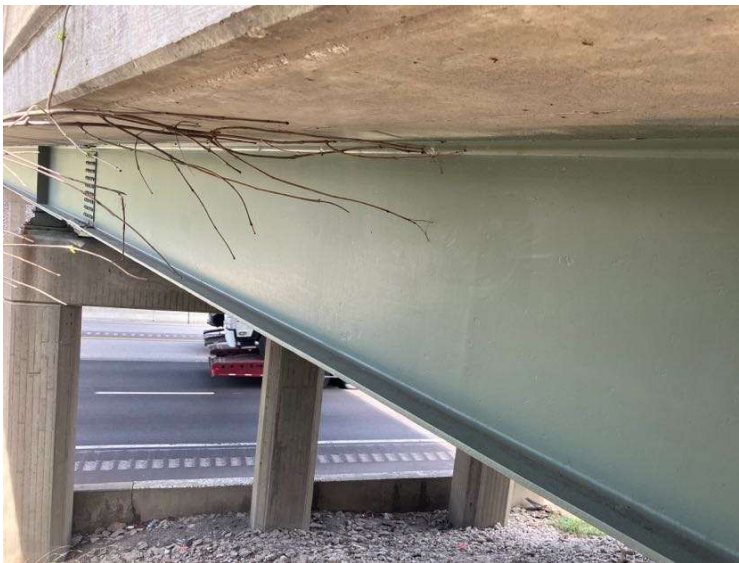
PHOTO 5  
View of outer beam. Paint in good condition.
