**41 E. Main Street Tree Preservation Plan – TREE-13098**

**November 3, 2025**

**Tom Kiepura, City Arborist ISA #OH-6684A** *TMK*

**City of Hudson**

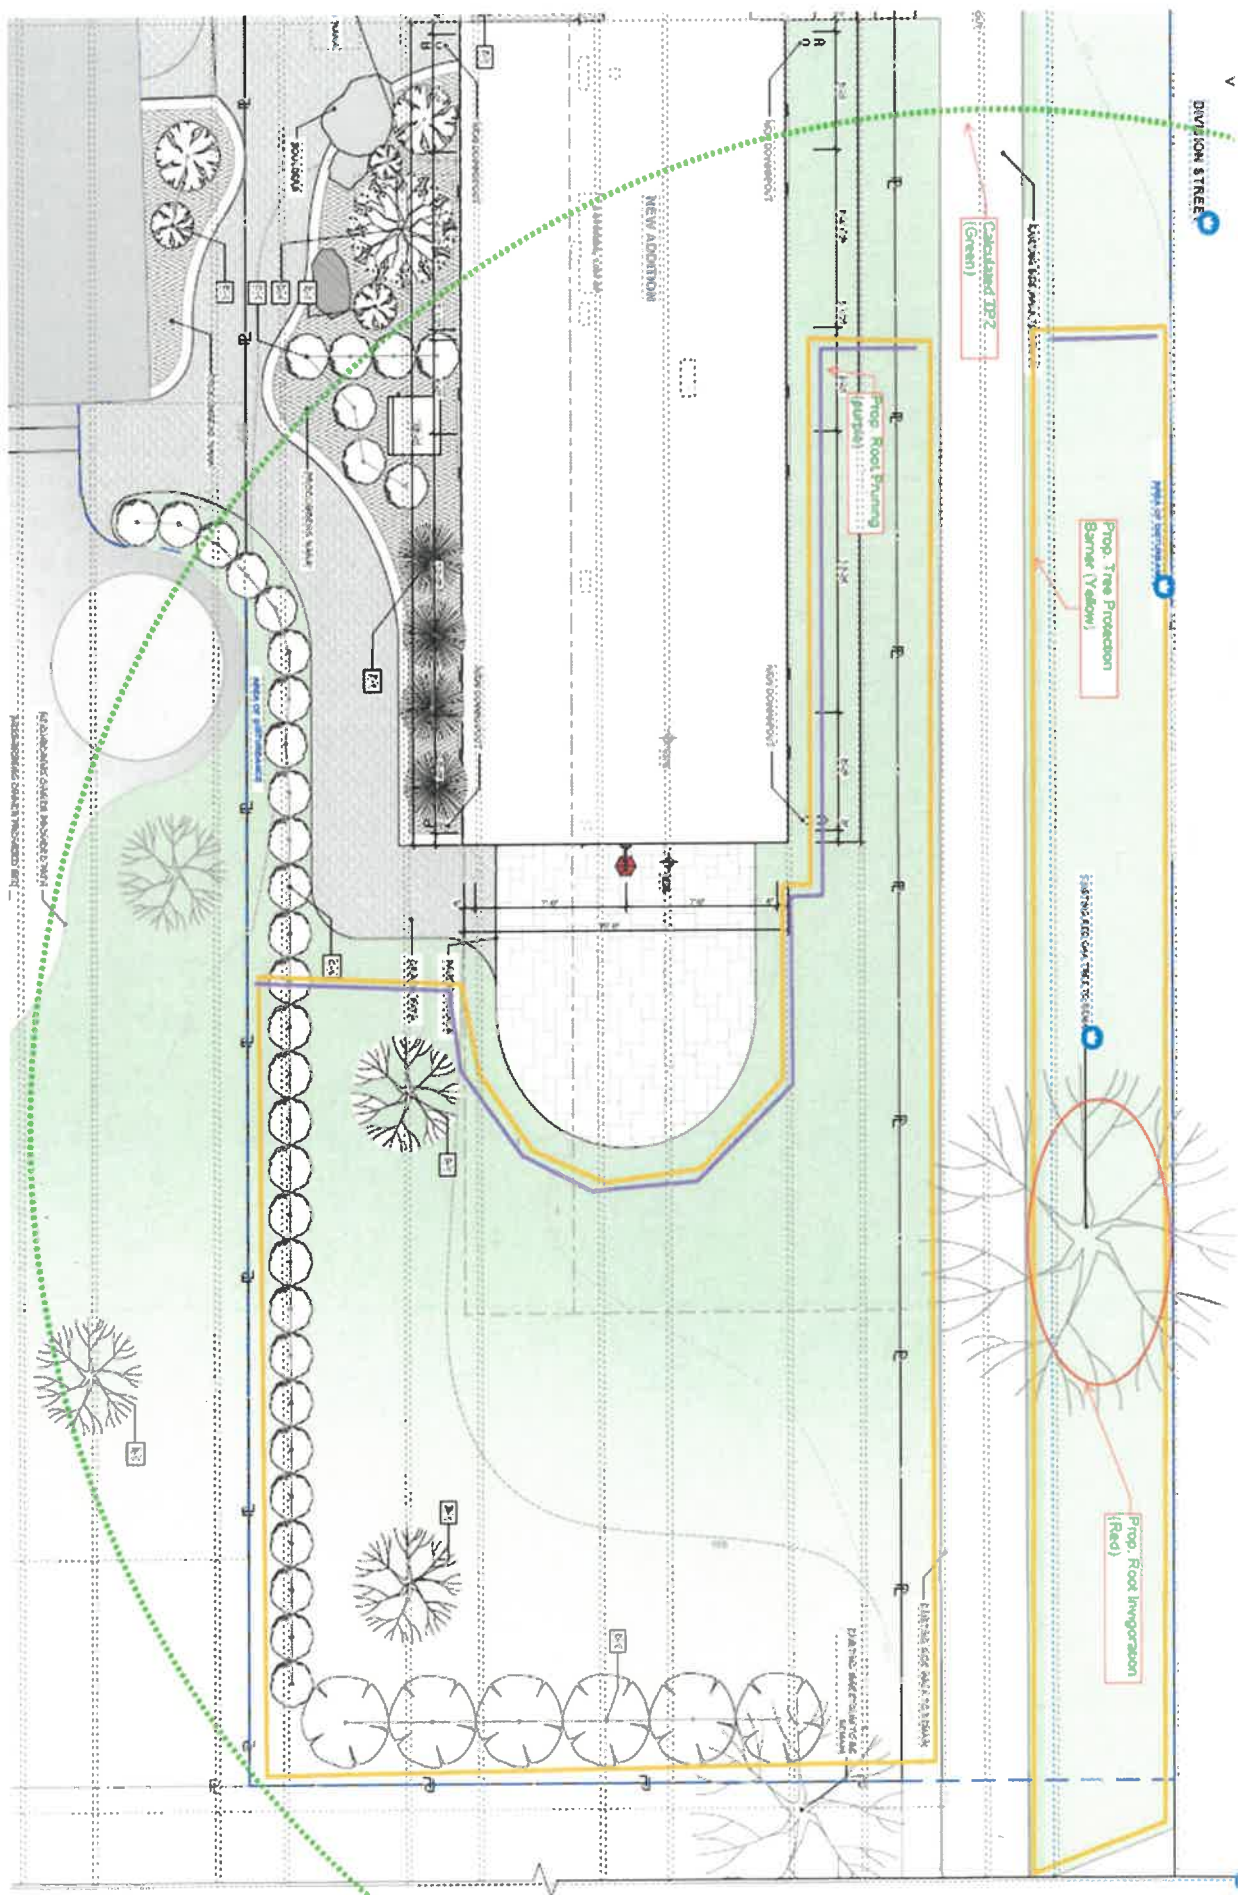
**The proposed construction, according to the revised plans submitted to the Arborist, would require excavation and removal of topsoil within the limits of the calculated TPZ.** Specifically, a trench would be dug for the footer for the proposed building, and topsoil removed for the installation of a paver patio. It should be noted that most of the fine roots that provide water and nutrient uptake exist in the uppermost soil profile and will be removed along with the topsoil. It is presumed that this excavation would then be backfilled with a limestone base. The proposed patio is approximately 135 square feet.
