**CITY OF HUDSON, OHIO  
FIRE & EMS  
EXISTING FACILITY CONDITION ASSESSMENT**

January 24, 2025

## Executive Summary

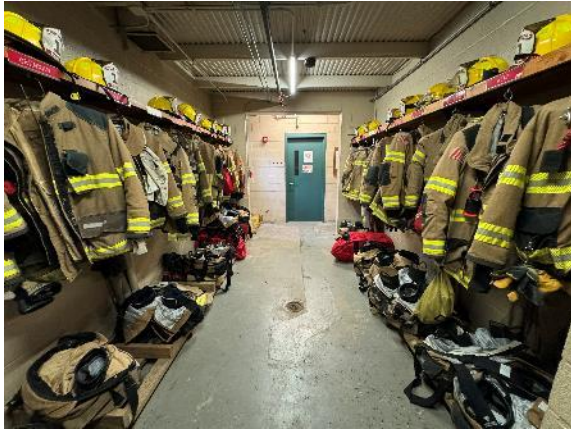
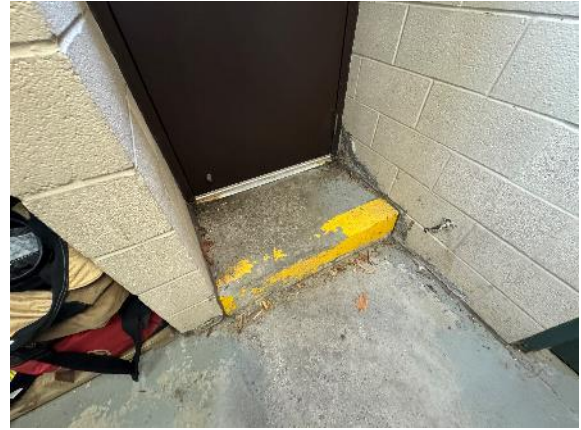
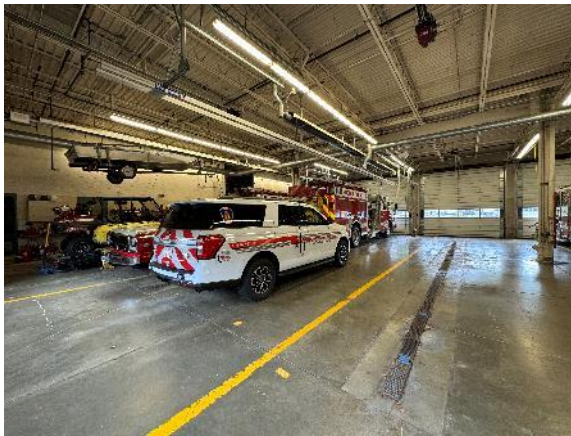
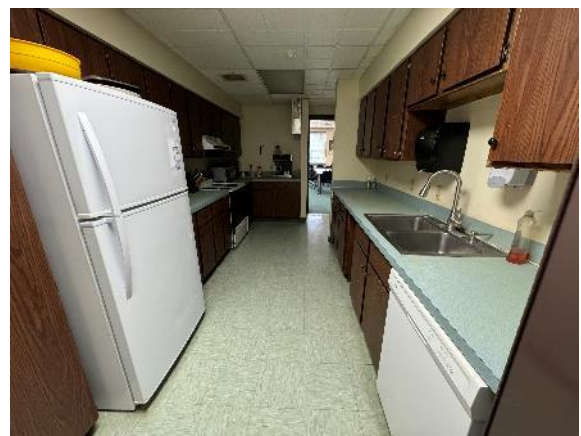
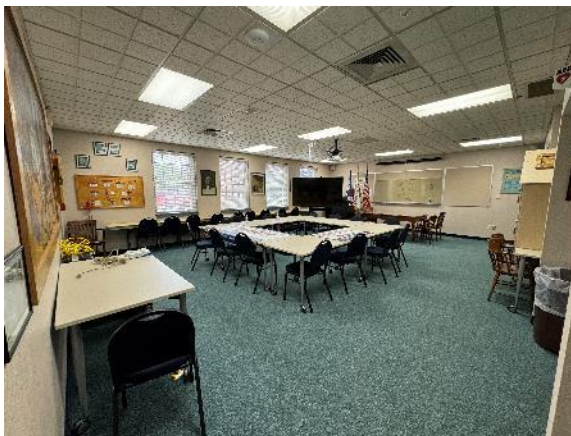
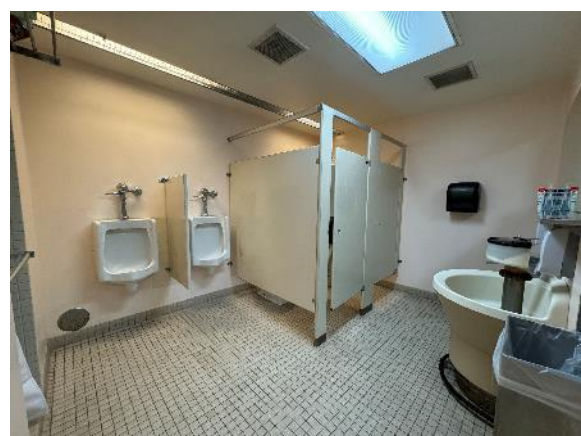
**EXTERIOR WALL REPAIRS & CONTINUOUS DAMAGE DUE TO LACK OF WATERPROOFING**

Portions of the block walls and mortar joints are deteriorating at the man door to the far northwest corner of the Apparatus Bays. This appears to be due to inadequate waterproofing of the below grade portion of the exterior wall.
