41 E. Main Street Tree Preservation Plan – TREE-13098 November 3, 2025

Tom Kiepura, City Arborist ISA #OH-6684A

TREE PRESERVATION PLAN

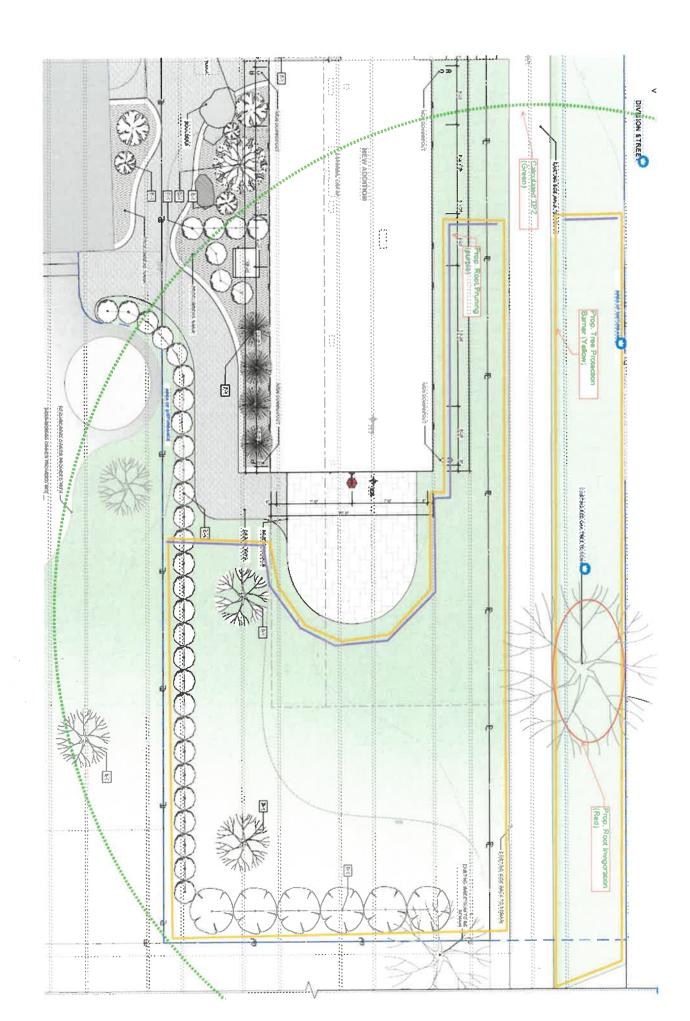
CONDITION: Appears to be vigorous and healthy. Very good crown structure. No major defects.

The proposed building addition at Village Dental, located at 41 E. Main Street, is likely to cause decline in the red oak (TREE-13098) located in the right-of-way on Division Street without adequate tree protection measures. Red oaks are known for being very sensitive to damage caused by construction activity. To mitigate the negative impact of this construction, I have put together a tree preservation plan that will give the tree the best chances of survival. If no tree protection measures are taken, I would expect the tree to decline slowly over a period of 3-5 years and eventually die.

The proposed construction, according to the revised plans submitted to the Arborist, would require excavation and removal of topsoil within the limits of the calculated TPZ. Specifically, a trench would be dug for the footer for the proposed building, and topsoil removed for the installation of a paver patio. It should be noted that most of the fine roots that provide water and nutrient uptake exist in the uppermost soil profile and will be removed along with the topsoil. It is presumed that this excavation would then be backfilled with a limestone base. The proposed patio is approximately 135 square feet.

In an effort to preserve the tree, I recommend both a low-nitrogen fertilizer and phosphorus acid formula (such as Forti-phite) be injected into the soil under the tree up to the dripline via deep root fertilization between late fall and early spring. This application should be made before any other tree protection measures. In addition, I recommend the area around the root flare in a 6-foot radius be cultivated with an air knife and the soil amended with biochar, organic mulch, arborist wood chips and C20 Soil Builder. Forti-phite, fertilizer application, and soil amendments will help prepare the tree for stress induced by loss of root volume. These applications are to be made by a Certified Arborist.

I propose that at the limits of disturbance, prior to construction, any roots that are to be cut shall be exposed with an air spade and cut cleanly with a saw. This root pruning should take place

Additionally, some limbs will need to be removed above the proposed structure. This pruning shall be done by a Certified Arborist between October 15th and April 15th to minimize the chances of oak wilt infection. Pruning shall be kept to a minimum and only remove what is necessary.
