Hudson City Administration Center

Space Utilization Study

Space Utilization Study
Hudson City Administration Building
1140 Terex Road, Hudson, Ohio

Architect's Project Number: 17087
January 2018

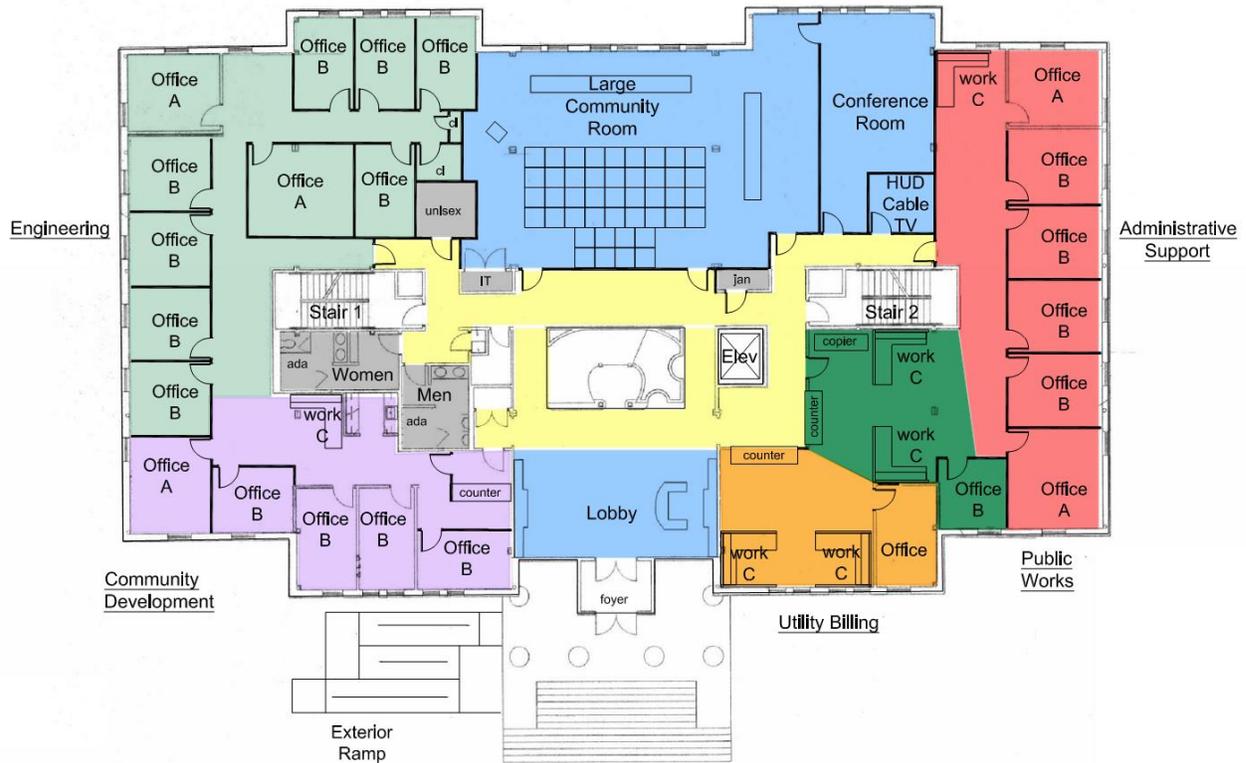
First Floor

FIRST FLOOR SPACE DIAGRAM

The primary public entrance for City Administration Offices will be through the north entrance on the First Floor. An exterior ramp will be added and integrated into the landscape for wheelchair access. The two departments with the most public visitors, Utility Billing and Community Development, are located adjacent to the main lobby. Access to all other departments and a central Community Room is made via the public corridor surrounding the central stair.

- Public Lobby
- Utility Department
- Public Works Department
- Administrative Support
- Community Development Department
- Engineering Department
- Large Community Room
- Large Conference Room

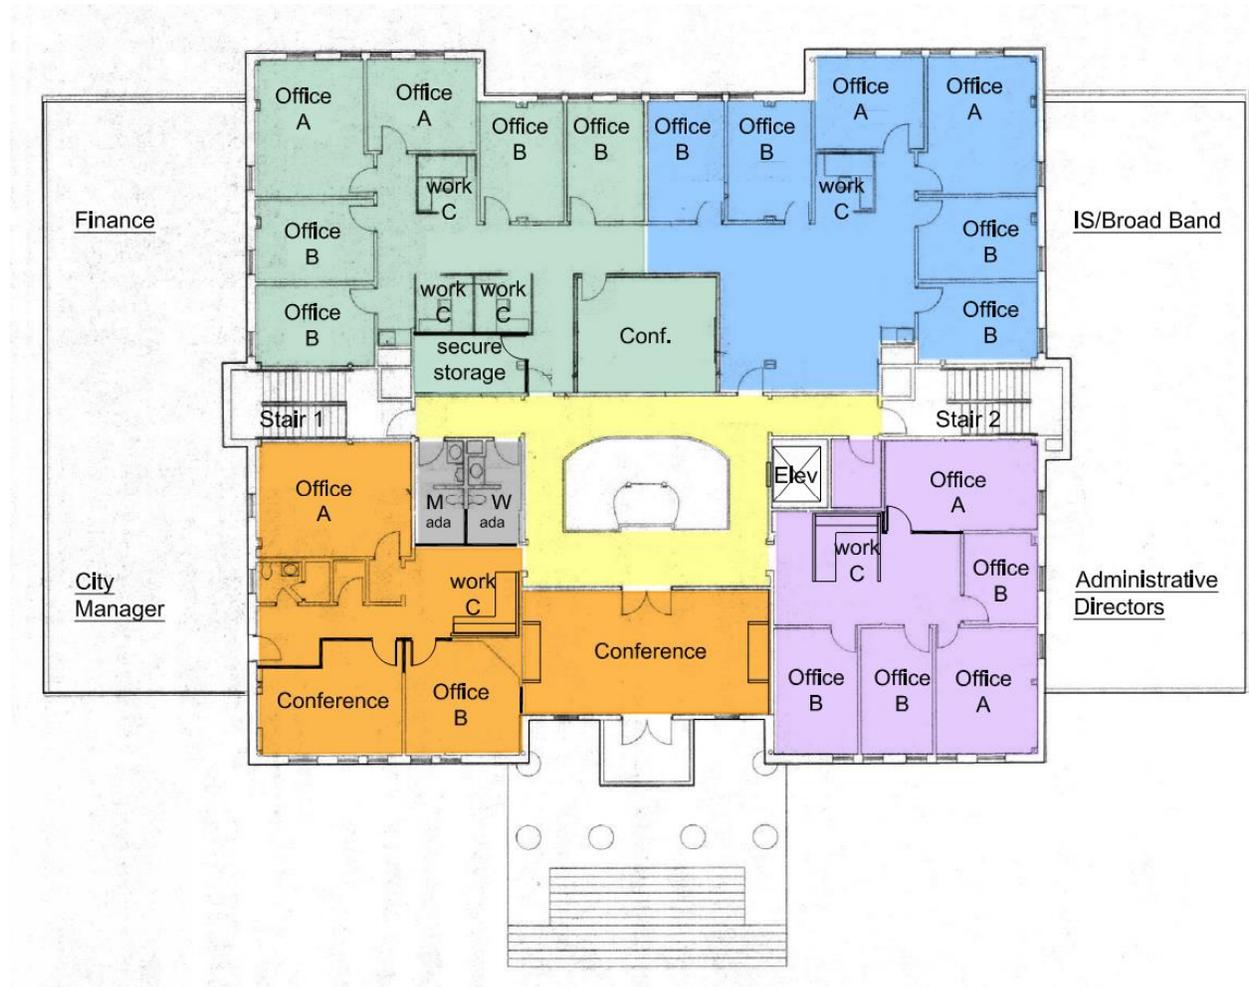
SECOND FLOOR SPACE DIAGRAM

The majority of the Second Floor contains private offices that can be utilized as is. Minor reconfiguration is needed to provide ADA restrooms and storage areas.

- City Manager Offices
- Administrative Support Offices
- Finance Department
- IS/Broad Band Department

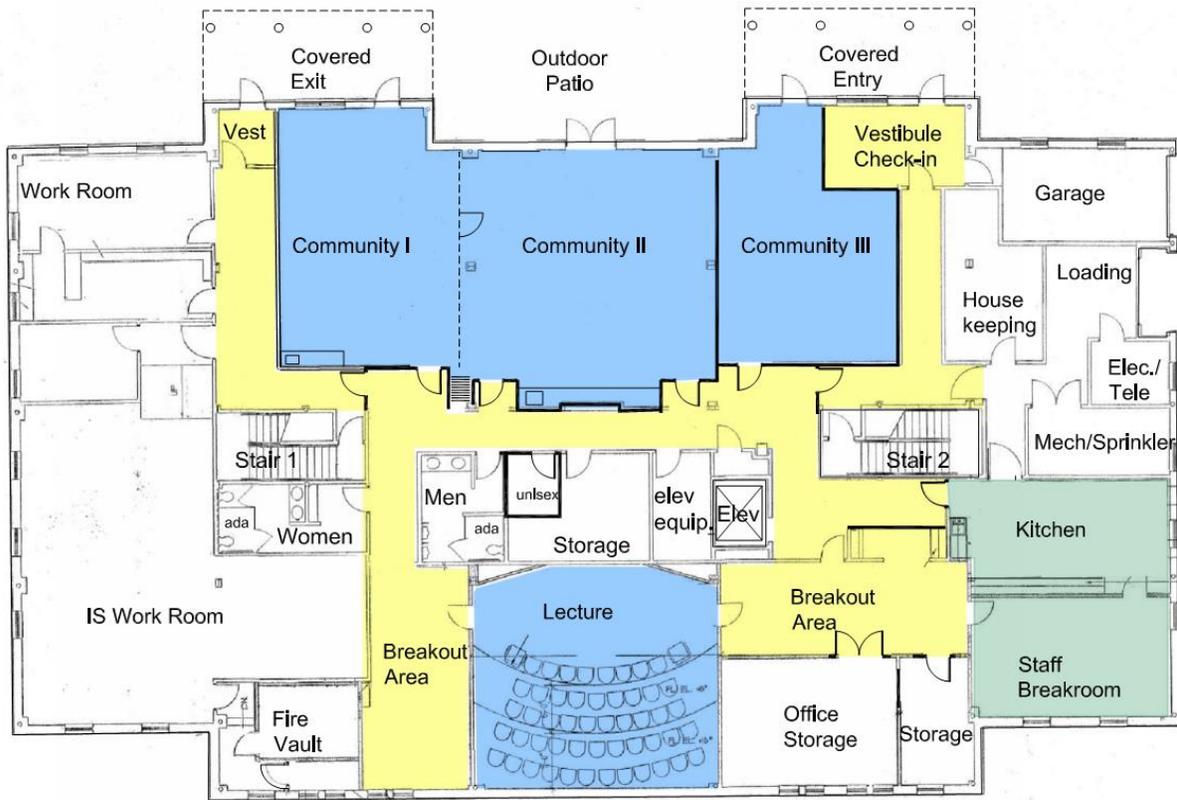
GROUND FLOOR SPACE DIAGRAM

Aside from the ADA and unisex restrooms being completed in Phase 1, all work on the Ground Floor is planned for a Future Phase. There is an opportunity on the Ground Floor to provide meeting and presentation spaces for the general community. There is a need for this type of space in Hudson that is not adequately being met. This floor is envisioned to be available for both day and evening use. Only authorized personnel will be able to access the upper floors from the Ground Level.

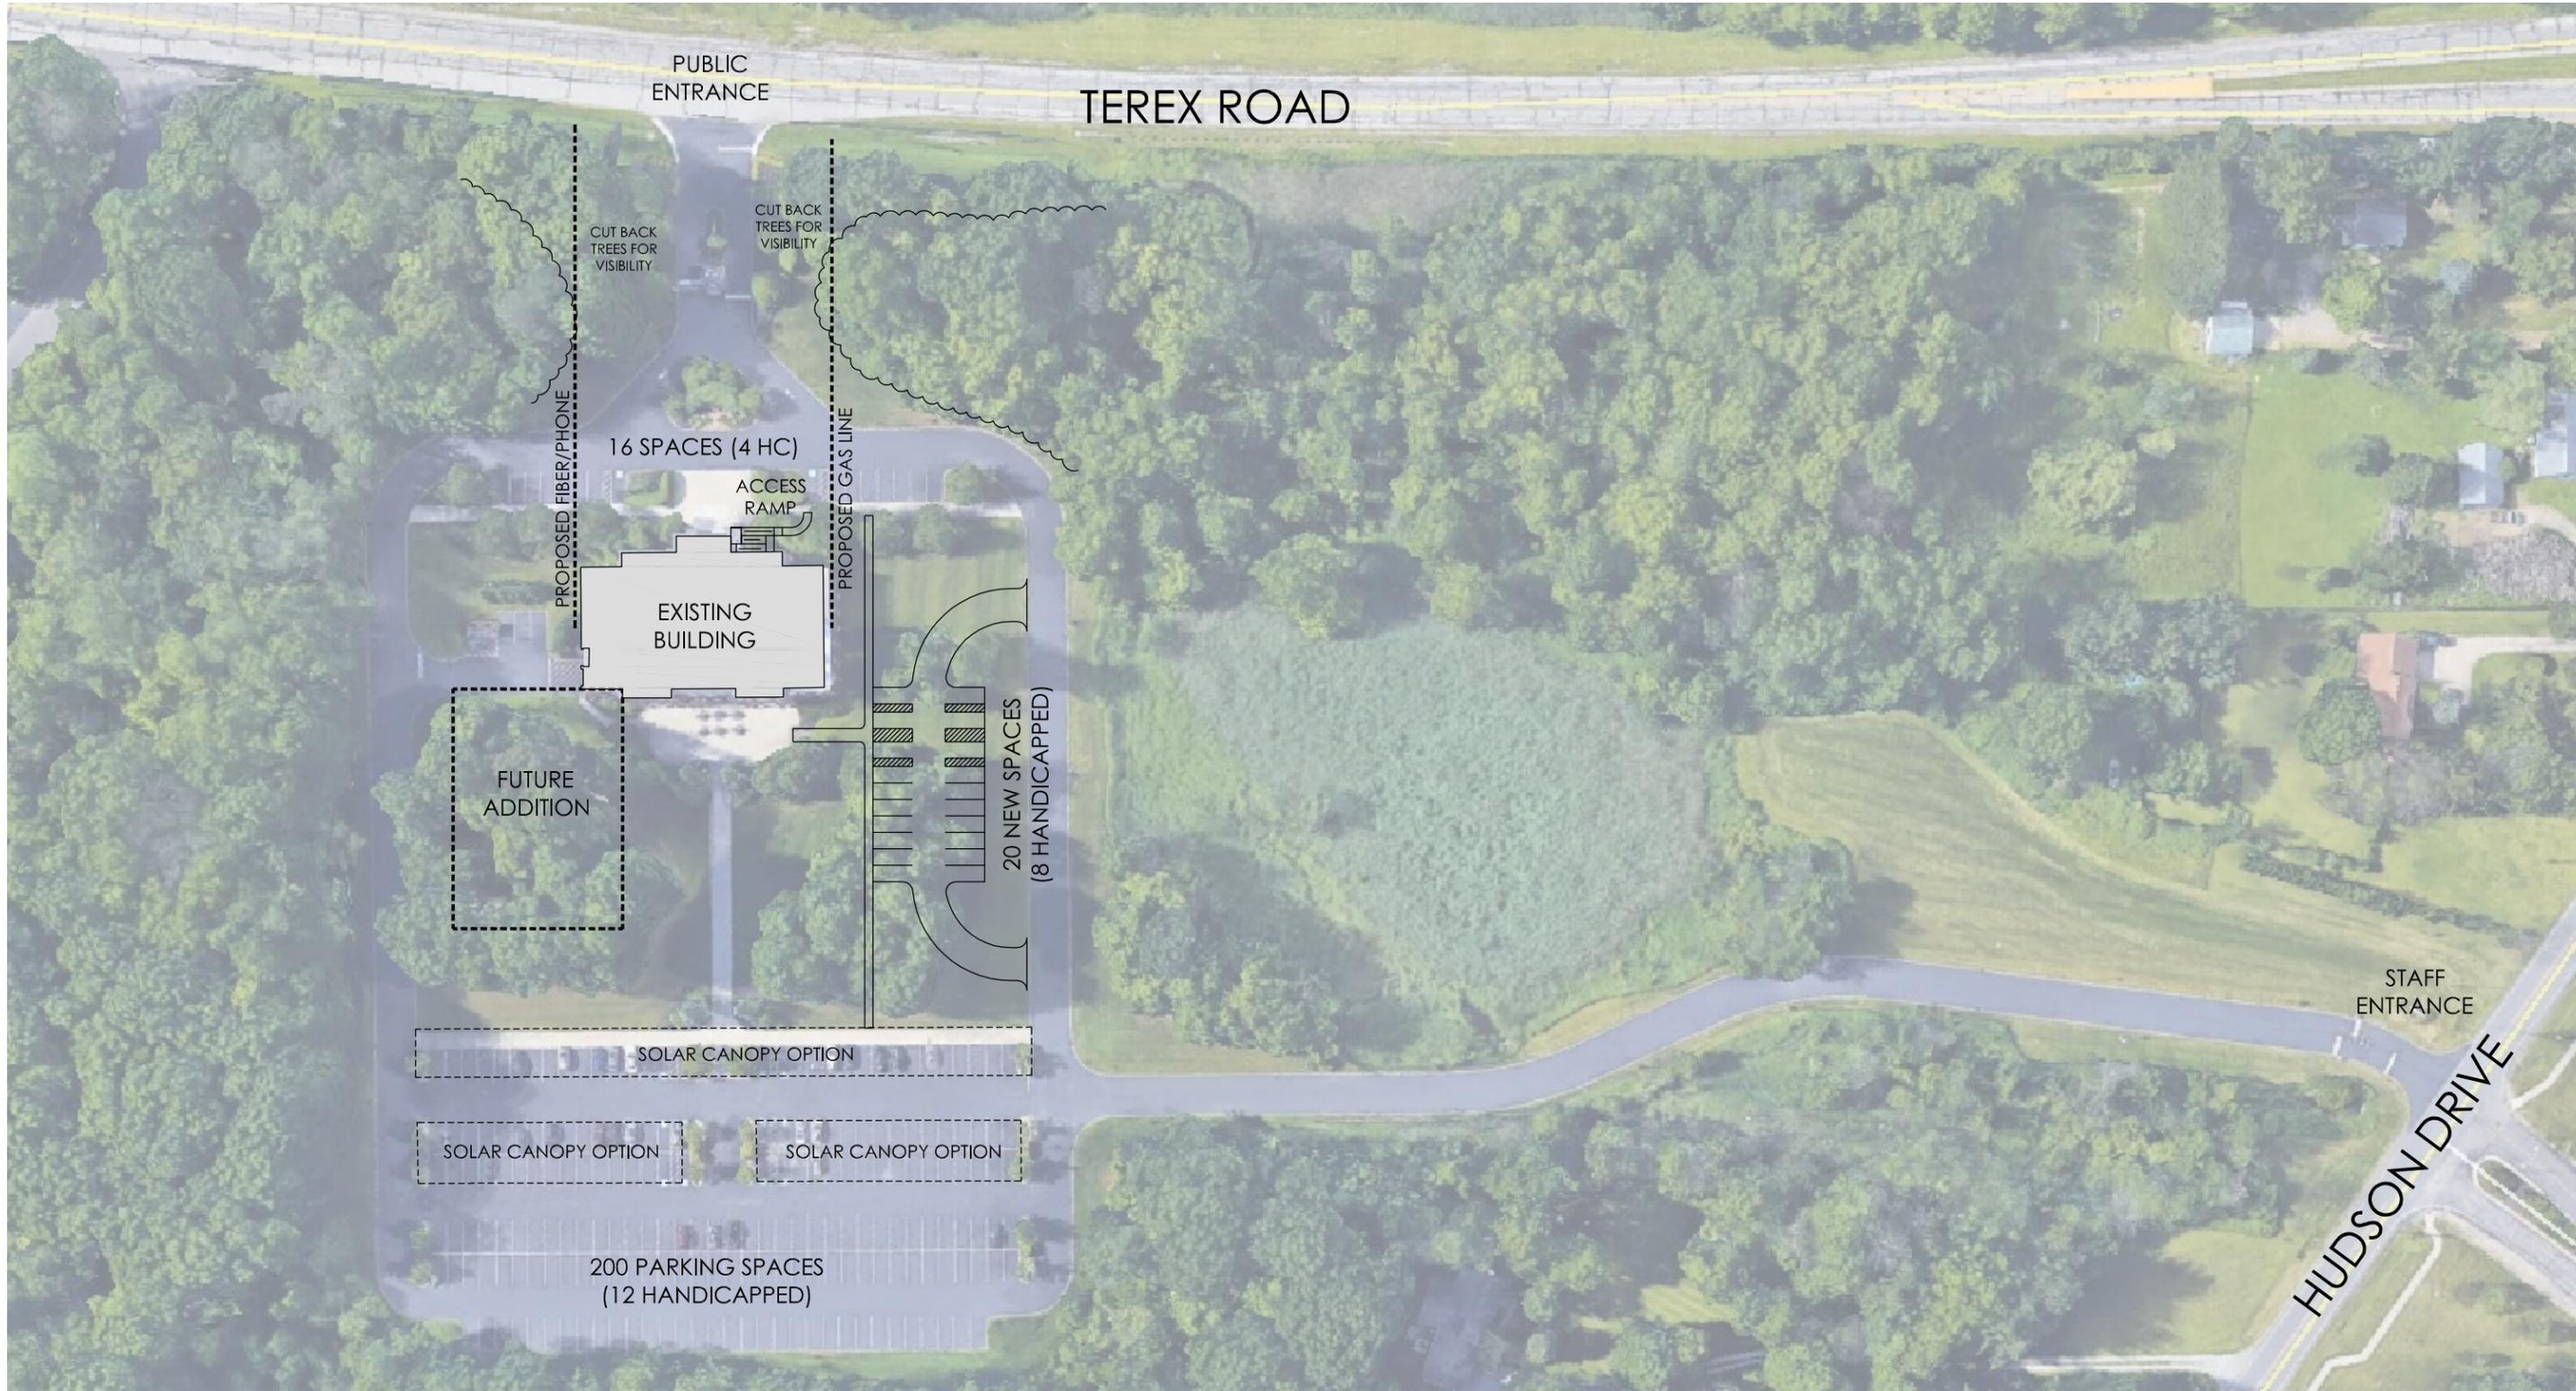
Site Plan

1"=50'-0"

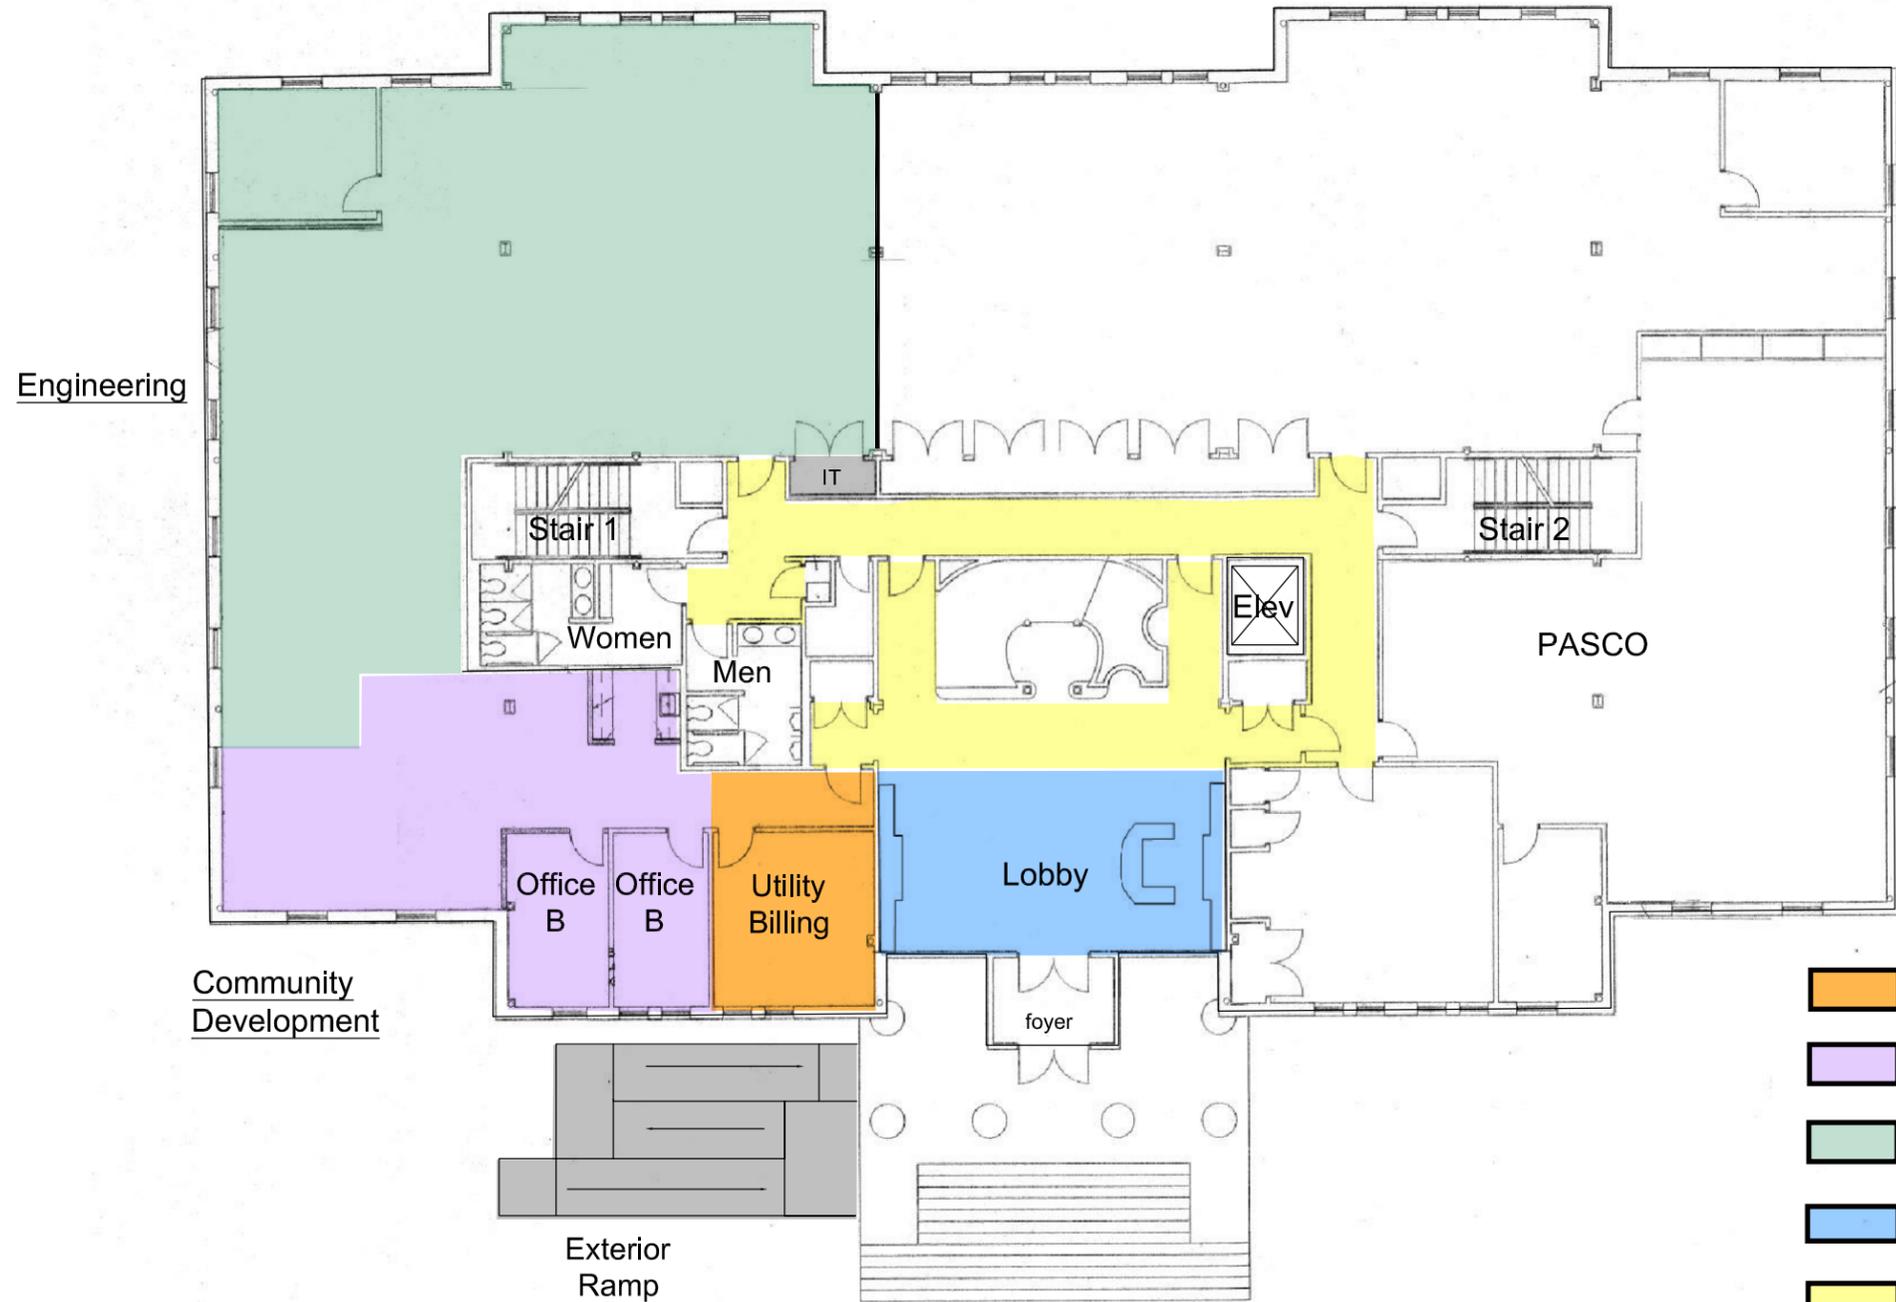
First Floor PHASE 1 Concept
 January - June 1, 2018

- UTILITY DEPARTMENT
- COMMUNITY DEVELOPMENT
- ENGINEERING
- PUBLIC AREAS
- CIRCULATION / BREAK-OUT
- ADA RESTROOMS / SUPPORT

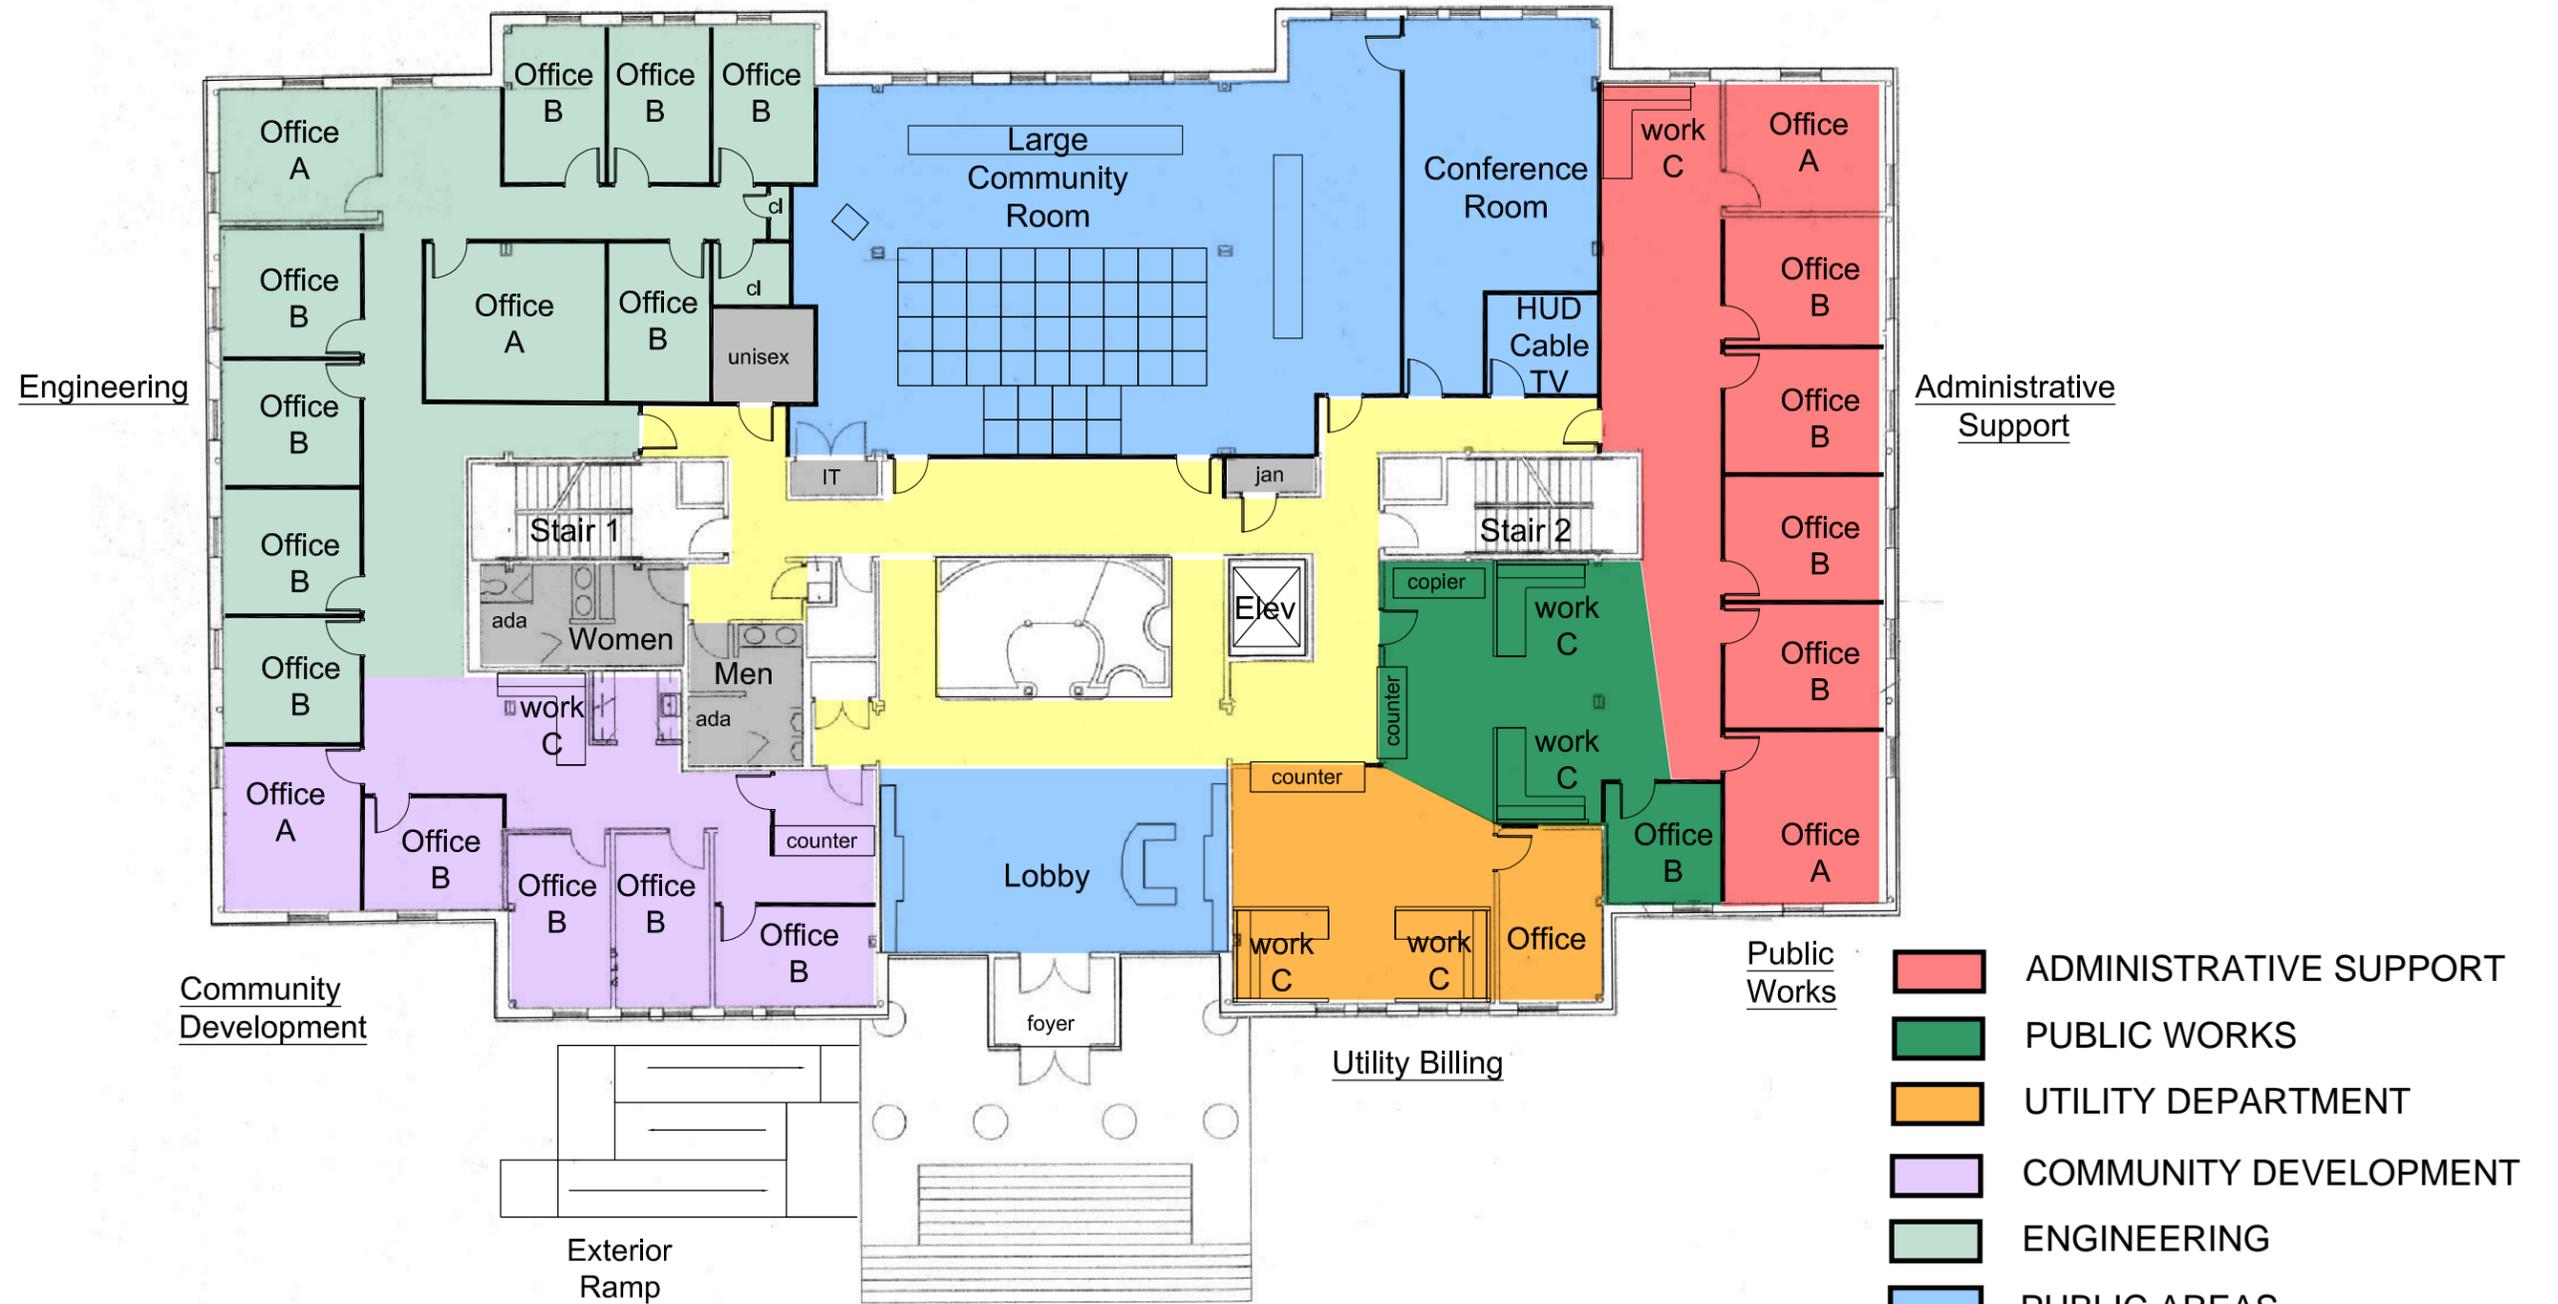
First Floor PHASE 2 Concept

June 1 - November, 2018

- ADMINISTRATIVE SUPPORT
- PUBLIC WORKS
- UTILITY DEPARTMENT
- COMMUNITY DEVELOPMENT
- ENGINEERING
- PUBLIC AREAS
- CIRCULATION / BREAK-OUT
- ADA RESTROOMS / SUPPORT

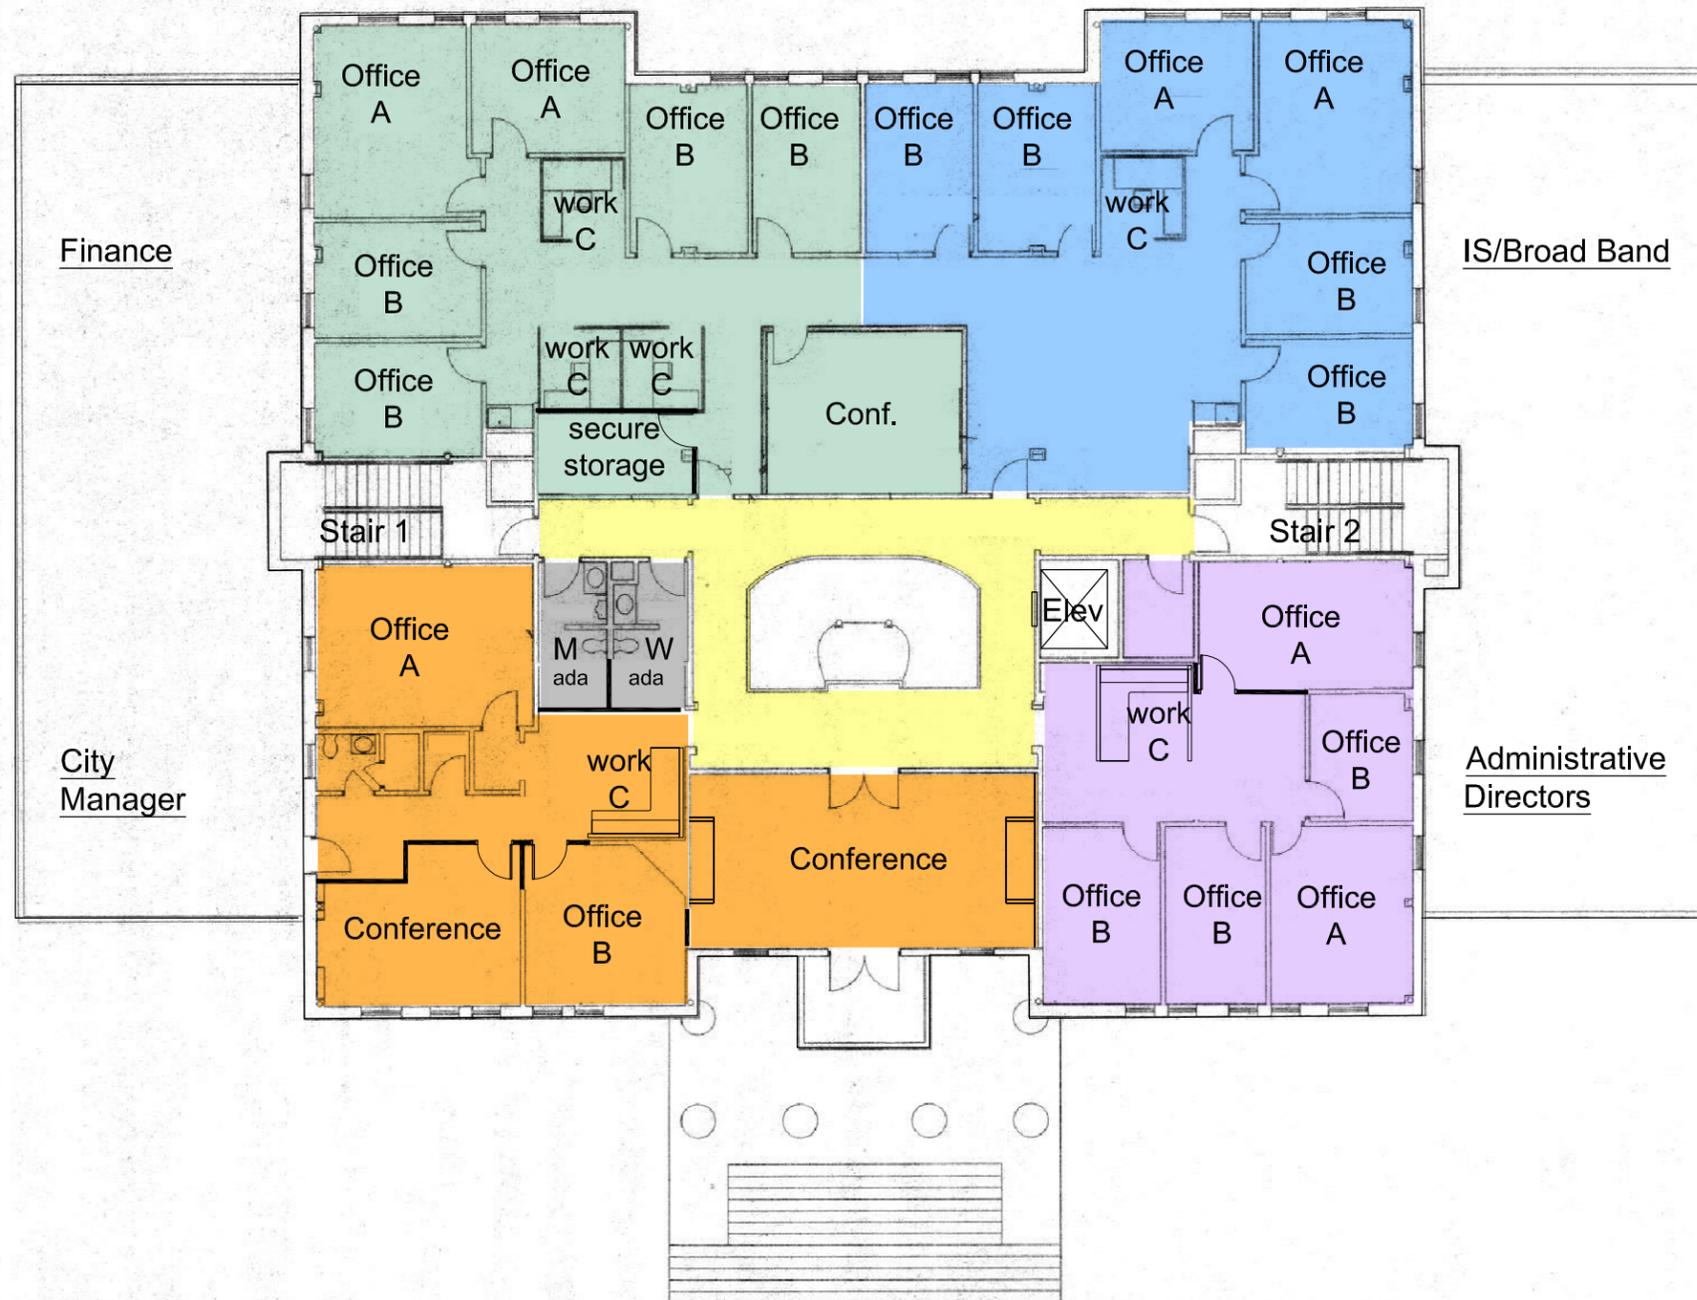
Second Floor PHASE 2 Concept

- CITY MANAGER
- ADMINISTRATIVE DIRECTORS
- FINANCE
- CIRCULATION / BREAK-OUT
- ADA RESTROOMS / SUPPORT

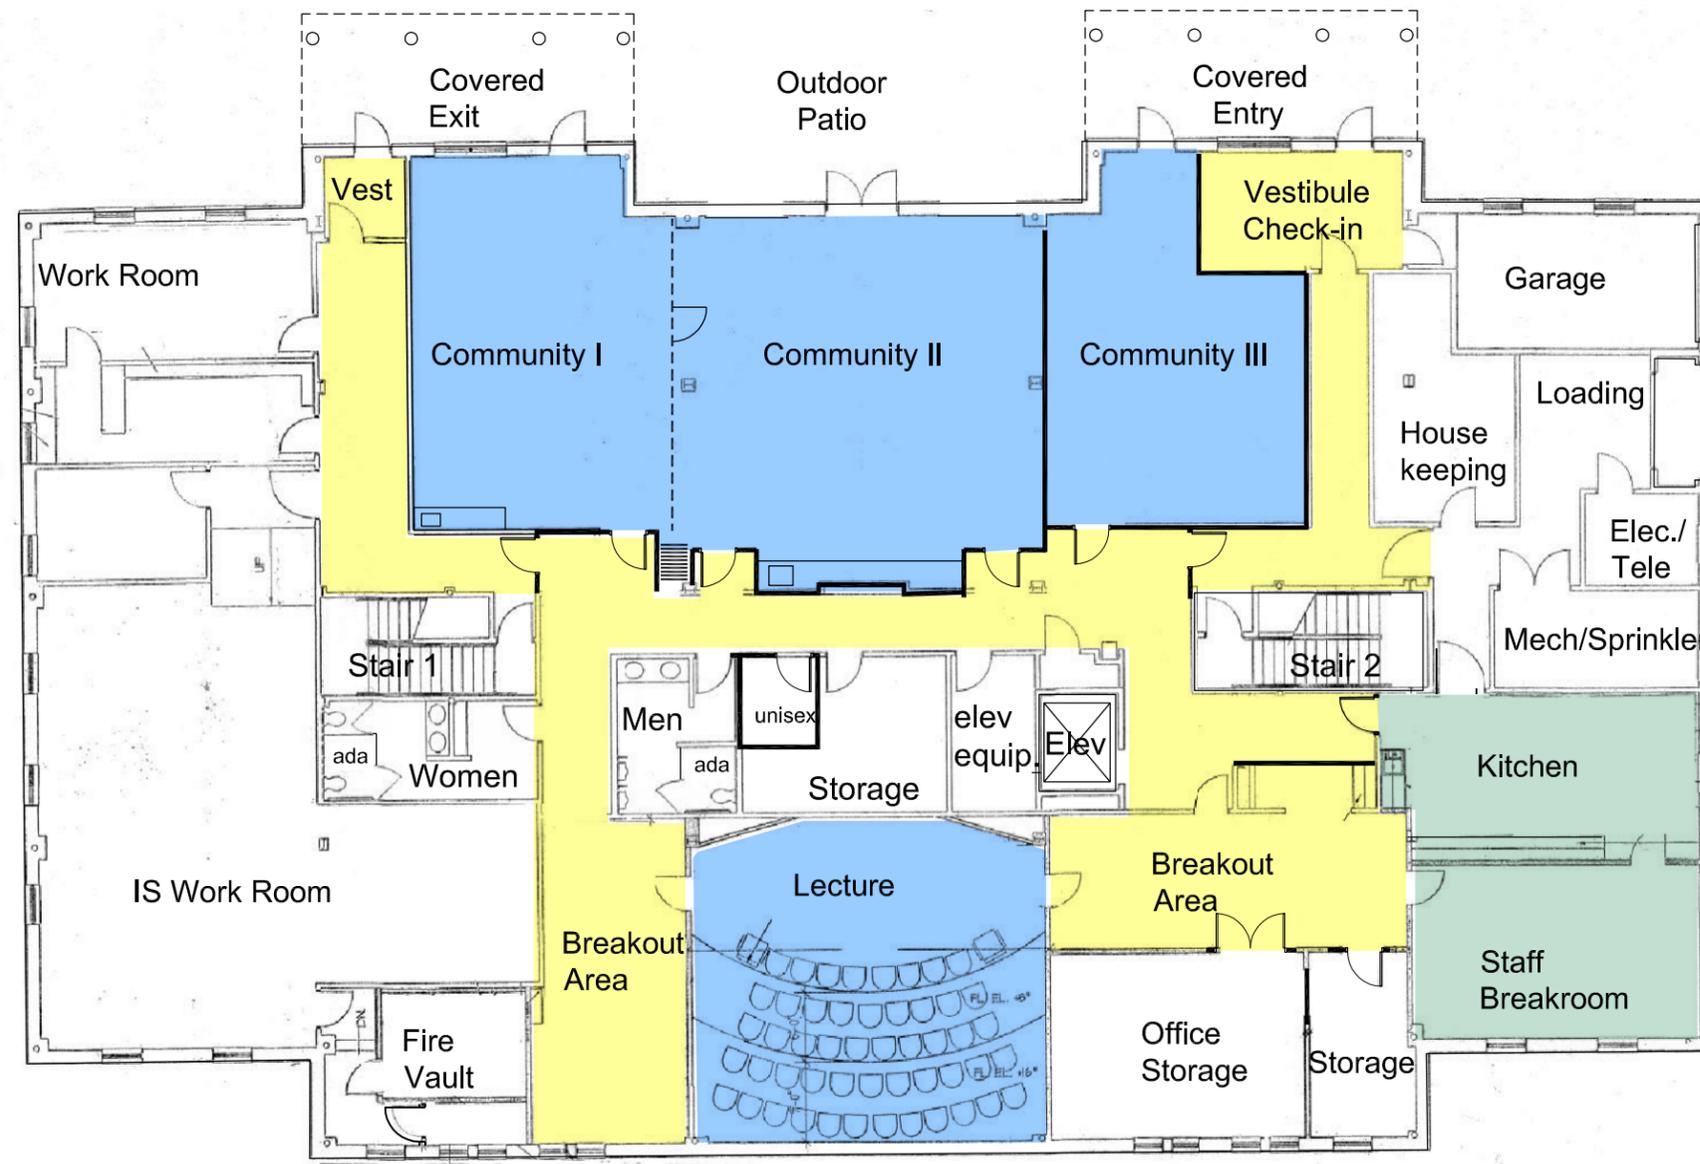
Ground Floor FUTURE Concept

- STAFF AREAS
- PUBLIC AREAS
- CIRCULATION / BREAK-OUT
