EVAMERE RENOVATION TO ADMIN. OFFICE/HCR
 HUDSON, OHIO 44235
 DEMO FIRST FLOOR PLAN OVERALL

EVAMERE RENOVATION TO ADMIN. OFFICE/HCER
 76 N HAYDEN PKWY
 HUDSON, OHIO 44236

**EVEAMERE – CONVERSION TO ADMINISTRATIVE OFFICES
BUILDING IMAGES**

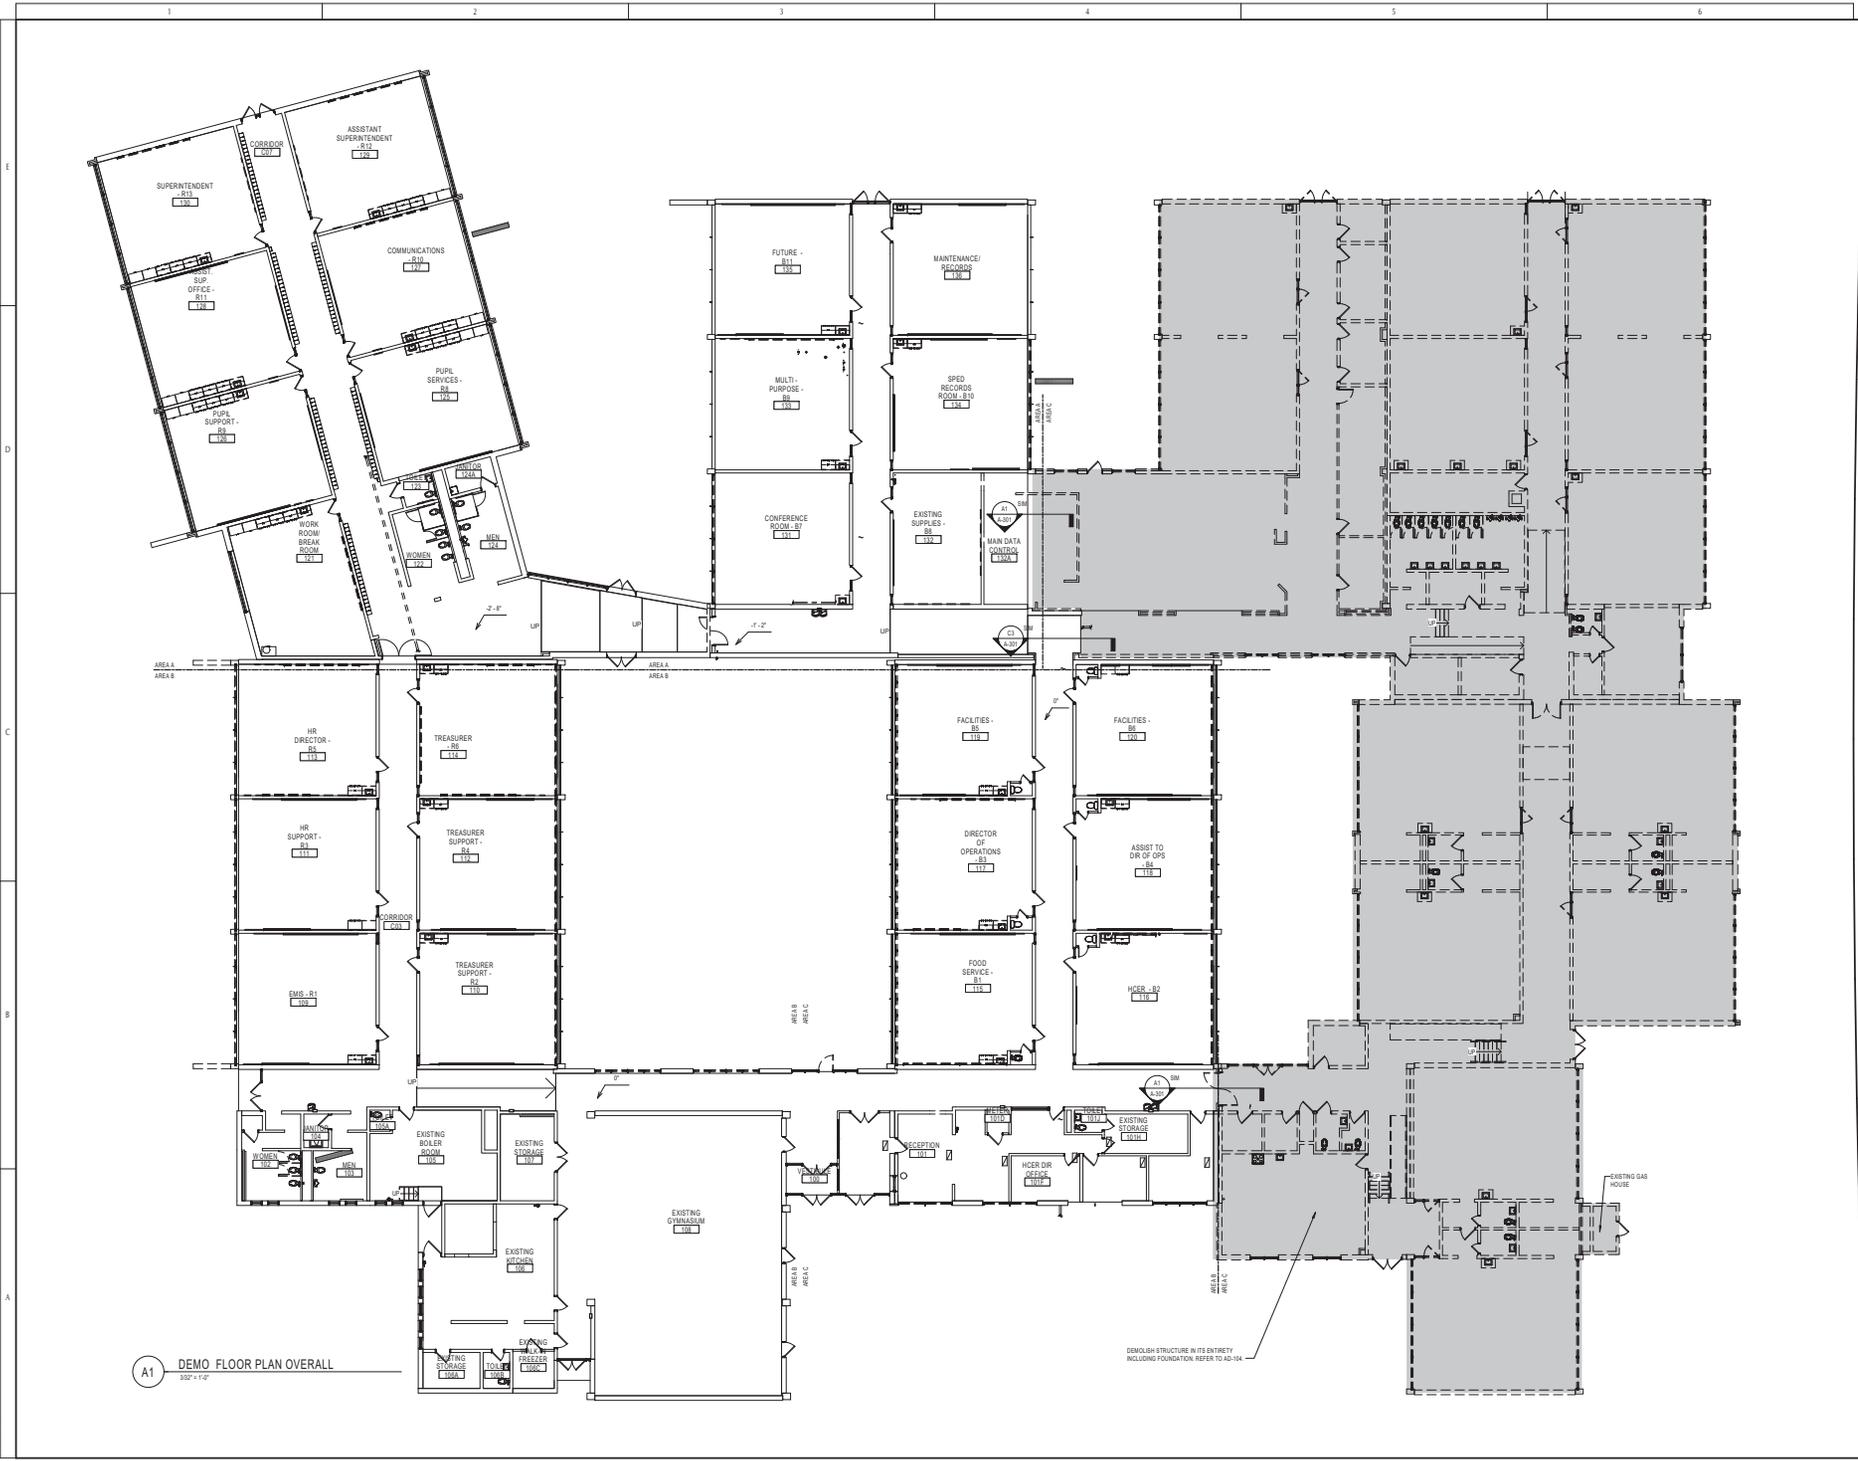
AD-101

A1 DEMO FLOOR PLAN OVERALL
 330' x 110'

DEMOLISH STRUCTURE IN ITS ENTIRETY INCLUDING FOUNDATION. REFER TO AD-104

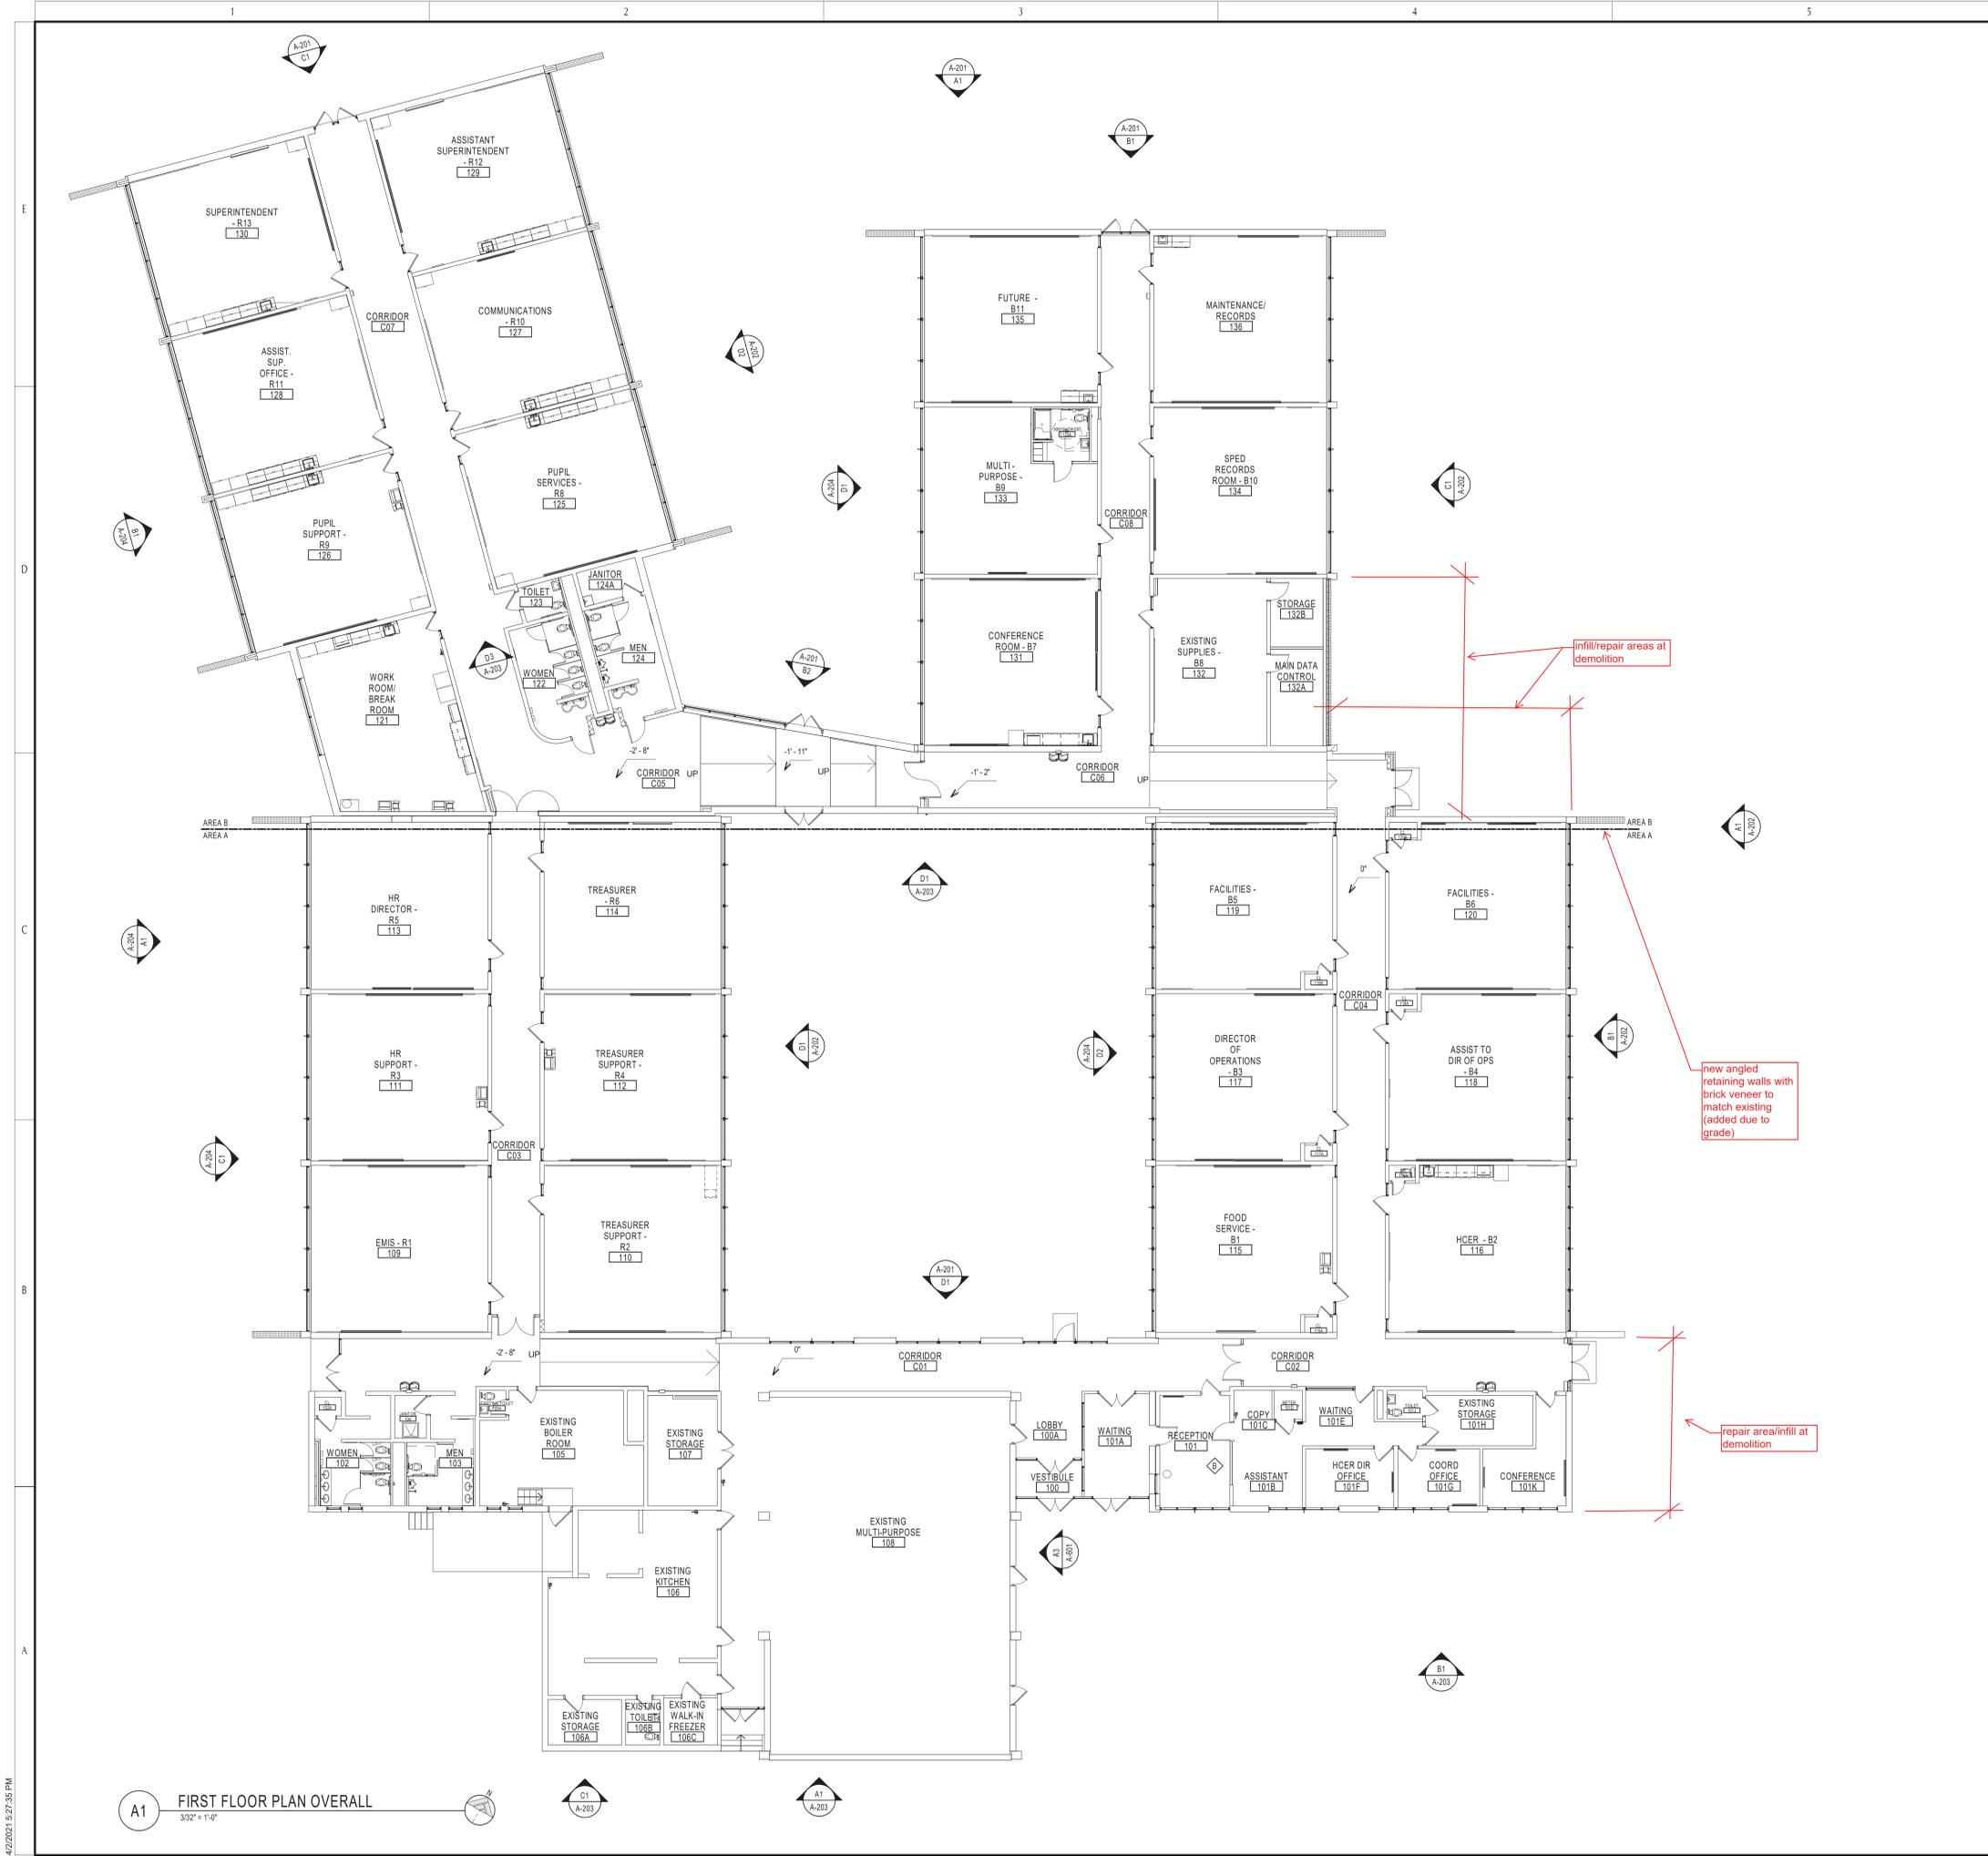
A-101

A1 FIRST FLOOR PLAN OVERALL
 3/32" = 1'-0"

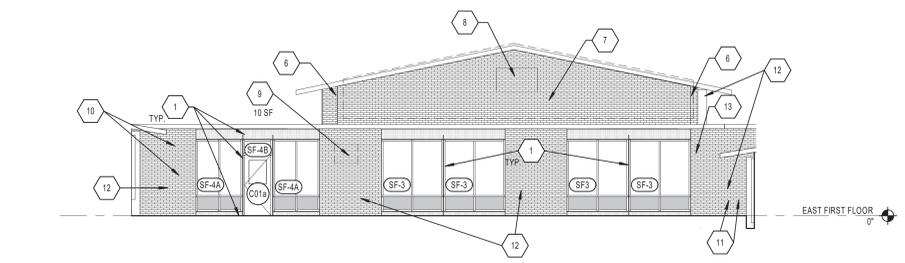
D1 NORTH ELEVATION 4
 18" = 1'-0"

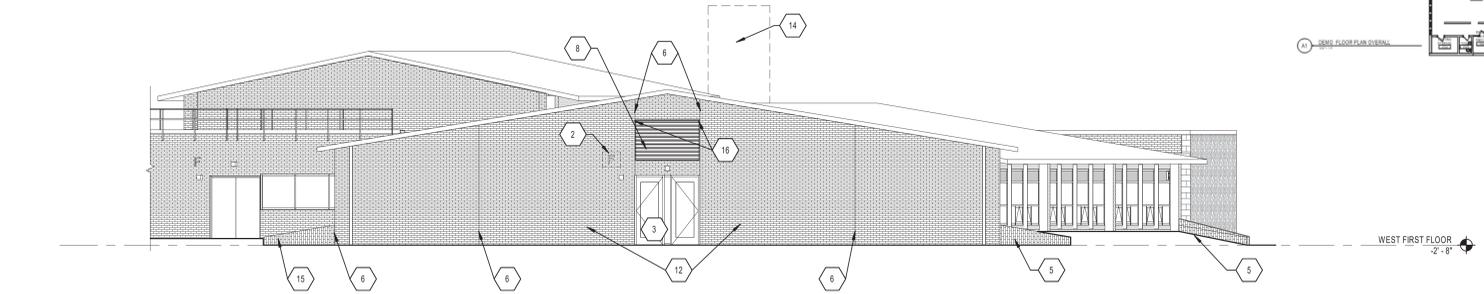
C1 NORTH ELEVATION 3
 18" = 1'-0"

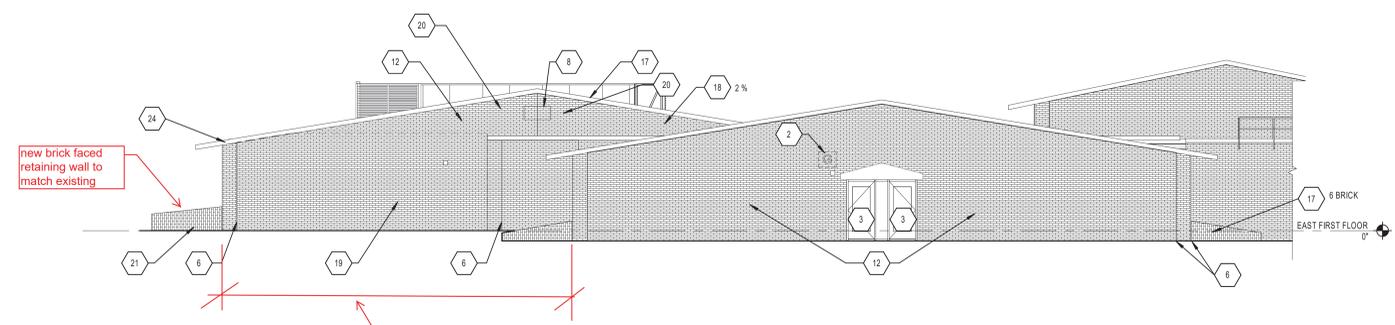
B1 NORTH ELEVATION 1
 18" = 1'-0"

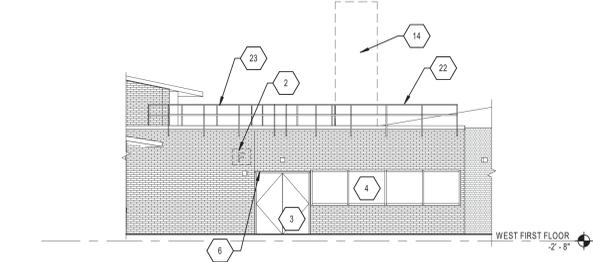
B2 NORTH ELEVATION 2
 18" = 1'-0"

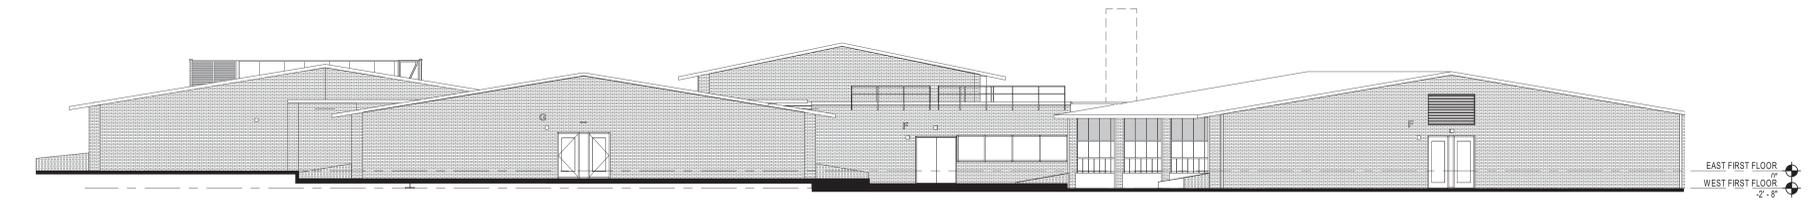
A1 NORTH ELEVATION OVERALL
 3/2" = 1'-0"

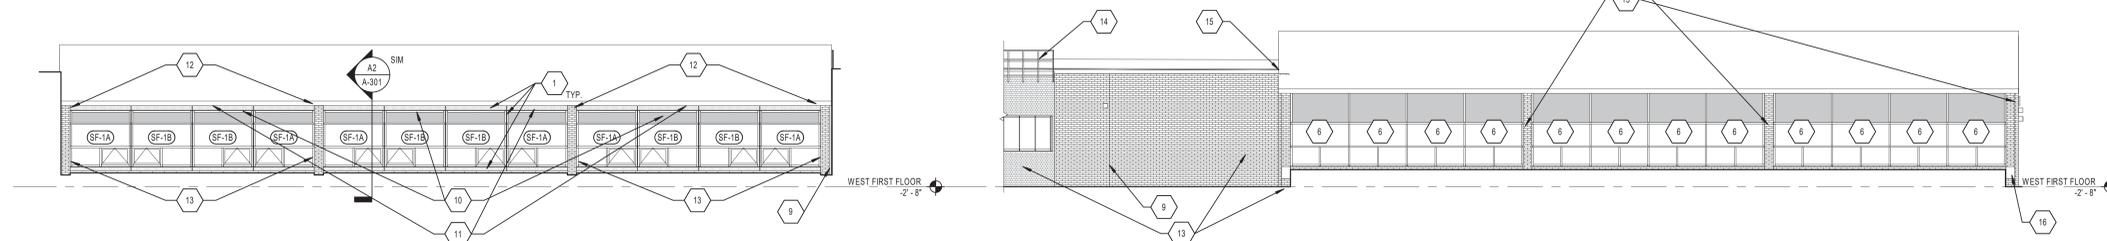
D1 EAST ELEVATION 3
1/8" = 1'-0"

D2 EAST ELEVATION 4
1/8" = 1'-0"

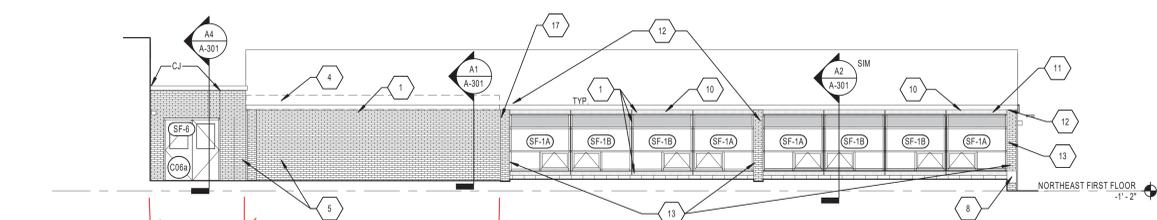
C1 EAST ELEVATION 2
1/8" = 1'-0"

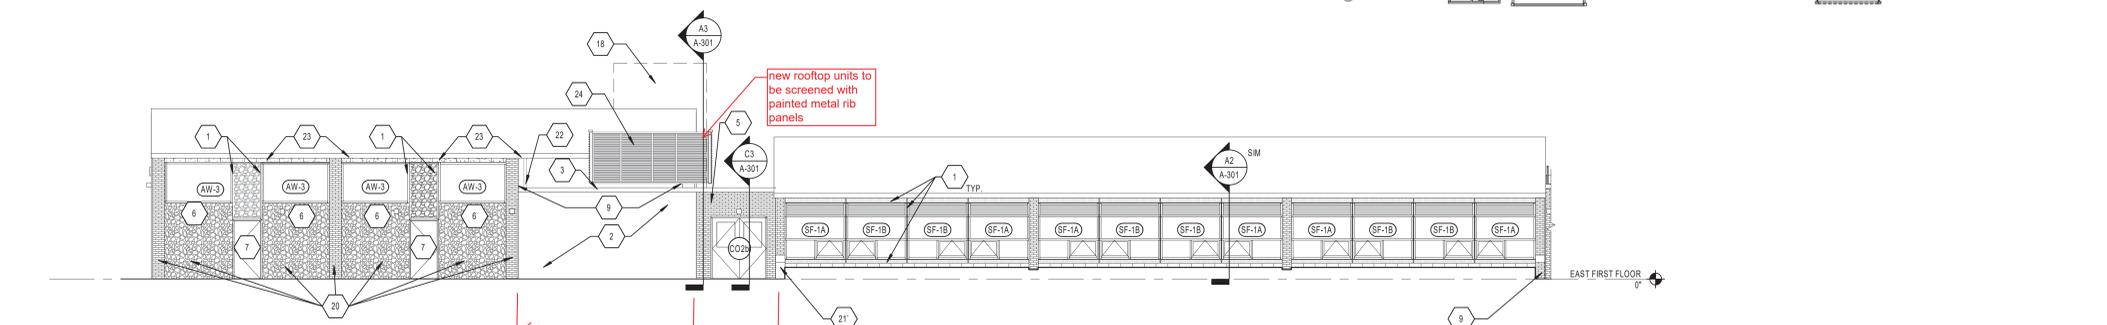
B1 EAST ELEVATION 1
1/8" = 1'-0"

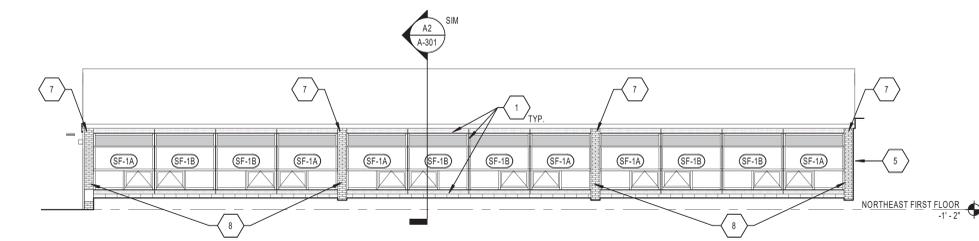
D1 WEST ELEVATION 3
1/8" = 1'-0"

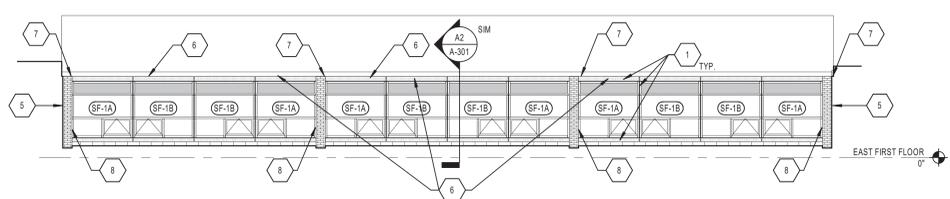
D2 WEST ELEVATION 4
1/8" = 1'-0"

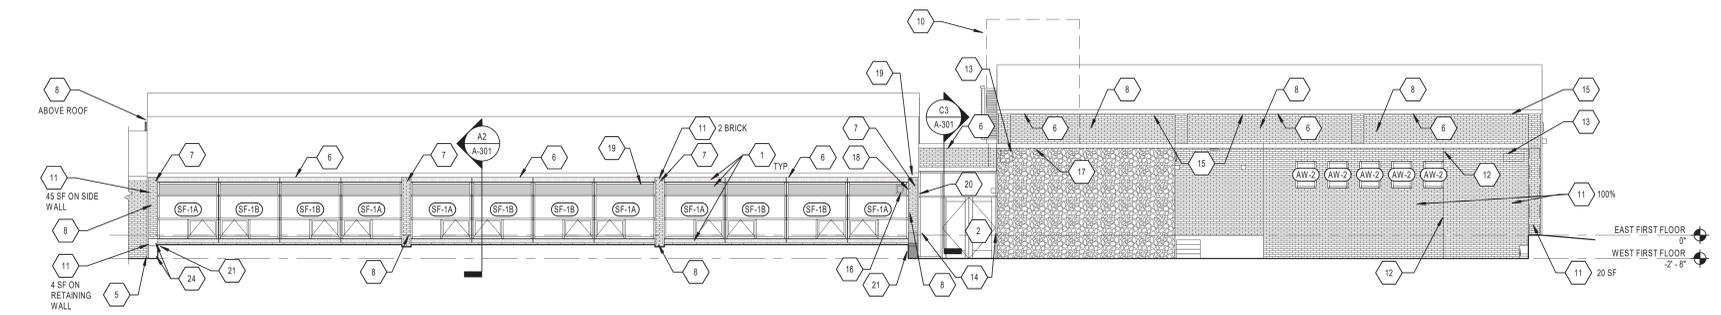
C1 WEST ELEVATION 2
1/8" = 1'-0"

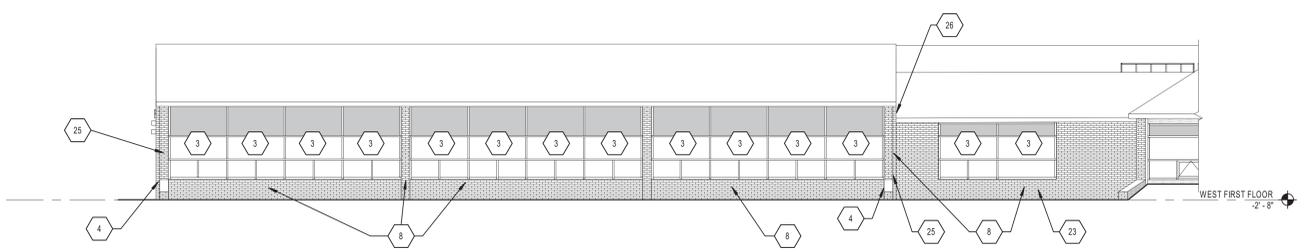
B1 WEST ELEVATION 1
1/8" = 1'-0"

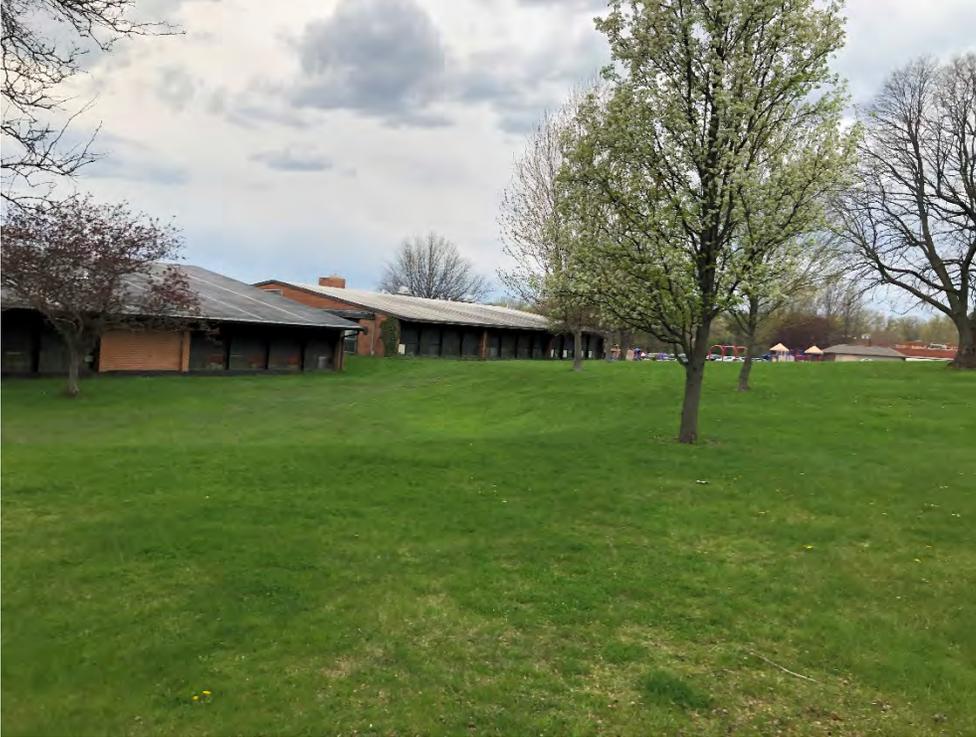
View looking northwest – these sections are to be demolished, creating more lawn area.

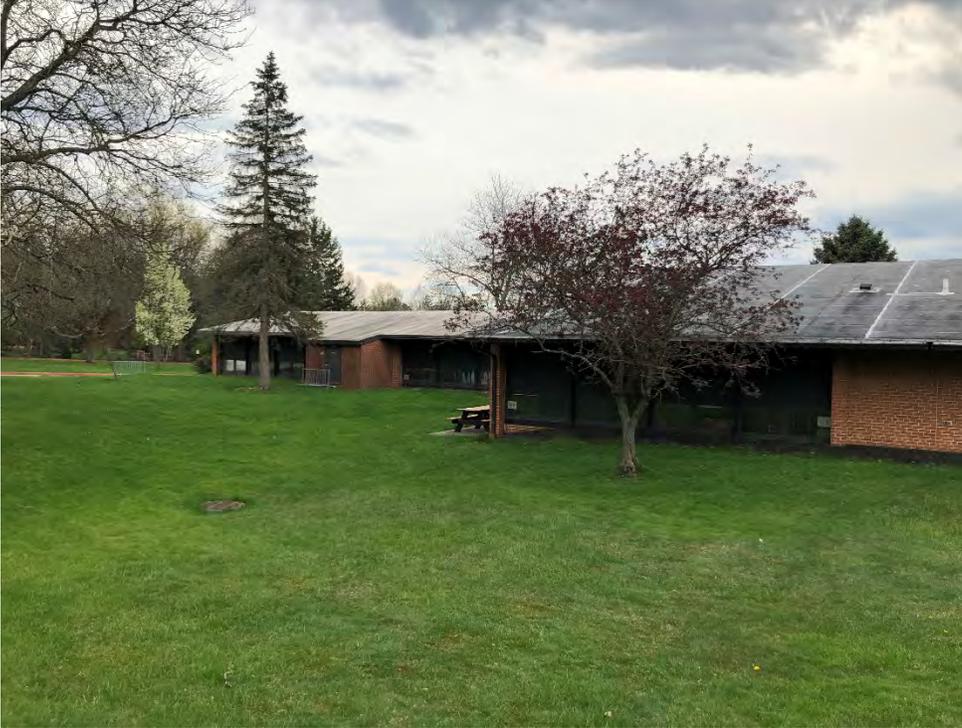
View from front lawn looking west/southwest – these sections are to be demolished

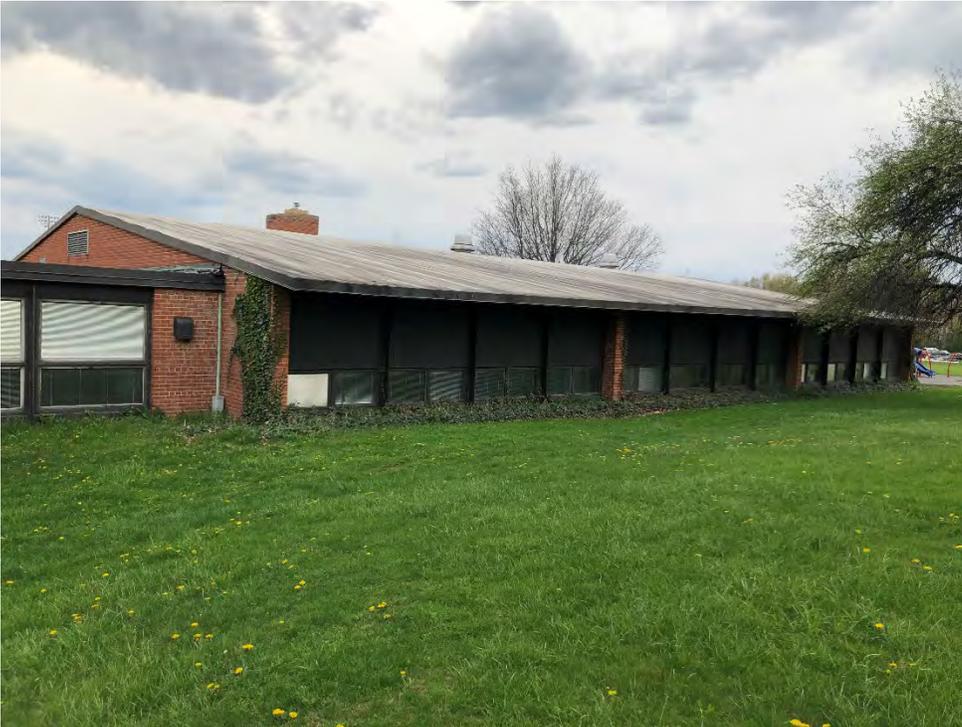
View from front lawn looking west/northwest – this section is to be demolished

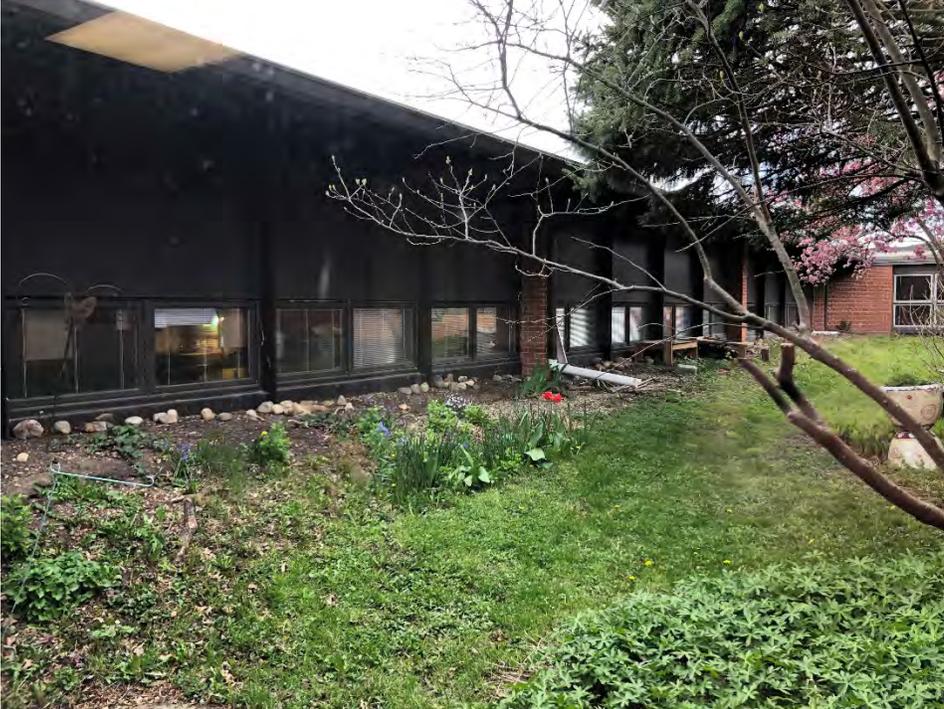
View inside east courtyard. This exterior wall will now face N. Hayden Pkwy. Windows are to be replaced with windows similar to the 2007 addition windows. Construction to the far right will be demolished.

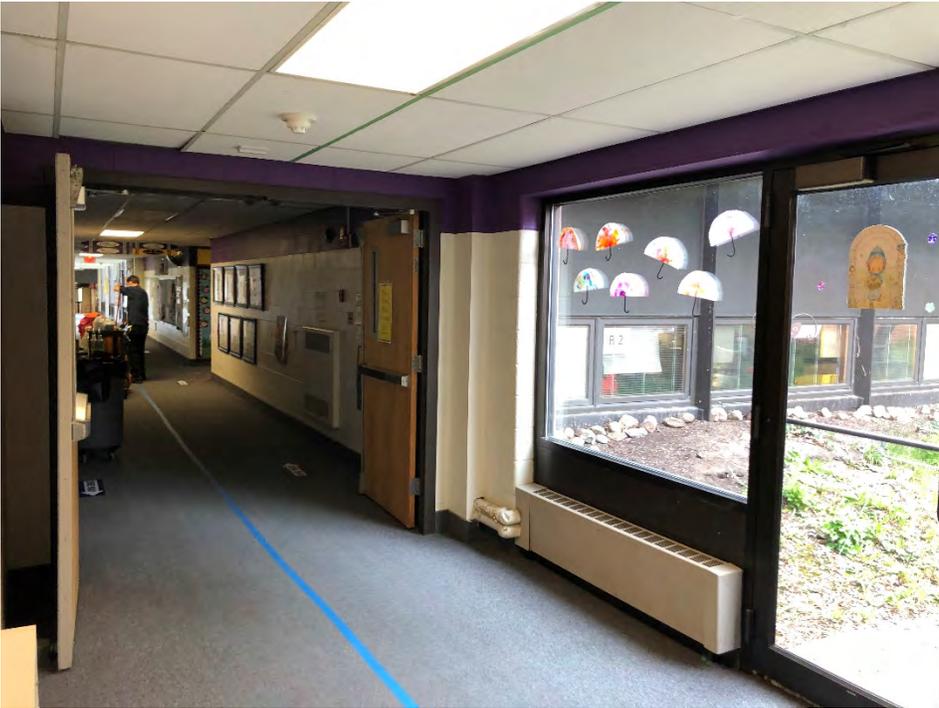
View inside corridor looking west. The courtyard in the picture above is to the right. This construction in the foreground will be demolished and wall at the double doors infilled with brick and FRP doors/aluminum storefront to match existing.

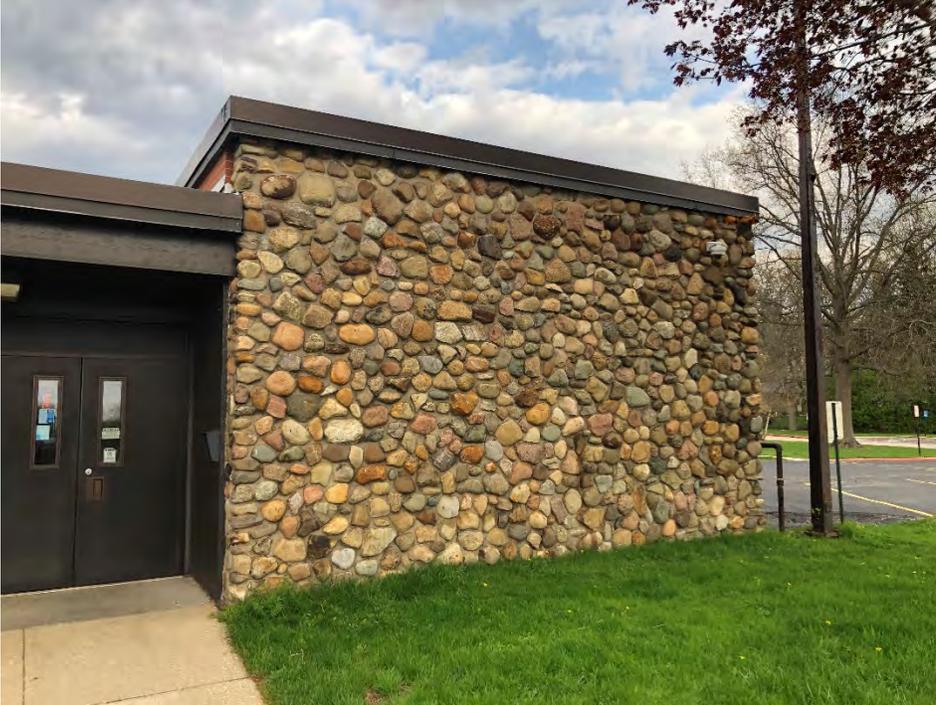
This image is of a cobblestone veneer wall on the west façade. Per the addition drawings, removal of an abutting wall adjacent to the existing main office area will reveal a similar wall. This wall will be repaired as necessary to match others.

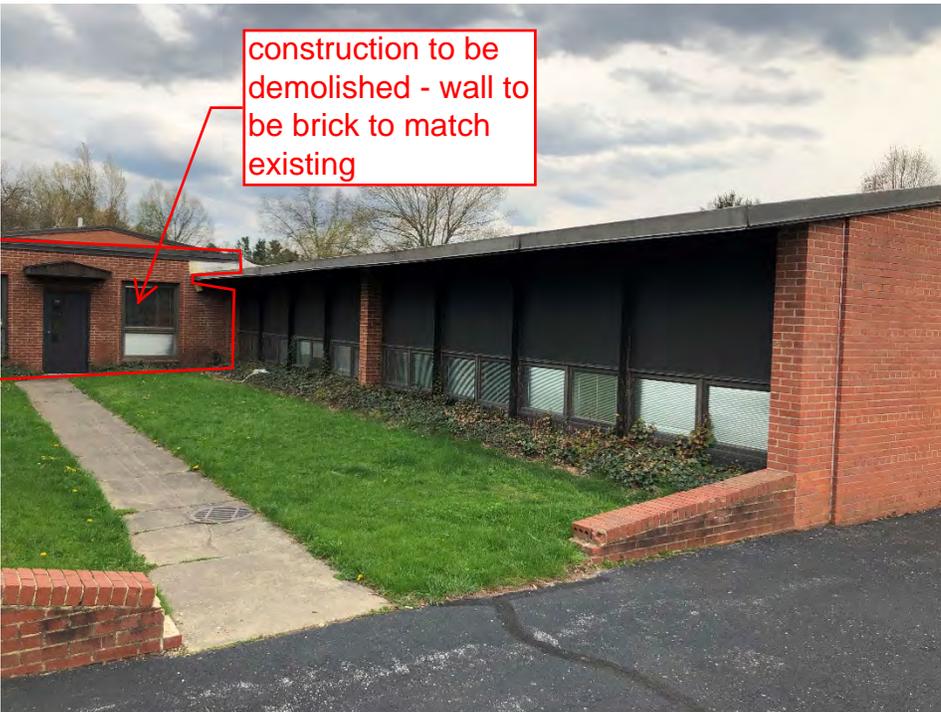
View of a retained section that will now face N. Hayden Pkwy. The construction to the left is to be demolished. The windows are to be replaced with windows similar to the 2007 addition windows.

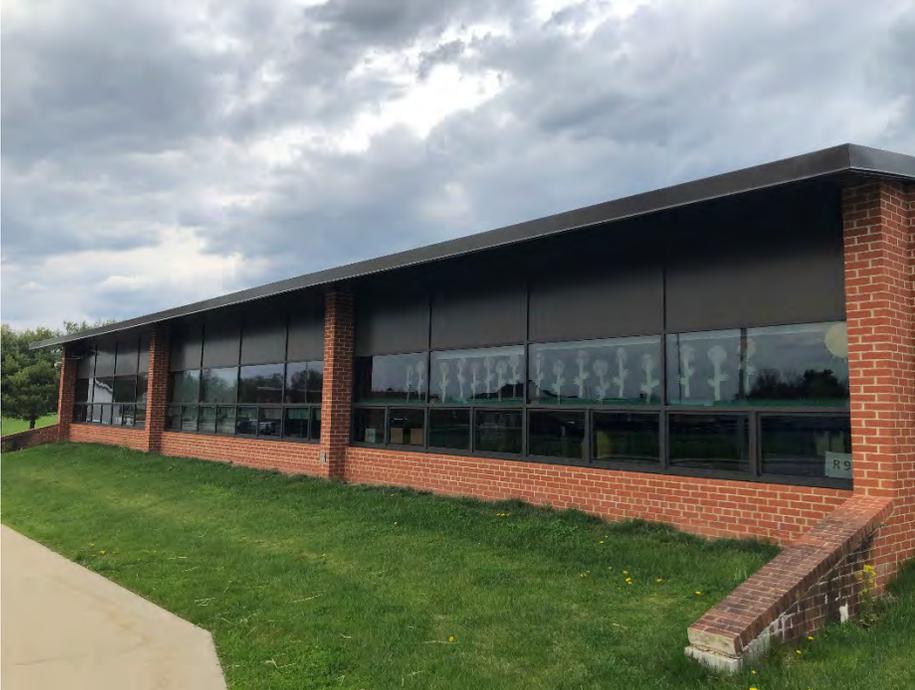
West façade of the 2007 addition. These windows will remain. Window replacement on the balance of the remaining building are to be similar to these windows, with dark bronze finished aluminum with metal panels above.

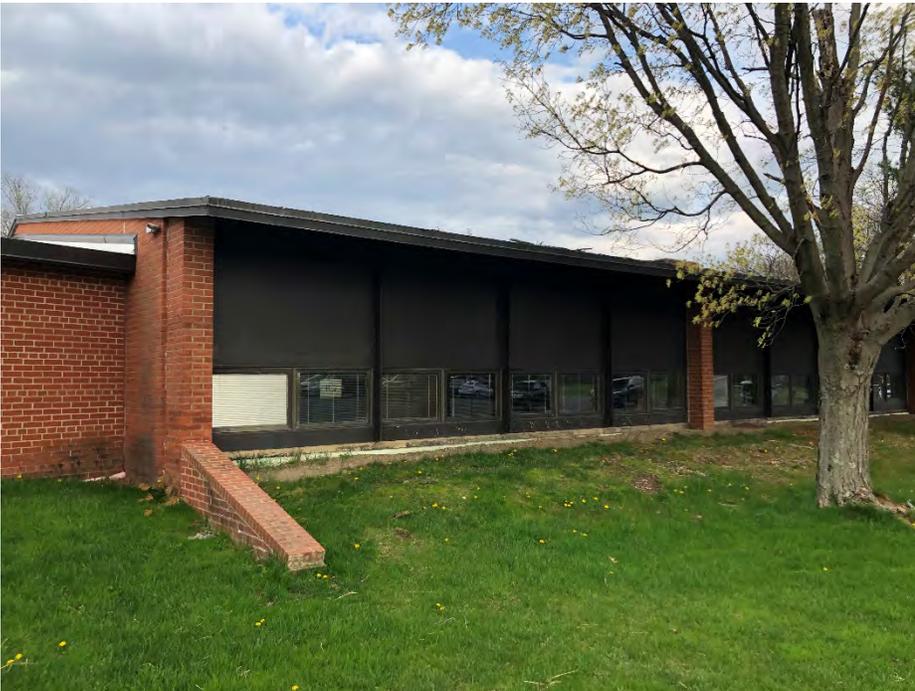
Portion of west façade facing parking lot, adjacent to the 2007 building. Windows are to be replaced with windows similar to the 2007 addition, dark bronze aluminum with metal panels above. Window glass area to be increased for additional natural light, similar to the 2007 addition windows.

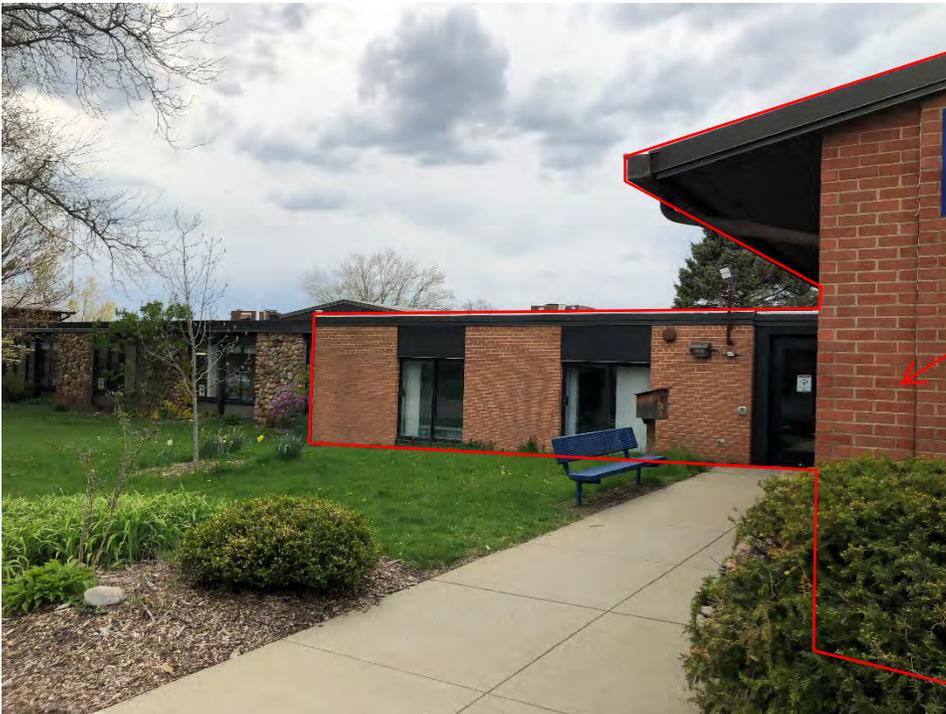
area to be
demolished

View looking north from the entrance drive. Construction to the right to be demolished. The existing main office construction to the left is to remain. The demolition is anticipated to reveal a cobblestone veneer – this will be restored.

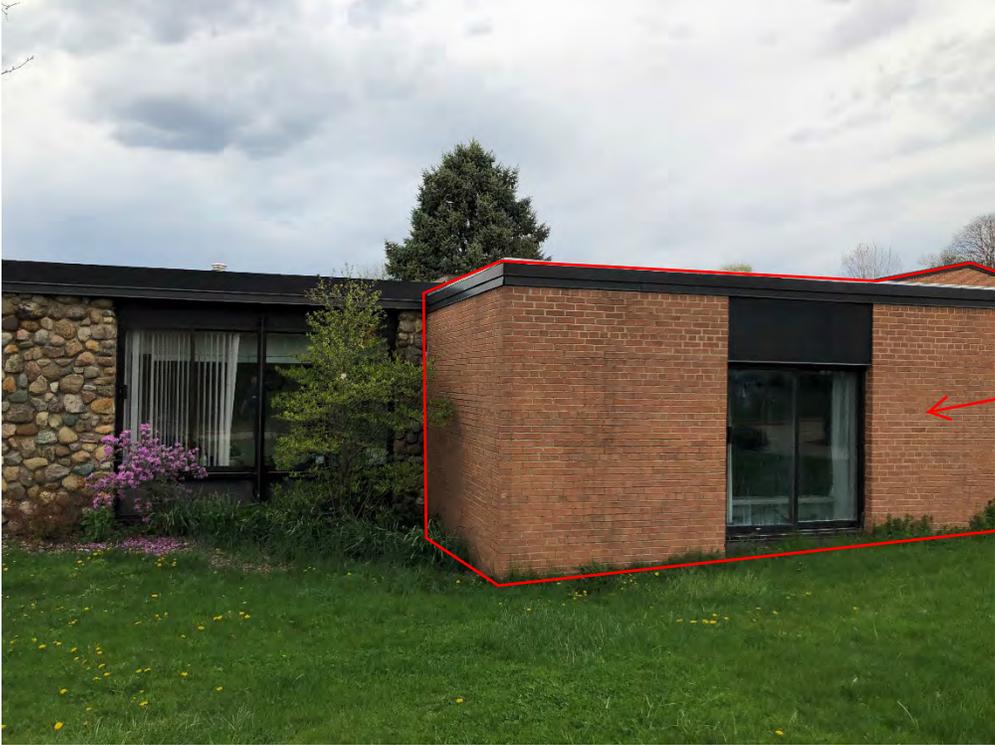
area to be demolished

Connection point between existing construction to remain to the left and construction to be demolished to the right.

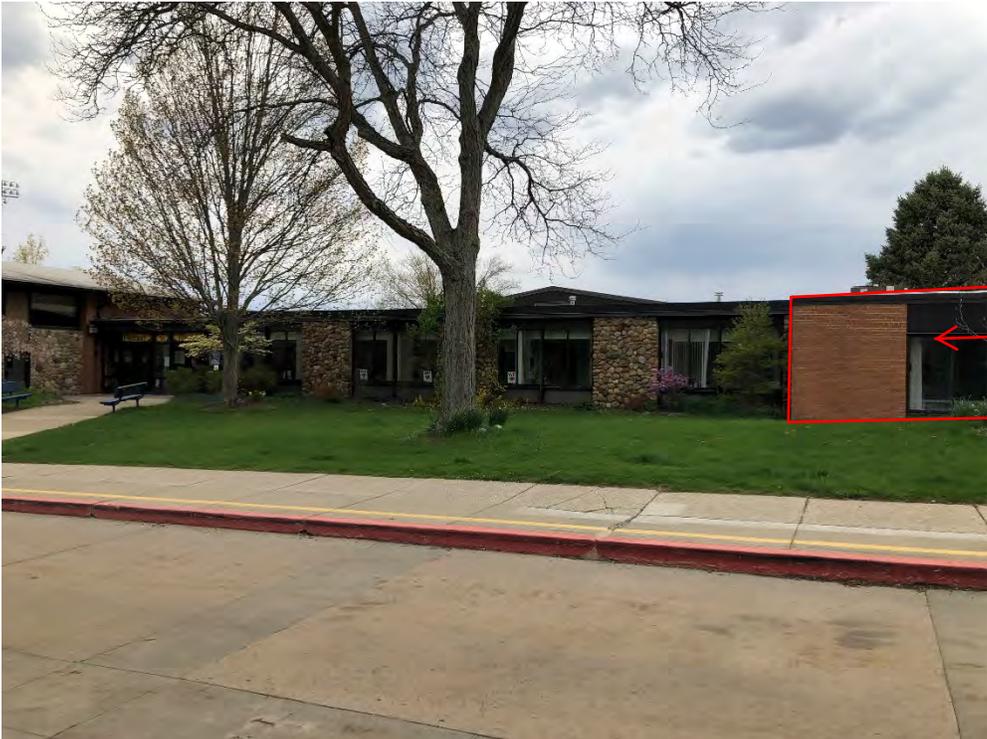
area to be demolished

View from entrance drive to main entrance/main office area. Construction to the right to be demolished.

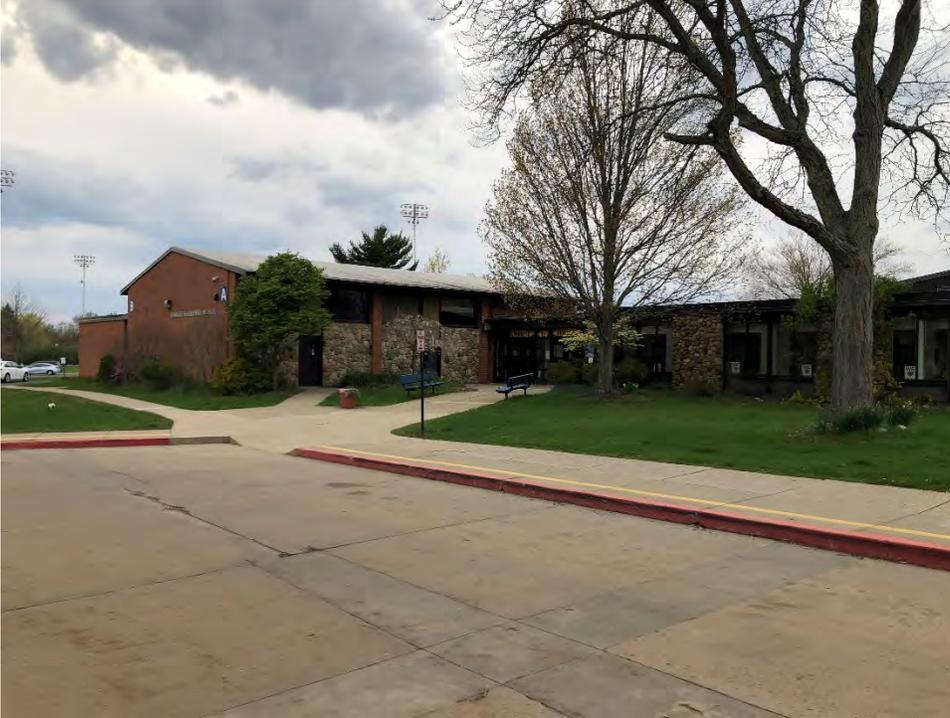
View from entrance drive looking northwest to main entrance. This area is to remain and be renovated.

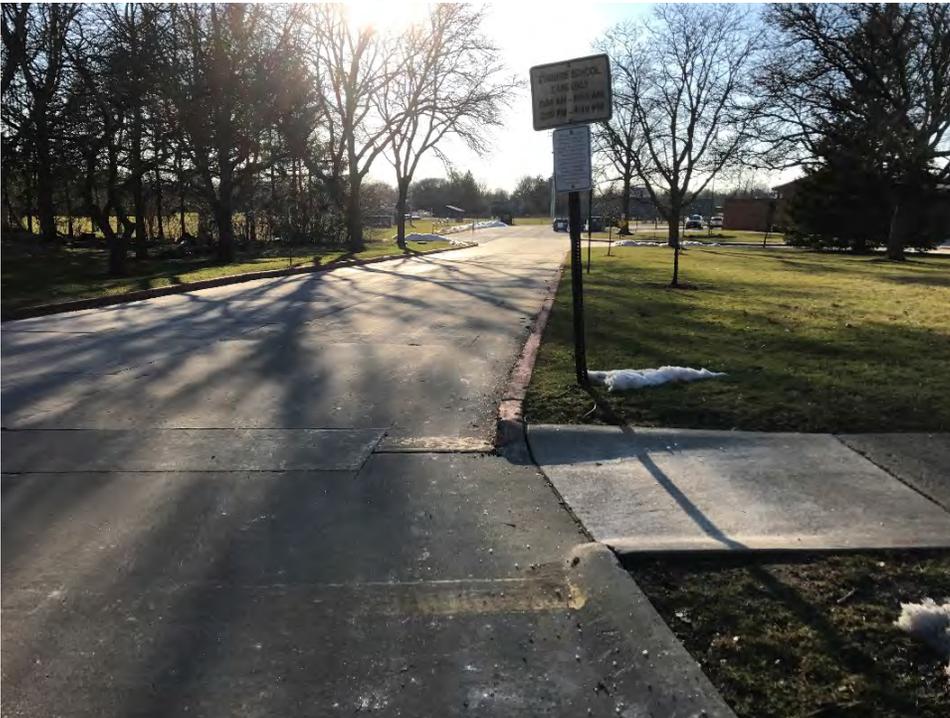
View looking west from N. Hayden Pkwy. along south entrance drive. A new bike/pedestrian trail will be provided along the south side of the drive to N. Hayden Pkwy.

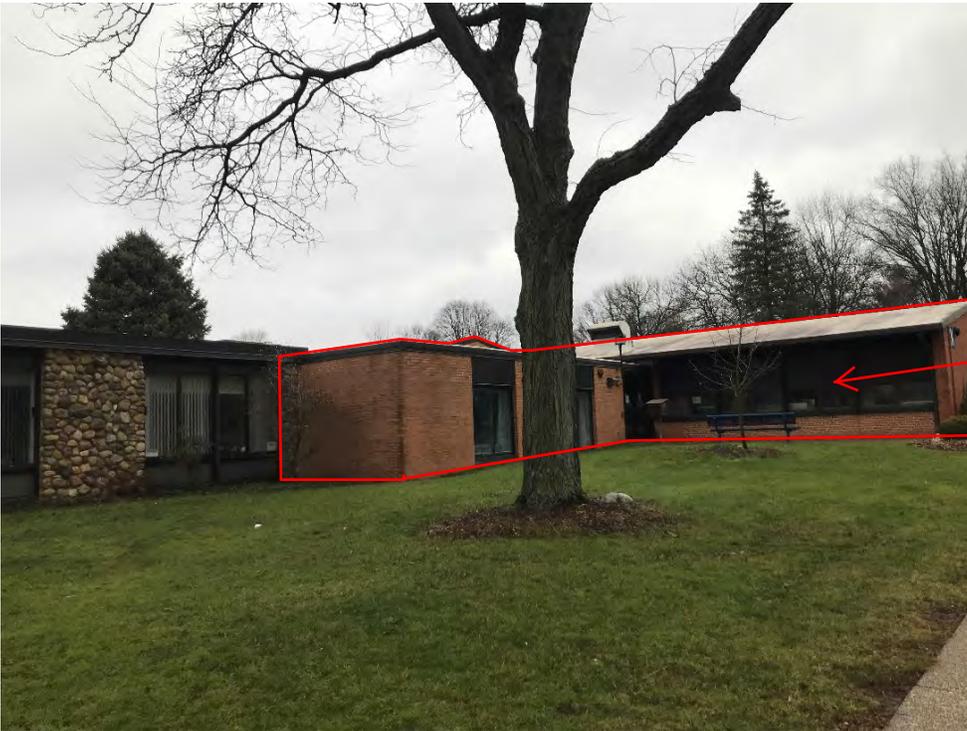
area to be demolished

View of partial south elevation – center and right sections are to be demolished.

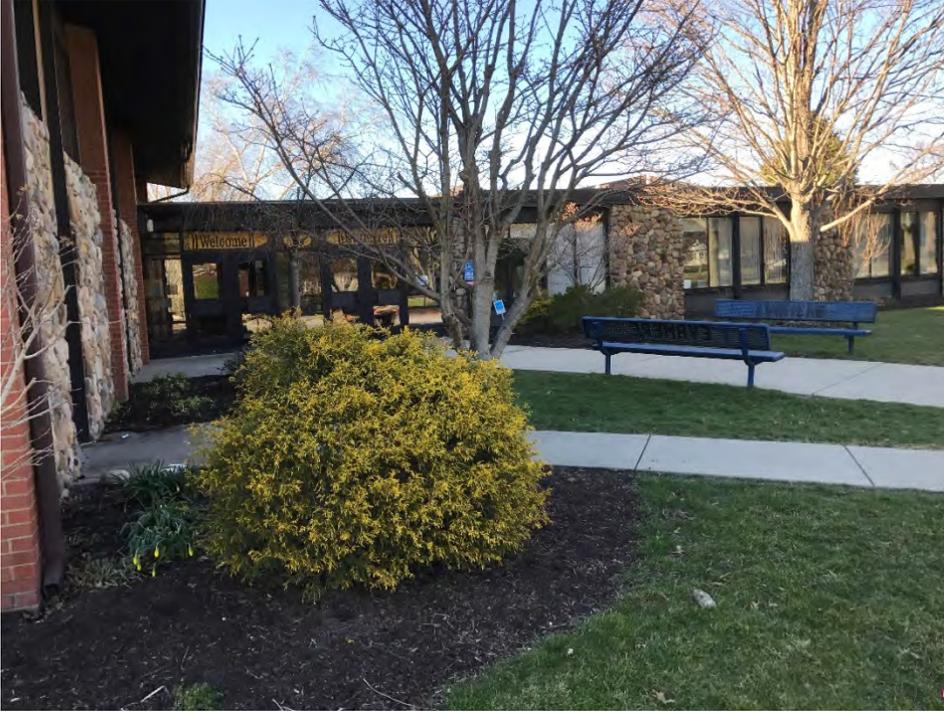
View of main entrance – windows are to be replaced. Existing aluminum storefront and FRP doors are to remain.
