EVAMERE RENOVATION TO ADMIN. OFFICE/HCR
 HUDSON, OHIO 44235
 DEMO FIRST FLOOR PLAN OVERALL

EVAMERE RENOVATION TO ADMIN. OFFICE/HCER
 76 N HAYDEN PKWY
 HUDSON, OHIO 44236

**EVEAMERE – CONVERSION TO ADMINISTRATIVE OFFICES
BUILDING IMAGES**

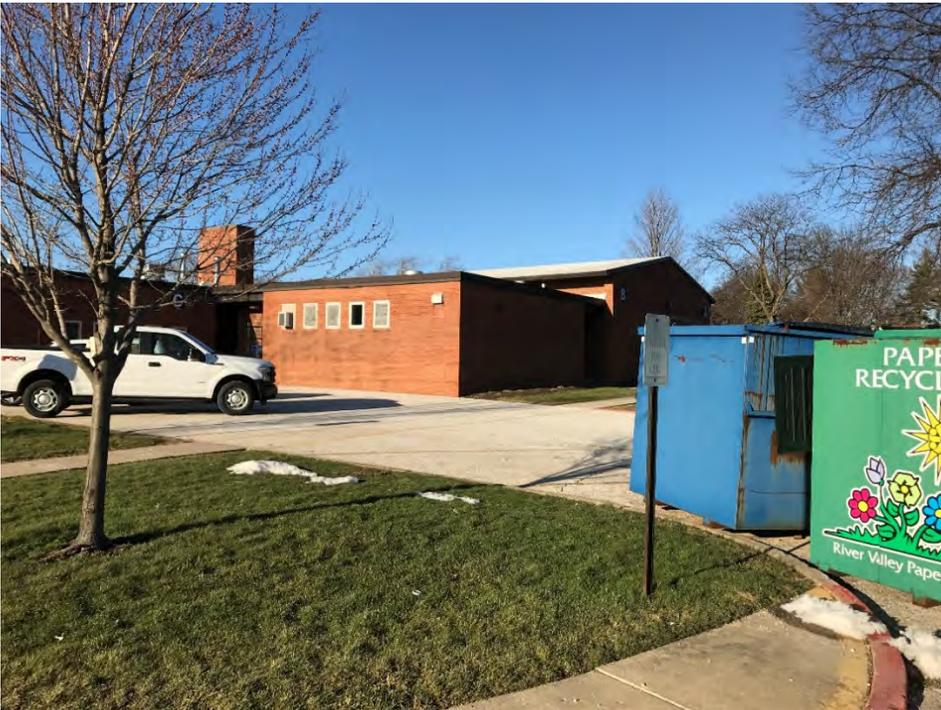
View of delivery area – trash dumpster is to be removed from the site. The recycling dumpster is to be moved to by the filed house.

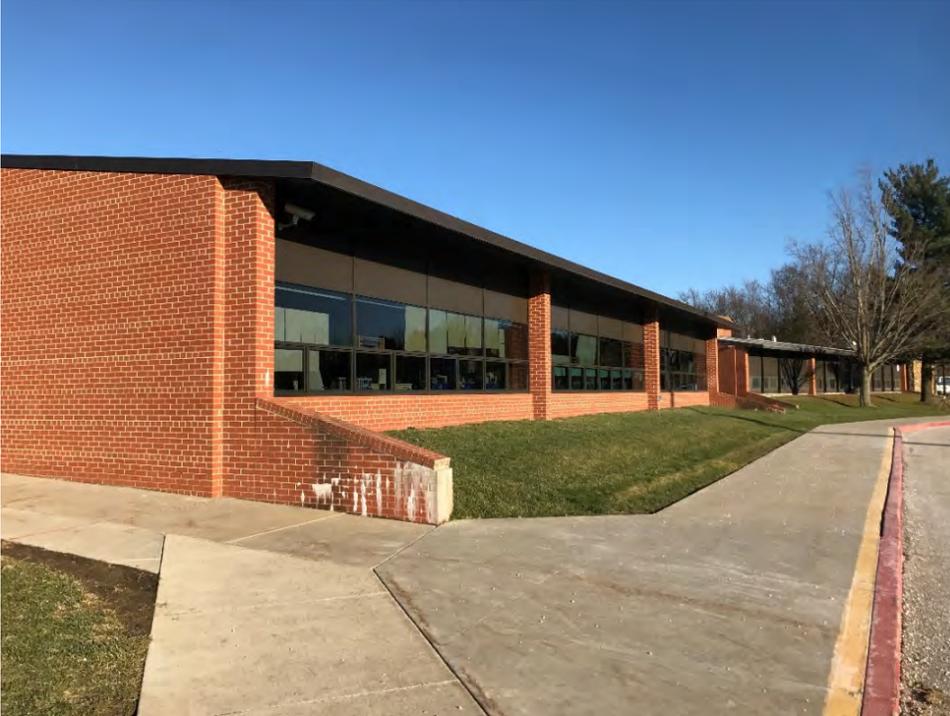
View of the west elevation of the 2007 addition looking south. Brickwork to be repaired as funds are available (alternate bid).

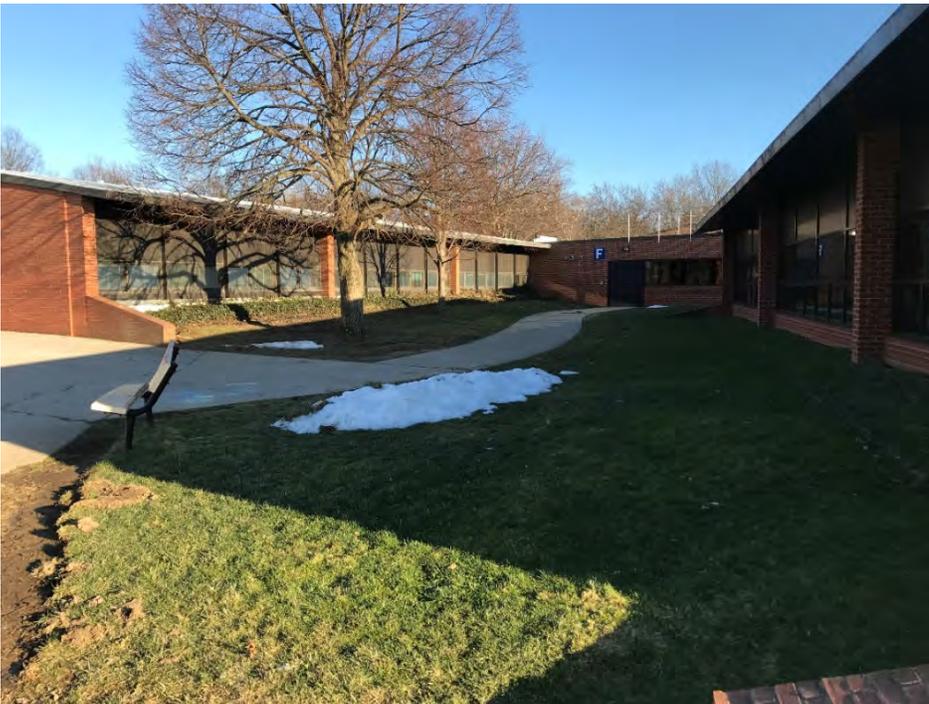
View from the north looking south – east elevation of the 2007 addition to the right, west elevation of the 1960 addition to the left.

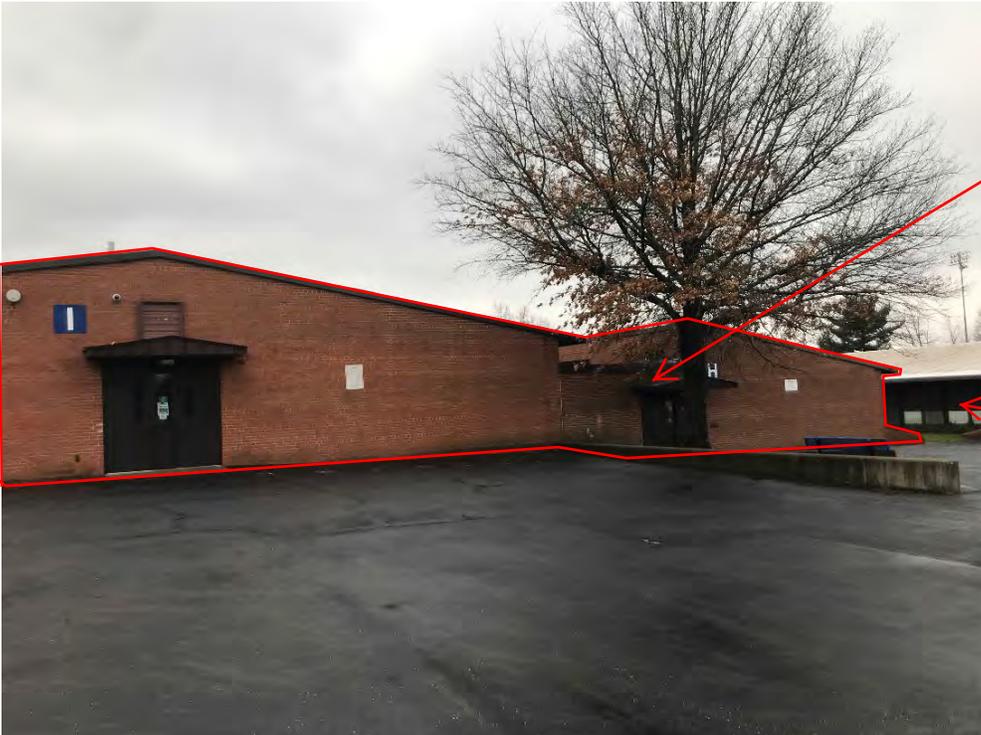
View from the north looking south – areas to be demolished (1960/1975)

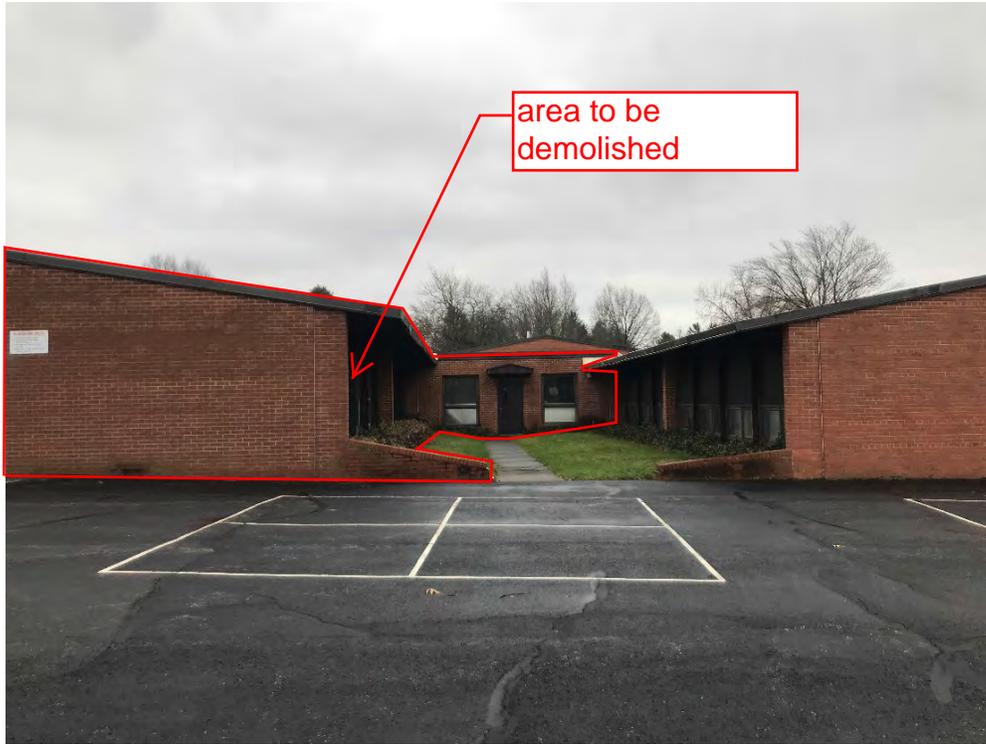
View along north elevation – construction to the left to be demolished.
