OHIO HISTORIC INVENTORY

1. No.		4. Present Name(s)	
2. County Summit		5. Other Name(s)	
3. Location of Negatives HHA 38-12			
6. Specific Location 252 North Main Street		16. Thematic Category C

17. Date(s) or Period c. 1828	
7. City or Town If Rural, Township & Vicinity Hudson		18. Style or Design Greek Revival	
8. Site Plan with North Arrow

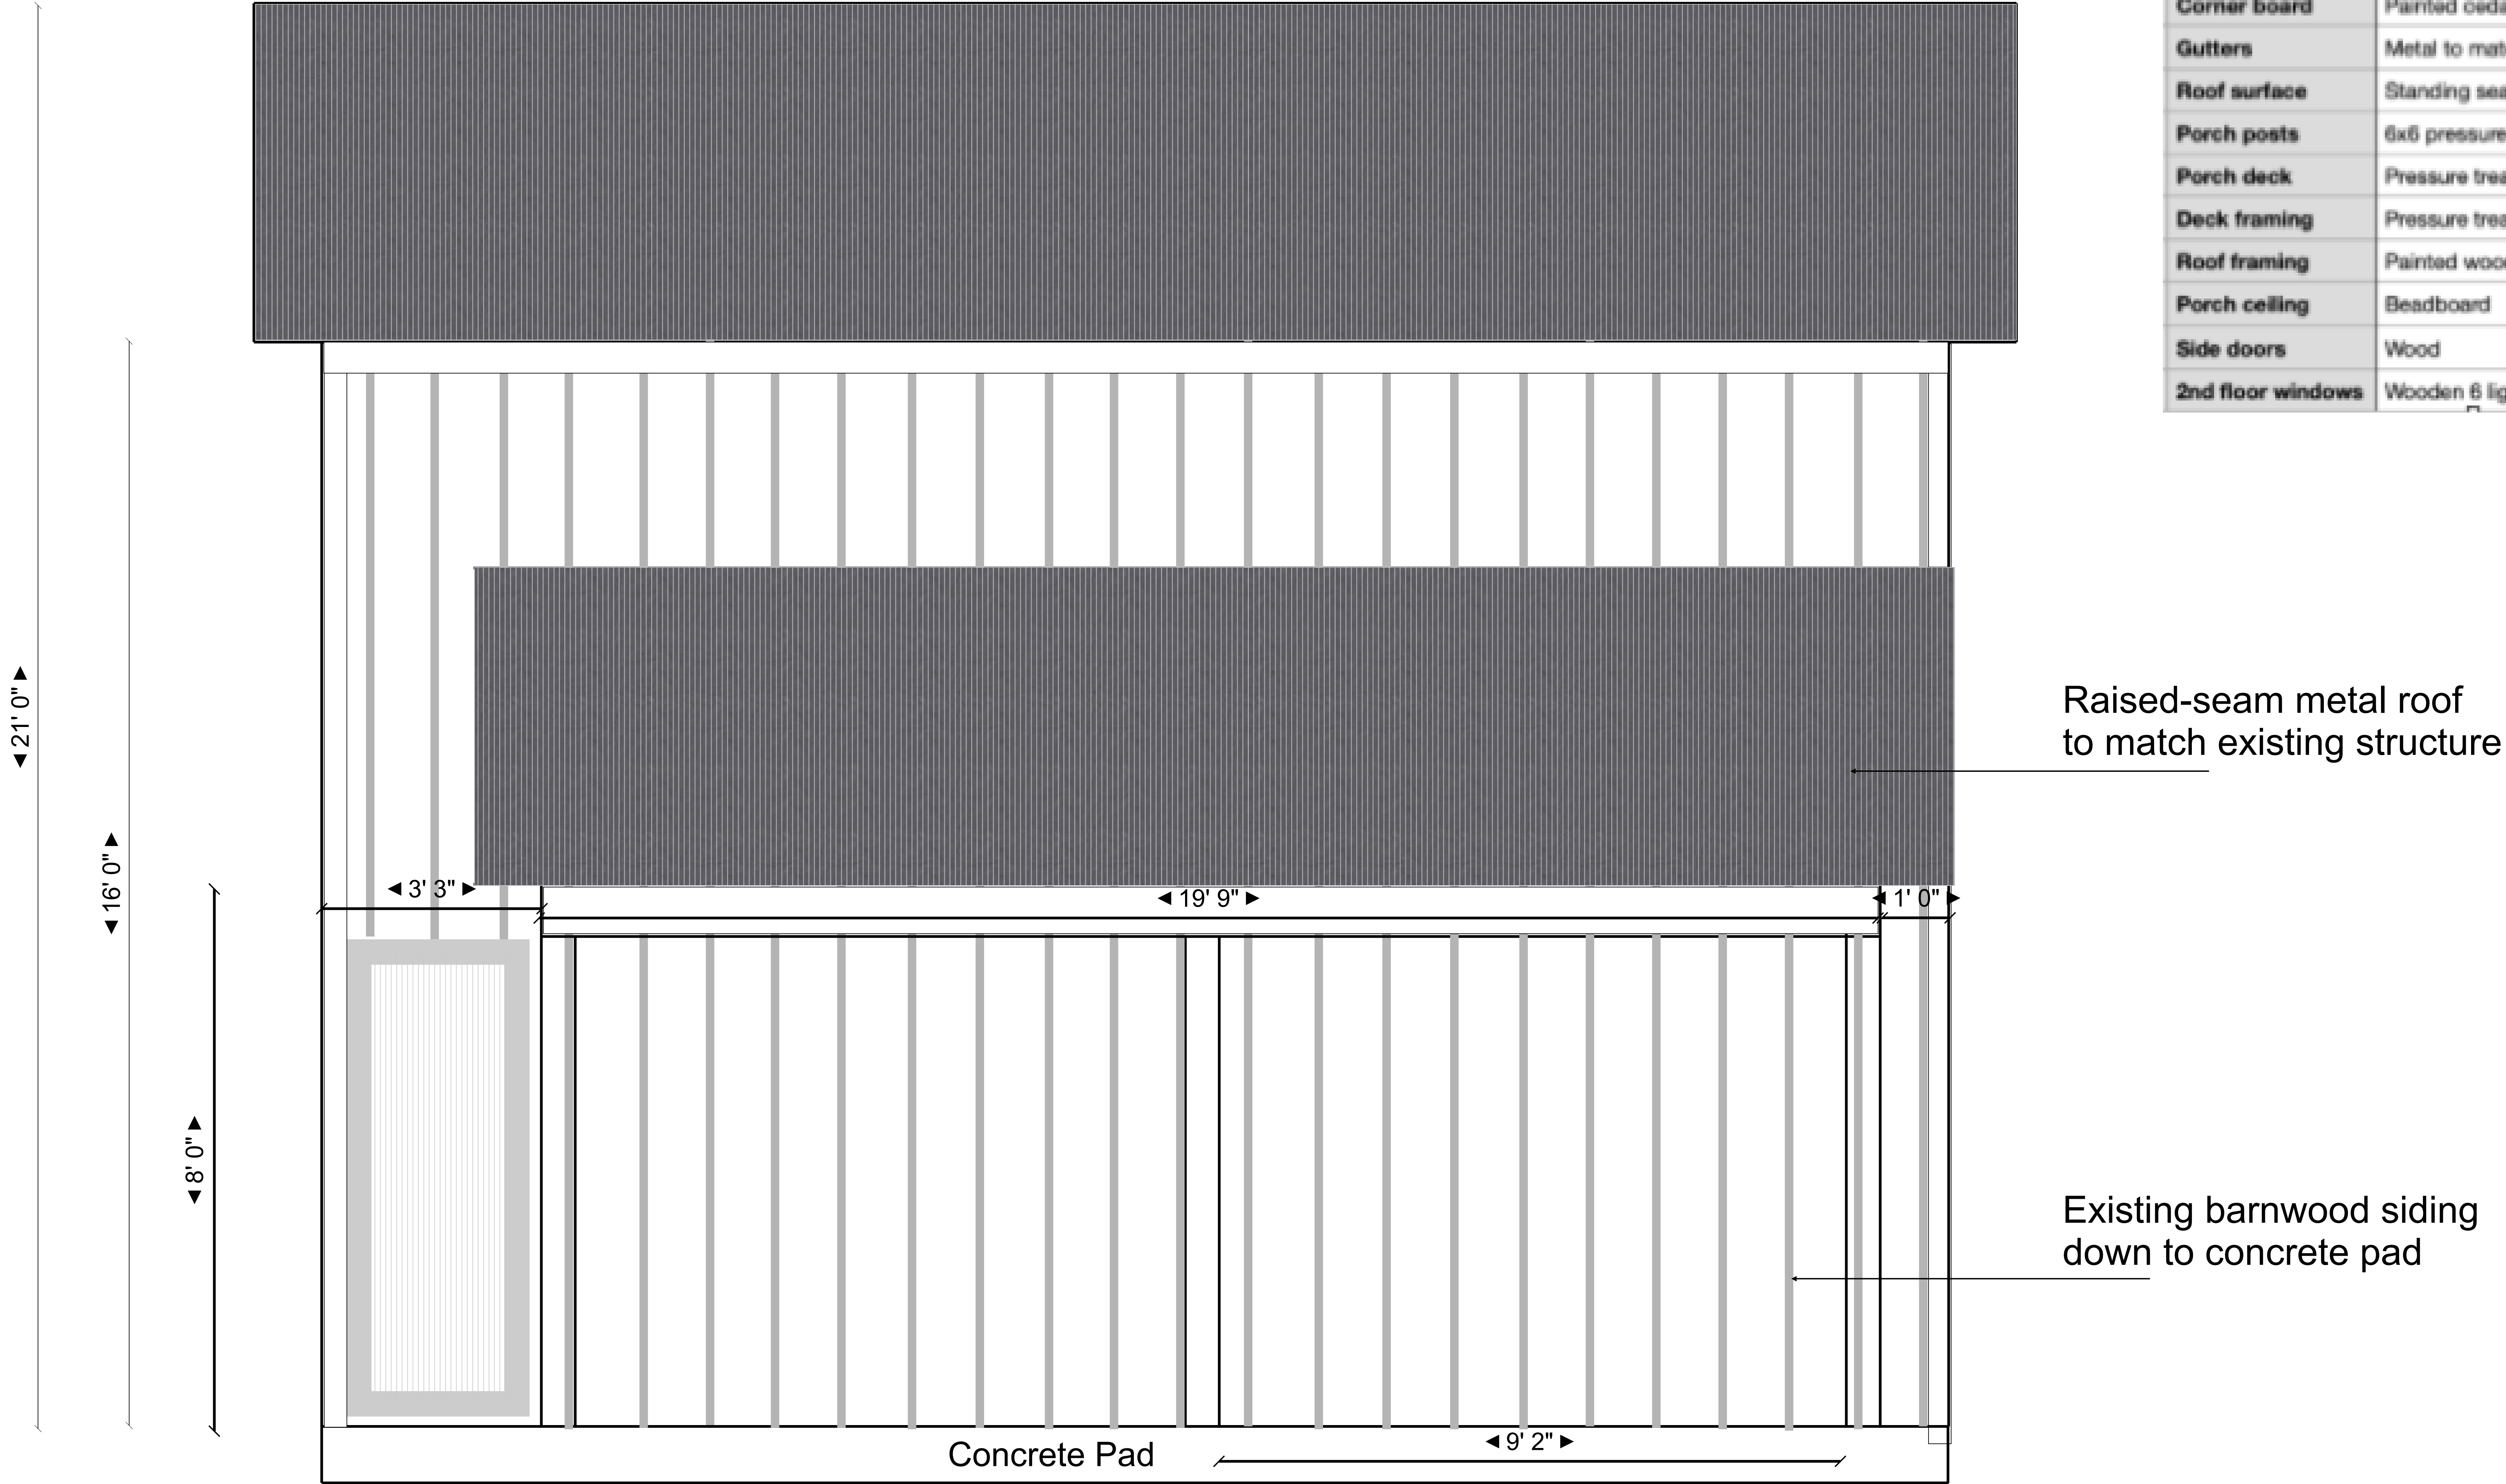
South Elevation

Application	Material/Finish	Source	Photo?
Siding	12" barn boards & battens	Existing	Yes
Eave/soffit	Painted wood	New	
Frieze board	Painted wood	New	
Corner board	Painted cedar	New	
Gutters	Metal to match existing	New	
Roof surface	Standing seam metal	New (as main roof)	
Porch posts	6x6 pressure treated	New	
Porch deck	Pressure treated 5/4x6" boards	New	
Deck framing	Pressure treated lumber	New	
Roof framing	Painted wood lumber	New	
Porch ceiling	Beadboard	New	
Side doors	Wood	Reclaimed	Yes
2nd floor windows	Wooden 6 lights	Reclaimed sash	Yes

Horizontal boards to be removed and replaced with vertical siding to match existing barn

Horizontal boards to be removed and replaced
with vertical siding to match existing barn

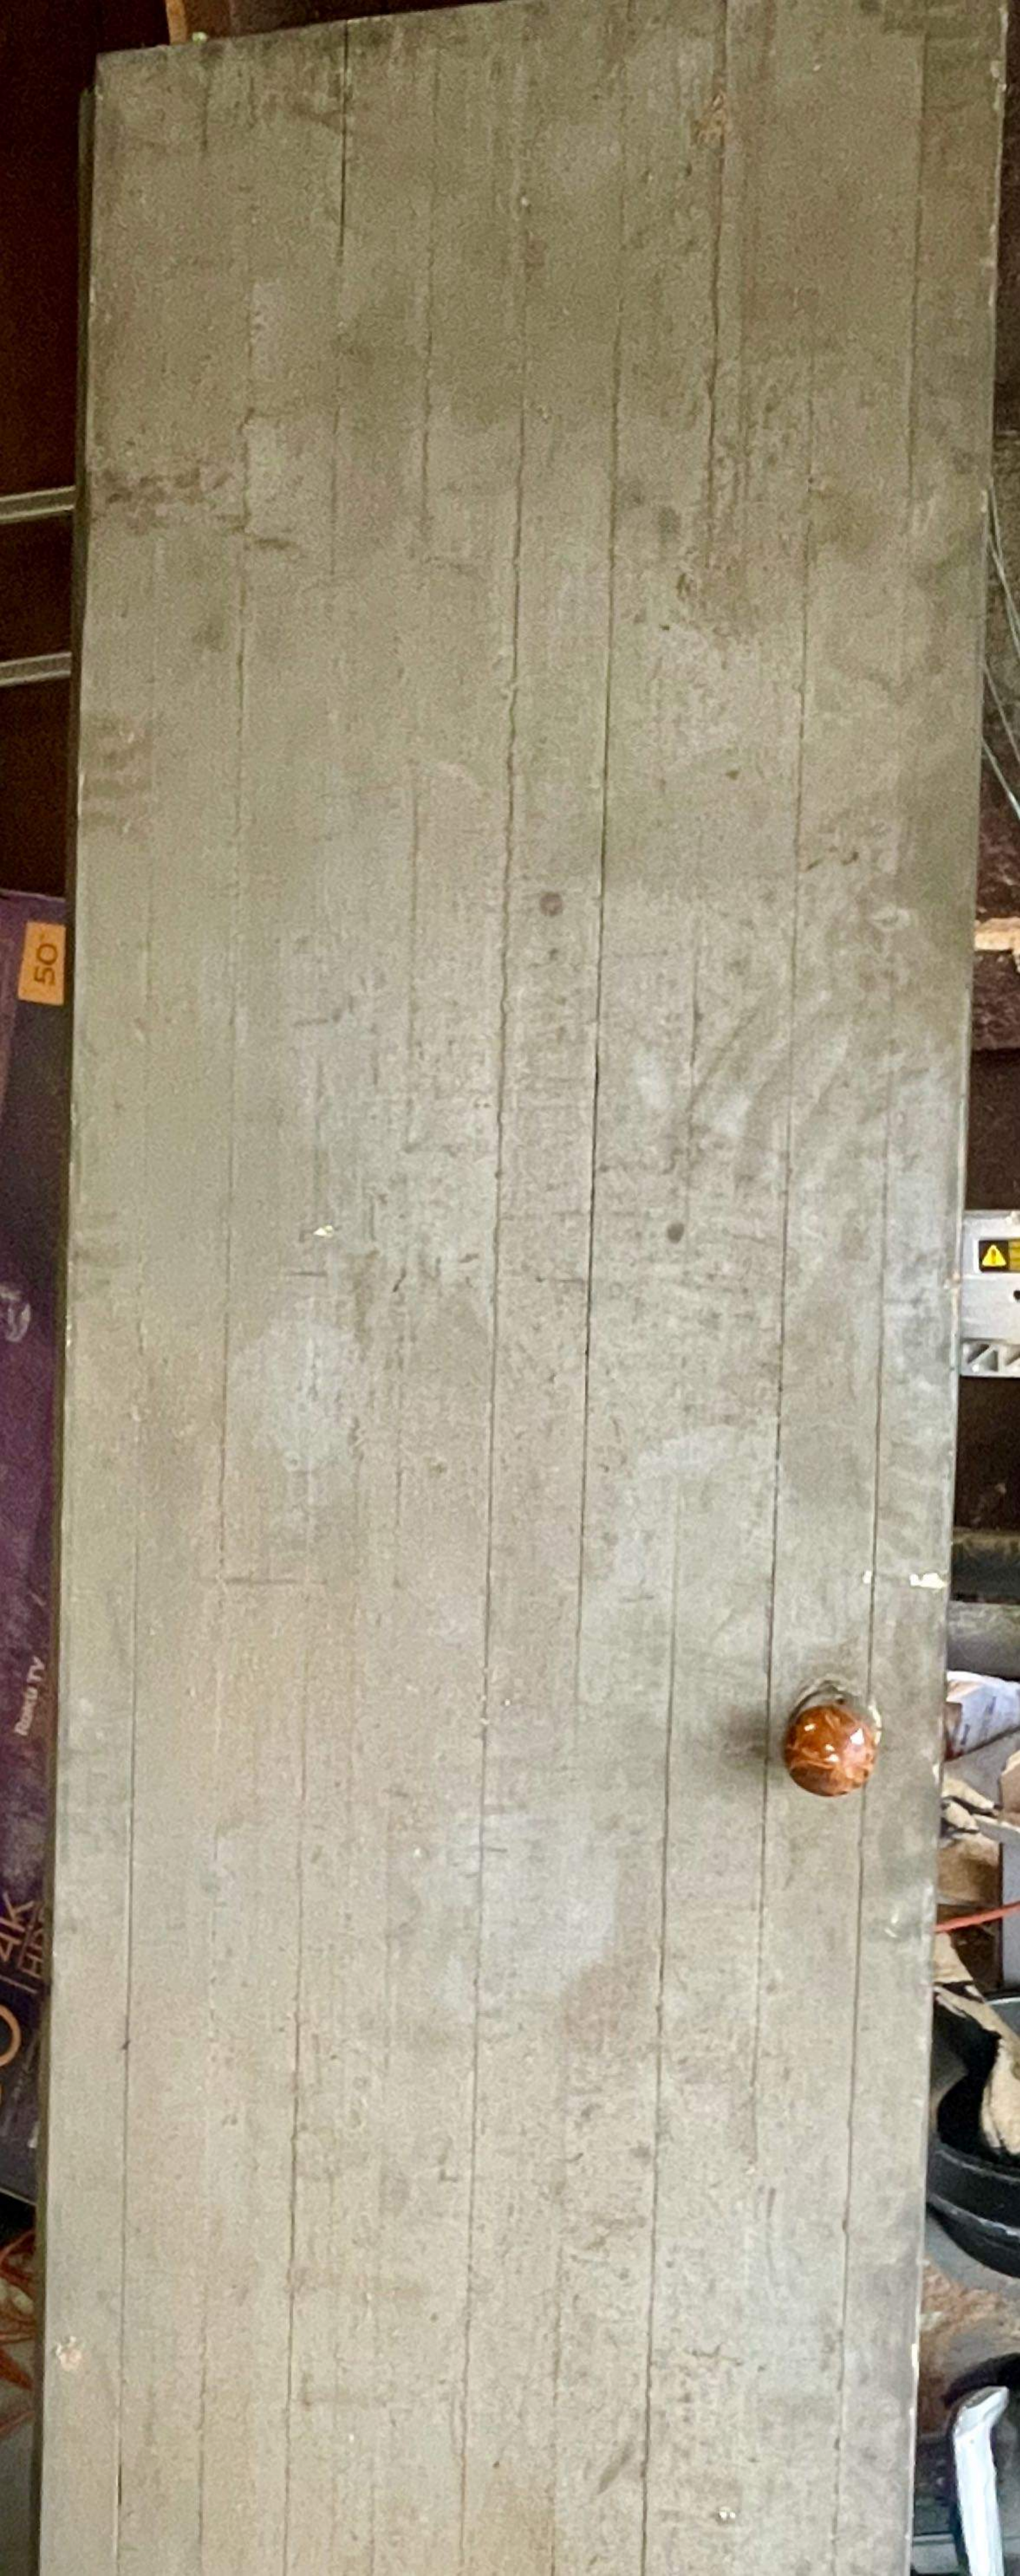
North Elevation

Application	Material/finish	Source	Photo?
Siding	12" barn boards & battens	Existing	Yes
Eave/soffit	Painted wood	New	
Frieze board	Painted wood	New	
Corner board	Painted cedar	New	
Gutters	Metal to match existing	New	
Roof surface	Standing seam metal	New (as main roof)	
Porch posts	6x6 pressure treated	New	
Porch deck	Pressure treated 5/4x6" boards	New	
Deck framing	Pressure treated lumber	New	
Roof framing	Painted wood lumber	New	
Porch ceiling	Beadboard	New	
Side doors	Wood	Reclaimed	Yes
2nd floor windows	Wooden 6 lights	Reclaimed sash	Yes
