# OHIO HISTORIC INVENTORY

1. No.		4. Present Name(s) Residence, June Mohler		1. No.  2. County Summit  4. Present Name(s) Residence, June Mohler  5. Other Name(s)
2. County Summit		5. Other Name(s)

The Beckwith Addition

## New Exterior Additions to Historic Buildings: Preservation Concerns

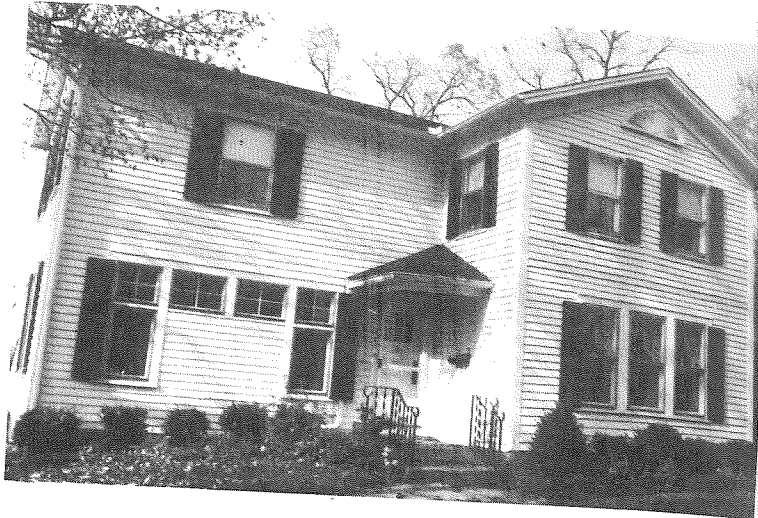
## 145 AURORA STREET

Despite many alterations, the Federal styling is still evident in the roof pitch, delicate frieze and corner boards and attic fanlight. There is some evidence that the house was built around a log cabin.

The existing 3 season room on back of house will be demolished and rebuilt from the ground up (including foundation) to accommodate a kitchen extension and dinette, measuring 10' x 20' 4" off back of house. All materials to match as closely as possible to existing.

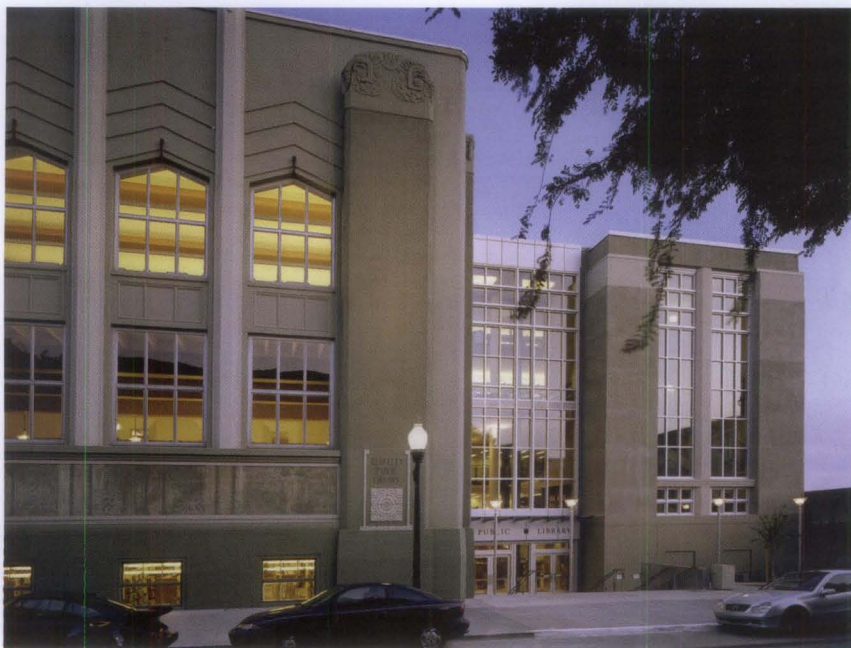
*Figure 1. The addition to the right with its connecting hyphen is compatible with the Collegiate Gothic-style library. The addition is set back from the front of the library and uses the same materials and a simplified design that references, but does not copy, the historic building. Photo: David Wakely Photography.*

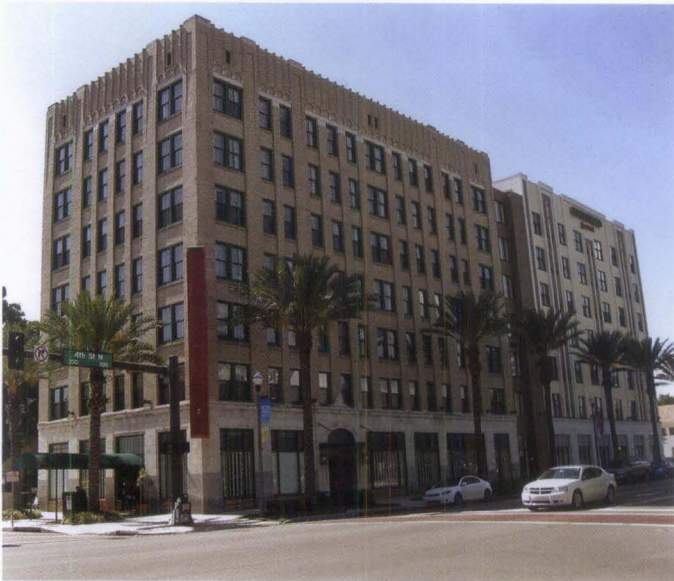
Figure 2. The new section on the right is appropriately scaled and reflects the design of the historic Art Deco-style hotel. The apparent separation created by the recessed connector also enables the addition to be viewed as an individual building.

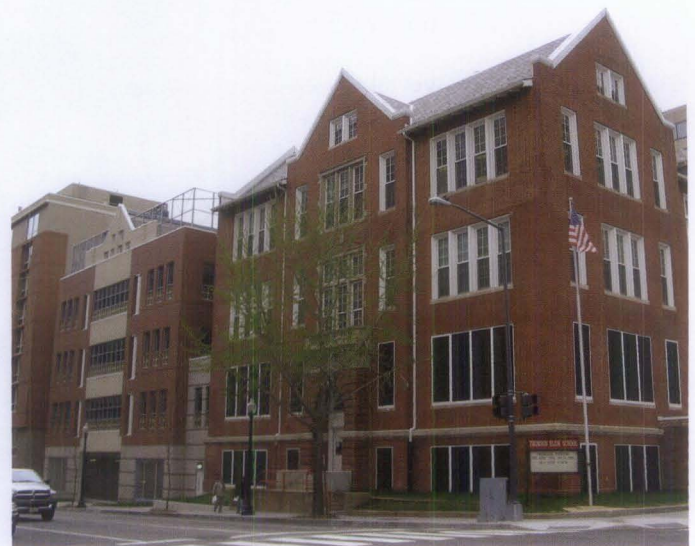
Figure 3. The red and buff-colored parking addition with a rooftop playground is compatible with the early-20th century school as well as with the neighborhood in which it also serves as infill in the urban setting.

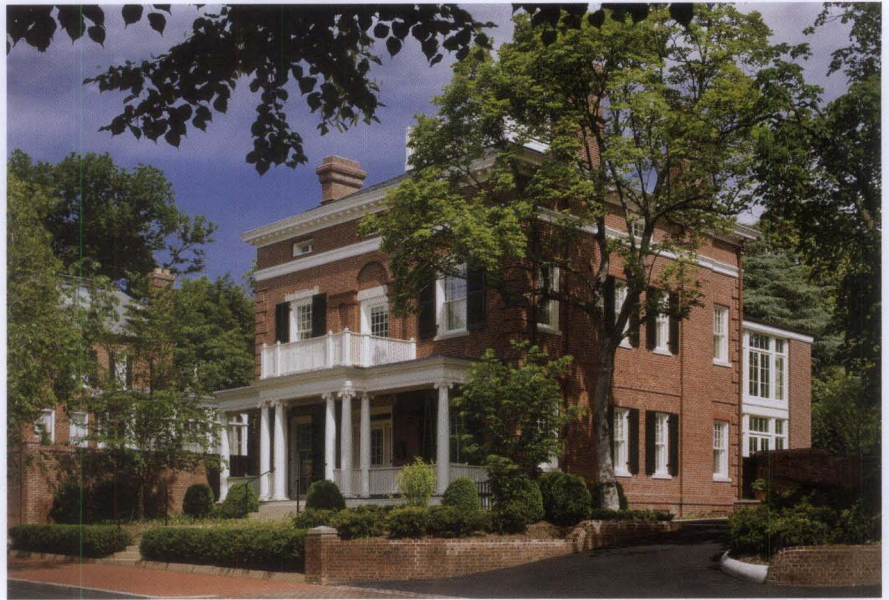
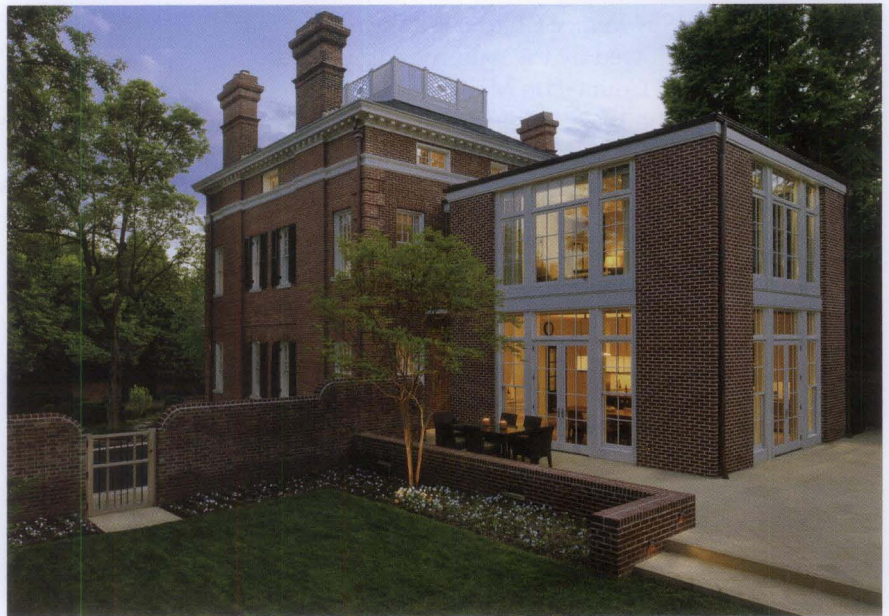
*Figure 4. This glass and brick structure is a harmonious addition set back and connected to the rear of the Colonial Revival-style brick house. Cunningham/Quill Architects. Photos: © Maxwell MacKenzie.*

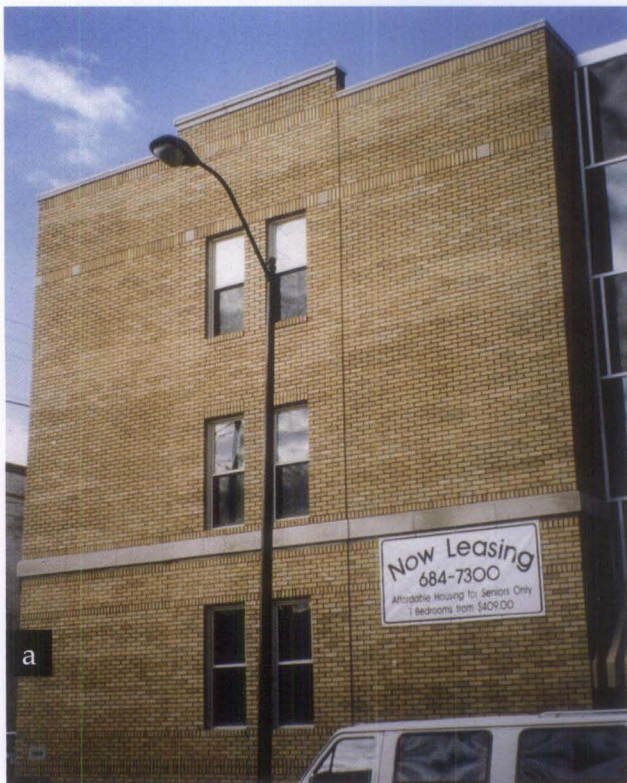
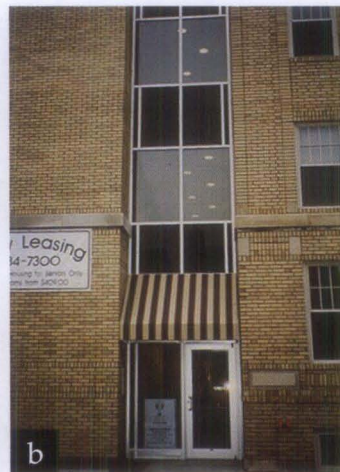
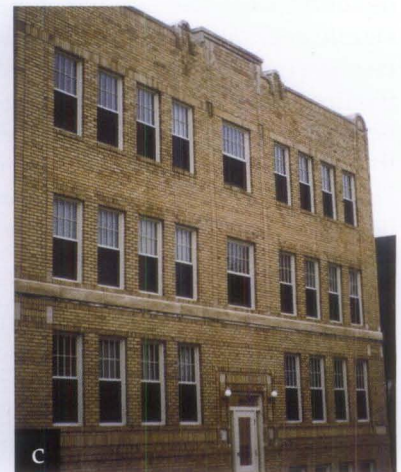
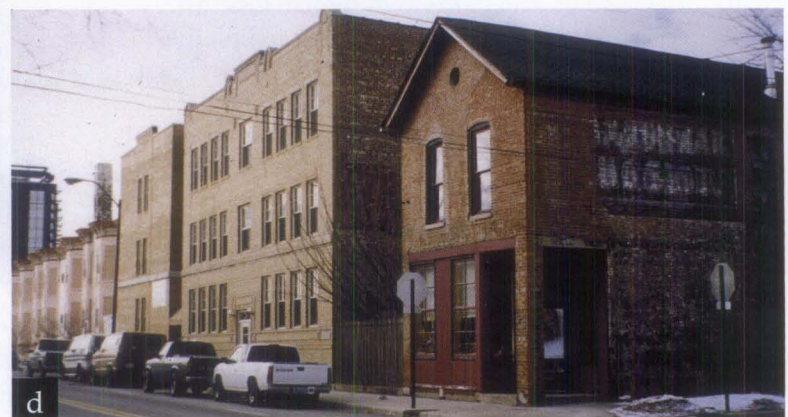
Figure 5. This addition (a) is constructed of matching brick and attached by a recessed connector (b) to the 1914 apartment building (c). The design is compatible and the addition is smaller and subordinate to the historic building (d).

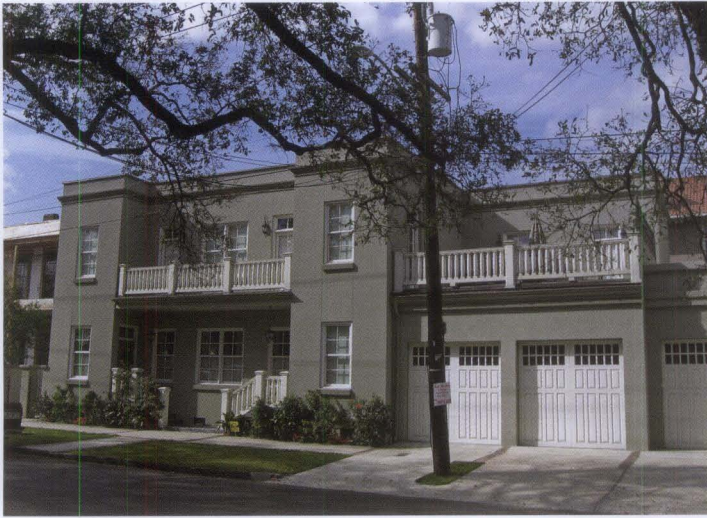
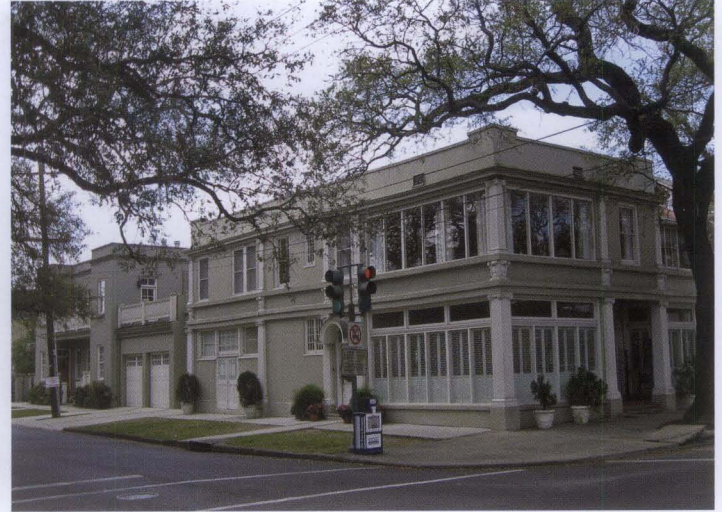
*Figure 6. A new addition (left) is connected to the garage which separates it from the main block of the c. 1910 former florist shop (right). The addition is traditional in style, yet sufficiently restrained in design to distinguish it from the historic building.*

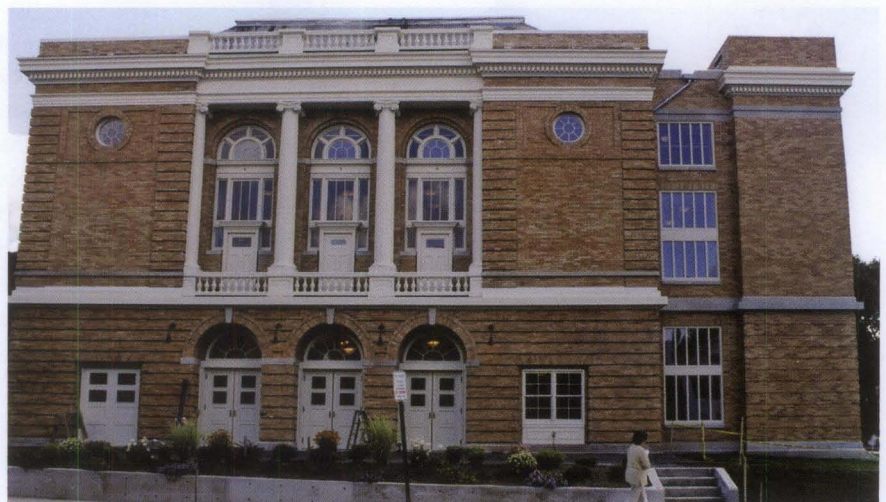
*Figure 7. A vacant side lot was the only place a new stair tower could be built when this 1903 theater was rehabilitated as a performing arts center. Constructed with matching materials, the stair tower is set back with a recessed connector and, despite its prominent location, it is clearly subordinate and differentiated from the historic theater.*

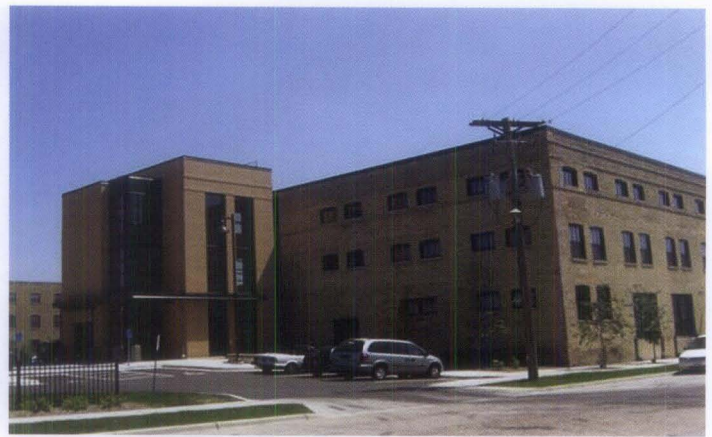
Figure 8. The rehabilitation of this large, early-20th century warehouse (left) into affordable artists' lofts included the addition of a compatible glass and brick elevator/stair tower at the back (right).

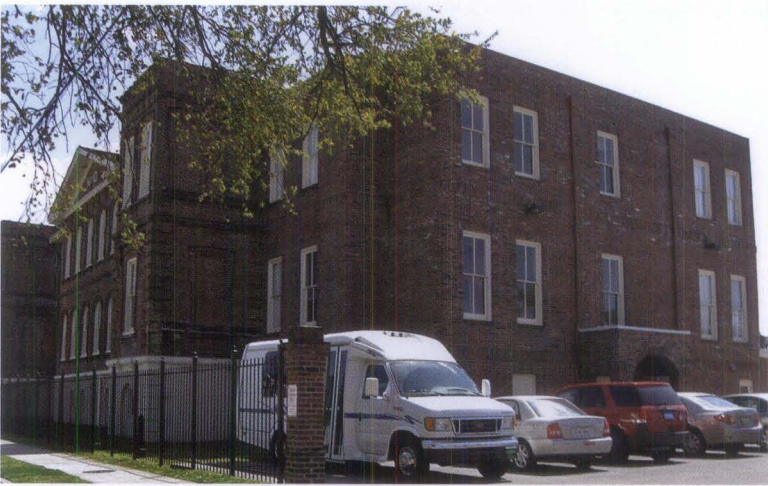
Figure 9. A simple, brick stair tower replaced two non-historic additions at the rear of this 1879 school building when it was rehabilitated as a women's and children's shelter. The addition is set back and it is not visible from the front of the school.

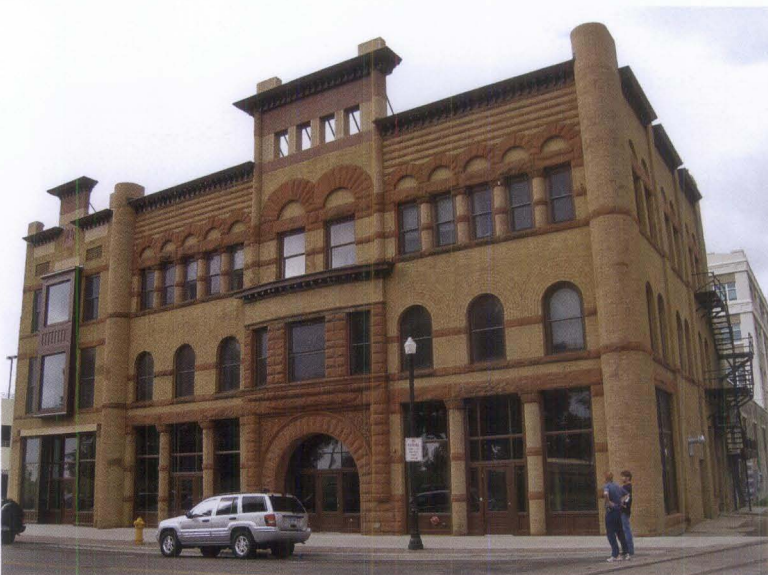
Figure 10. The small size and the use of matching materials ensures that the new addition on the left is compatible with the historic Romanesque Revival-style building.

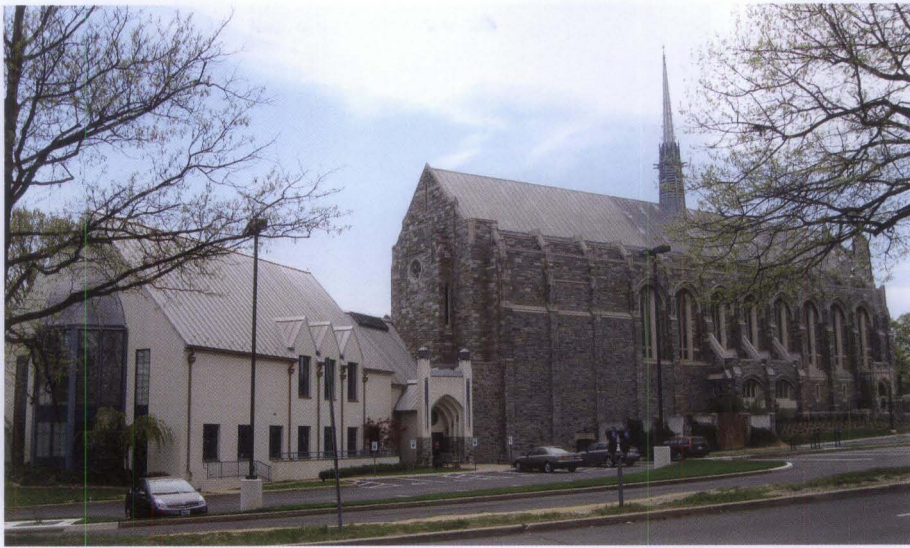
Figure 11. The addition to this early-20th century Gothic Revival-style church provides space for offices, a great hall for gatherings and an accessible entrance (left). The stucco finish, metal roof, narrow gables and the Gothic-arched entrance complement the architecture of the historic church. Placing the addition in back where the ground slopes away ensures that it is subordinate and minimizes its impact on the church (below).

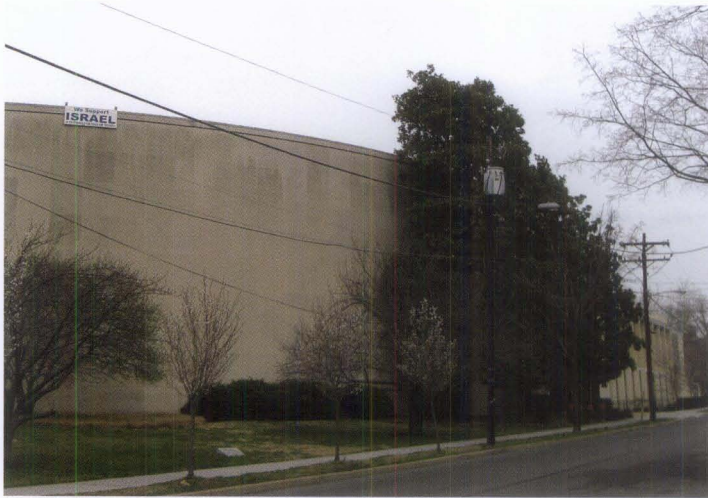
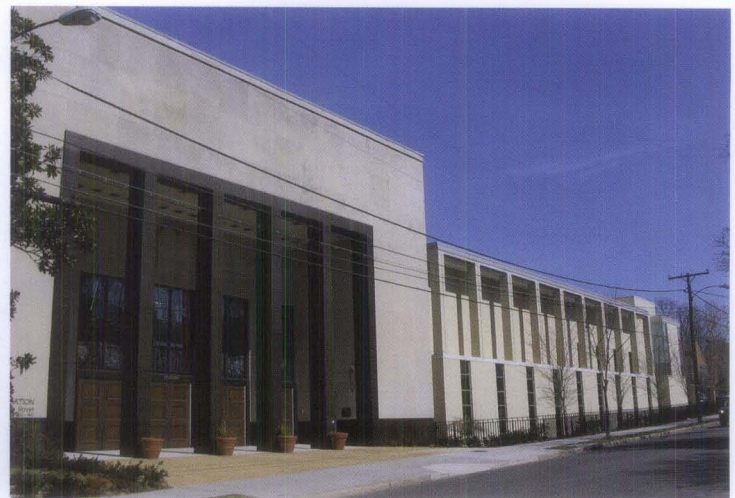
Figure 12. This 1954 synagogue (left) is accessed through a monumental entrance to the right. The new education wing (far right) added to it features the same vertical elements and color and, even though it is quite large, its smaller scale and height ensure that it is secondary to the historic resource.

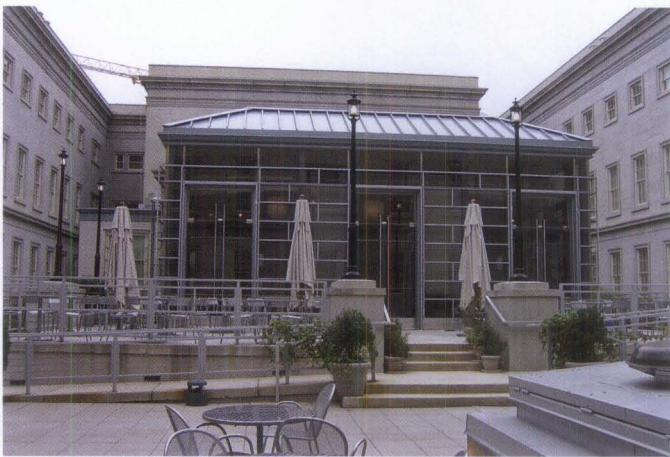
Figure 13. A glass and metal structure was constructed in the courtyard as a restaurant when this 1839 building was converted to a hotel. Although such an addition might not be appropriate in a more public location, it is compatible here in the courtyard of this historic building.

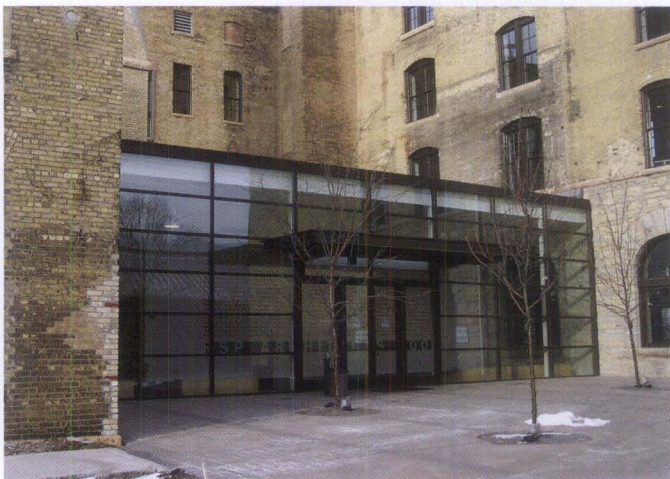
Figure 14. This glass addition was erected at the back of an 1895 former brewery during rehabilitation to provide another entrance. The addition is compatible with the plain character of this secondary elevation.

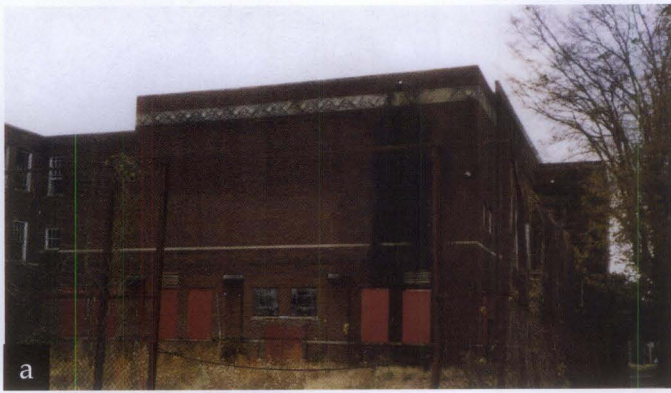
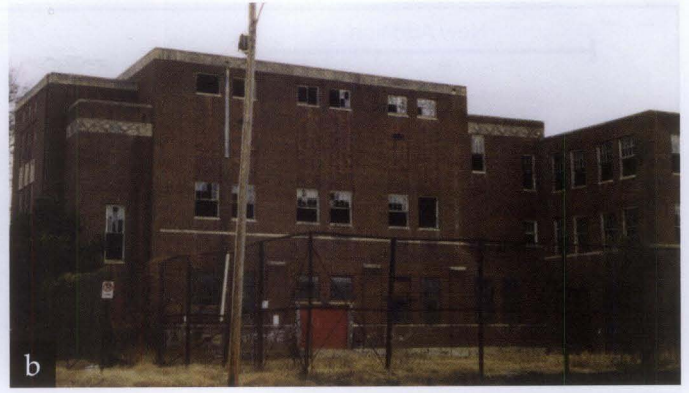
Figure 15. The rehabilitation of a c. 1930 high school auditorium for a clinic and offices proposed two additions: a one-story entrance and reception area on this elevation (a); and a four-story elevator and stair tower on another side (b). The gabled entrance (c) first proposed was not compatible with the flat-roofed auditorium and the design of the proposed stair tower (d) was also incompatible and overwhelmed the historic building. The designs were revised (e-f) resulting in new additions that meet the Standards (g-h).

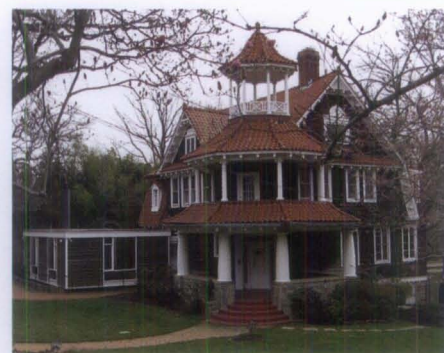
Figure 17. The small addition on the left is starkly different and it is not compatible with the eclectic, late-19th century house.

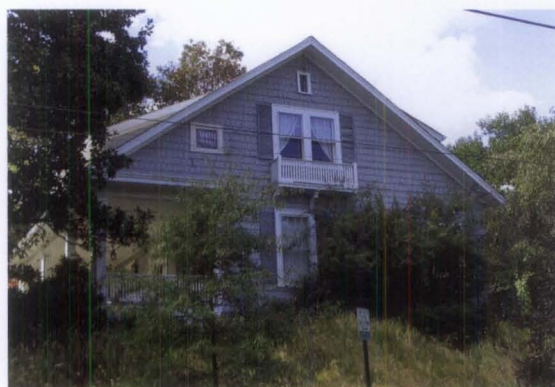
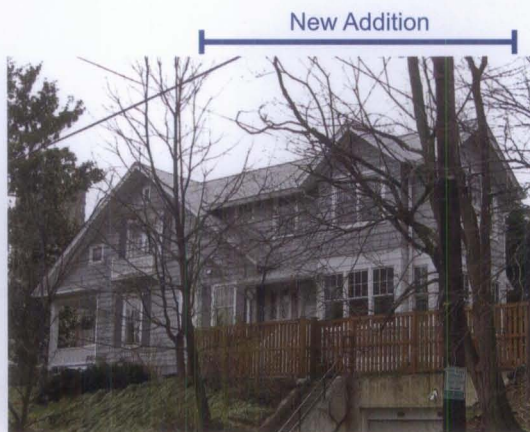
Figure 18. The expansion of a one- and one-half story historic bungalow (left) with a large two-story rear addition (right) has greatly altered and obscured its distinctive shape and form.

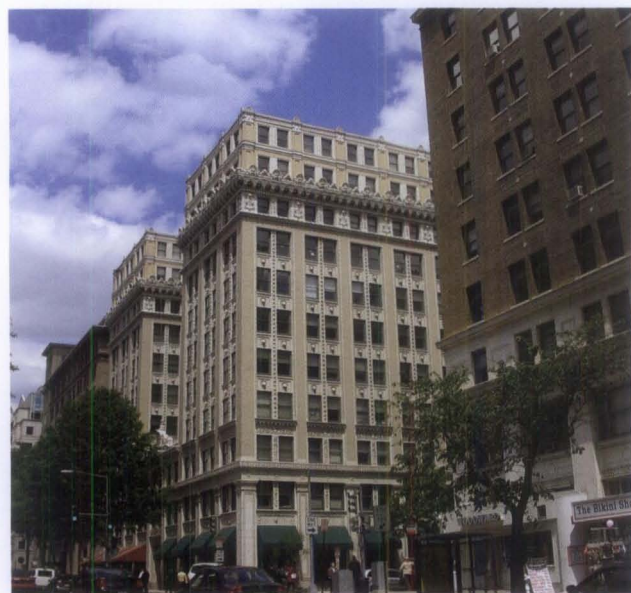
Figure 19. The upper two floors of this early-20th century office building were part of the original design, but were not built. During rehabilitation, the two stories were finally constructed. This treatment does not meet the Standards because the addition has given the building an appearance it never had historically.

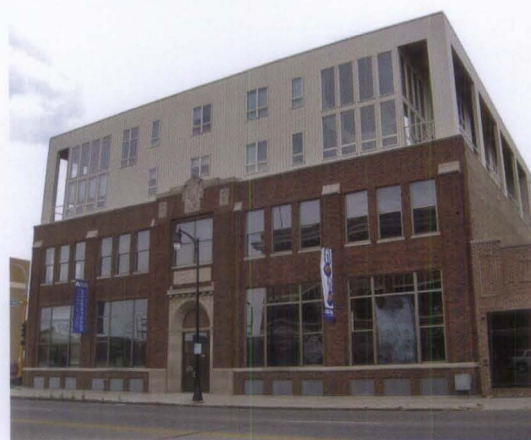
Figure 20. The height, as well as the design, of these two-story rooftop additions overwhelms the two-story and the one-story, low-rise historic buildings.

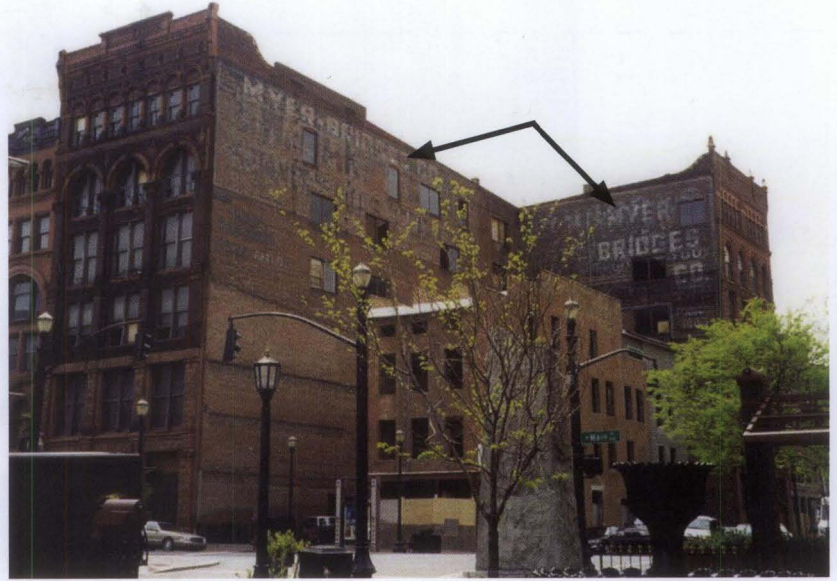
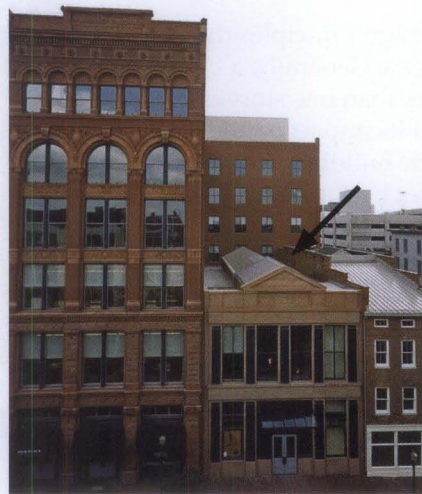
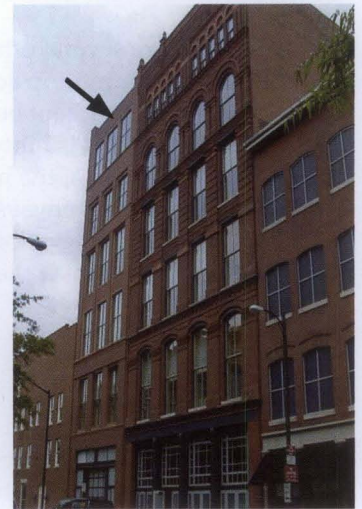
Figure 21. Both wings of this historic L-shaped building (top), which fronts on two city streets, adjoined vacant lots. A two-story addition was constructed on one lot (above, left) and a six-story addition was built on the other (above, right). Like the historic building, which has two different facades, the compatible new additions are also different and appear to be separate structures rather than part of the historic building.

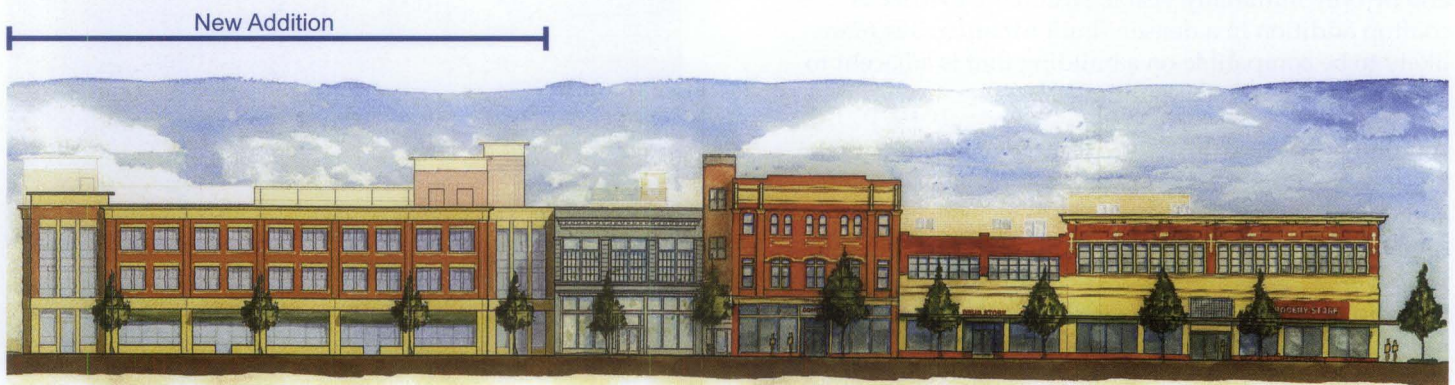
Figure 22. The proposed new addition is compatible with the historic buildings that remain on the block. Its design with multiple storefronts helps break up the mass.

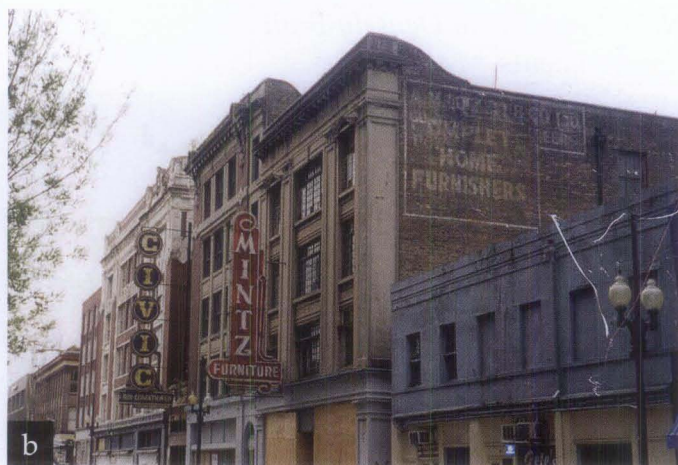
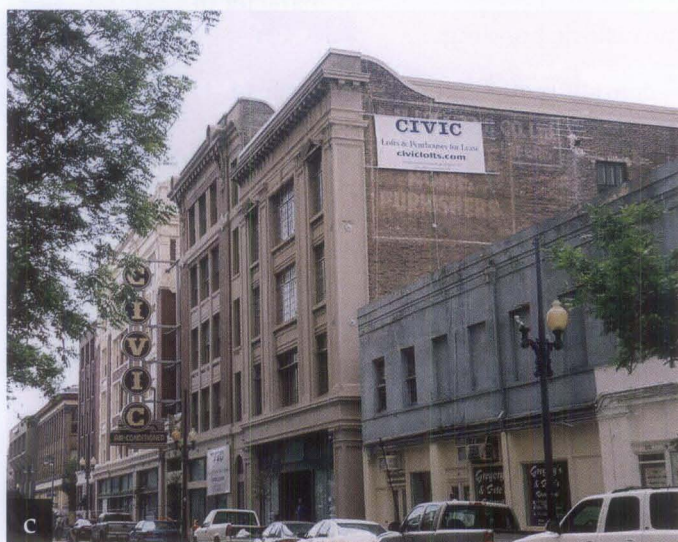
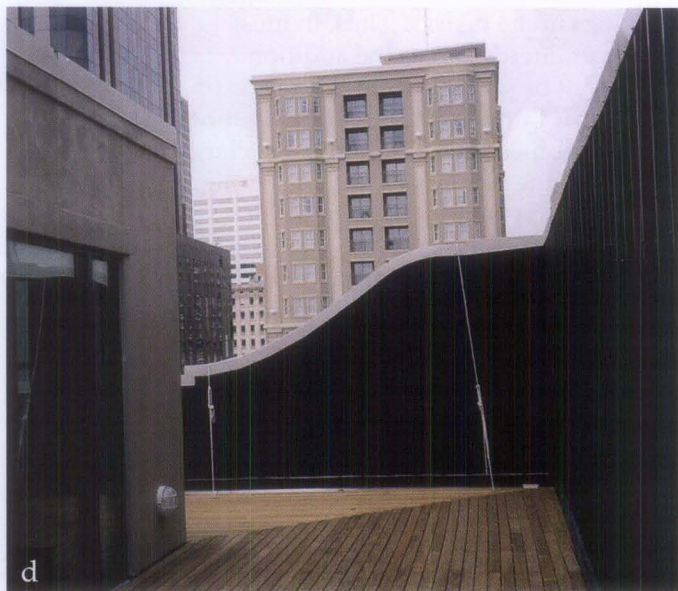
Figure 23. Colored flags marking the location of a proposed penthouse addition (a) were placed on the roof to help evaluate the impact and visibility of an addition planned for this historic furniture store (b). Based on this evaluation, the addition was constructed as proposed. It is minimally visible and compatible with the 1912 structure (c). The tall parapet wall conceals the addition from the street below (d).

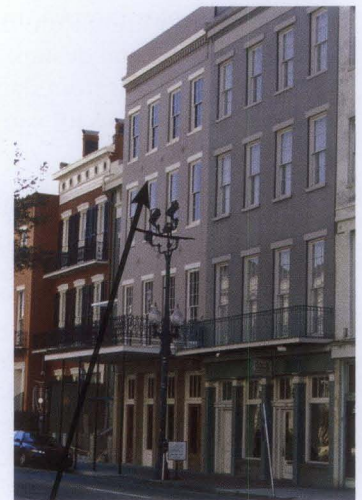
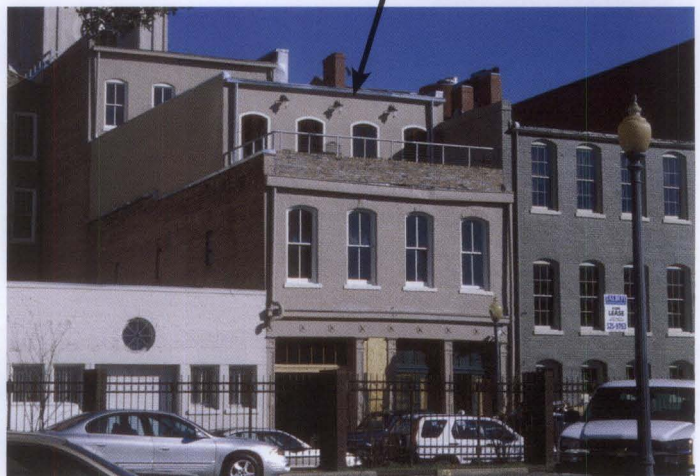
**Figure 26.** A rooftop addition would have negatively impacted the character of the primary facade (right) of this mid-19th century, four-story structure and the low-rise historic district. However, a third floor was successfully added on the two-story rear portion (below) of the same building with little impact to the building or the district because it blends in with the height of the adjacent building.

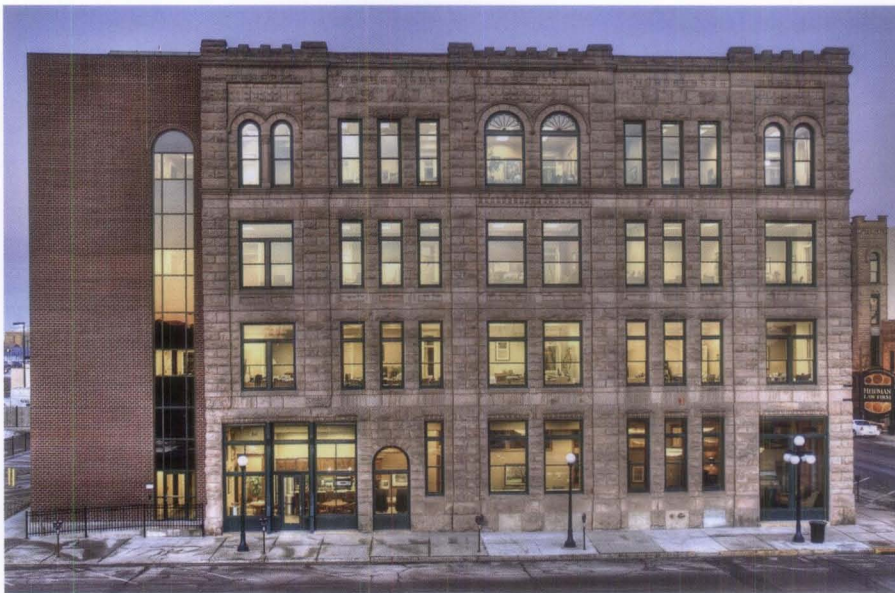
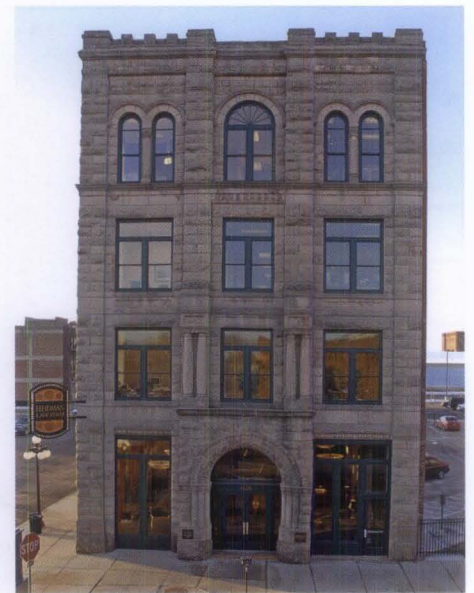
Figure 27. Although the new brick stair/elevator tower (left) is not visible from the front (right), it is on a prominent side elevation of this 1890 stone bank. The compatible addition is set back and does not compete with the historic building. Photos: Chadd Gossman, Aurora Photography, LLC.

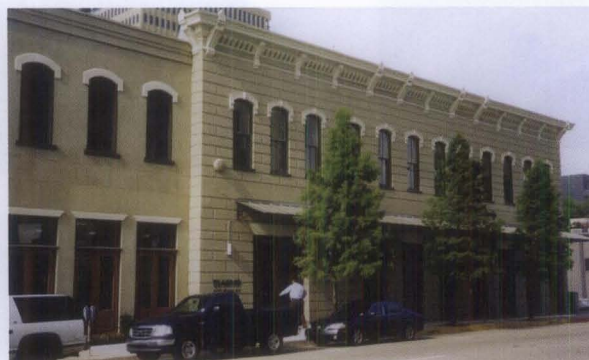
Figure 28. A small addition (left) was constructed when this 1880s train station was converted for office use. The paired doors with transoms and arched windows on the compatible addition reflect, but do not replicate, the historic building (right).

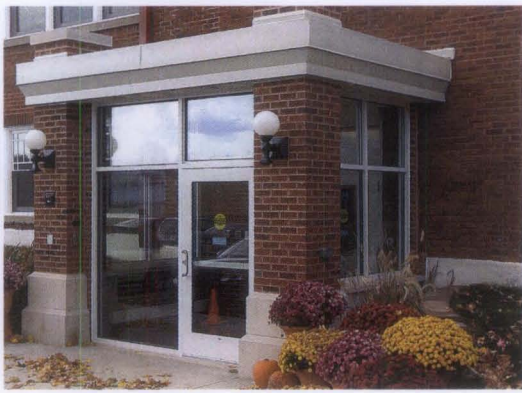
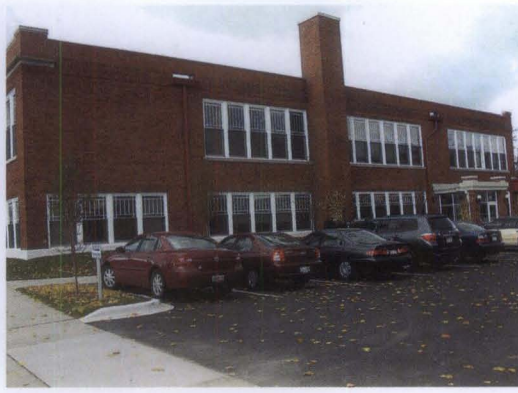
Figure 29. This simple glass and brick entrance (left) added to a secondary elevation of a 1920s school building (right) is compatible with the original structure.

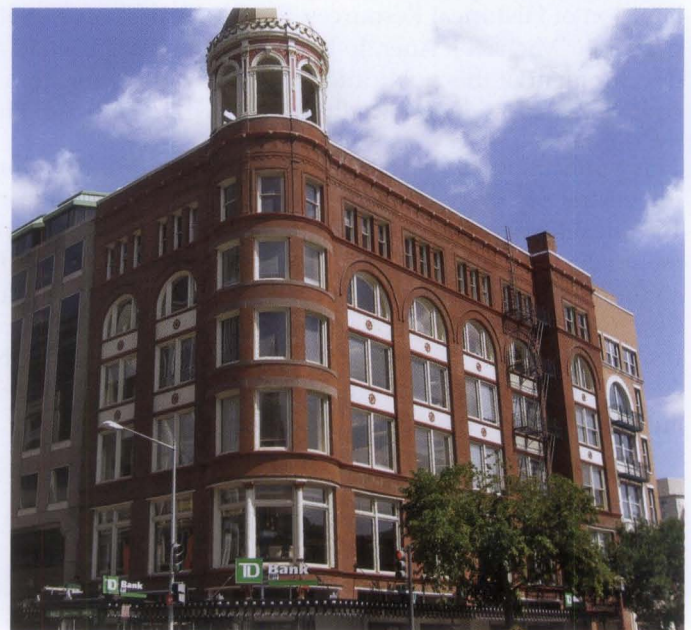
Figure 30. The small addition on the right of this late-19th century commercial structure is clearly secondary and compatible in size, materials and design with the historic building.

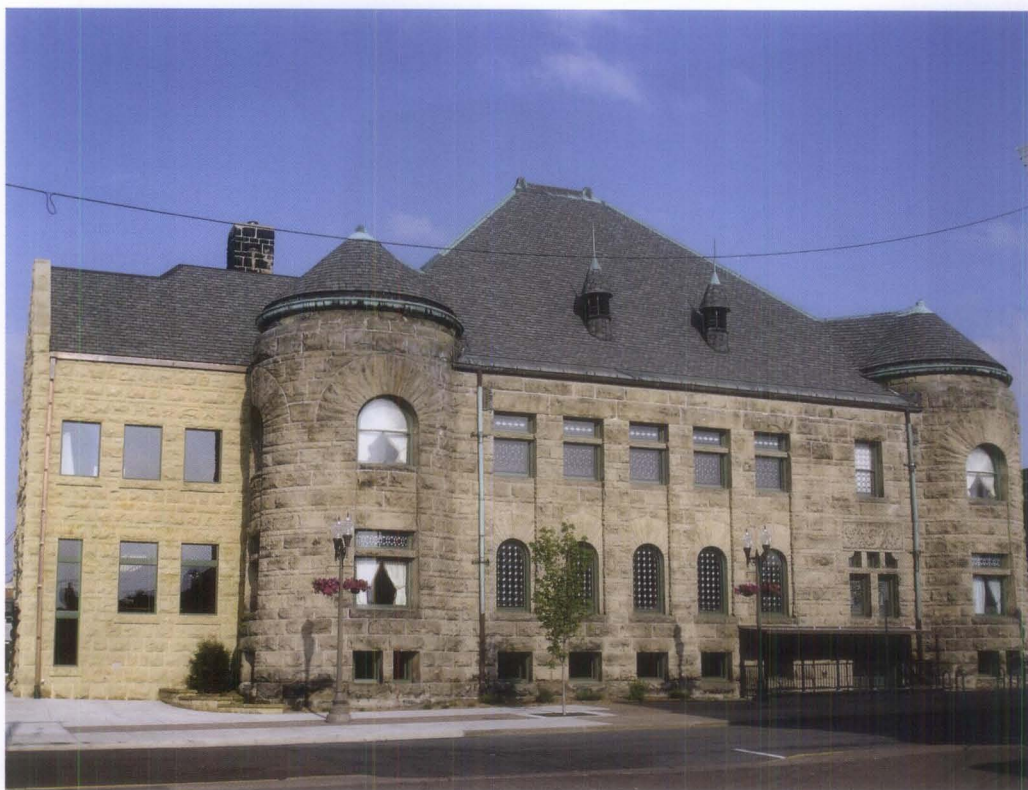
Figure 31. An elevator/stair tower was added at the back of this Richardsonian Romanesque-style theater when it was rehabilitated. Rough-cut stone and simple cut-out openings ensure that the addition is compatible and subordinate to the historic building. Photo: Chuck Liddy, AIA.
