# OHIO HISTORIC INVENTORY

1. No.	4. Present Name(s) Residence, Brian Strachan
2. County Summit	5. Other Name(s) Brown-Strong House
3. Location of Negatives HHA 37-37

DEMOLITION PLAN

**FORSYTH RESIDENCE**  
258 NORTH MAIN STREET, Hudson, Ohio 44236

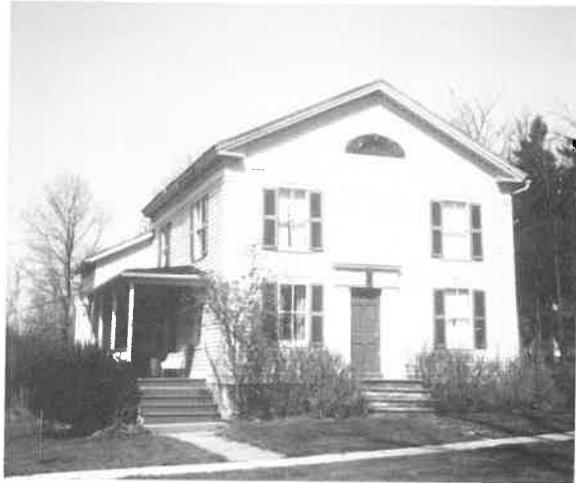
**H** Brown-Strong House  
1834

Greek Revival, with delicate Federal moldings and a noted Asher Benjamin door surround, built in 1834 by Owen Brown for his son, Oliver. Like his father and his brother, John, Oliver was a tanner. In 1836, the house was sold to Brown's fellow Abolitionist, Ephraim Strong. At one time Ephraim's son, Nathan, carried on his father's business here, and his daughter, Mary, conducted the Hudson Female Seminary on the property. The foundation is tooled sandstone, with some rough sandstone in the rear; the southeast corner porch is an addition.
