# OHIO HISTORIC INVENTORY

1. No.		4. Present Name(s)	
2. County Summit		5. Other Name(s)	
3. Location of Negatives HHA 38-12			
6. Specific Location  252 North Main Street		16. Thematic Category C

17. Date(s) or Period c. 1828	
7. City or Town If Rural, Township & Vicinity Hudson		18. Style or Design Greek Revival	
8. Site Plan with North Arrow  		19. Architect or Engineer

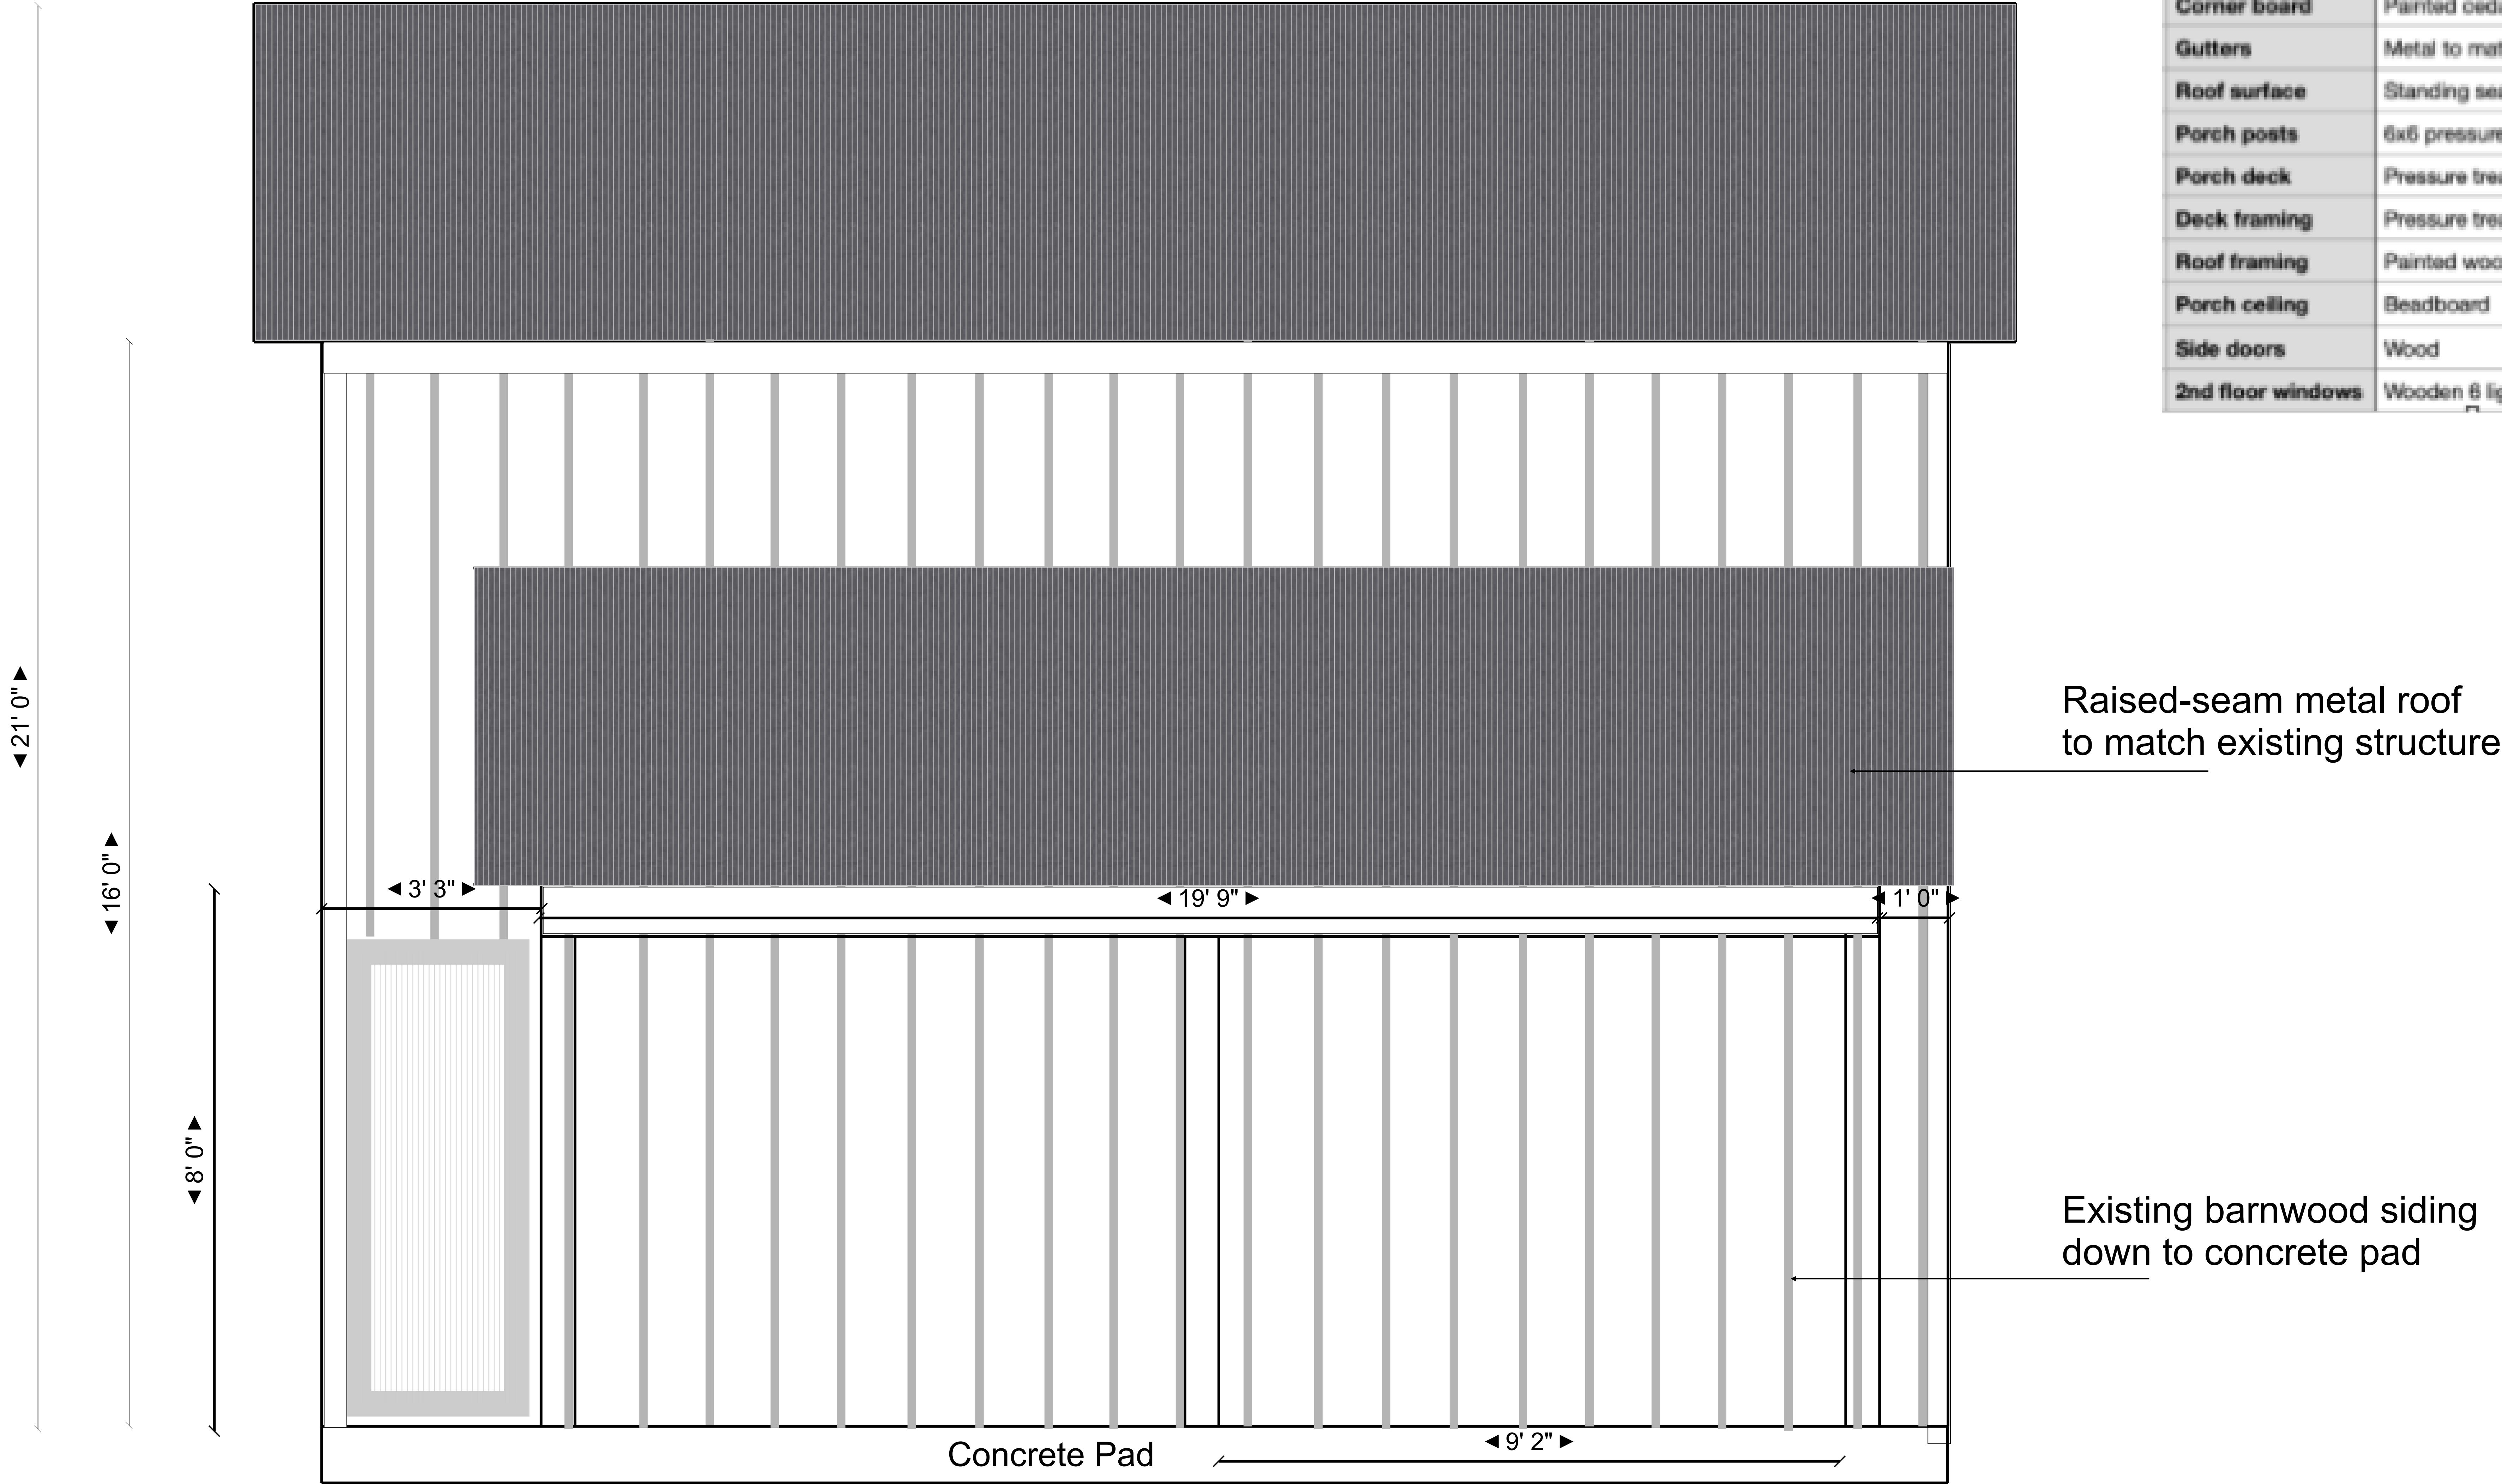
North Elevation

Application	Material/finish	Source	Photo?
Siding	12" barn boards & battens	Existing	Yes
Eave/soffit	Painted wood	New	
Frieze board	Painted wood	New	
Corner board	Painted cedar	New	
Gutters	Metal to match existing	New	
Roof surface	Standing seam metal	New (as main roof)	
Porch posts	6x6 pressure treated	New	
Porch deck	Pressure treated 5/4x6" boards	New	
Deck framing	Pressure treated lumber	New	
Roof framing	Painted wood lumber	New	
Porch ceiling	Beadboard	New	
Side doors	Wood	Reclaimed	Yes
2nd floor windows	Wooden 6 lights	Reclaimed sash	Yes

Horizontal boards to be removed and replaced with vertical siding to match existing barn

Horizontal boards to be removed and replaced  
with vertical siding to match existing barn

Horizontal boards to be removed and replaced with vertical siding to match existing barn
