# **MEMO**

Re: 172 Aurora Street

### SUBJECT PROPERTY: 172 Aurora Street

At the request of the City of Hudson, Ohio and per their Codified Ordinances Section 1202.04(b)(3), Perspectus is providing this advisory report to assist the Architectural and Historic Board of Review (AHBR) in their review of the Owner Application requesting alterations to the designated historic property. The following were applied as it pertains to this application under the Codified Ordinances Appendix D. - Architectural Design Standards Section III-2.b.(1):

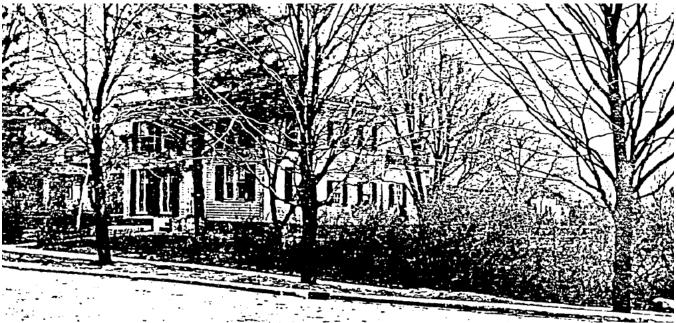
Image 1: Date 1918. Courtesy of the Hudson Historical Society. Note the paired windows on the right side of the front (north) elevation.

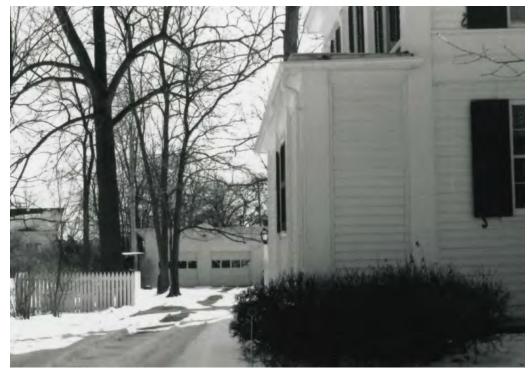
Image 2: Photograph included in the 1989 National Register Historic District Boundary Increase. Caption on the back of the photo states, "1920 Garage, 172 Aurora Street."

11. **Proposed changes #17-18** are <u>not appropriate</u> as the garage is listed as a contributing building to the Historic District. Removal of the garage will be removing a historically significant structure.

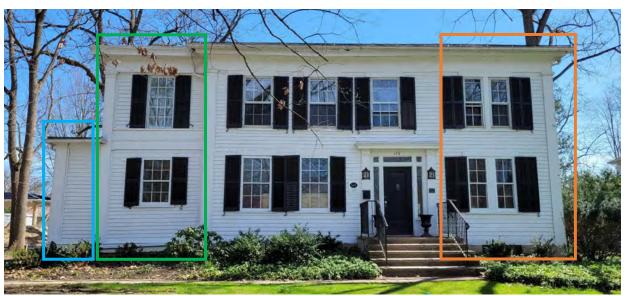
Image 3: Front (north) elevation. The orange box indicates the 1913 addition. The green box indicates the 1925 addition. The blue box indicates an addition with an unknown date.

- 1. Proposed Changes #1-3 are not appropriate because of the proposed removal of what appears to be historic materials from the site. The Secretary of the Interior Standards (SIS), #4, states that "changes to a property that have acquired historic significance in their own right will be retained and preserved." The period of significance for the District ends in 1963, any modifications which have happened up to c1963 have acquired historical significance. Note the construction date of the rear-most addition, which attaches to the 1913 addition, is unknown, but appears to date to within the period of significance based upon cursory observations of the condition of the wood materials.

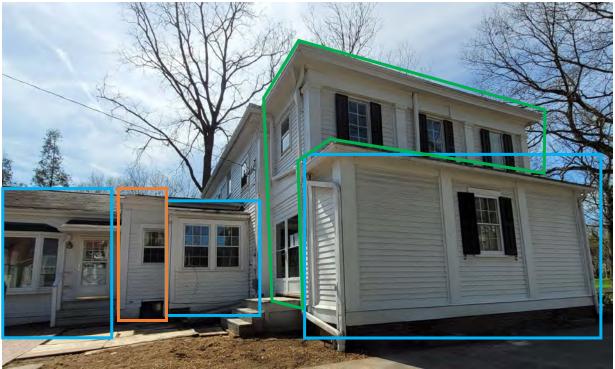
Image 4: Side (east) elevation. The orange block indicates the 1913 addition. The green box indicates the 1925 addition. The blue boxes indicate an addition with an unknown date.

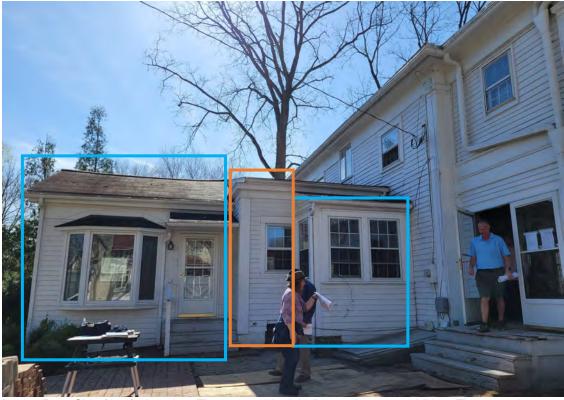
Image 5: Side (east) elevation. The orange block indicates the 1913 addition. The green box indicates the 1925 addition. The blue boxes indicate an addition with an unknown date.

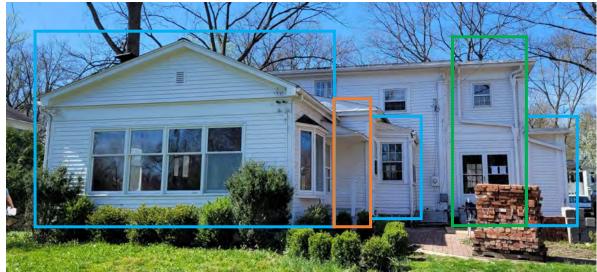
Image 6: Rear (south) elevation. The orange block indicates the 1913 addition. The green box indicates the 1925 addition. The blue boxes indicate an addition with an unknown date.

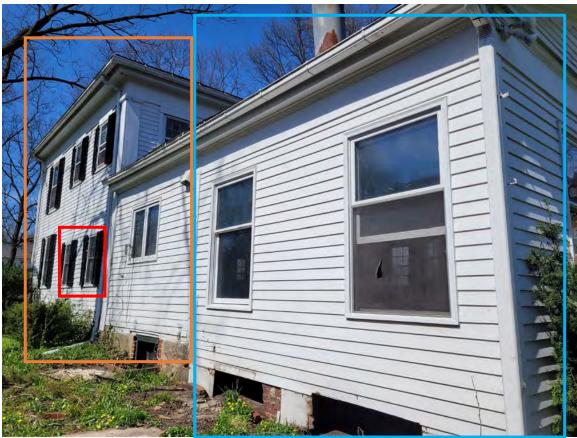
Image 7: Side (west) elevation. The orange block indicates the 1913 addition. The green box indicates the 1925 addition. The blue boxes indicates an addition with an unknown date. The red boxes indicate the vinyl replacement windows.

9. **Proposed Change #13** is <u>can become appropriate</u> because the proposed replacement window is a vinyl-clad wood. Detail drawings should be provided to see how accurately a vinyl-clad wood window can match historic profiles. It is also in our qualified professional opinion that the historic wood windows are in serviceable condition.

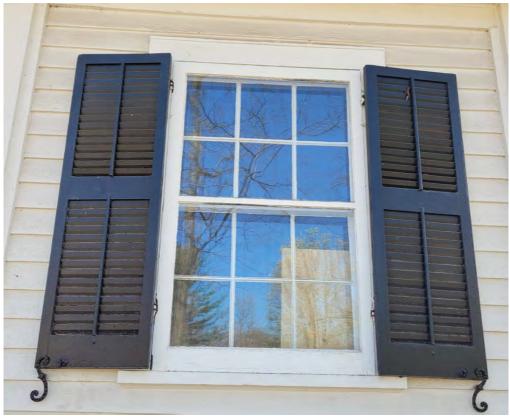
Image 8: Detail of a typical wood window and shutters to be replaced.

- 3. **Proposed Change #5** is <u>not appropriate</u> because, upon cursory review, the shutters appear not to be in a state of deterioration requiring full replacement. If in fact they are deteriorated beyond the state of repair documentation should be provided showing evidence of the deterioration. To comply with SIS #6, "Where the severity of deterioration requires replacement of a distinctive feature, the new feature shall match the old in design, color, texture, and other visual qualities, and where possible, materials."

8. **Proposed Changes #11-12** are <u>not appropriate</u> because of the proposed removal of the historic wood windows, which does not comply with SIS #6 as it will remove what appears to be historic materials from the site. The SIS #4 also applies to the removal of historic wood windows because while the windows may not be original to the house they appear to date within the period of significance (before1963). The exception is the two side (west) windows which are non-historic vinyl replacements.

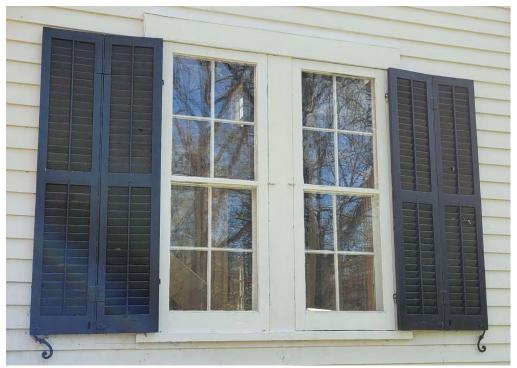
Image 9: Detail of front (north) historic wood paired window to be replaced.

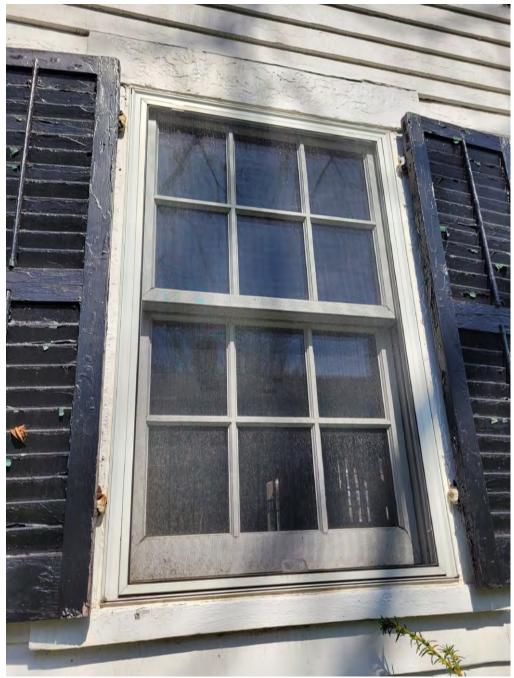
Image 10: Detail of typical vinyl replacement window to be replaced.

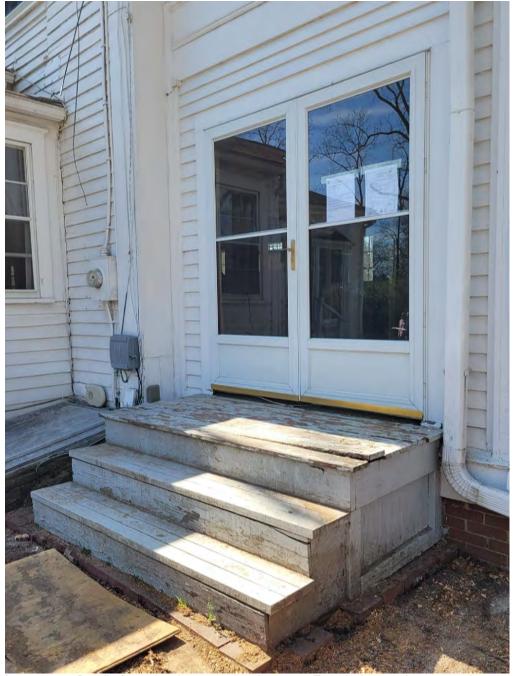
Image 11: Detail of wood staircase and replacement French doors to be removed.

- 6. **Proposed Change #9** is <u>appropriate</u> as the stairs and French doors appear to be outside the period of significance.
- 7. **Proposed Change #10** is <u>appropriate</u> because based upon cursory review (from the ground) of the existing roofing, it was determined that the existing roofing appears to be black asphalt shingles (non-historic).

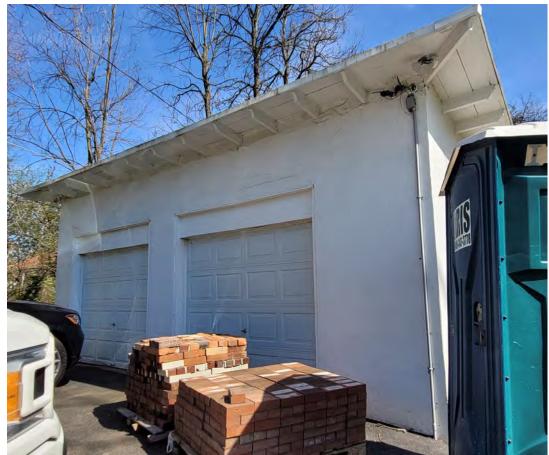
Image 12: Front (north) of garage.

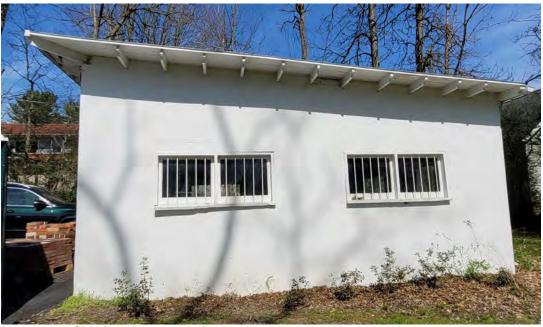
Image 13: Side (west) elevation of garage.

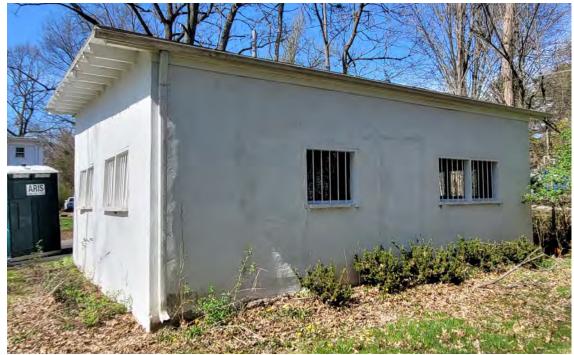
Image 14: Rear (south) of garage.
