PHYSICAL CONDITION REPORT

OTIC DESIGN PROJECT NO. 71-22-12 PROSPECT ROAD BRIDGE (CR 34) OVER THE OHIO TURNPIKE MILEPOST 182.1 SUMMIT COUNTY, OHIO

PHYSICAL CONDITION REPORT
Prospect Road Bridge Over the Ohio Turnpike, Milepost 182.1

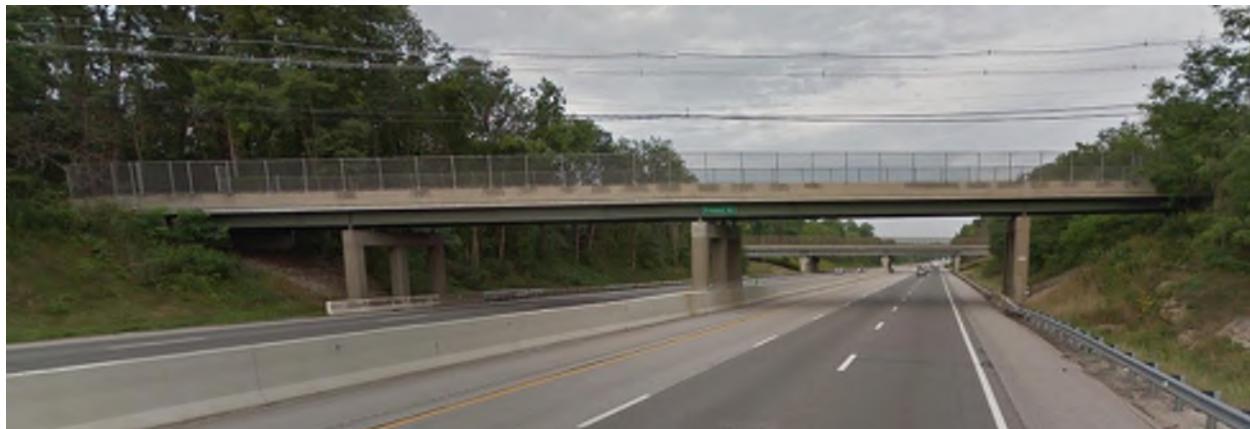
Photograph #1 - Partial Elevation of Right Fascia (looking West)

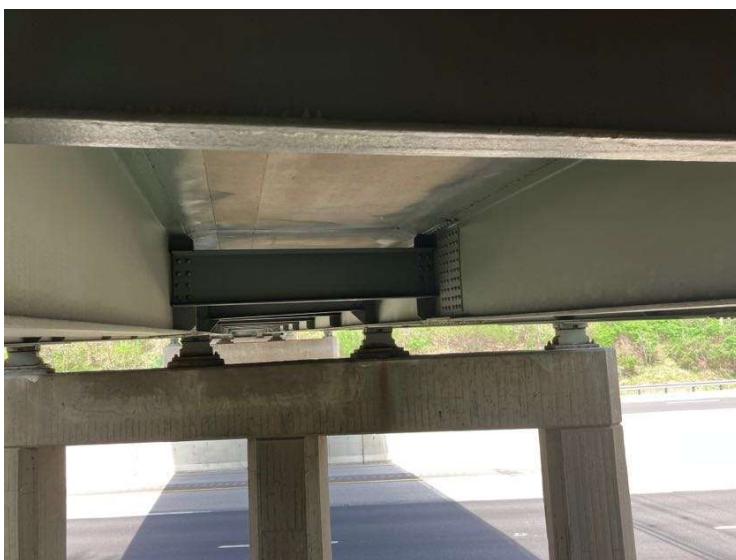
PHOTO 2
View of structure underside. No utilities were affixed.
